ENVIRONMENTAL MONITORING & AUDIT MONTHLY REPORT

November 2016

Contract Name: Castle Peak Road Trunk Sewer and Tuen Mun

Title of Project: Sewage Pumping Stations at Tai Lam Chung Tsuen

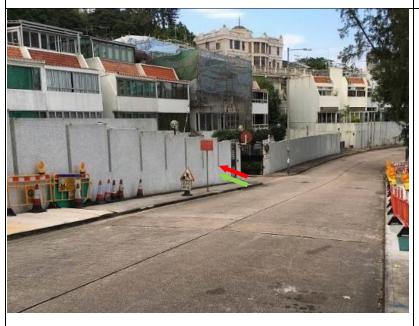
LC6a: The Castle Bay

- 1) LC6a: The air and noise monitoring station is set at a point 1m from the exterior of the sensitive receiver fence wall, and set at a position 1.2m above ground. Façade measurement will be carried out for noise monitoring.
- 2) LC9: The air monitoring station is set at the top of parapet wall of sensitive receivers building and the noise monitoring station is set at a point 1m from the exterior of the sensitive receivers building façade and set at a position 5m above the ground.

- 3.5.1 The monitoring procedures are as follows:
 - Monitoring Stations:
 - LC6a: The monitoring station was set at a point 1m from the exterior of the sensitive receiver fence wall and set at a position 1.2m above the ground. Façade measurement is carried out for noise monitoring.

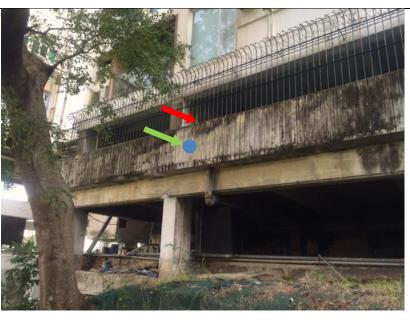
LC9: Castle Peak Villas Block C

- LC9: The monitoring station was set at the top of parapet wall of sensitive receivers building and the noise monitoring station is set at a point 1m from the exterior of the sensitive receivers building facade and set at a position 5m above
