ENVIRONMENTAL MONITORING & AUDIT MONTHLY REPORT

August 2017

Contract Name : Castle Peak Road Trunk Sewer and Tuen Mun Village Sewerage (Sewage Pumping Station at Lok Chui Street near Castle Peak Villas)

Contract No. : DC/2014/01

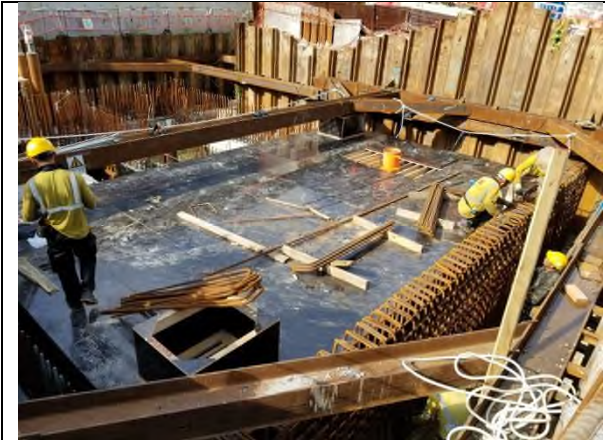
Table 1.2 Works undertaken Illustrations

<p>Construction of Pumping Station</p>

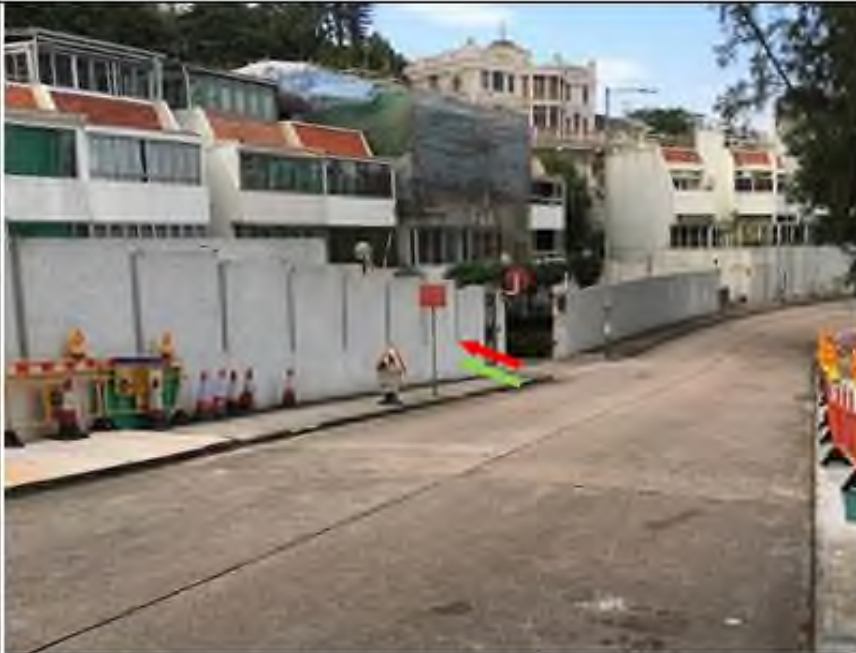
LC6a: The Castle Bay

- 1) LC6a: The air and noise monitoring station is set at a point 1m from the exterior of the sensitive receiver fence wall, and set at a position 1.2m above ground. Façade measurement will be carried out for noise monitoring.
- 2) LC9: The air monitoring station is set at the top of parapet wall of sensitive receivers building and the noise monitoring station is set at a point 1m from the exterior of the sensitive receivers building façade and set at a position 5m above the ground.

- Monitoring Stations:
 - LC6a: The monitoring station was set at a point 1m from the exterior of the sensitive receiver fence wall and set at a position 1.2m above the ground. Façade measurement is carried out for noise monitoring.
