Entrusted Portion of Widening of Tolo Highway / Fanling Highway between Island House Interchange and Fanling Stage 2

Monthly EM&A Report

May 2016

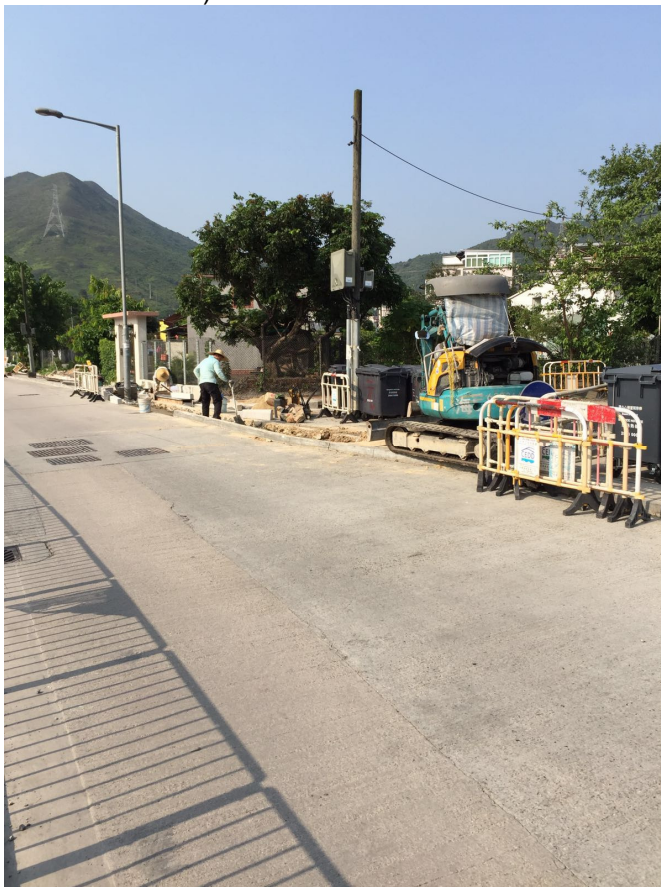
Photo 1: Road Works observed near the Noise Monitoring Station (Date: 16 May 2016)

Action taken / to be taken	As the exceedance was non-project related, no further investigation and specific remedial measure(s) would be recommended for the Entrusted Works. Nevertheless, the following mitigation measures had been implemented on-site for noise control: <ol style="list-style-type: none">1. Vessels and equipment operating should be checked regularly and properly maintained; and2. Operation of construction plants should be sequenced where practicable.
Remarks	-

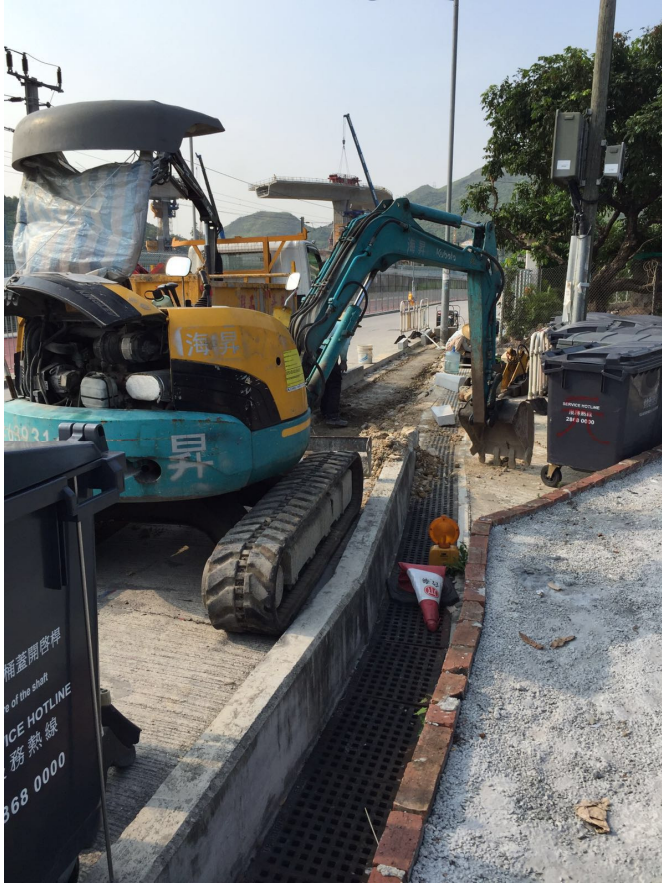
Photo 2: Excavator used for the excavation (Date: 16 May 2016)
