Entrusted Portion of Widening of Tolo Highway / Fanling Highway between Island House Interchange and Fanling Stage 2

Monthly EM&A Report

July 2016

Meinhardt Infrastructure and Environment Ltd

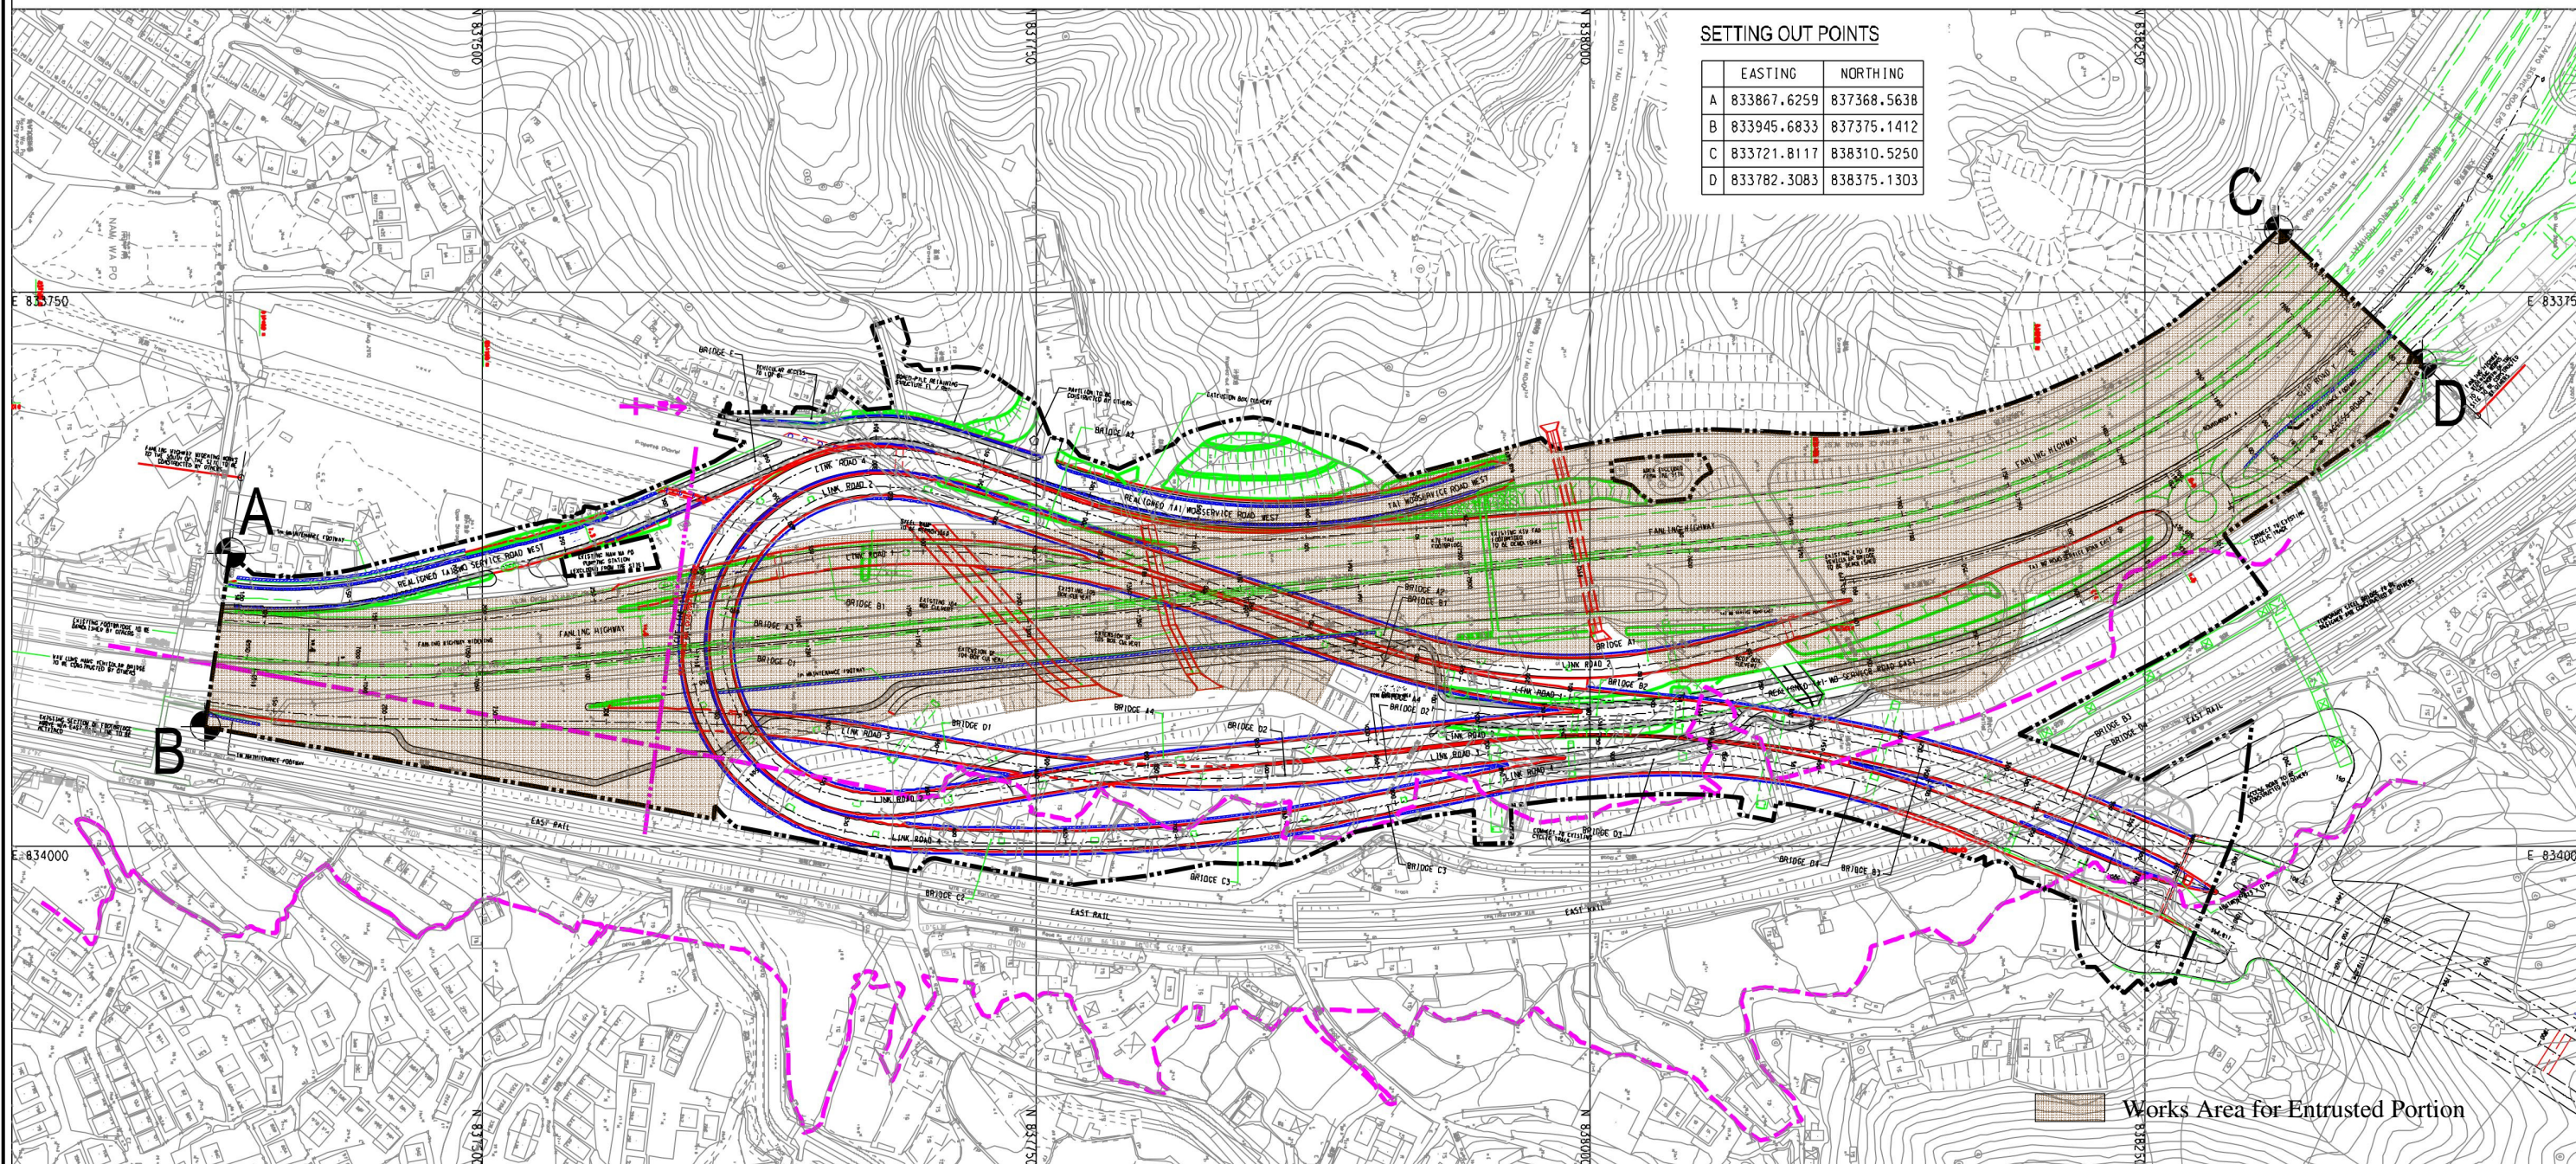
2.2.2 **Figure 1** shows the works areas for the Entrusted Portion of Widening of Tolo Highway / Fanling Highway between Island House Interchange and Fanling Stage 2.
