Contract No. EP/SP/61/10
Organic Resources Recovery
Centre (Phase 1):
Fifty-fourth Monthly EM&A Report

1 November 2019 – 30 November 2019

**Organic Resources Recovery Centre,
Phase I**

Monthly EM&A Report
(1 November 2019 – 30 November 2019)

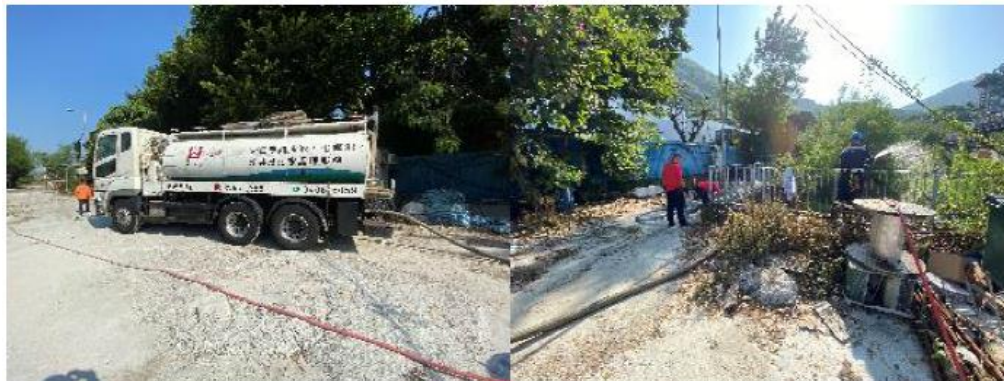
Figure.1 Vacuum tanker was arranged to cleanup the nullah

On 5/11/2019 morning at around 7:50am, black water was found discharging to the nullah from the storm water discharge channel. The team immediate carried out investigation to identify if there had any leakage from the plant. It was found that suspension was overflowed from the overflow tank of IDT to the surface channel inside AD tanks farm. Operation Team immediate contacted the Central Control Room to stop all feedings to the IDT. The suspension was stopped overflowed from the IDT overflow tank immediately.

The team immediate arranged to clean up the spillage inside the tank farm, nearby surface channel and around the IDT. A vacuum tanker truck was also immediate arranged to clean up the suspension at the nullah (Figure 1). All the cleanup work was completed at around 11:00am. (Figure 2 and 3)

1. Stopped all the feedings to the IDT
2. Arranged to clean up the suspension leaked to the nullah by a vacuum tanker truck
3. Arranged to clean up the suspension at the surface channel near the IDT
