**Contract No. EP/SP/58/08 – Sludge Treatment Facilities  
Environmental Monitoring Results in Operation Phase – Monthly HCMP Reports (May 2016)**

**Contract EP/SP/58/08 Sludge Treatment Facilities**

**OPERATIONAL PHASE ECOLOGICAL MONITORING OF GREBE  
POND IN ACCORDANCE WITH THE APPROVED HABITAT  
CREATION AND MANAGEMENT PLAN**

2016-05

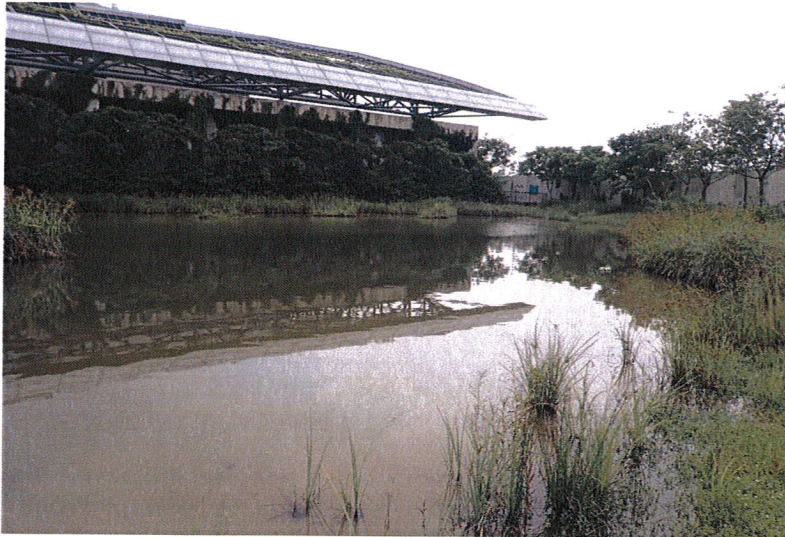
**Plate 1**

Management Activities Required	Action
Minor remedial work:	<ul style="list-style-type: none"> <li>No fish or fry were observed in the Pond (<b>Plate 1</b>).</li> <li>The Landscape Contractor should remove all snails and destroy egg masses during their routine maintenance work in the Pond. At least weekly removal of Apple Snails is recommended.</li> <li>As a routine maintenance practice, the landscape contractor should remove the unwanted climbers (<i>Mikania micrantha</i> and <i>Acacia concinna</i>) and the self-seeded small tree <i>Tamarix chinensis</i>. All vegetation should be disposed away from the Grebe Pond.</li> <li>A Red Imported Fire Ant (RIFA) nests was observed at the Pond gate (<b>Plate 2</b>). Any RIFA nest observed on site should be treated with pesticide as soon as possible to</li> </ul>	<ul style="list-style-type: none"> <li>NA</li> <li>Contractor</li> <li>Contractor</li> <li>Contractor</li> </ul>

The Grebe Pond.

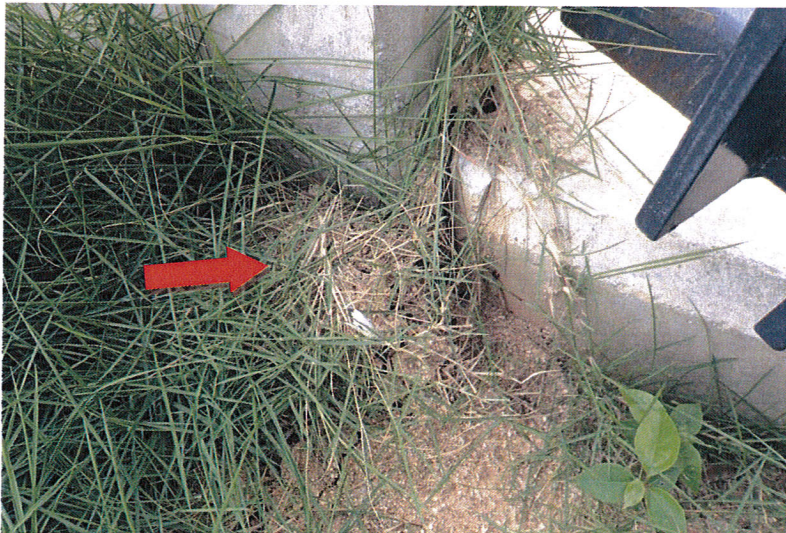
**Plate 2**

Red Imported Fire Ant (RIFA) nests were observed around the Little Grebe pond.

<ul style="list-style-type: none"> <li>prevent further spreading.</li> <li>Grass cutting is needed around the pond (<b>Plate 3</b>).</li> </ul>	<ul style="list-style-type: none"> <li>Contractor</li> </ul>
<b>Minor Comments:</b>	<ul style="list-style-type: none"> <li>Less rubbish was noted in the Pond area. The Contractor should continue to remove the rubbish during the routine maintenance work.</li> </ul>	<ul style="list-style-type: none"> <li>Contractor</li> </ul>
<b>Water quality checks:</b>	<ul style="list-style-type: none"> <li>Water quality checks will normally form part of the Operational Phase monitoring of the Grebe Pond as per Section 8, Table 7 of the Habitat Creation and Management Plan. Summarised water quality results are shown in <b>Table 2</b> below.</li> <li>The water level of the pond is approximately at the +5.6mPD level, no water level adjustment is required.</li> <li>As a reminder, only freshwater can be pumped into the Grebe Pond. The contractor should regularly check the salinity level of the pumped water and avoid pumping water with high salinity level.</li> </ul>	<ul style="list-style-type: none"> <li>NA</li> <li>Contractor</li> <li>Contractor</li> </ul>

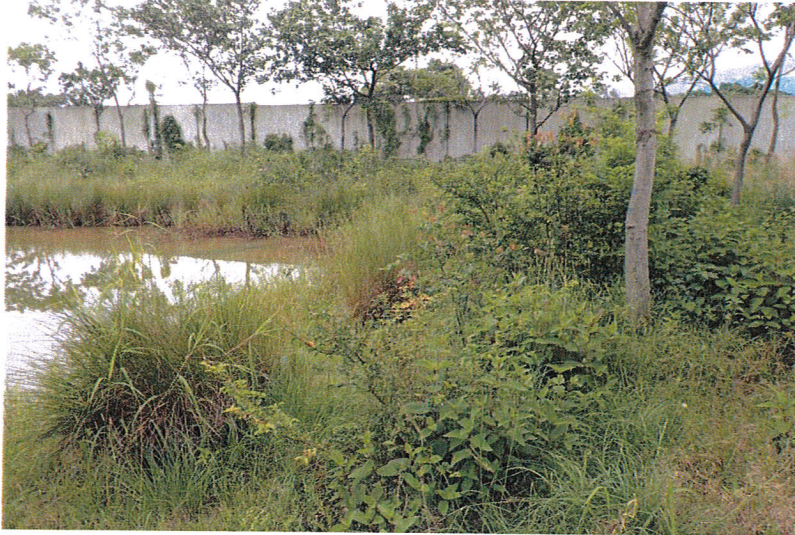
**Plate 3**

Grass around the Pond needs cutting.
