Contract EP/SP/58/08 Sludge Treatment Facilities

ESTABLISHMENT PHASE ECOLOGICAL MONITORING OF GREBE POND IN ACCORDANCE WITH THE APPROVED HABITAT CREATION AND MANAGEMENT PLAN

ECOLOGICAL MONITORING OF GREBE POND IN ACCORDANCE WITH THE APPROVED HABITAT CREATION AND MANAGEMENT PLAN 2015-07

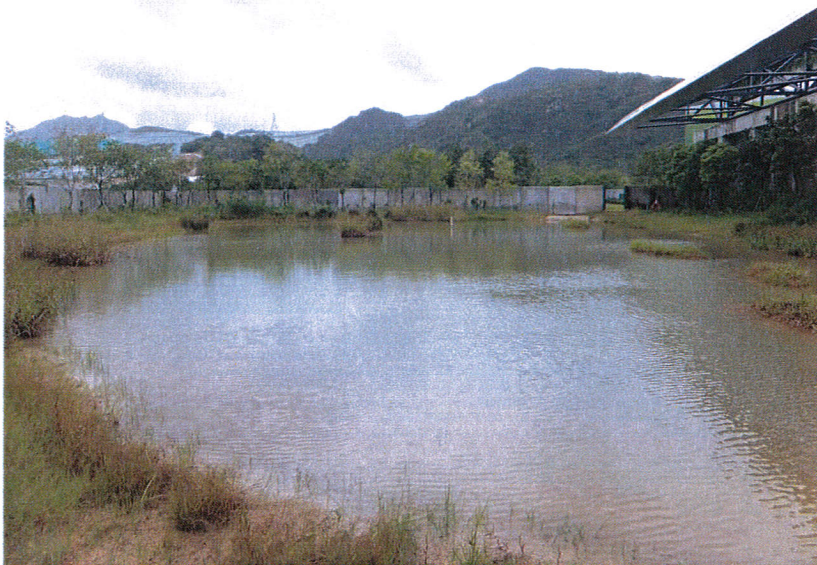
Plate 1

The Grebe Pond is fully filled after the recent rainstorm.

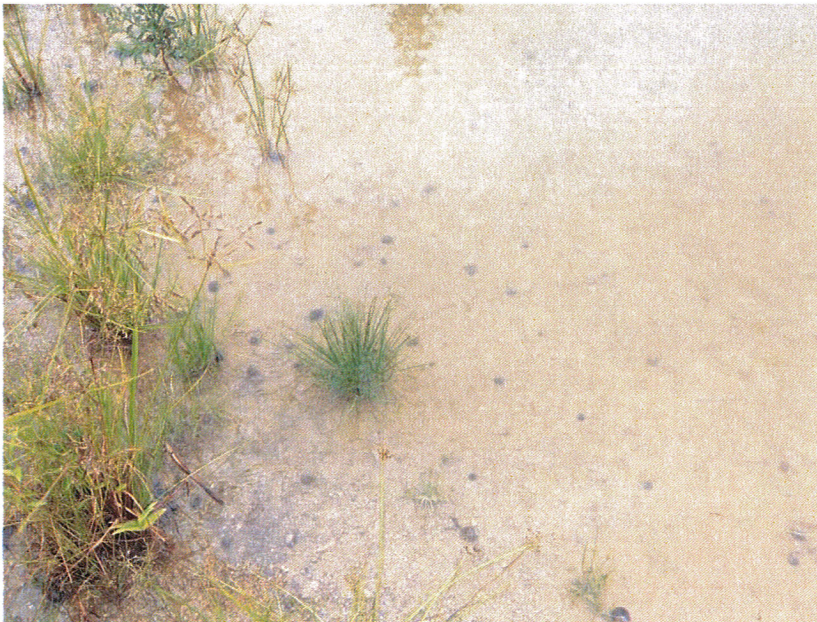
Plate 2

Apple Snails were sometimes noted along the pond edge.

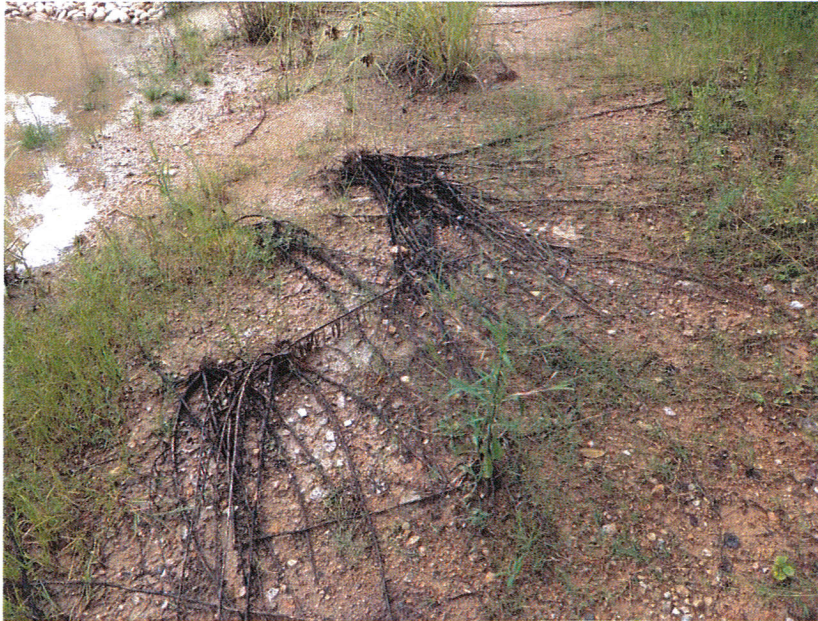
Plate 3

Naturally established herb *Conyza sumatrensis* was uprooted by the landscape contractor as a routine maintenance practice, but the removed plant debris was not disposed away from the Grebe Pond.

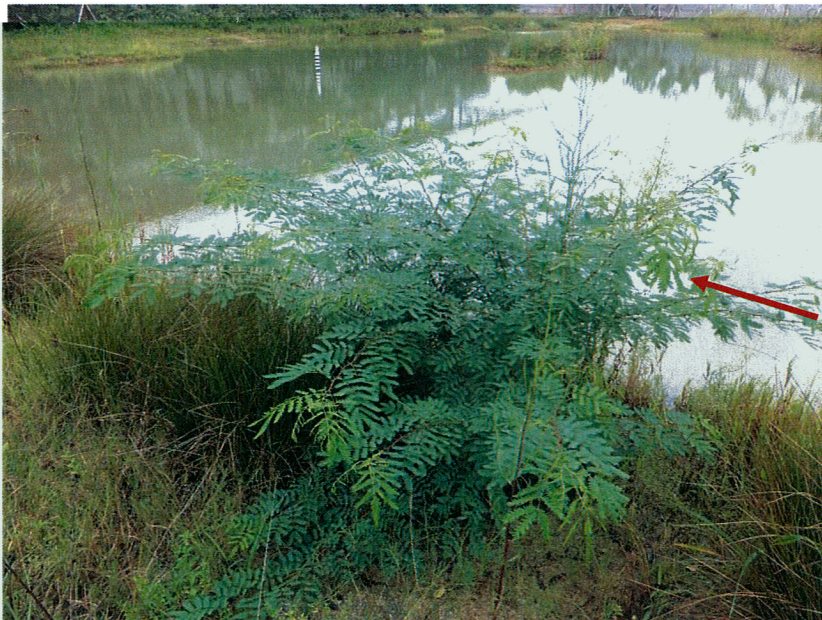
Plate 4

The landscape contractor should remove the unwanted climbers *Acacia concinna* located at the southern edge of the pond.

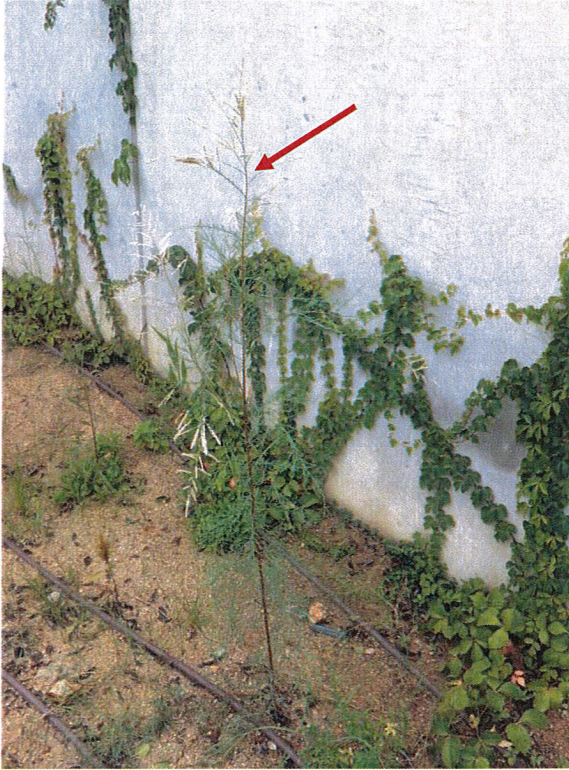
Plate 5

The landscape contractor should remove the seedlings of small tree *Tamarix chinensis* in the whole Grebe Pond area.

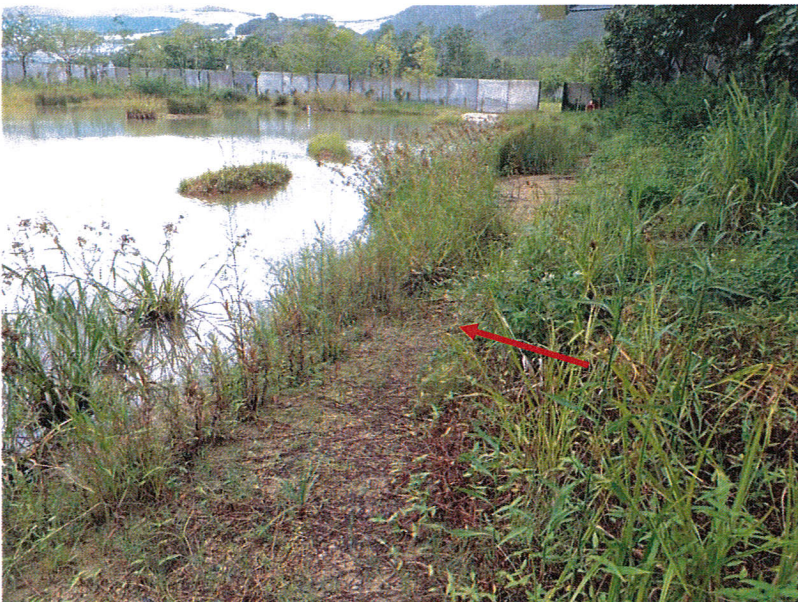
Plate 6

The path was progressively covered by the creeping wetland herbs, but some sections of the path were still as a bare ground.

<p>a result of excessive, unauthorized access. This path has developed some cover from creeping wetland herbs, but some sections of the path are still bare ground (Plate 6). Remedial planting work is still required to provide suitable riparian habitat by planting creeping wetland herbs and emergent vegetation. This area should be restricted from general access. Instruction for planting wetland herbs will be provided to the landscape contractor in early July.</p>	
Minor Comments:	<ul style="list-style-type: none"> • Access to the Grebe Pond via the northwestern corner and main gate was unobstructed, with neither end closed off (Plate 7) during the site inspection on 23rd July 2015. The Contractor should regularly inspect the condition of the barriers and remind the workers not to enter the Grebe Pond unless routine pond and landscape maintenance. • The densities of the floating vegetation and wetland plants on the islands and creeping herbs planted along the riparian zone have been improved. • Less rubbish was noted in the Grebe Pond area. The Contractor should remove the rubbish during the routine maintenance work. • Excessive rainwater was trapped in a low-lying area at the eastern boundary of the Grebe Pond (Plate 8). Such condition is regarded as temporary, but the Contractor may need to review if this may influence the normal operation of the civil structure underneath. 	<ul style="list-style-type: none"> • Contractor • NA • Contractor • Contractor

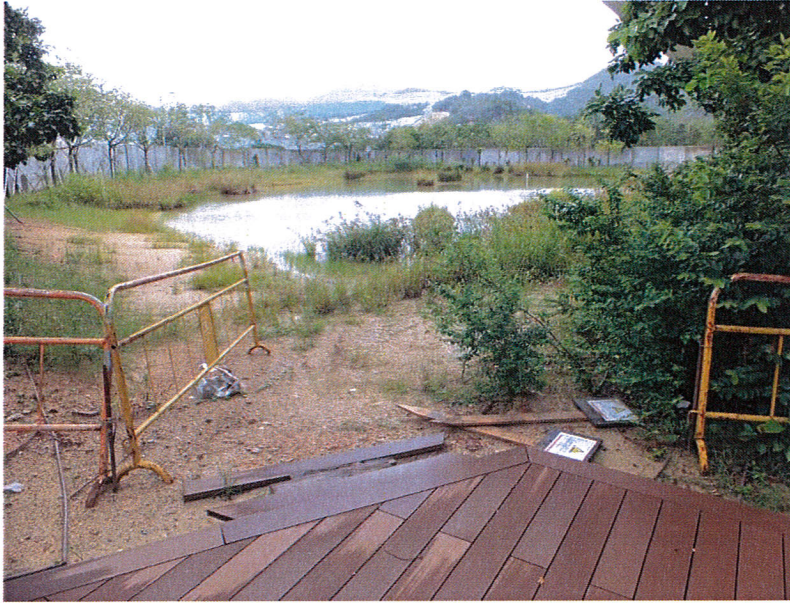
Plate 7

The barriers at the northwestern corner of the Grebe Pond were opened as observed on 24th July 2015.

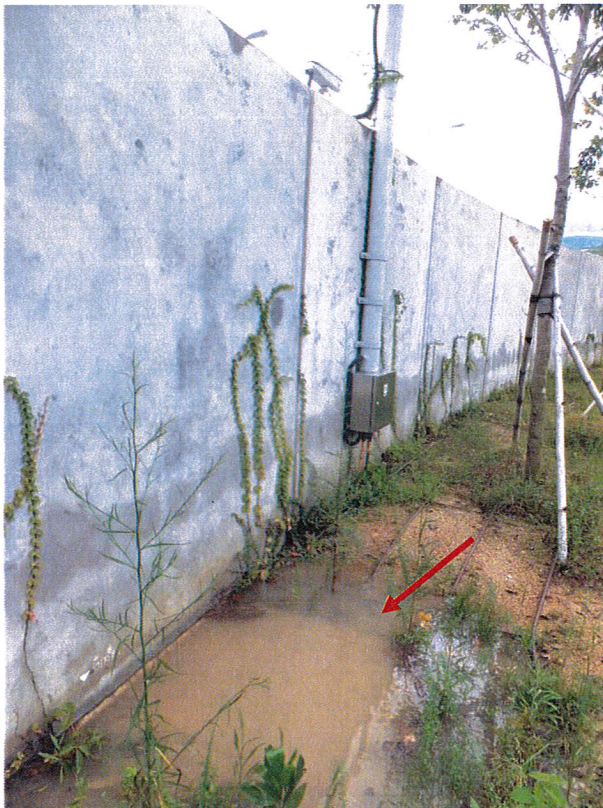
Plate 8

Excessive rainwater was trapped in a low-lying area at the eastern boundary of the Grebe Pond.

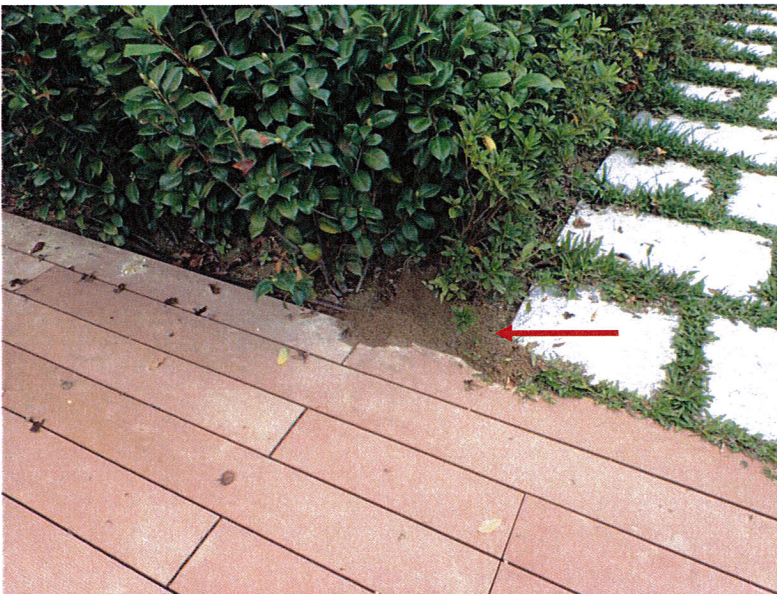
Plate 2

Red Imported Fire Ant (RIFA) nest was observed at the northwestern corner of the Grebe Pond.

<ul style="list-style-type: none"> A Red Imported Fire Ant (RIFA) nest was observed at the northwestern corner of the Grebe pond (Plate 2). Any RIFA nest observed on site should be treated with pesticide as soon as possible to prevent spreading. Access to the Pond via the northwestern corner and main gate was unobstructed, with neither end closed off during the site inspection on 31st August 2015. This gate should be locked and a suitable barrier erected in the NW corner as the presence of humans will reduce the potential for the Pond to be utilised by Little Grebes. There should be no unauthorized access. 	<ul style="list-style-type: none"> Contractor Contractor
Minor Comments:	<ul style="list-style-type: none"> Less rubbish was noted in the Pond area. The Contractor should remove the rubbish during the routine maintenance work. 	<ul style="list-style-type: none"> Contractor
Water quality checks:	<ul style="list-style-type: none"> Water quality checks will normally form part of the Establishment Phase monitoring of the Grebe Pond as per Section 8, Table 7 of the Habitat Creation and Management Plan. The measured water quality parameters are within Action Level of the Contingency Plan (Table 8 in HCMP) (see Table 2 below). The level pole showed that the water level of the pond almost reached +5.6mPD as inspected on July 2015. As a reminder, only freshwater can be pumped into the Grebe Pond. The contractor should regularly check the salinity level of the pumped water and avoid pumping water with high salinity level. 	<ul style="list-style-type: none"> NA NA NA Contractor

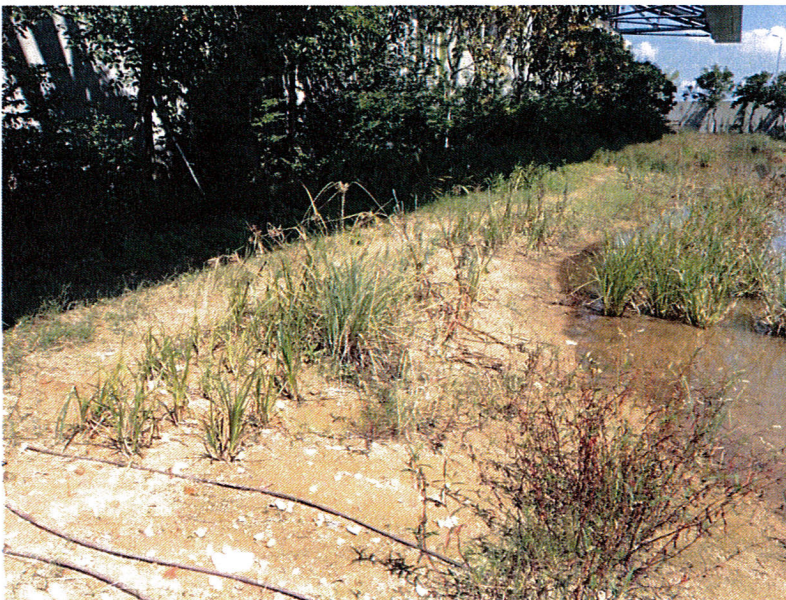
Plate 2

The path was progressively covered by the creeping wetland herbs, but some sections of the path were still as a bare ground.

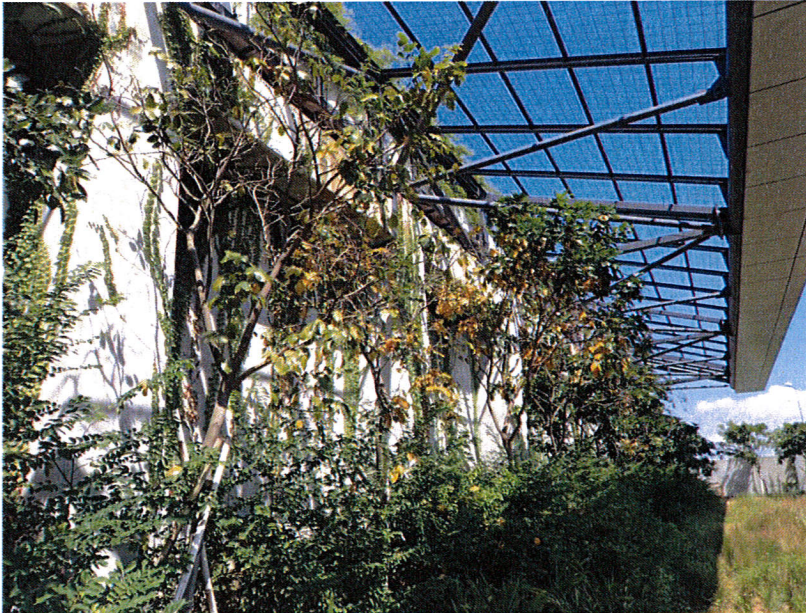
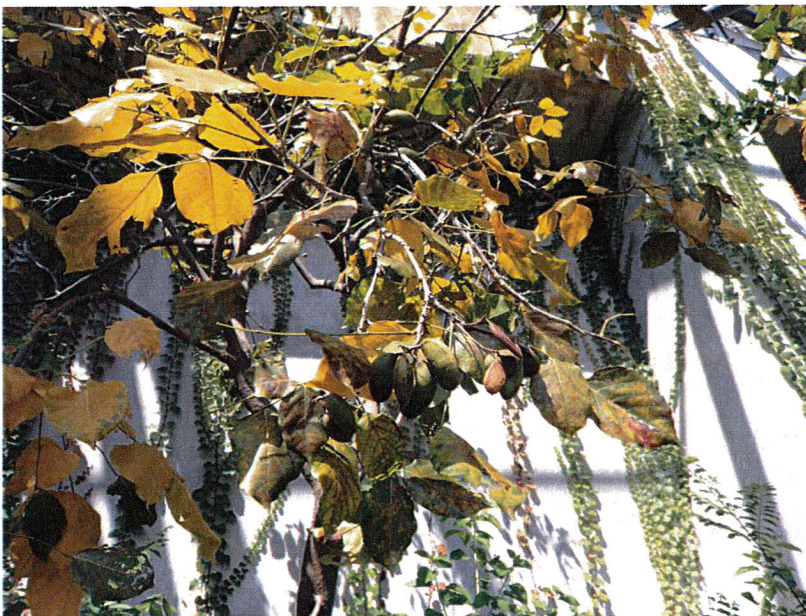
Plate 3

Dry leaves were observed on four trees *Pongamia pinnata* along the western side of the pond.

Minor Comments:	<ul style="list-style-type: none"> • Less rubbish was noted in the Pond area. The Contractor should remove the rubbish during the routine maintenance work. • Dry leaves were observed on four trees <i>Pongamia pinnata</i> along the western side of the pond (Plate 3). The Contractor should irrigate these trees regularly. 	<ul style="list-style-type: none"> • Contractor • Contractor
Water quality checks:	<ul style="list-style-type: none"> • Water quality checks will normally form part of the Establishment Phase monitoring of the Grebe Pond as per Section 8, Table 7 of the Habitat Creation and Management Plan. • The measured water quality parameters are within Action Level of the Contingency Plan (Table 8 in HCMP) (see Table 2 below). • The level pole showed that the water level of the pond almost reached +5.6mPD as inspected on July 2015. • As a reminder, only freshwater can be pumped into the Grebe Pond. The contractor should regularly check the salinity level of the pumped water and avoid pumping water with high salinity level. • A water sample has been taken during the site visit for detail analysis at the STF laboratory, as required once every six months by the HCMP. 	<ul style="list-style-type: none"> • NA • NA • NA • Contractor • NA

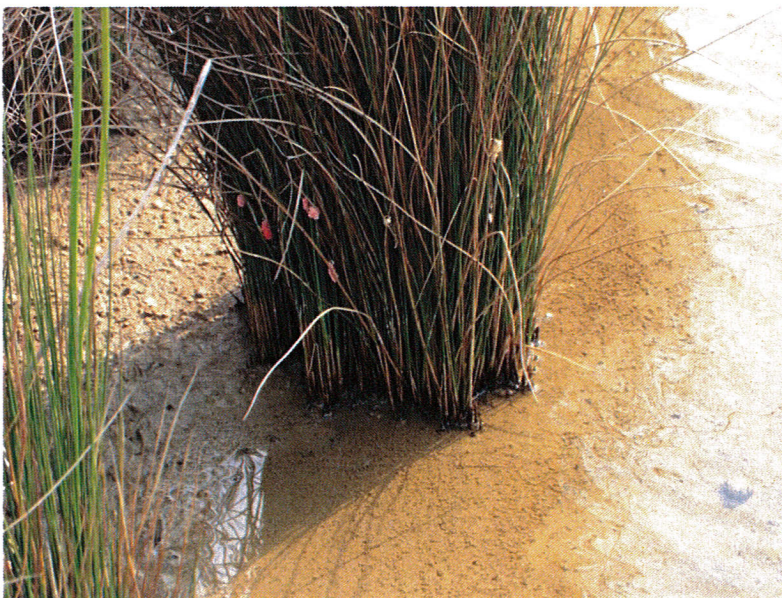
Plate 2

Apple Snails and their egg masses were observed along pond.

Management Activities Required	Action
Minor remedial work:	<ul style="list-style-type: none"> • No fish or fry were observed in the Pond (Plate 1). • Apple Snails and egg masses (Plate 2) were observed along the pond edge and on the emergent plants in the wetland. • The Landscape Contractor should remove all snails and destroy egg masses during their routine maintenance work in the Pond. At least weekly removal of Apple Snails is recommended. • As a routine maintenance practice, the landscape contractor should remove the unwanted climbers (<i>Mikania micrantha</i> and <i>Acacia concinna</i>) and the self-seeded seedlings of the small tree <i>Tamarix chinensis</i>. All vegetation should be disposed away from the Grebe Pond. • A path has developed along the western side of the Pond; a result of excessive, unauthorized access. Remedial planting work is still required by planting creeping wetland herbs and emergent vegetation. This area should be restricted from general access (Plate 3). 	<ul style="list-style-type: none"> • NA • Contractor • Contractor • Contractor • Contractor

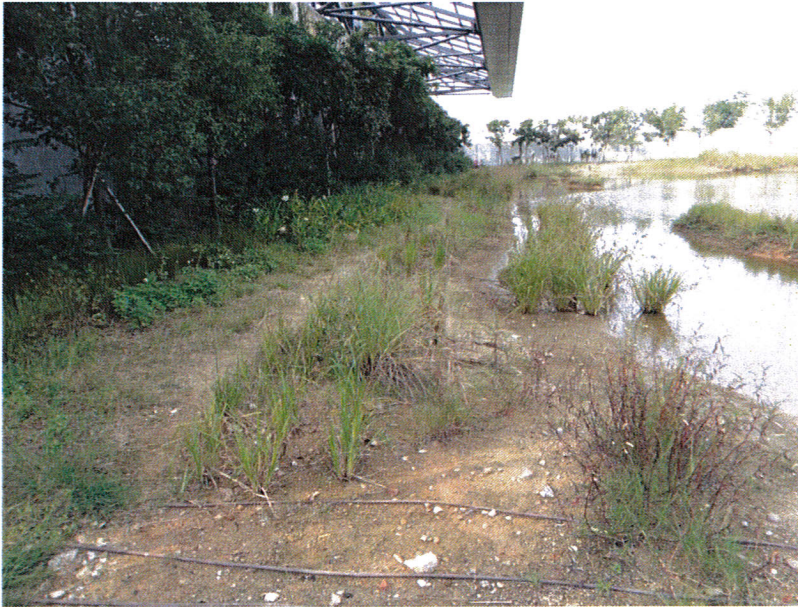
Plate 3

The path was progressively covered by the creeping wetland herbs, but some sections of the path were still as a bare ground.

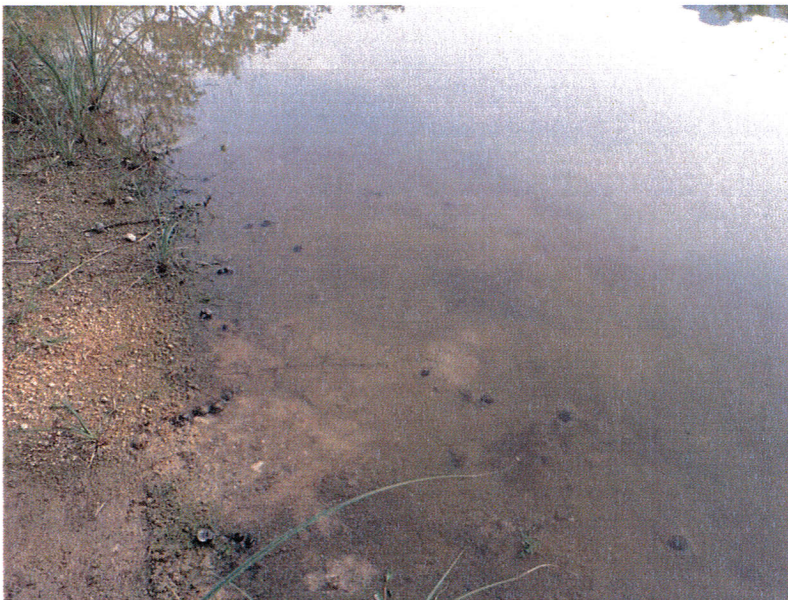
Plate 2

Apple Snails and their egg masses were observed along pond.

Management Activities Required	Action
Minor remedial work:	<ul style="list-style-type: none">No fish or fry were observed in the Pond (Plate 1).Apple Snails and egg masses (Plate 2) were observed along the pond edge and on the emergent plants in the wetland.The Landscape Contractor should remove all snails and destroy egg masses during their routine maintenance work in the Pond. At least weekly removal of Apple Snails is recommended.As a routine maintenance practice, the landscape contractor should remove the unwanted climbers (<i>Mikania micrantha</i> and <i>Acacia concinna</i>) and the self-seeded seedlings of the small tree <i>Tamarix chinensis</i>. All vegetation should be disposed away from the Grebe	<ul style="list-style-type: none">NAContractor Contractor Contractor

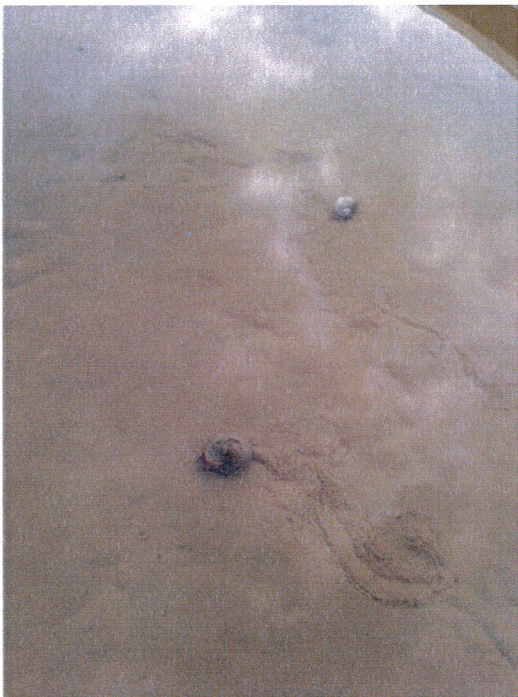
Plate 2

Apple Snails and their egg masses were observed along pond.

Management Activities Required	Action
Minor remedial work:	<ul style="list-style-type: none"> No fish or fry were observed in the Pond (Plate 1). Apple Snails and egg masses (Plate 2) were observed along the pond edge and on the emergent plants in the wetland. The Landscape Contractor should remove all snails and destroy egg masses during their routine maintenance work in the Pond. At least weekly removal of Apple Snails is recommended. As a routine maintenance practice, the landscape contractor should remove the unwanted climbers (<i>Mikania micrantha</i> and <i>Acacia concinna</i>) and the self-seeded small tree <i>Tamarix chinensis</i>. All vegetation should be disposed away from the Grebe Pond. 	<ul style="list-style-type: none"> NA Contractor Contractor Contractor
Minor Comments:	<ul style="list-style-type: none"> Less rubbish was noted in the Pond area. The Contractor should continue to remove the rubbish during the routine maintenance work. The path developed along the western side of the Pond from unauthorised access has been recovered (Plate 3). 	<ul style="list-style-type: none"> Contractor Contractor

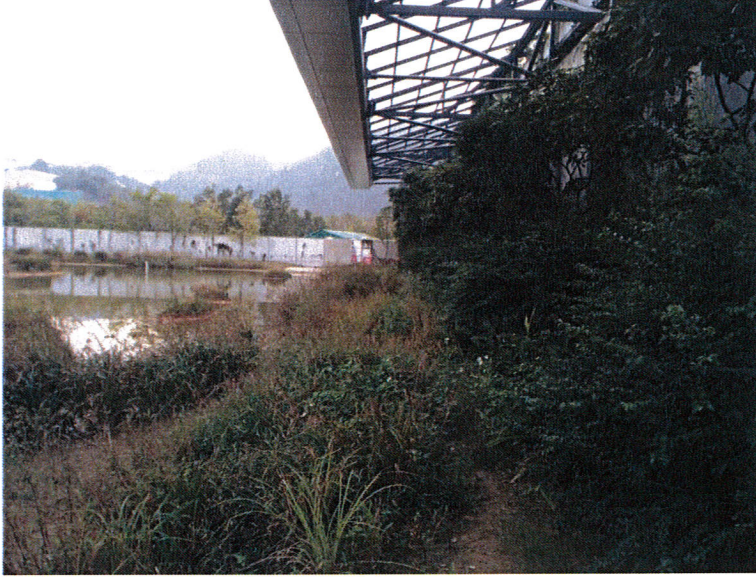
Plate 3

The path along the western side of the Pond from unauthorised access has recovered.

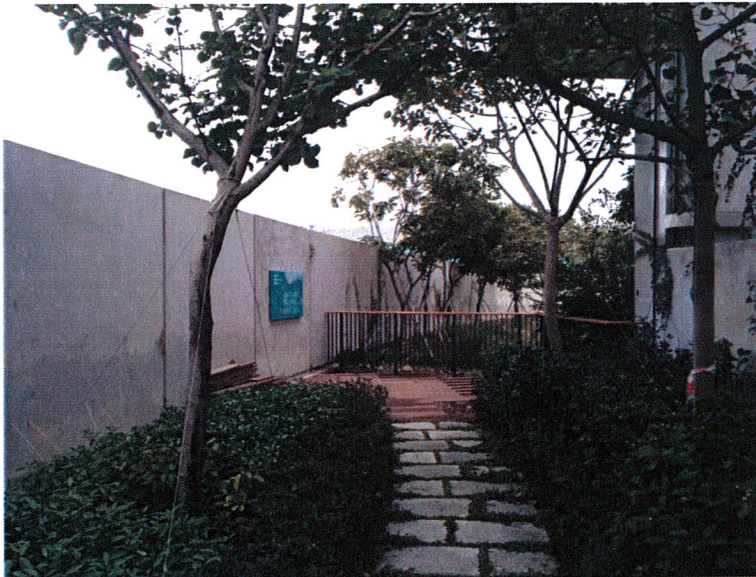
Plate 4

A permanent fence has been installed to restrict general access to the Pond.

<p>General access should continue to be restricted in this area to minimise the level of disturbance to the Pond.</p> <ul style="list-style-type: none"> • A permanent fence has been put in place to restrict general access (Plate 4) 	<ul style="list-style-type: none"> • NA
Water quality checks:	<ul style="list-style-type: none"> • Water quality checks will normally form part of the Operational Phase monitoring of the Grebe Pond as per Section 8, Table 7 of the Habitat Creation and Management Plan. Summarised water quality results are shown in Table 2 below. • The water level of the pond is currently two bars lower than the +5.6mPD level, pumping is required to fill the Pond. • As a reminder, only freshwater can be pumped into the Grebe Pond. The contractor should regularly check the salinity level of the pumped water and avoid pumping water with high salinity level. 	<ul style="list-style-type: none"> • NA • Contractor • Contractor

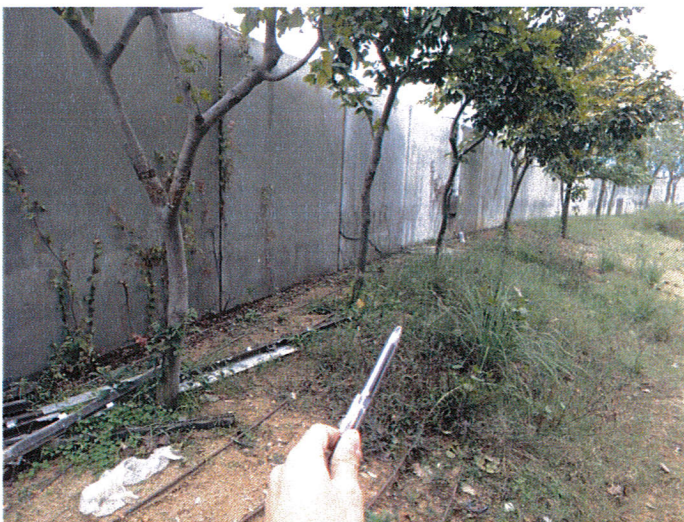
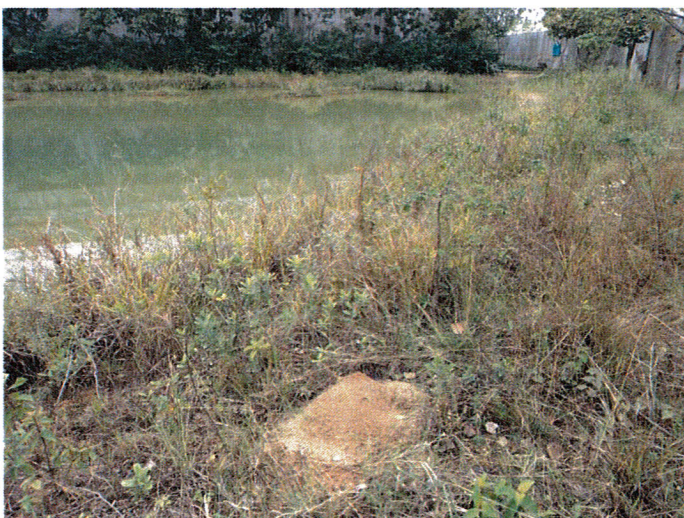
Plate 2

Red Imported Fire Ant (RIFA) nests were observed around the Little Grebe pond.

<ul style="list-style-type: none"> Around ten Red Imported Fire Ant (RIFA) nests were observed around the Grebe pond and at the trees (Plate 2). Any RIFA nest observed on site should be treated with pesticide as soon as possible to prevent further spreading. 	<ul style="list-style-type: none"> Contractor
Minor Comments:	<ul style="list-style-type: none"> Rubbish was noted in the Pond area (Plate 3). The Contractor should remove the rubbish during the routine maintenance work. 	<ul style="list-style-type: none"> Contractor
Water quality checks:	<ul style="list-style-type: none"> Water quality checks will normally form part of the Operational Phase monitoring of the Grebe Pond as per Section 8, Table 7 of the Habitat Creation and Management Plan. Summarised water quality results are shown in Table 2 below. The water level of the pond is currently at the +5.6mPD level, no water level adjustment is required. As a reminder, only freshwater can be pumped into the Grebe Pond. The contractor should regularly check the salinity level of the pumped water and avoid pumping water with high salinity level. 	<ul style="list-style-type: none"> NA Contractor Contractor

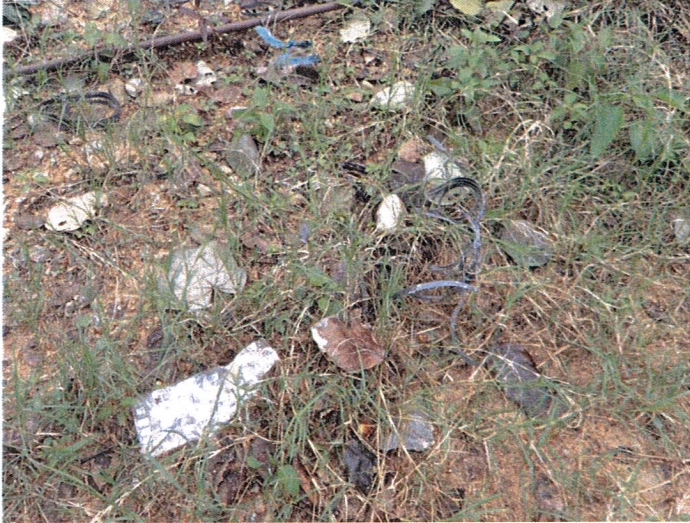
Plate 3

Rubbish was noted near the northwestern corner of the Pond.

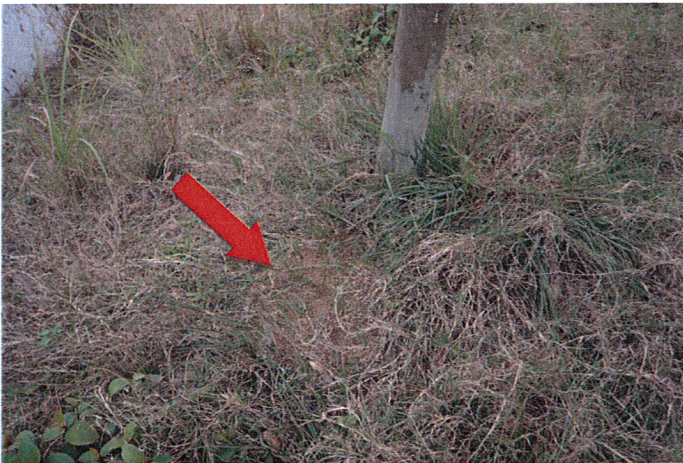
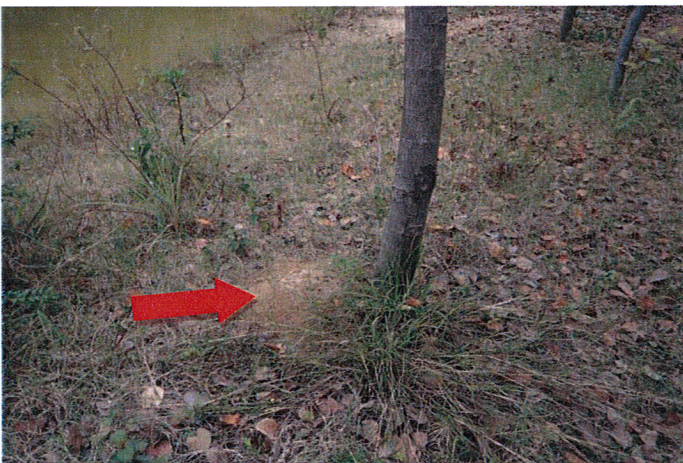
Plate 2

Red Imported Fire Ant (RIFA) nests were observed around the Little Grebe pond.

treated with pesticide as soon as possible to prevent further spreading.	
Minor Comments:	<ul style="list-style-type: none"> Less rubbish was noted in the Pond area. The Contractor should continue to remove the rubbish during the routine maintenance work. 	<ul style="list-style-type: none"> Contractor
Water quality checks:	<ul style="list-style-type: none"> Water quality checks will normally form part of the Operational Phase monitoring of the Grebe Pond as per Section 8, Table 7 of the Habitat Creation and Management Plan. Summarised water quality results are shown in Table 2 below. The water level of the pond is approximately at the +5.6mPD level, no water level adjustment is required. As a reminder, only freshwater can be pumped into the Grebe Pond. The contractor should regularly check the salinity level of the pumped water and avoid pumping water with high salinity level. 	<ul style="list-style-type: none"> NA Contractor Contractor

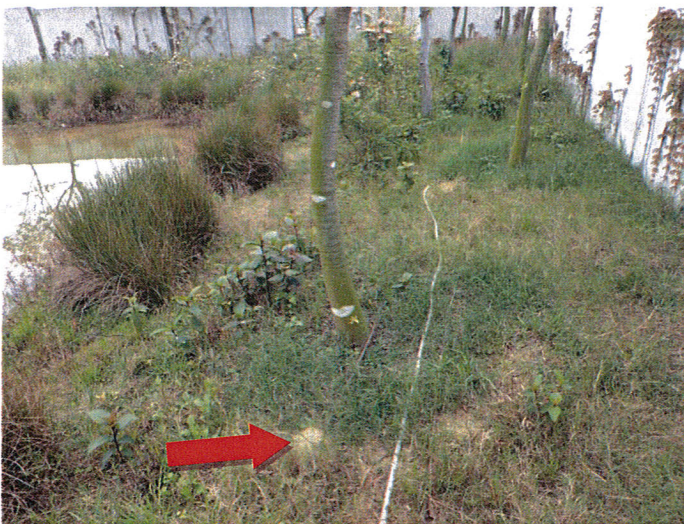
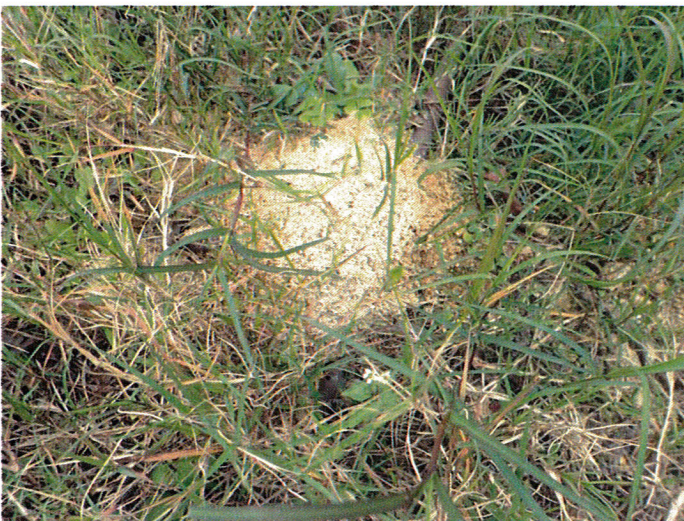
Plate 2

Red Imported Fire Ant (RIFA) nests were observed around the Little Grebe pond.

treated with pesticide as soon as possible to prevent further spreading.	
Minor Comments:	<ul style="list-style-type: none"> Less rubbish was noted in the Pond area. The Contractor should continue to remove the rubbish during the routine maintenance work. 	<ul style="list-style-type: none"> Contractor
Water quality checks:	<ul style="list-style-type: none"> Water quality checks will normally form part of the Operational Phase monitoring of the Grebe Pond as per Section 8, Table 7 of the Habitat Creation and Management Plan. Summarised water quality results are shown in Table 2 below. The water level of the pond is approximately at the +5.6mPD level, no water level adjustment is required. As a reminder, only freshwater can be pumped into the Grebe Pond. The contractor should regularly check the salinity level of the pumped water and avoid pumping water with high salinity level. 	<ul style="list-style-type: none"> NA Contractor Contractor

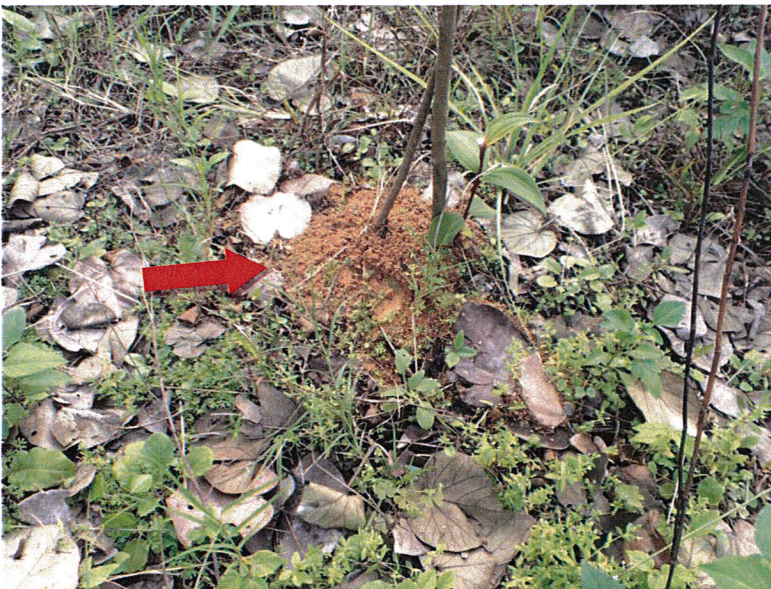
Plate 2

Red Imported Fire Ant (RIFA) nests were observed around the Little Grebe pond.

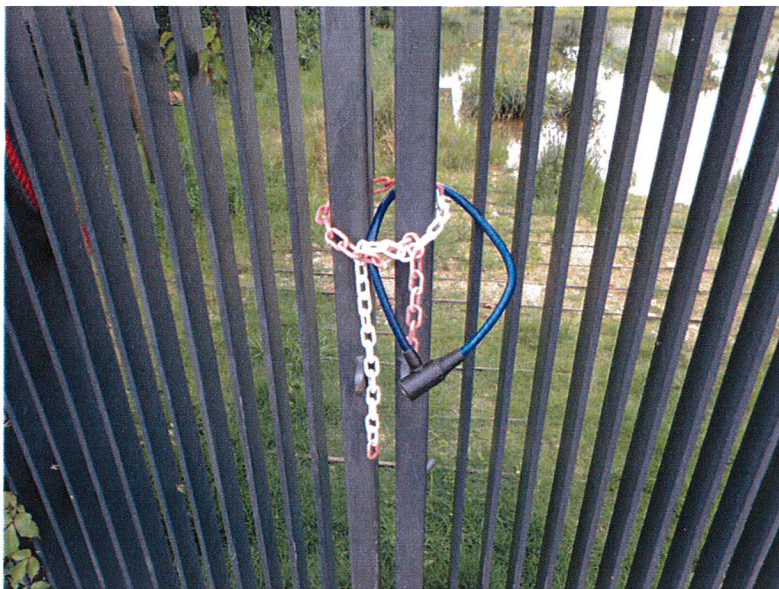
Plate 3

Padlock missing on Pond gate.

<p>treated with pesticide as soon as possible to prevent further spreading.</p> <ul style="list-style-type: none"> The padlock on Pond gate has gone missing (Plate 3). Contractor should replace the padlock as soon as possible. 	<ul style="list-style-type: none"> Contractor
Minor Comments:	<ul style="list-style-type: none"> Less rubbish was noted in the Pond area. The Contractor should continue to remove the rubbish during the routine maintenance work. 	<ul style="list-style-type: none"> Contractor
Water quality checks:	<ul style="list-style-type: none"> Water quality checks will normally form part of the Operational Phase monitoring of the Grebe Pond as per Section 8, Table 7 of the Habitat Creation and Management Plan. Summarised water quality results are shown in Table 2 below. The water level of the pond is approximately at the +5.6mPD level, no water level adjustment is required. As a reminder, only freshwater can be pumped into the Grebe Pond. The contractor should regularly check the salinity level of the pumped water and avoid pumping water with high salinity level. 	<ul style="list-style-type: none"> NA Contractor Contractor
