**Shatin to Central Link – Tai Wai
to Hung Hom Section**

**Land Contamination Assessment
of Magazine Site at TKO Area 137**

Contamination Assessment Plan

Final | April 2016

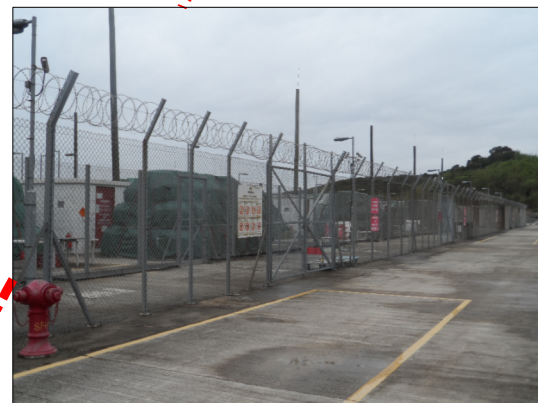
Photo 1

- 2.2.3** The magazine storage was concrete paved in good condition and no chemicals were found to be stored within the magazine site (**Photo 1**).
- 2.2.4** Similar to the findings of the approved EIA report and the ERR report, a generator room was observed in the southeast of the magazine store. The generator room was paved with intact concrete and enclosed by corrugated metal sheets. The bottom of the corrugated metal sheets was sealed with the concrete slab with cement. Also, the area that immediately next to the generator room was concrete paved (**Photo 2**). Diesel-fired generators and oil drums with drip trays were observed inside the generator room (**Photo 3**). Although the generators and the oil drums with drip trays were placed on a concrete slab, oil stains were observed on the concrete slab (**Photo 4**).

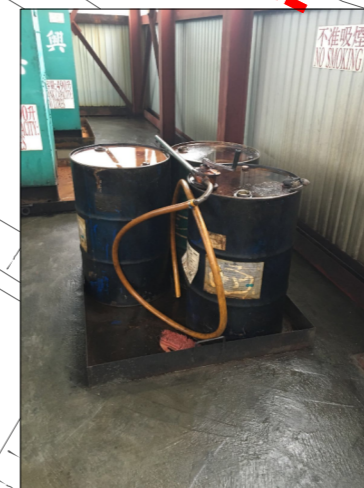
Photo 4

3.1.2 From the site survey, oil stains were observed on the intact concrete slab of the generator room but not the part of the vehicle access road that previously store the waste chemical drums.

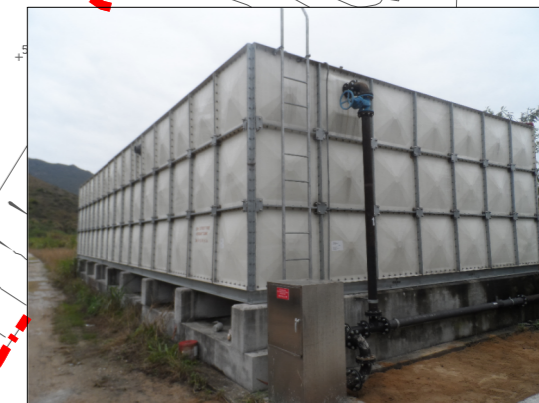
Photo 5

- 2.2.5** A fire hydrant tank and a pump room were also observed next to the generator room. Both the fire hydrant tanks and the pumps were placed on thick concrete slab (**Photo 5** and **Photo 6**). No oil stain or other sign of potential land contamination was observed near the fire hydrant tank

and the pump room.

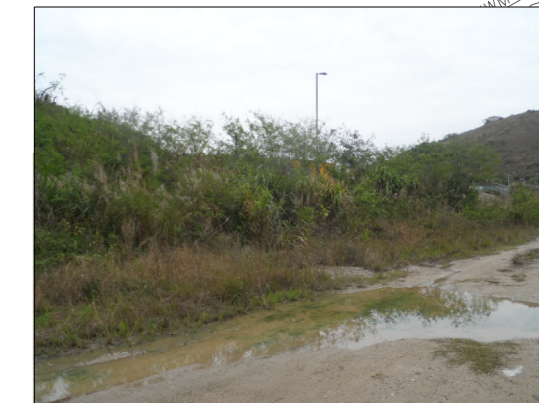
Photo 7

- 2.2.6** For the waste chemical drums storage on the vehicle access road that previously identified in the approved EIA report, the vehicle access road was cleared during the site visit. No waste chemical drum nor oil stain was observed during the site survey (**Photo 7**).

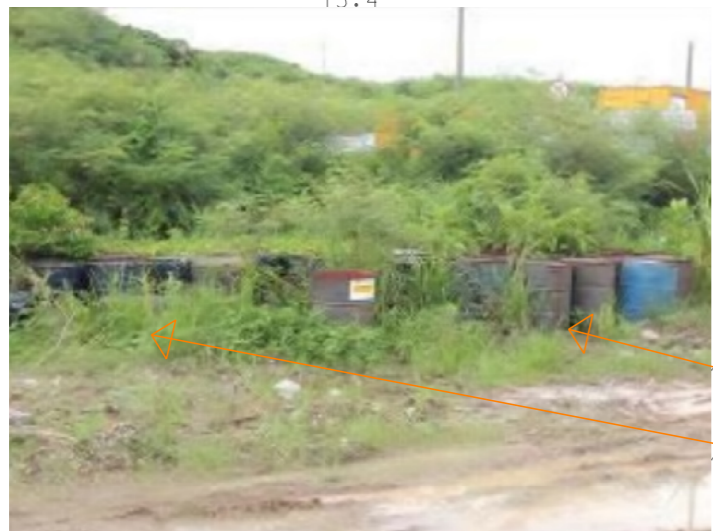
2.1.6 Furthermore, waste chemical drums with the label “bituminous waterproofing emulsion” were observed at the side of the vehicle access road southwest of the magazine storages. No secondary containment

was observed for the waste chemical drums. According to the photo records of the approved EIA report, it is estimated that the dimension of the storage area is around 6m x 4m.

* The photo is extracted from Figure 8A.3c of the approved EIA report of "Desalination Plant at Tseung Kwan O" (AEIAR-192/2005)

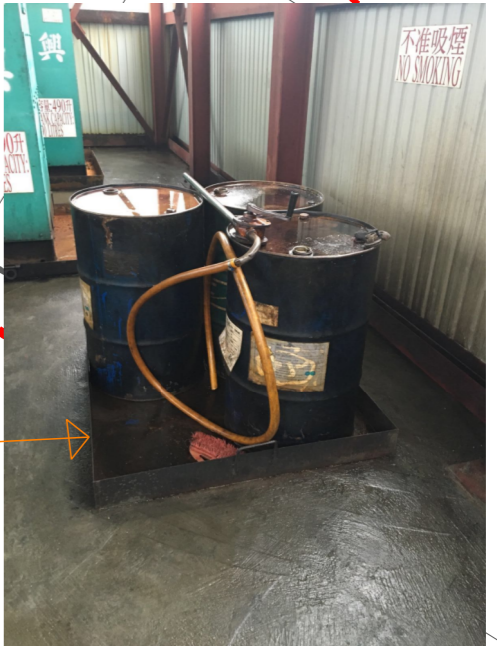
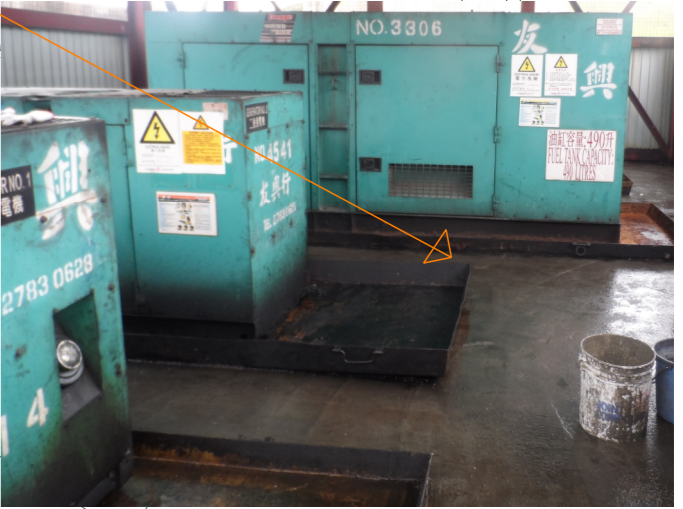
- PROJECT BOUNDARY
- AREA A - GENERATOR ROOM
- AREA B - WASTE CHEMICAL DRUMS STORAGE AREA
- PROPOSED TRIAL PIT LOCATION

3.1.4 Based on the findings from the approved EIA report and site survey, the potential land contamination area identified could be divided into two parts according to the historical landuse nature, namely, the generator room (Area A) and the part of the vehicle access road where waste chemical drums were stored (Area B). The details are summarized in **Table 3.1** and shown in **Figure 3.1**.

4.1.2 In view of the Area A covers 66m², two sampling locations are proposed to cover the identified hotspots (i.e. potential leakage from oil drums (TP1) and the oil stains around the generator (TP2)). The proposed locations are shown in **Figure 3.1**.

4.1.3 The area of the waste chemical drums storage (i.e. Area B) is estimated to be around 48m² based on the approved EIA report. Two sampling locations (TP3 and TP4) were also proposed to cover the potentially contaminated area. The proposed locations are shown in **Figure 3.1**.

3.2.1 Environmental site investigation (SI) is recommended to be carried out at the two potentially contaminated sites, i.e. Area A and Area B to determine the types and quantities of contaminants that could be present in the sites. Details of the potentially contaminated areas and the number of sampling locations to be proposed in each area will be based on a hot-spot approach, i.e. sampling point will be located at or near potential sources of contamination identified.
