**Contract No. HY/2013/01 – HZMB HKBCF – Passenger Clearance
Building
Quarterly EM&A Report No. 10 for January 2017 to March 2017**

**Contract No. HY/2013/01
Hong Kong – Zhuhai – Macao Bridge
Hong Kong Boundary Crossing Facilities – Passenger Clearance Building
Certification of Quarterly EM&A Report No. 10 (Revision 1)**

**Quarterly EM&A Report No. 10
(Covering the Period from 1 January 2017 to 31 March 2017)**

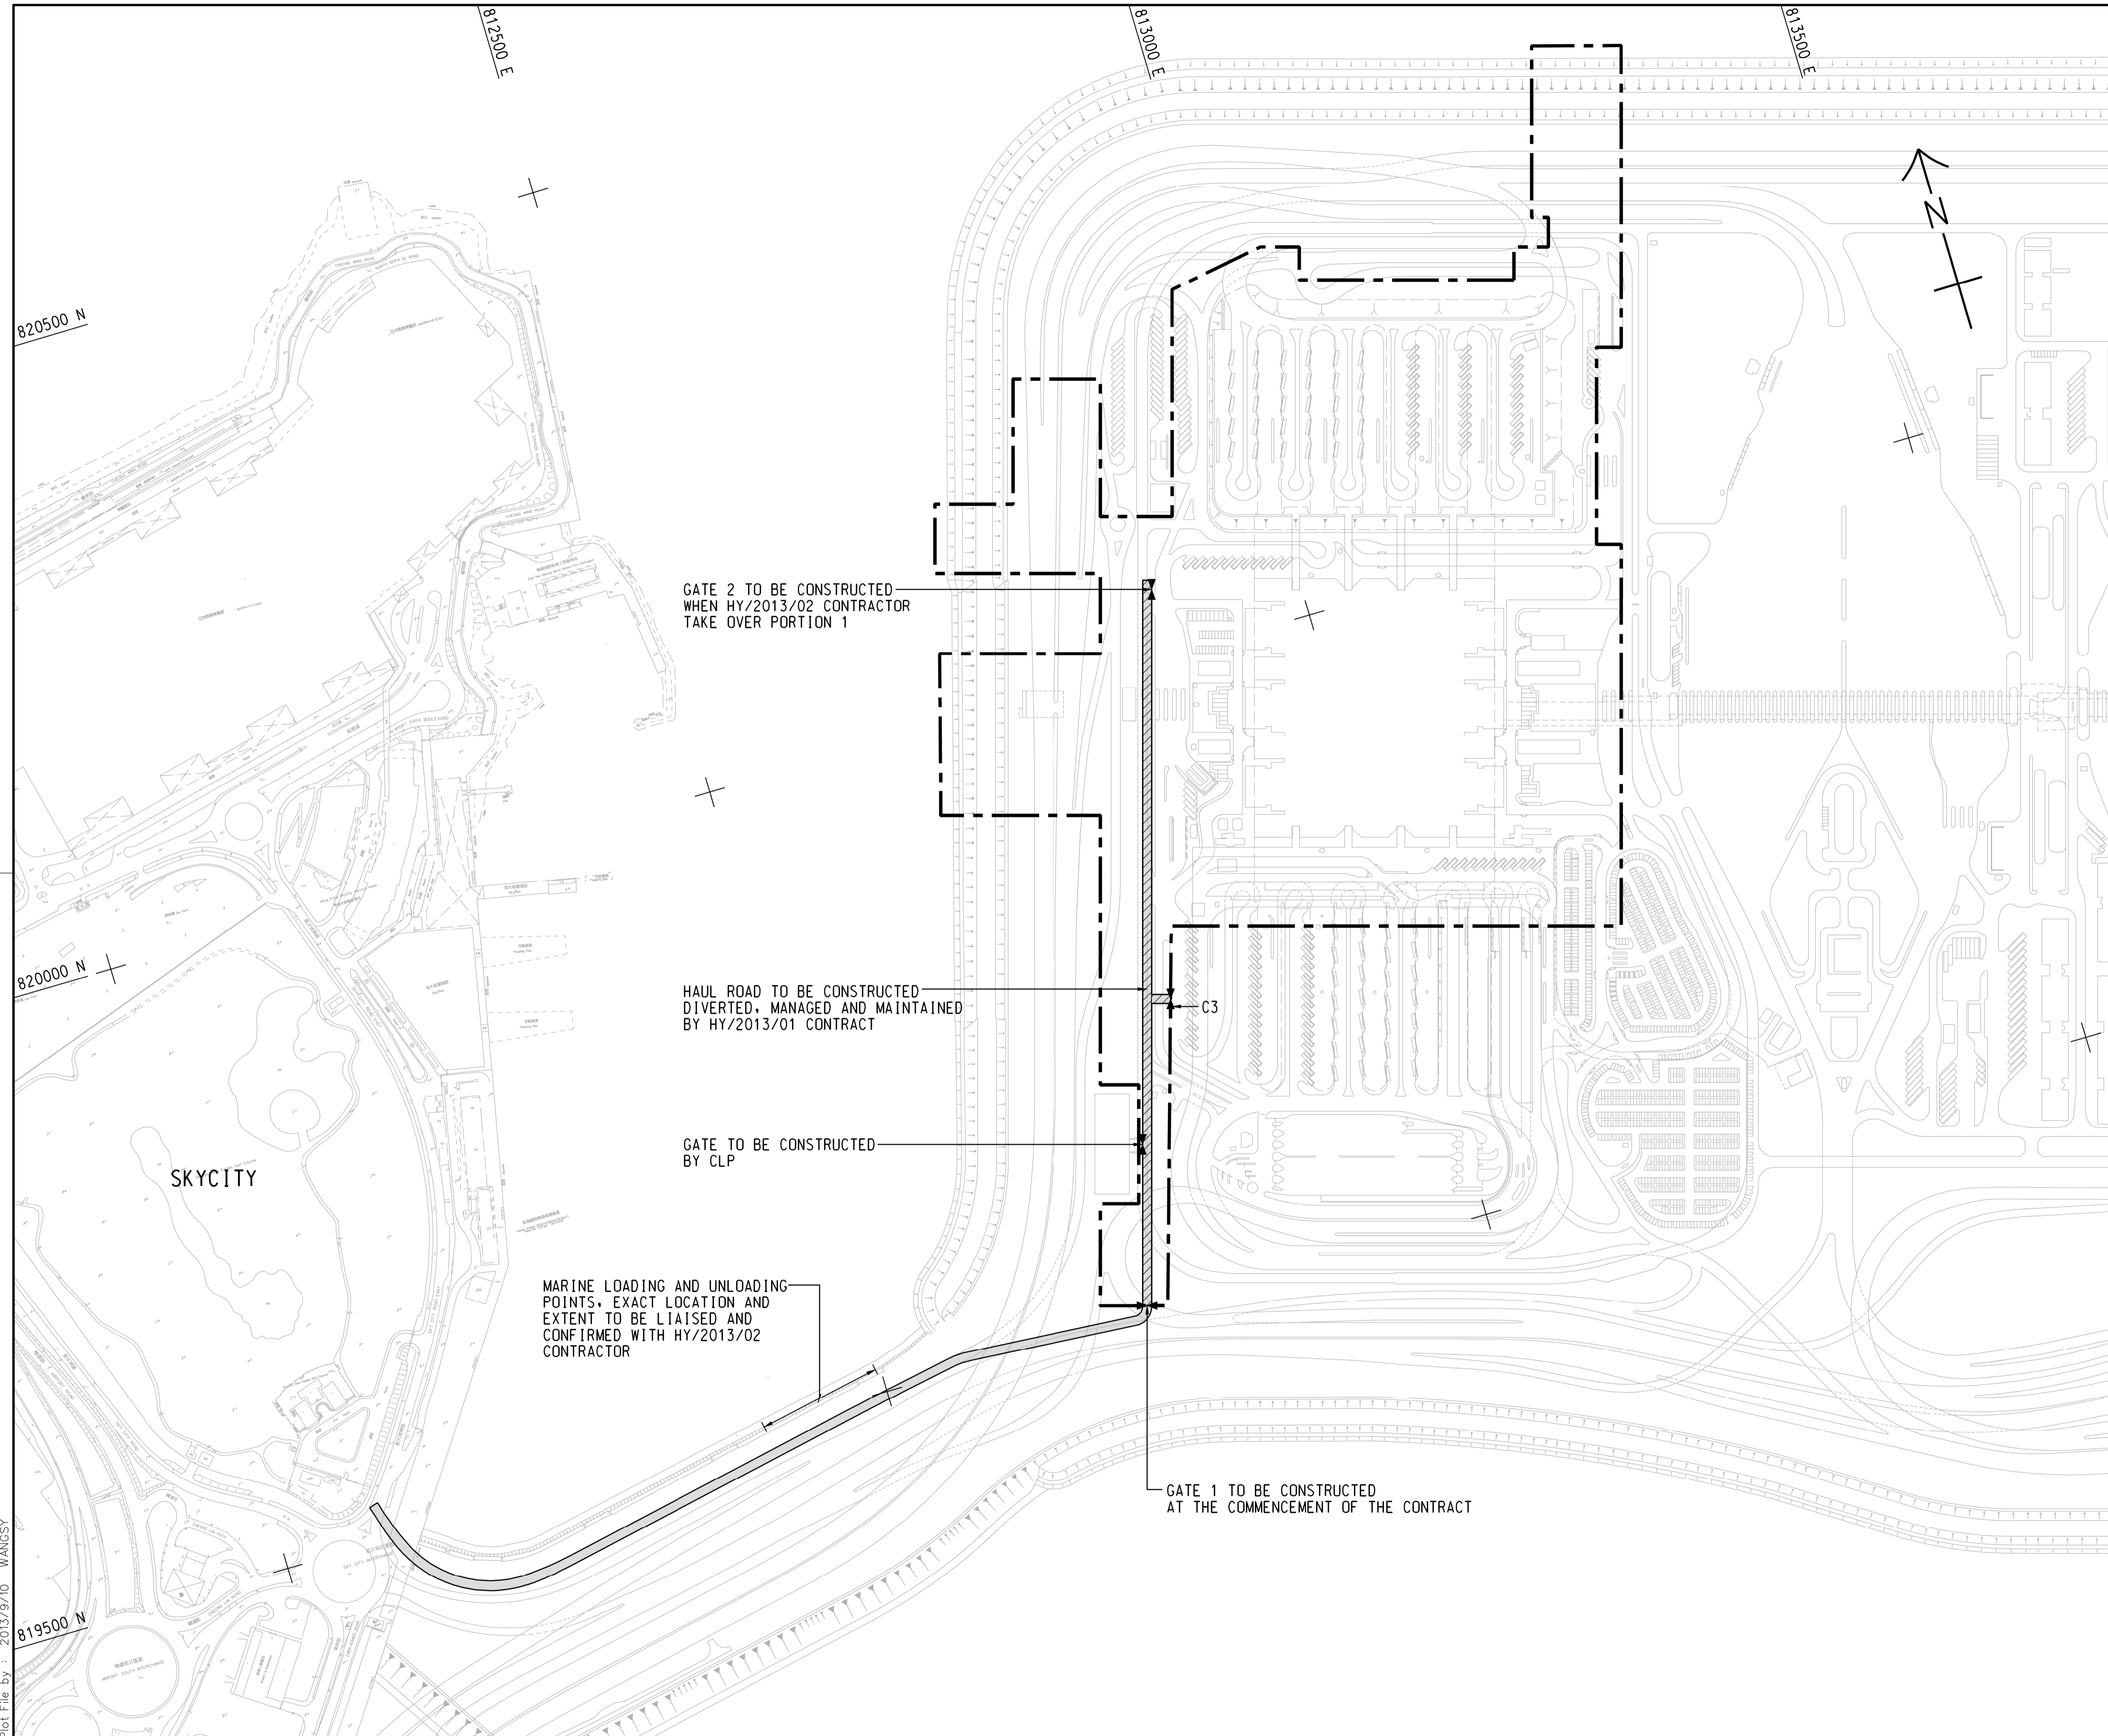
GATE 2 TO BE CONSTRUCTED WHEN HY/2013/02 CONTRACTOR TAKE OVER PORTION 1

HAUL ROAD TO BE CONSTRUCTED DIVERTED, MANAGED AND MAINTAINED BY HY/2013/01 CONTRACT

MARINE LOADING AND UNLOADING POINTS, EXACT LOCATION AND EXTENT TO BE LIAISED AND CONFIRMED WITH HY/2013/02 CONTRACTOR

GATE 1 TO BE CONSTRUCTED AT THE COMMENCEMENT OF THE CONTRACT
