**CONTRACT NO.: HY/2013/02
HONG KONG – ZHUHAI- MACAO BRIDGE
HONG KONG BOUNDARY CROSSING
FACILITIES – INFRASTRUCTURE
WORKS STAGE I
(WESTERN PORTION)
MONTHLY EM&A REPORT
NO. 31
(01 JUNE – 30 JUNE 2017)**

**Contract No. HY/2013/02 – HZMB HKBCF – Infrastructure Works Stage I
(Western Portion)
Monthly Environmental Monitoring & Audit Report for June 2017**

This is the Thirty-first Monthly Environmental Monitoring and Audit (EM&A) Report for the Contract which summaries findings of the EM&A works conducted during the reporting period from 01 June to 30 June 2017.

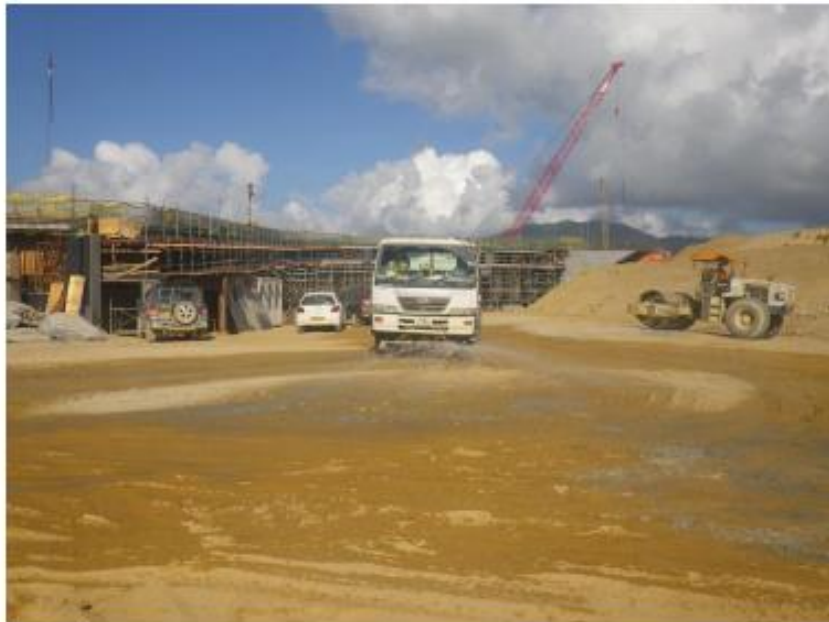
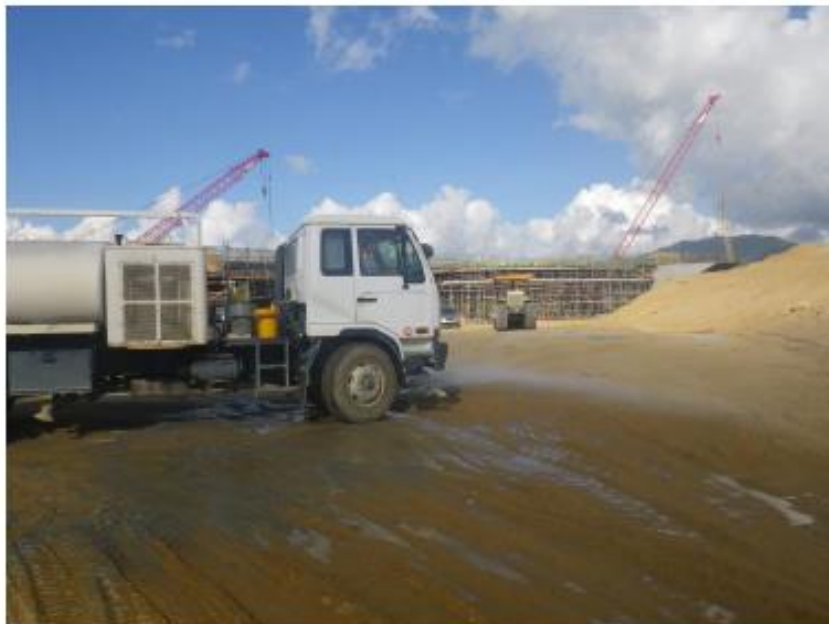
Photo 170608_001 – Regular Watering

According to the site inspection between 14:30 to 15:30 on 08 June 2017, the worksite was wetted with water near 出入境旅檢地盤. Besides, 出入境旅檢地盤 was not managed by Contract No. HY/2013/02. Hence, the complaint was found non-related to Contract No. HY/2013/02. The complaint investigation report (Log No.013) for the above mentioned complaint on 02 June 2017 was provided in **Appendix J**.

6.6.3 According to the site inspection between 14:30 to 15:30 on 08 June 2017, the worksite was wetted with water near 出入境旅檢地盤. Besides, 出入境旅檢地盤 was not managed by Contract No. HY/2013/02. Hence, the complaint was found non-related to Contract No. HY/2013/02. The complaint investigation report (Log No.013) for the above mentioned complaint on 02 June 2017 was provided in **Appendix J**.

Details of Action(s) Taken by the Contactor of Contract No. HY/2013/02			
<ol style="list-style-type: none"> 1. Wet the worksites with water regularly; 2. Keep the watering record for inspection; 3. Cover the dusty materials with impervious sheeting; 4. Spray water during demolition activities; 			
Conclusion			
Refer to the above mentioned inspection, since watering was carried out during the site inspection on 08 June 2017 and 出入境旅檢地盤 was belonged to other contract, the complaint was found non-related to Contract No. HY/2013/02.			
Although this complaint was non-related to Contract No. HY/2013/02, the Contractor of Contract No. HY/2013/02 was reminded to provide appropriate mitigation measures to minimize dust generation.

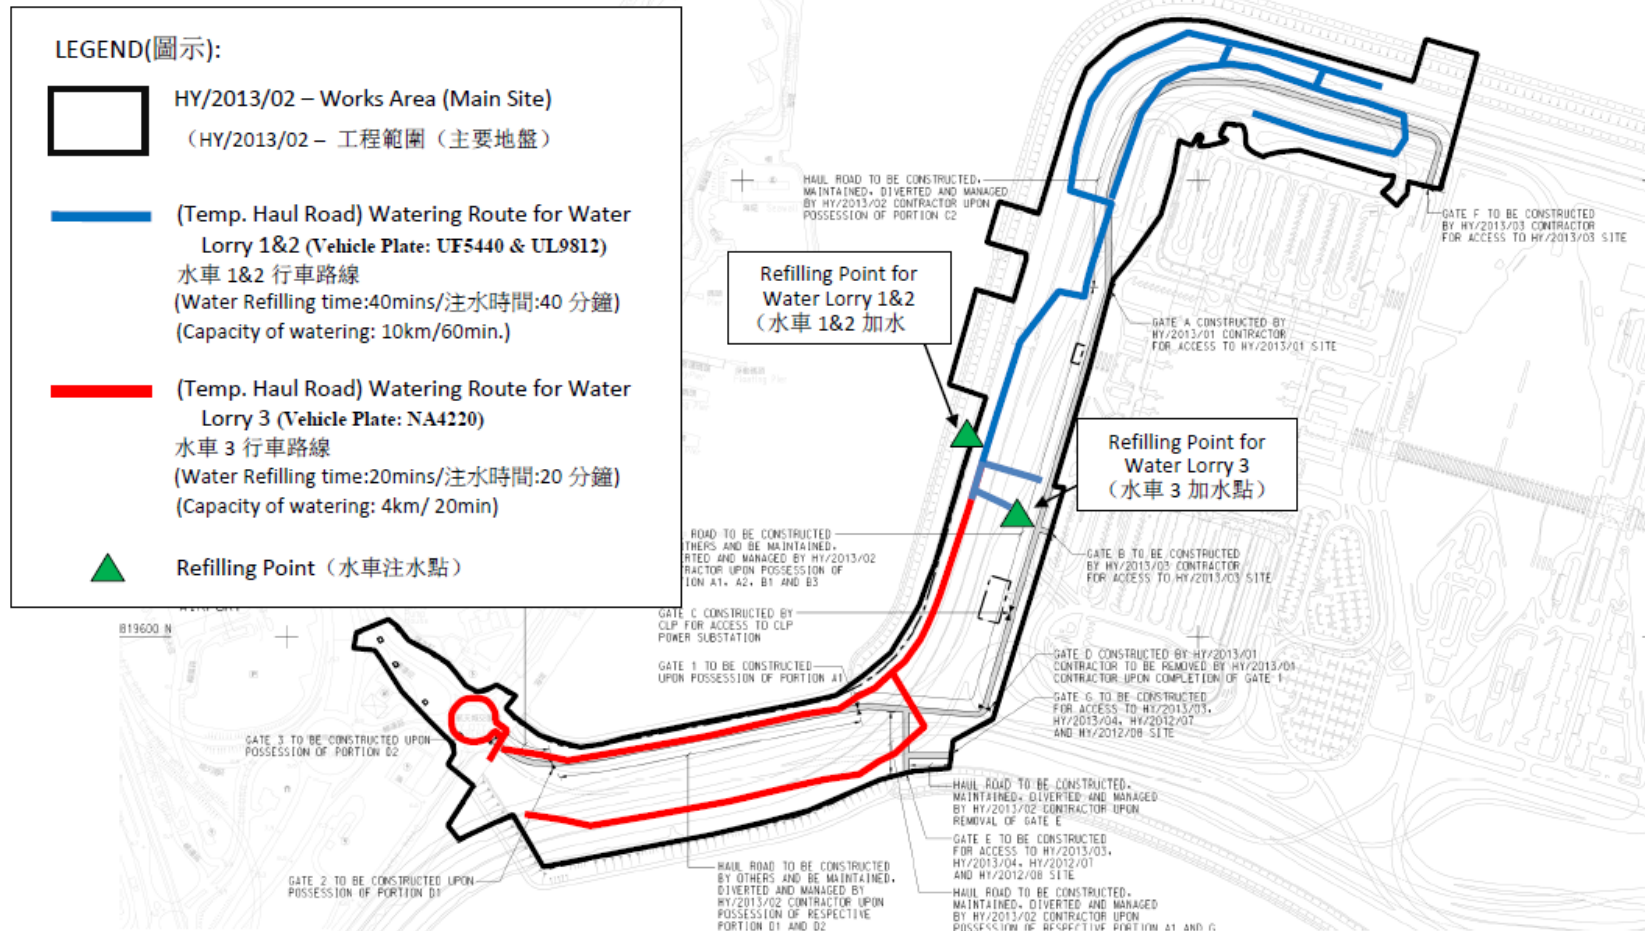
The watering route of main haul road and access

主要行車道路及通道灑水圖

環境許可證(EP-353/2009/K)3.23 條款要求每日至少進行八次灑水
