**CONTRACT NO.: HY/2013/02
HONG KONG – ZHUHAI- MACAO BRIDGE
HONG KONG BOUNDARY CROSSING
FACILITIES – INFRASTRUCTURE
WORKS STAGE I
(WESTERN PORTION)
QUARTERLY EM&A REPORT
NO. 11
(01 JUNE – 31 AUGUST 2017)**

Report No.: ENA75843

**Contract No. HY/2013/02 – HZMB HKBCF – Infrastructure Works Stage I
(Western Portion)
Quarterly EM&A Report No. 11 for June 2017 to August 2017**

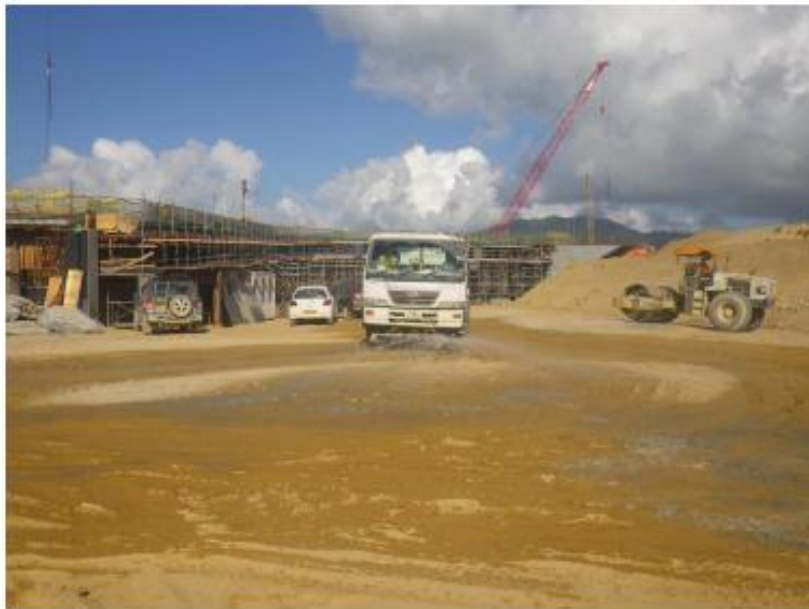
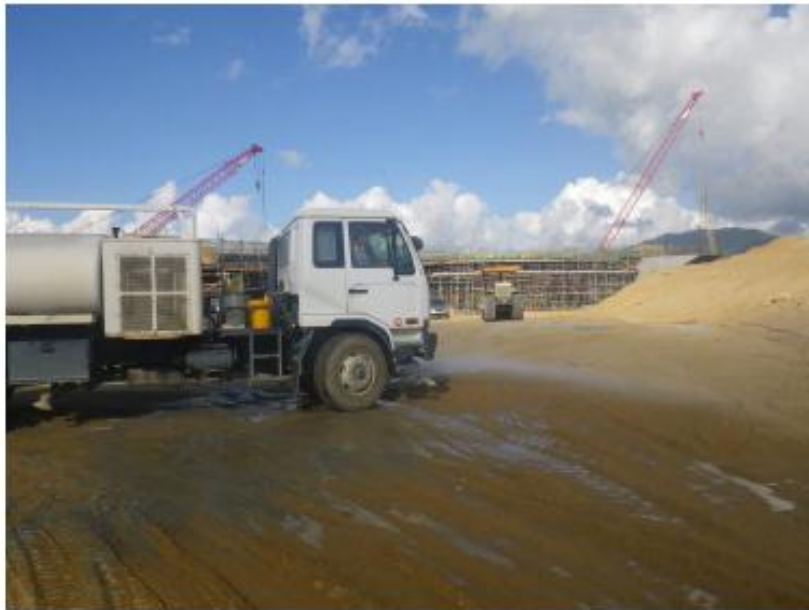
According to the site inspection between 14:30 to 15:30 on 08 June 2017, the worksite was wetted with water near 出入境旅檢地盤. Besides, 出入境旅檢地盤 was not managed by Contract No. HY/2013/02. Hence, the complaint was found non-related to Contract No. HY/2013/02. The complaint investigation report (Log No.013) for the above mentioned complaint on 02 June 2017 was provided in **Appendix K**.

Photo 170608_001 – Regular Watering

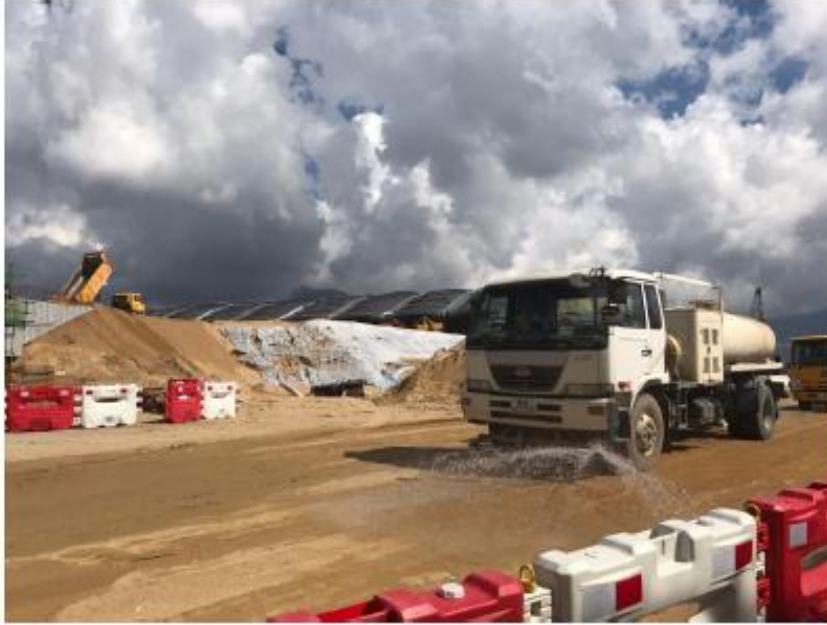
Photo 170608_002 – Watering near 出入境旅檢地盤

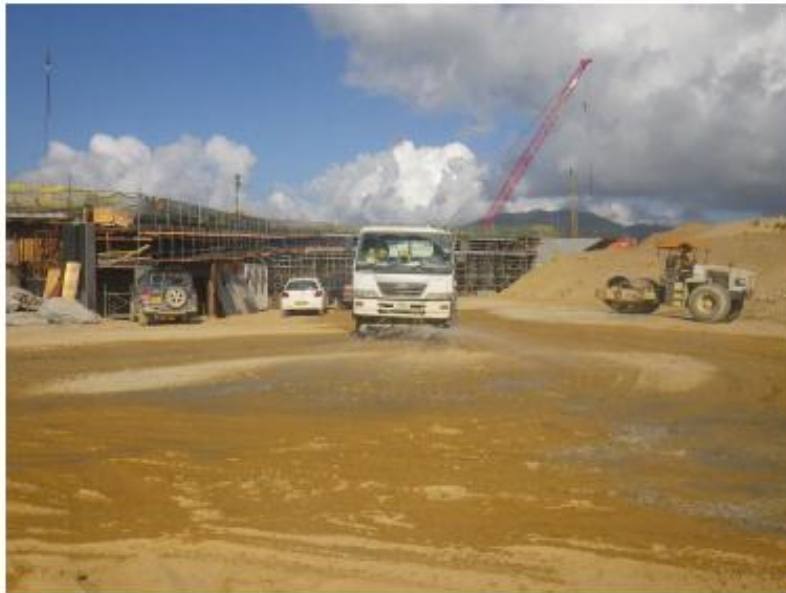
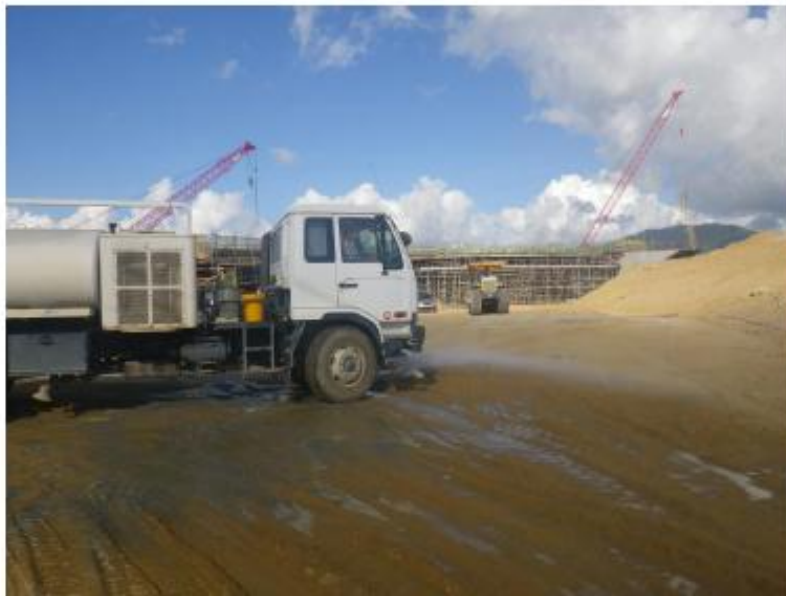
According to the site inspection between 14:30 to 15:30 on 08 June 2017, the worksite was wetted with water near 出入境旅檢地盤. Besides, 出入境旅檢地盤 was not managed by Contract No. HY/2013/02. Hence, the complaint was found non-related to Contract No. HY/2013/02. The complaint investigation report (Log No.014) for the above mentioned complaint on 05 June 2017 was provided in **Appendix K**.

Photo 170608_001 – Regular Watering

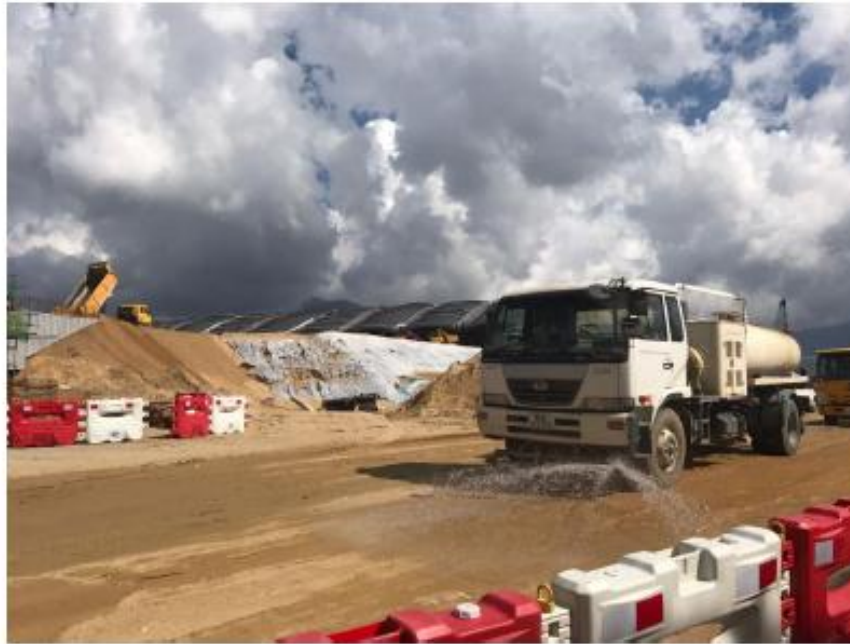
Photo 170608_002 – Watering near 出入境旅檢地盤
