**CHINA HARBOUR ENGINEERING CO.
LTD.**

**CONTRACT NO.: HY/2013/02
HONG KONG – ZHUHAI- MACAO BRIDGE
HONG KONG BOUNDARY CROSSING
FACILITIES – INFRASTRUCTURE
WORKS STAGE I
(WESTERN PORTION)
MONTHLY EM&A REPORT
NO. 34
(01 SEPTEMBER – 30 SEPTEMBER 2017)**

Report No.: ENA75842

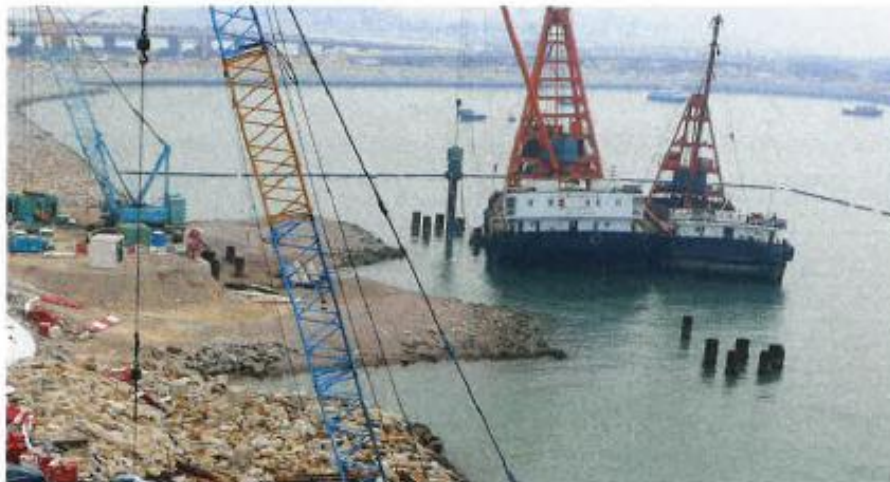
- It was confirmed that there was only one marine based activity which is demolition of temporary loading and unloading point of this Contract worked at HKBCF reclamation site near the sea area or area near the monitoring station IS5, IS10(N), IS(M)11, IS17 and SR5(N) on 01 September 2017 under Contract No. HY/2013/02. **Figure 1** showing the locations of the Water Quality Monitoring Stations where the exceedances of DO were recorded and all relevant WQM stations.

- The demolition of temporary loading and unloading point was started from 18 July 2017. The major marine based activity was the removal of marine piling of temporary loading and unloading point which was shown in the following photo. All marine based activities were carried out within the silt curtain and no defect of silt curtain was recorded by Contract No. HY/2010/02 from 18 July 2017 to 01 September 2017. Besides, there was also no DO exceedance recorded during 18 July 2017 to 31 August 2017. Therefore, the low DO marine water was not caused by demolition of temporary loading and unloading point.

- The water quality mitigation measures as mentioned in EM&A Manual and EP was fully implemented in this Contract which including maintenance of the silt curtain on a daily basis by Contract No. HY/2010/02 etc. The exceedances were considered as non-Project related.

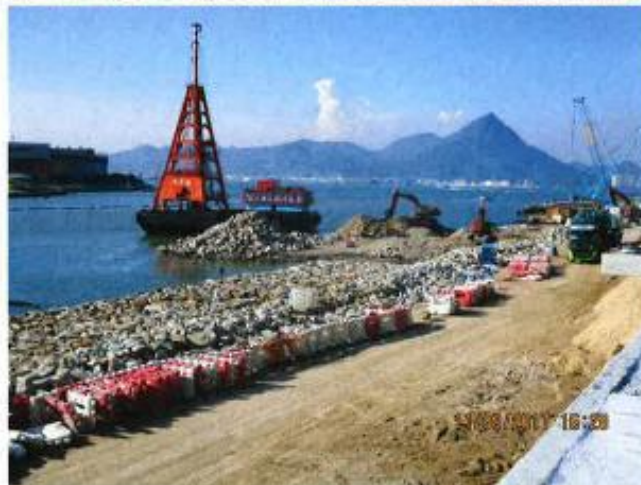
- As confirmed by SRE, removal of temporary loading and unloading point by Contract No. HY/2013/02, which involved marine work, was completed on 10 September and the area was handed back to Reclamation Contractor on 11 September 2017 for subsequent seawall construction. The following photo was taken on 11 September 2017 showing that all the marine piling of temporary loading and unloading point was removed.

- Hence, it was confirmed that there was no marine works or barge of this Contract worked at HKBCF reclamation site near the sea area or area near the above mentioned monitoring stations during the monitoring period on 11 September 2017 so it was unlikely to deteriorate the water quality in the marine water to cause the DO exceedances recorded at the monitoring station IS8, IS(Mf)9, IS10(N), IS(Mf)11, IS(Mf)16, IS17, SR4(N), SR5(N), SR6, SR7, SR10A and SR10B(N) during the monitoring
