**Contract No. HY/2013/04 Hong Kong-Zhuhai-Macao Bridge (HZMB)
Hong Kong Boundary Crossing Facilities – Infrastructure Works Stage II
(Southern Portion)**

Monthly EM&A Report for November 2017

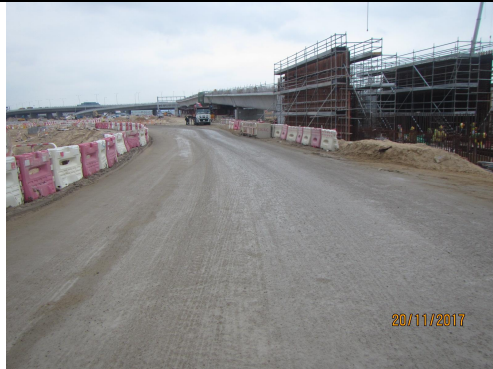
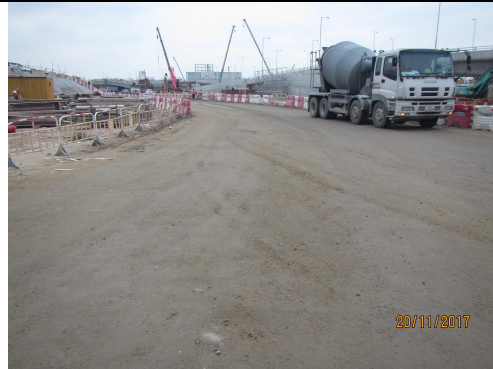
1a. Water spray provided for haul roads in the HY/2013/04 site area (near Box Culvert C). No fugitive dust generation was observed.

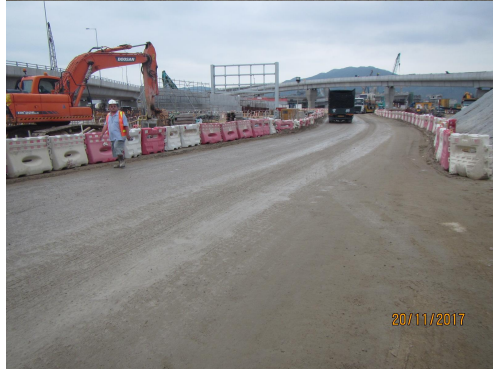
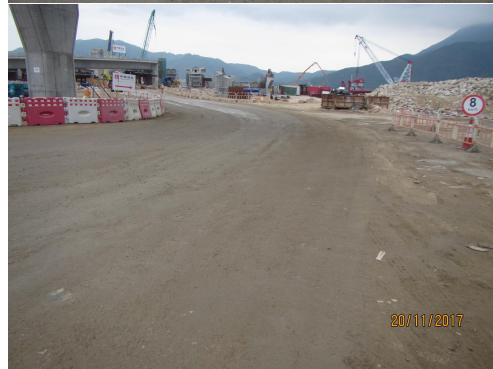
1b. Water spray provided for haul roads in the HY/2013/04 site area (near Box Culvert D). No fugitive dust generation was observed.

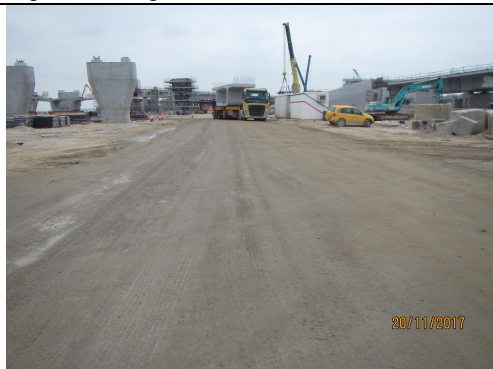
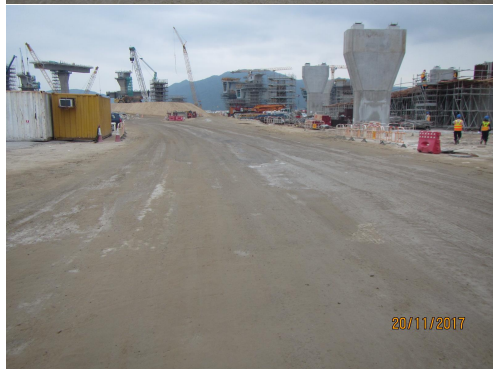
1c. Water spray provided for haul roads in the HY/2013/04 site area (near Bridge D12). No fugitive dust generation was observed.

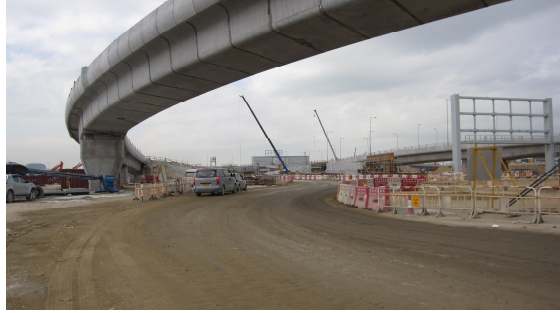
1a. Water spray provided for haul roads in the HY/2013/04 site area (near Box Culvert C). No fugitive dust generation was observed.

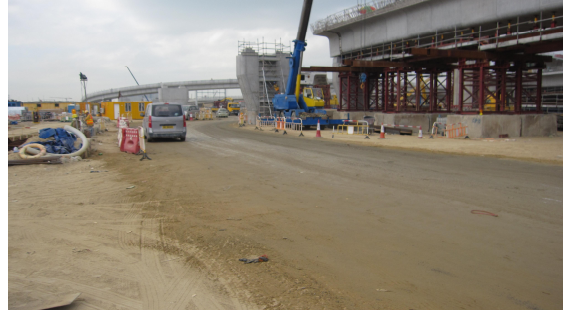
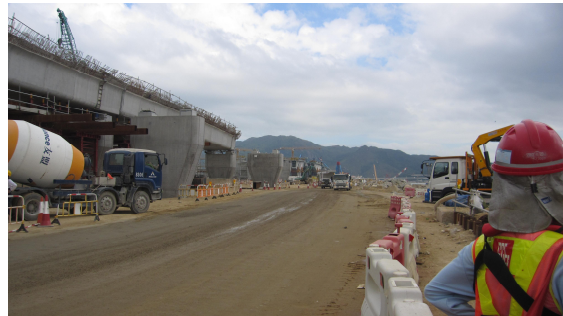
1b. Water spray provided for haul roads in the HY/2013/04 site area (near Box Culvert D). No fugitive dust generation was observed.

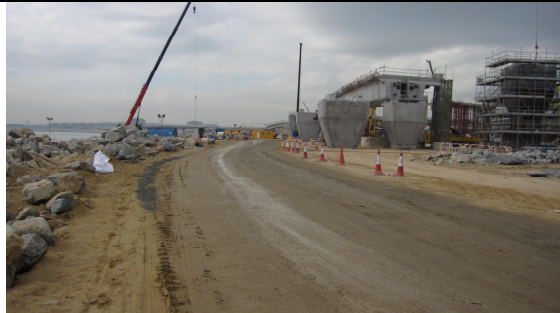
1c. Water spray provided for haul roads in the HY/2013/04 site area (near Bridge D12). No fugitive dust generation was observed.
