**Re: Agreement No. CE 48/2011 (EP)
Environmental Project Office for the
HZMB Hong Kong Link Road, HZMB Hong Kong Boundary Crossing
Facilities, and Tuen Mun-Chek Lap Kok Link – Investigation**

**Contract No. HY/2013/01
HZMB HKBCF – Passenger Clearance Building
Quarterly EM&A Report No. 14 for December 2017 to February 2018**

**Contract No. HY/2013/01
Hong Kong – Zhuhai – Macao Bridge
Hong Kong Boundary Crossing Facilities – Passenger Clearance Building
Certification of Quarterly EM&A Report No. 14**

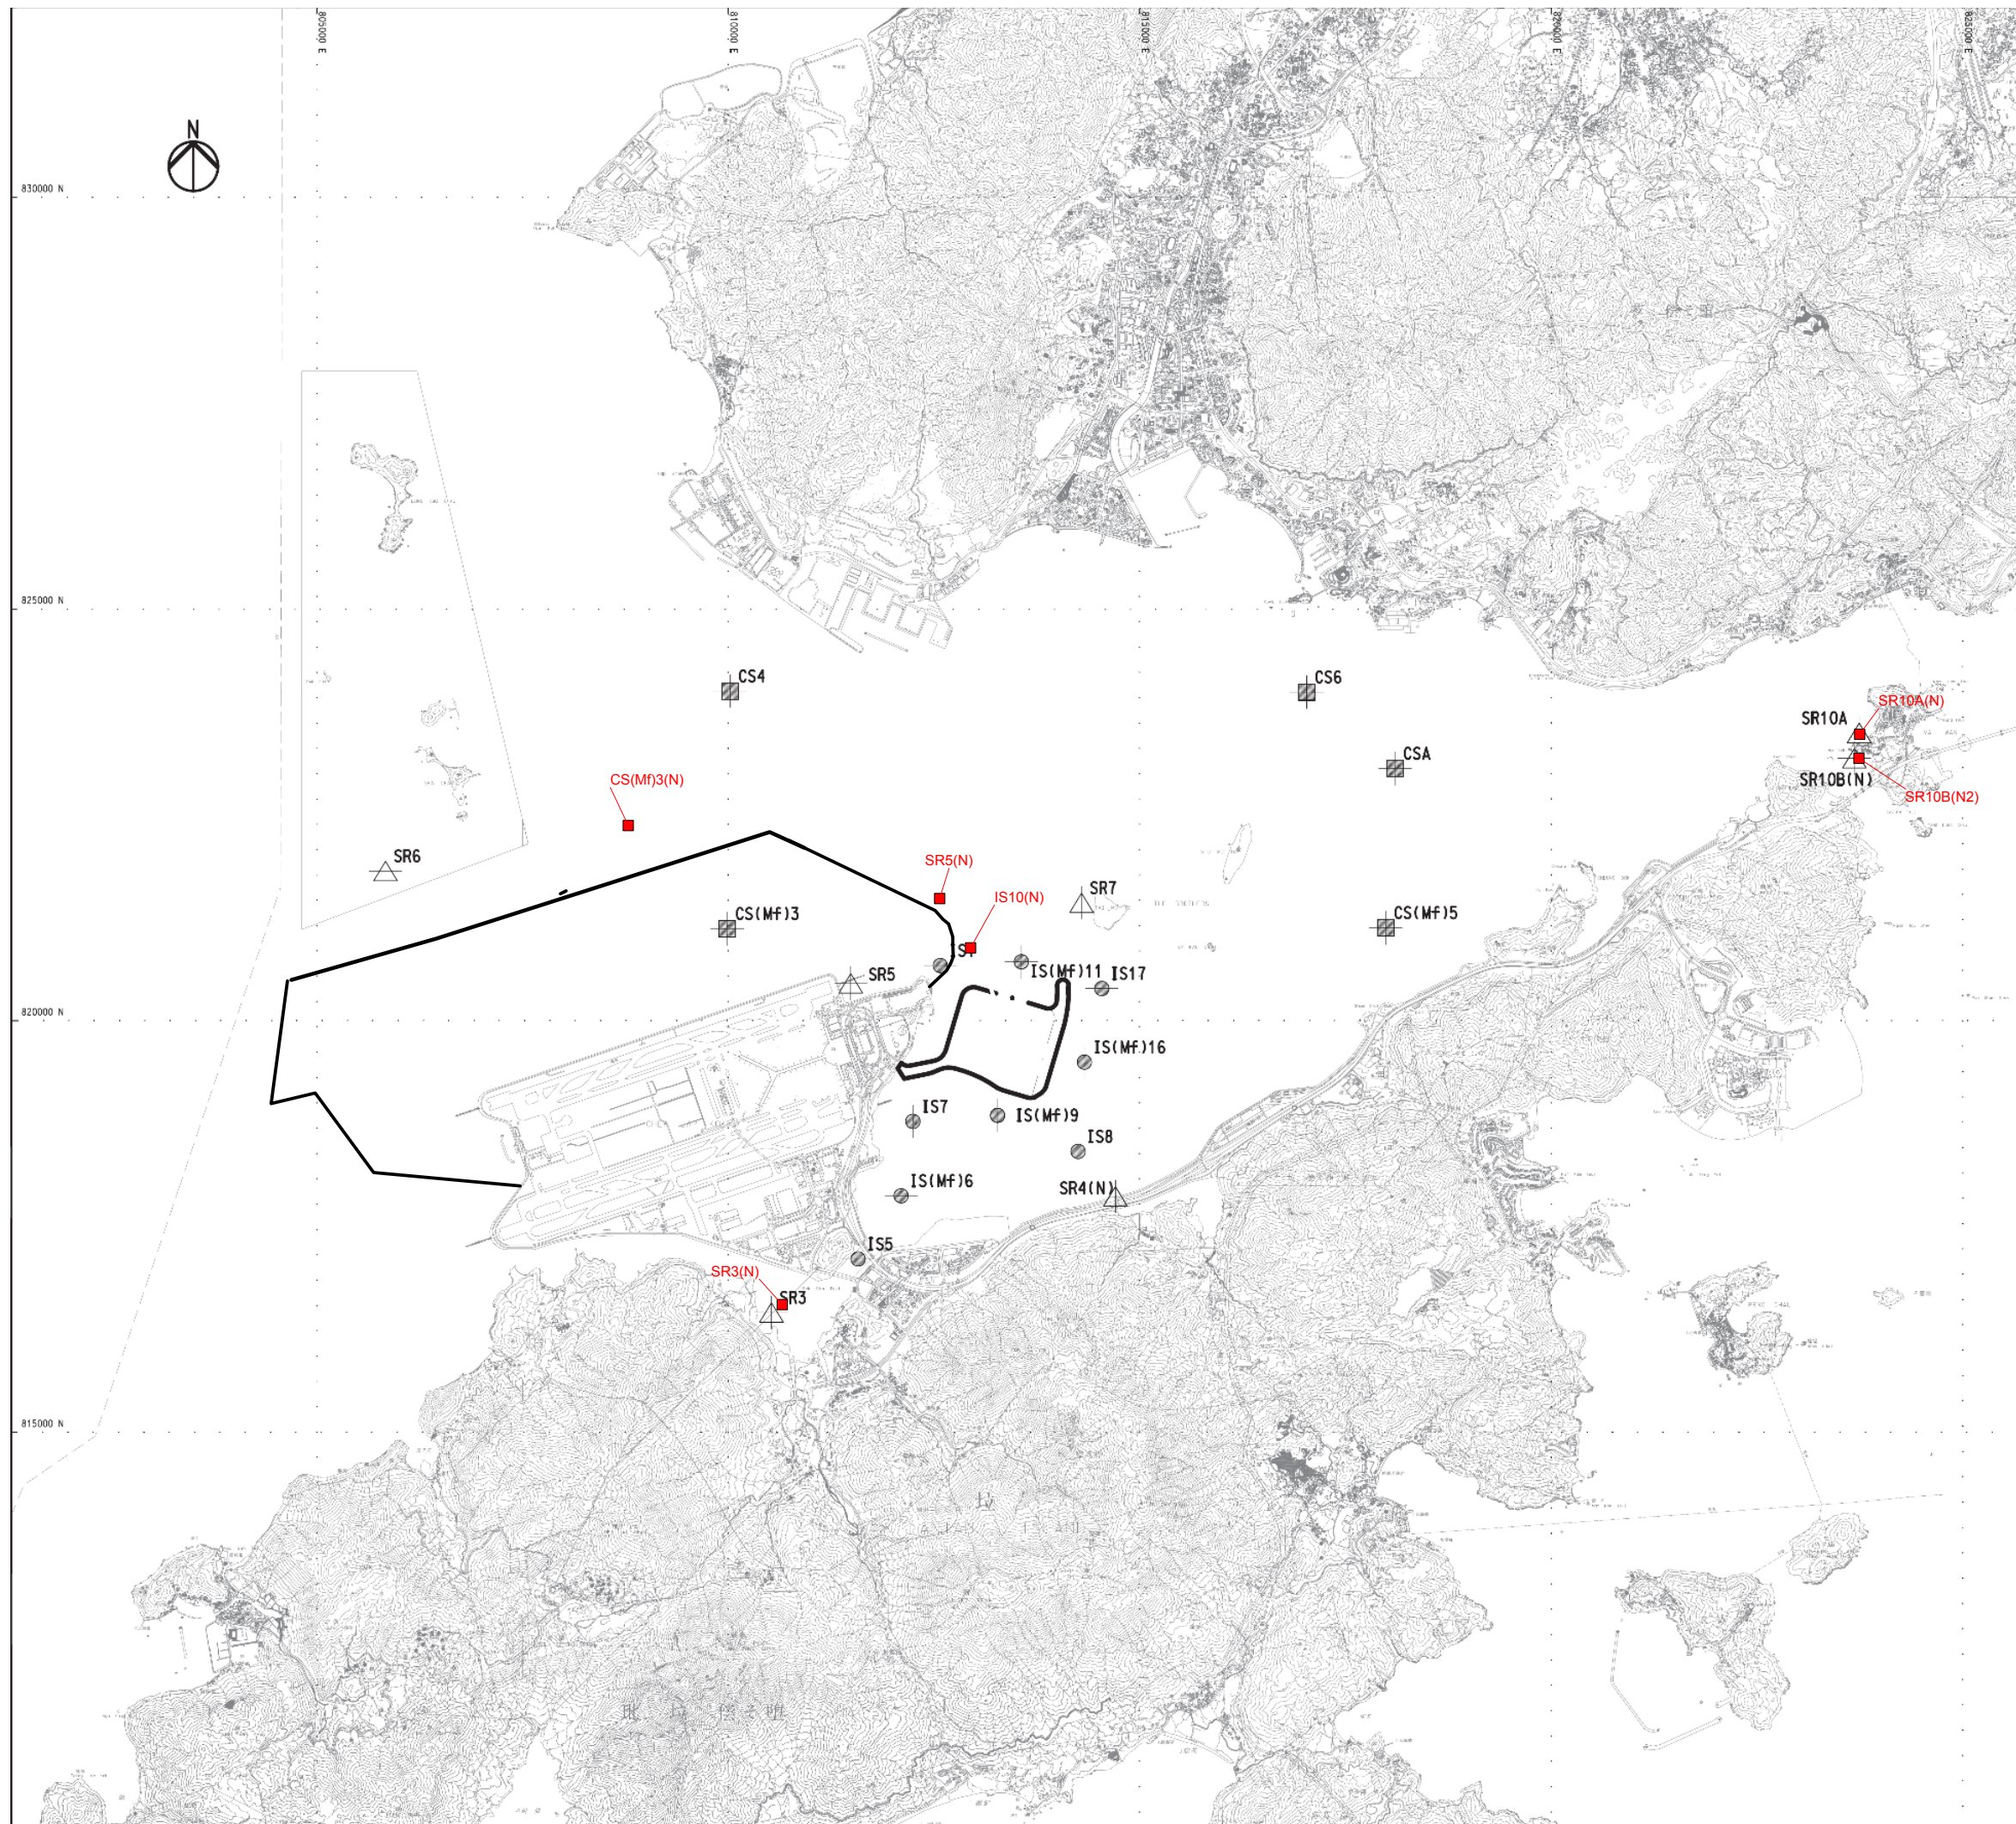
FIGURE 2.3b - Location of Water Quality Monitoring (WQM) Stations (The WQM Station IDs After 22 December 2017)

Station	East	North
IS5	811579	817106
IS(Mf)6	812101	817873
IS7	812244	818777
IS8	814251	818412
IS(Mf)9	813273	818850
IS10(N)	812942	820881
IS(Mf)11	813562	820716
IS(Mf)16	814328	819497
IS17	814539	820391
SR3(N)	810689	816591
SR4(N)	814705	817859
SR5(N)	812569	821475
SR6	805837	821818
SR7	814293	821431
SR10A(N)	823644	823484
SR10B(N2)	823689	823159
CS(Mf)3(N)	808814	822355
CS(Mf)5	817990	821129
CS4	810025	824004
CS6	817028	823992
CSA	818103	823064

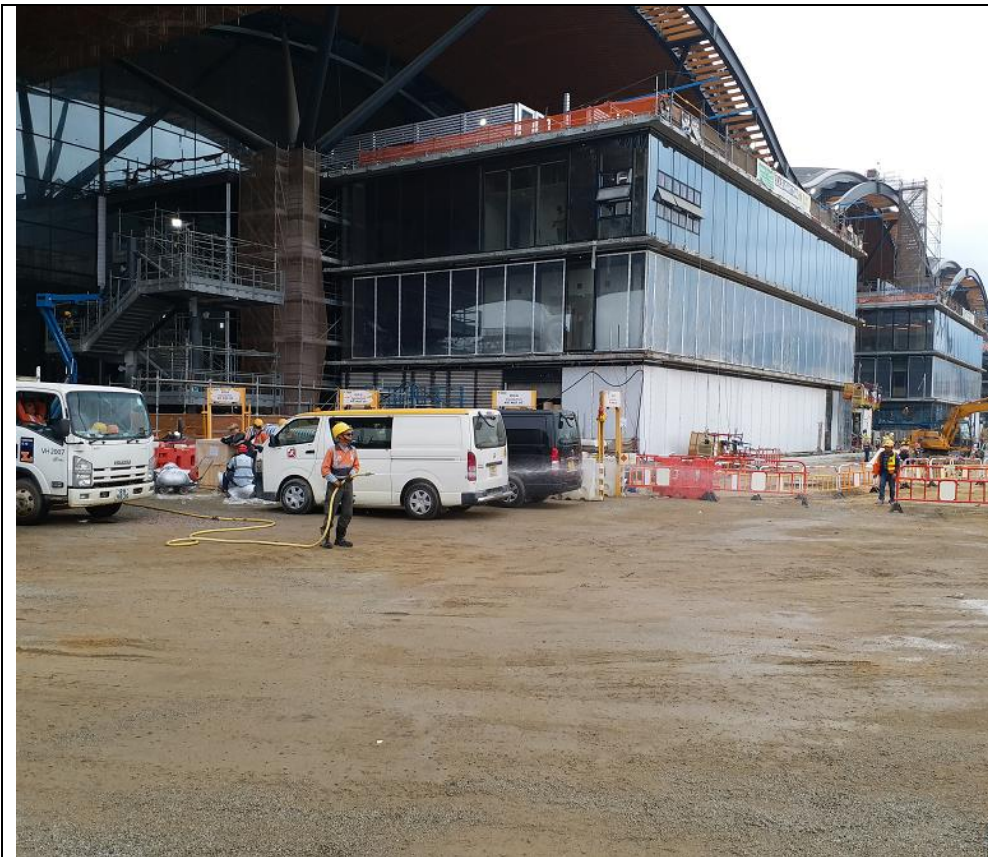
Haul road is wet (Location 1)

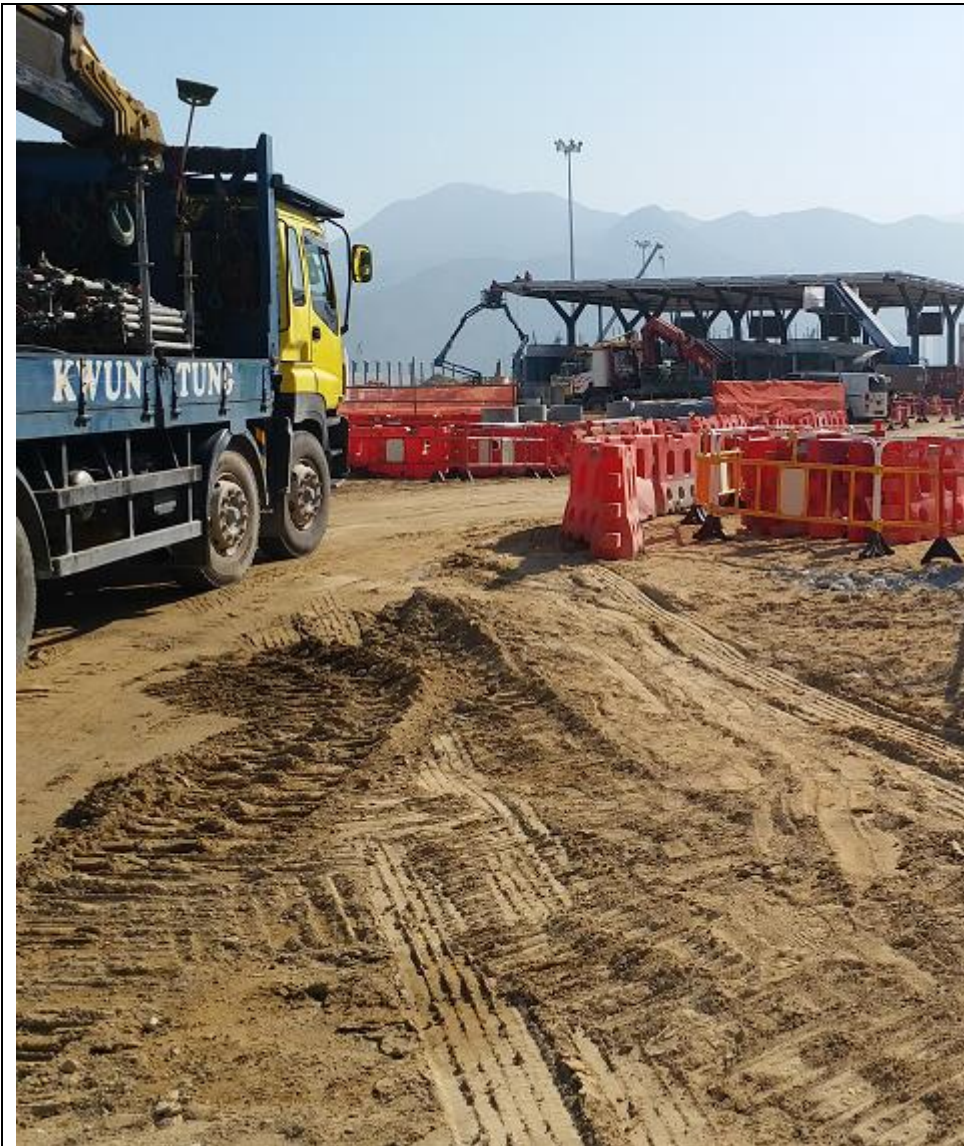
Haul road is wet (Photo taken during site inspection on 27 December 2017)

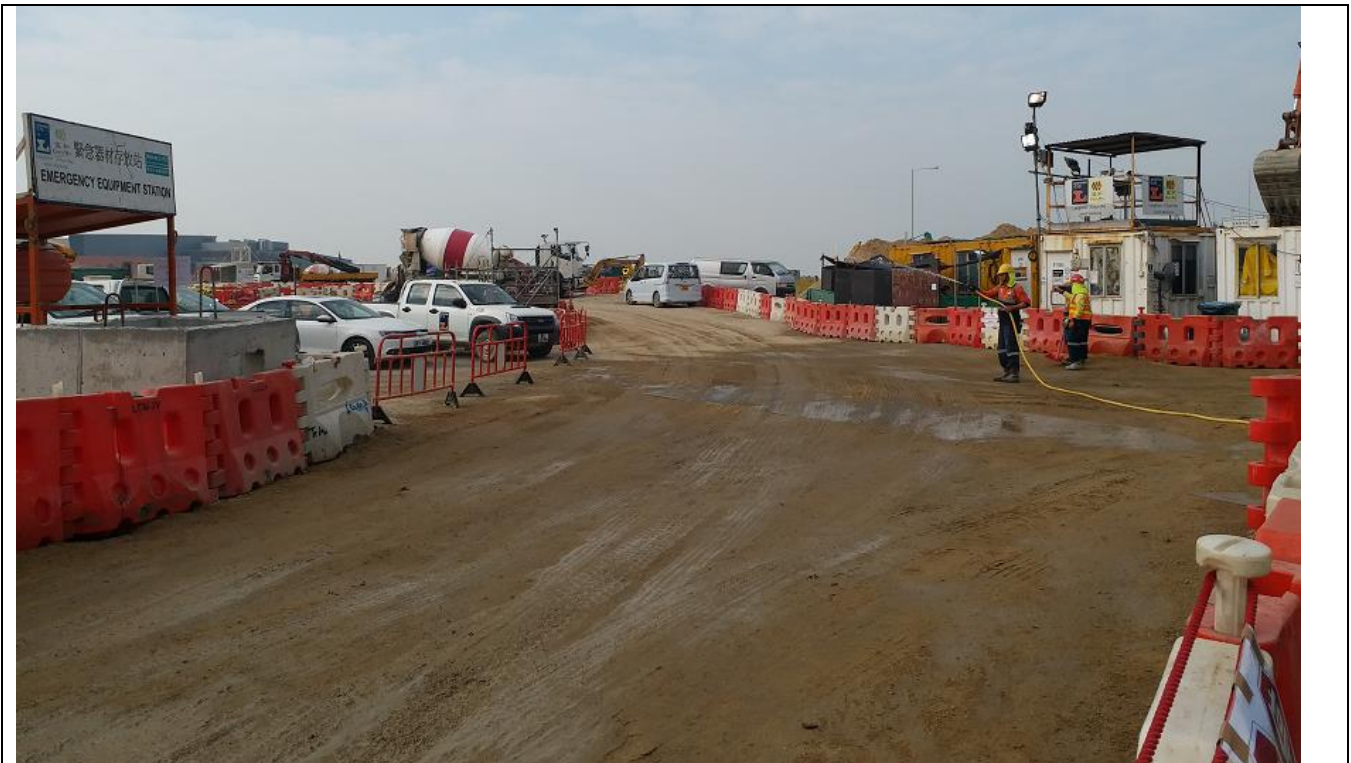
Haul road is wet (Location 1)

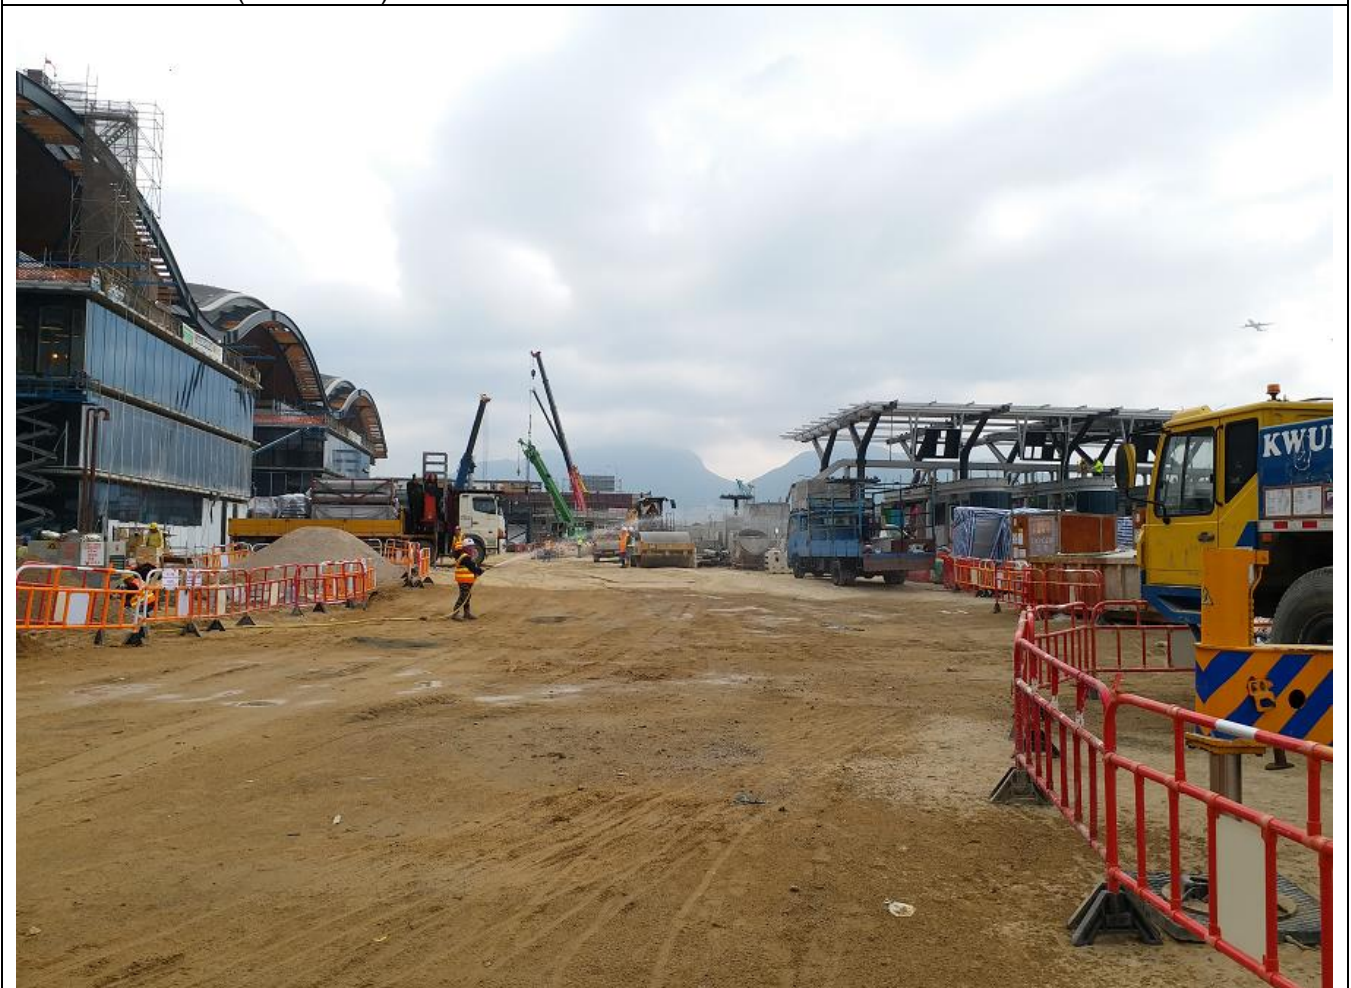
Water spray on haul road (Location 2)
