**Re: Agreement No. CE 48/2011 (EP)
Environmental Project Office for the
HZMB Hong Kong Link Road, HZMB Hong Kong Boundary Crossing
Facilities, and Tuen Mun-Chek Lap Kok Link – Investigation**

**Contract No. HY/2013/01
HZMB HKBCF – Passenger Clearance Building
Quarterly EM&A Report No. 15 for March 2018 to May 2018**

**Contract No. HY/2013/01
Hong Kong – Zhuhai – Macao Bridge
Hong Kong Boundary Crossing Facilities – Passenger Clearance Building
Certification of Quarterly EM&A Report No. 15**

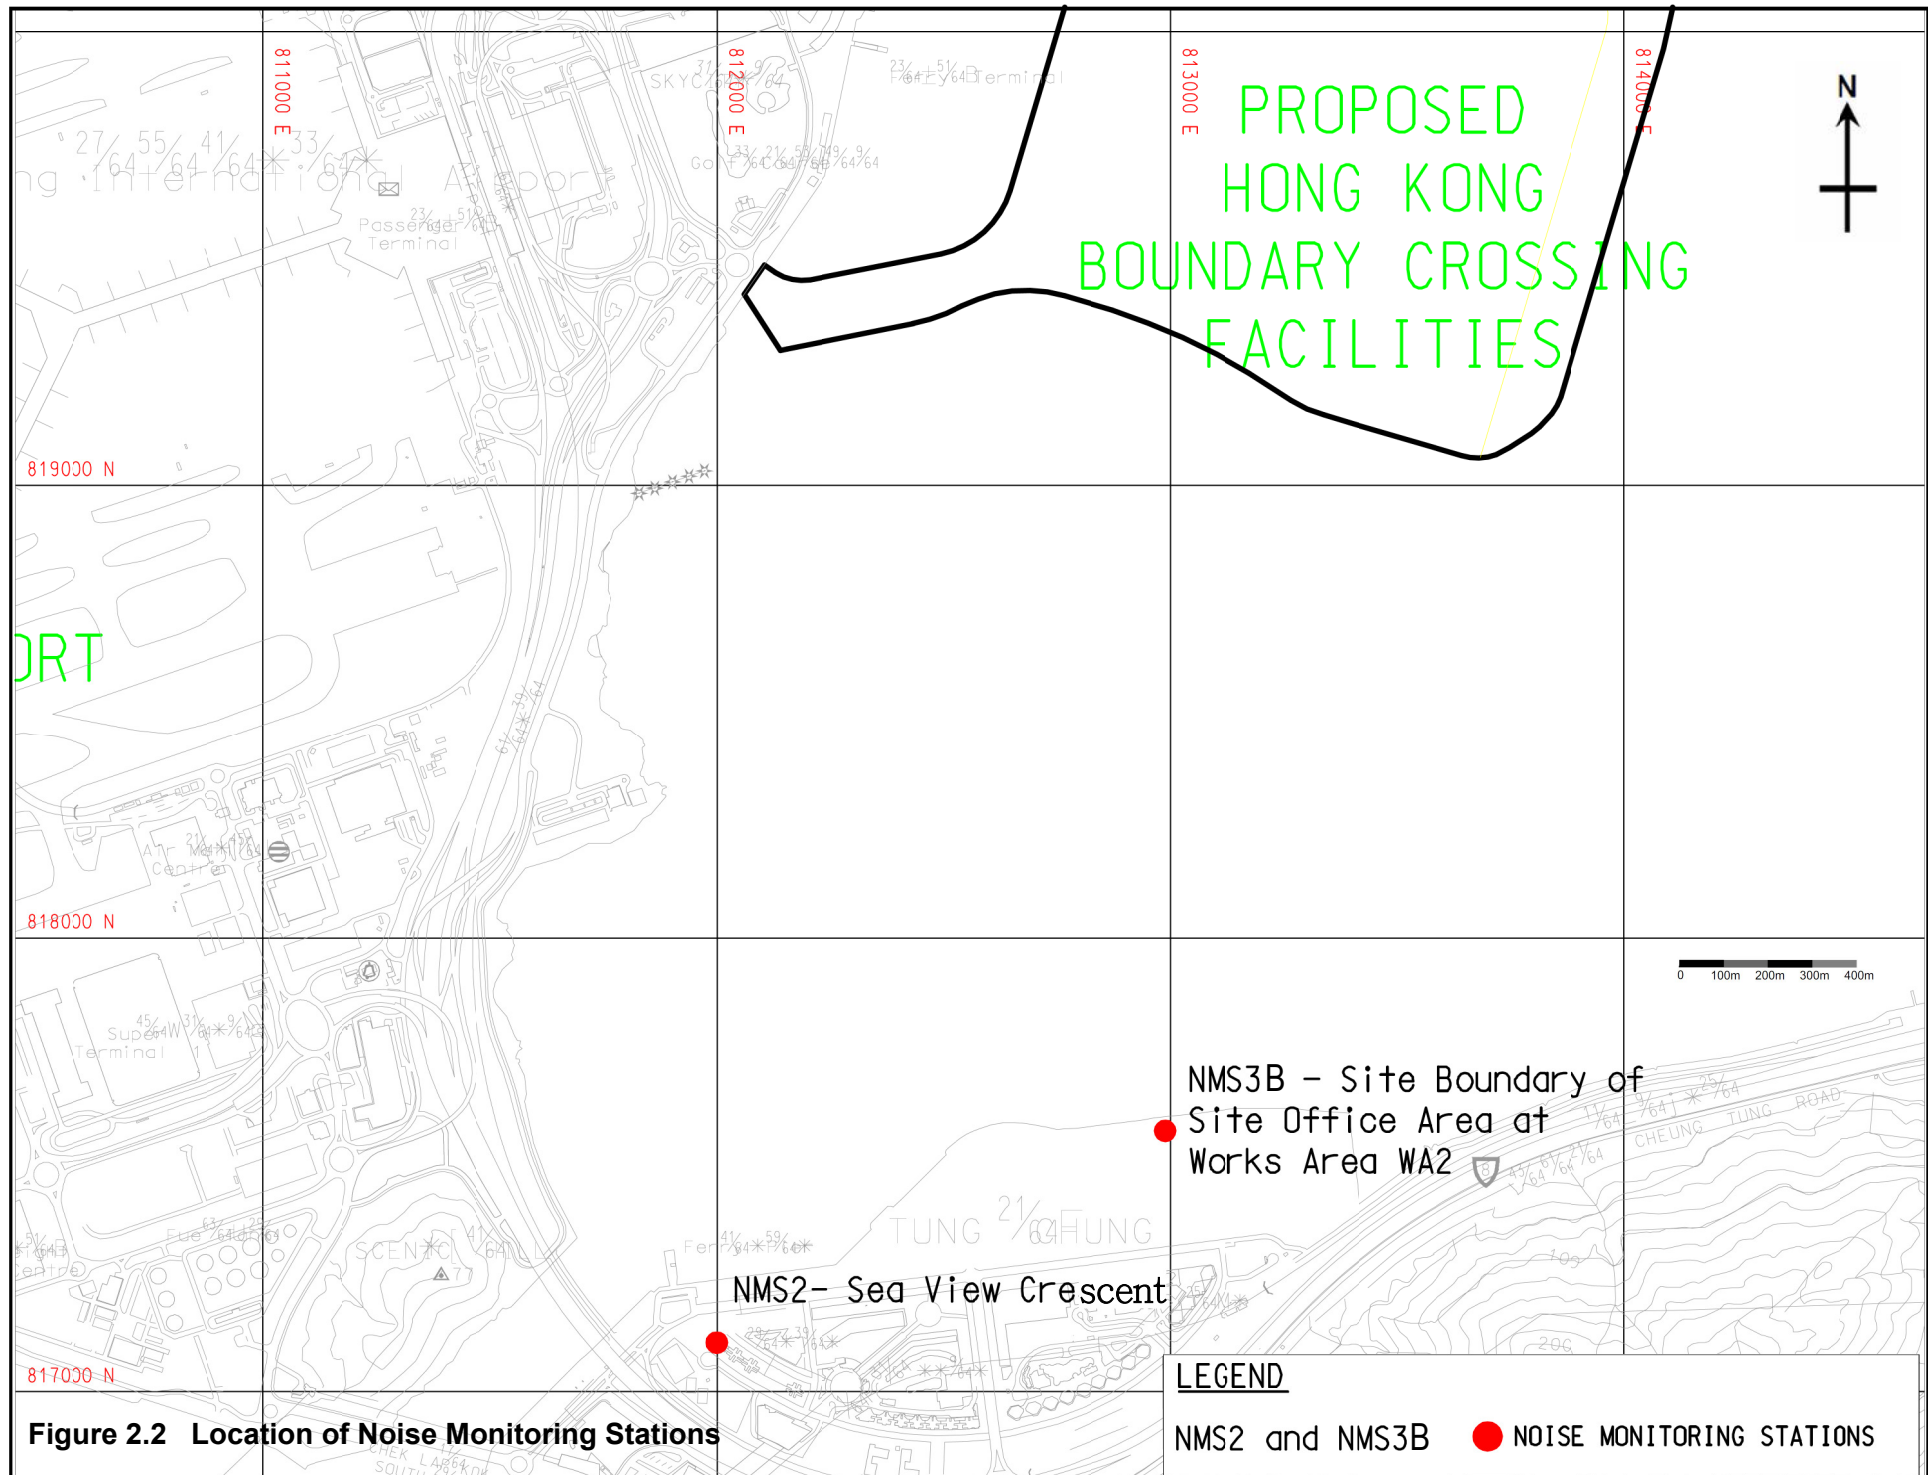
Figure 2.2 Location of Noise Monitoring Stations

NMS2 and NMS3B ● NOISE MONITORING STATIONS

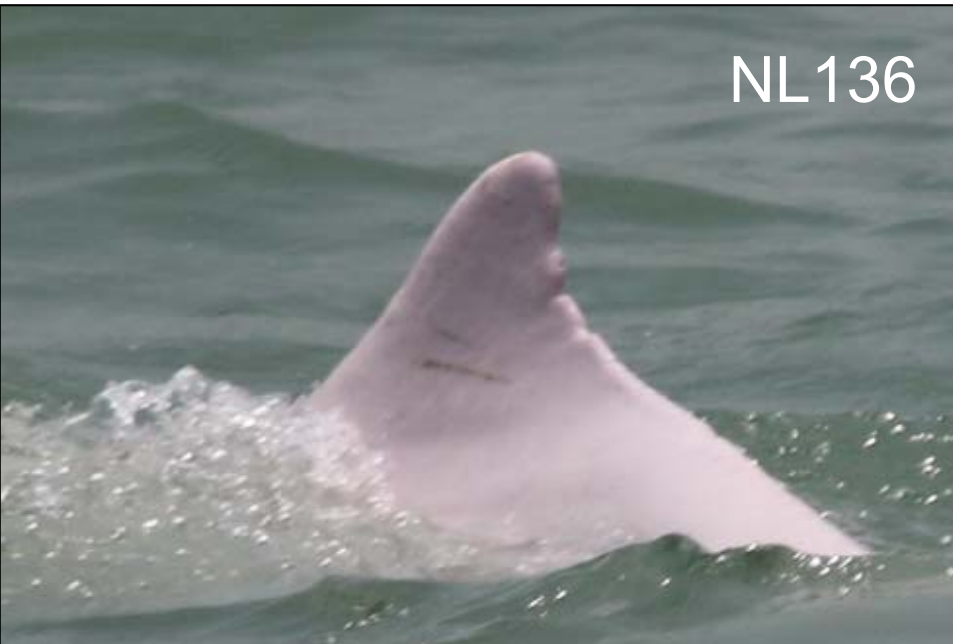
NL136

Appendix IV. Twelve individual dolphins that were identified during March to May 2018 under HKBCF impact phase monitoring surveys
