**CONTRACT NO.: HY/2013/02  
HONG KONG – ZHUHAI- MACAO BRIDGE  
HONG KONG BOUNDARY CROSSING  
FACILITIES – INFRASTRUCTURE  
WORKS STAGE I  
(WESTERN PORTION)  
QUARTERLY EM&A REPORT  
NO. 15**

**(01 JUNE 2018 – 31 AUGUST 2018)**

Report No.: ENA86327

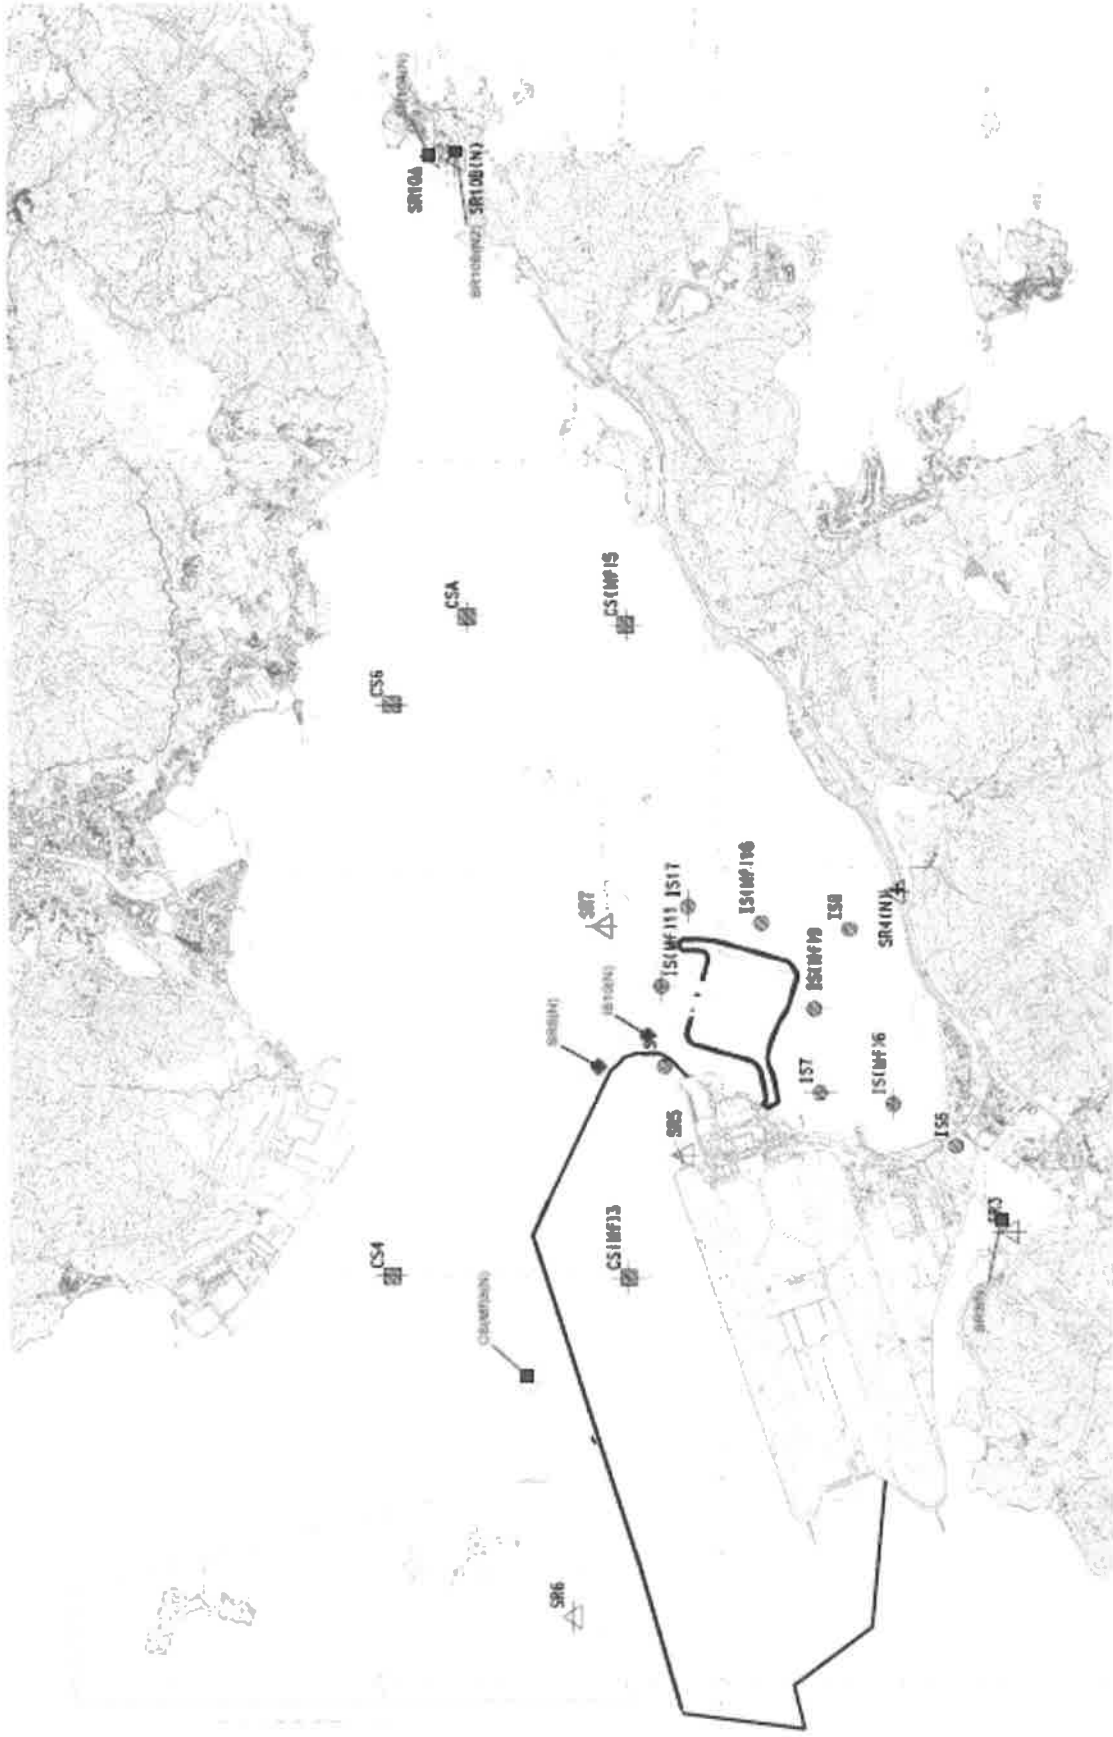
Figure 2 Water Quality Monitoring Stations (construction phases)

**2.1.3** The water monitoring works for the Contract are covered by Contract No. HY/2013/01 Hong Kong-Zhuhai-Macao Bridge HKBCF – Passenger Clearance Building. The ET of the Contract or another ET of the HZMB project is required to conduct water quality monitoring at twenty one stations (9 Impact Stations, 7 Sensitive Receiver Stations and 5 Control/Far Field Stations). Due to topographical conditions of SR3, SR10A and SR10B(N), the water quality monitoring (WQM) stations was proposed to be monitored at alternative WQM stations named as SR3(N), SR10A (N) and SR10B(N2). The proposal for alternation of water quality monitoring stations for HZMB HKBCF was justified by the ET Leader for Contract No. HY/2013/01 on 08 November 2017 and verified by the IEC on 13 November 2017; and submitted to EPD on 29 November 2017, and it was approved by EPD on 22 December 2017. **Table 2.2** and **Figure 2** shows the locations of water quality monitoring stations.

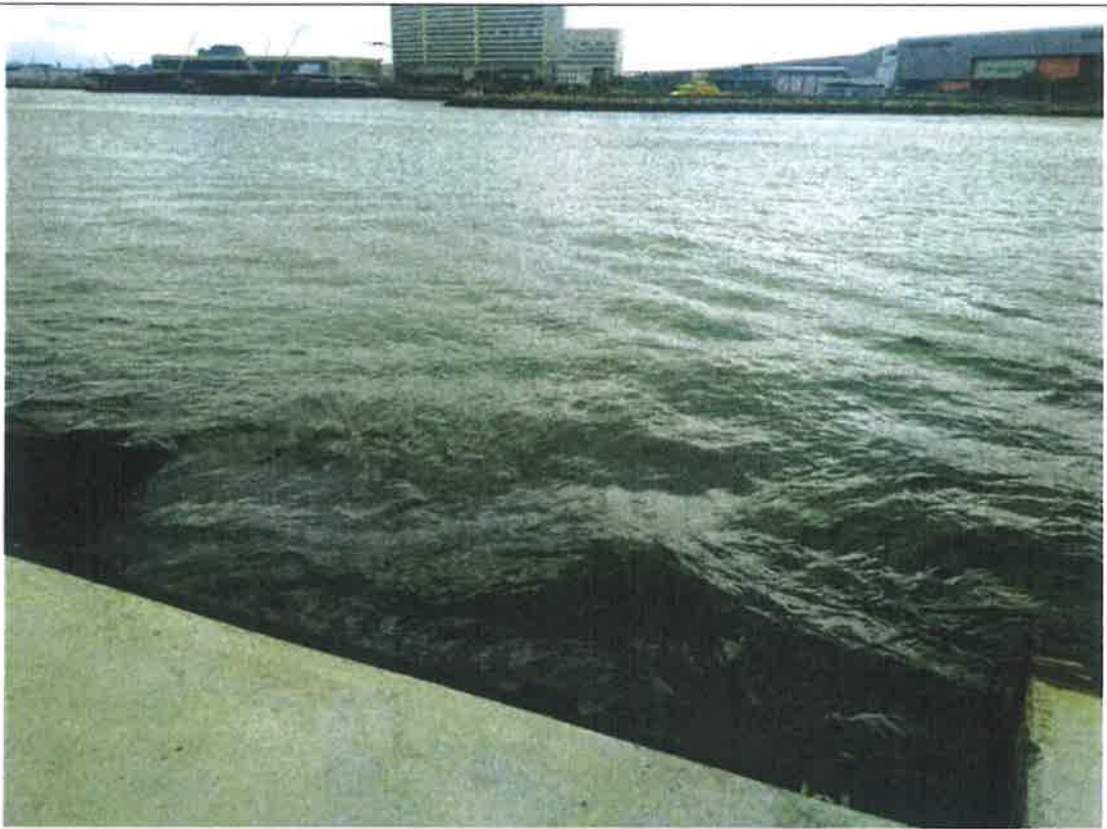
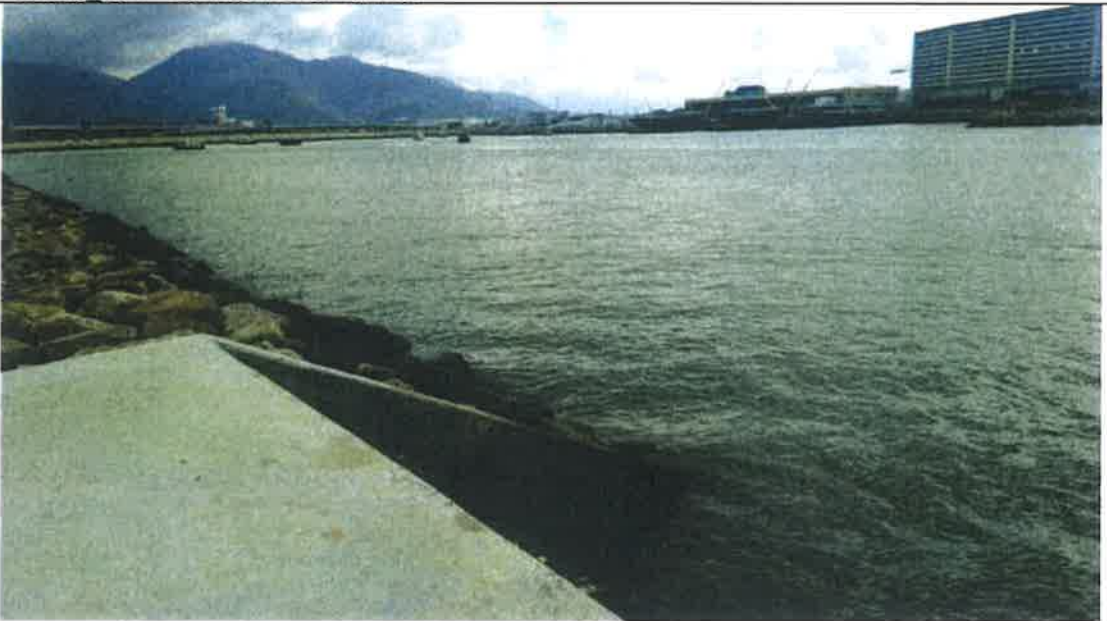
<b>Details of Follow up action(s)</b>			
<p>After received the details of the complaint from the ENPO on 25 June 2018, a related follow-up inspection was conducted by ET and the Contractor of Contract No. HY/2013/02 to investigate this event. The inspection was concentrated to check if there is any improper discharged by Contract No. HY/2013/02. After checked with the Contractor of Contract No. HY/2013/02, only Box Culvert A is within our site boundary. There was no any muddy water discharge observed during inspection (see attached photo 180625_001 &amp; 002) on 25 June 2018. Besides, during weekly environmental site inspection on 27 June 2018, Box Culvert A was checked and inspected. No muddy water discharge was observed (see attached photo 180627_001, 002 &amp; 003). Besides, the capital works were substantially completed on 28 March 2018 and no construction activities that would generate wastewater with high concentrations of suspended solid were conducted on 13 June 2018. Moreover, as discussed with the contractor, all the washing/de-silting/removal of grit works inside manholes has been completed before 30 April 2018 and no exposed earth ground was observed during the inspection. Hence, the complaint received on 13 June 2018 was found non-related to Contract No. HY/2013/02.</p> <p>Although this complaint was non-related to Contract No. HY/2013/02, the Contractor of Contract No. HY/2013/02 was reminded to provide appropriate water pollution mitigation measures, such as ensure all channels and manholes were maintained properly and any deposited silt and grit was removed regularly. Exposed stockpiles of soils or construction materials should be covered with impervious sheets or removed immediately to avoid release of pollutants into the drainage channels.</p>

Photo 180625\_001 –Box Culvert A on 25 June 2018

Photo 180625\_002 –Box Culvert A on 25 June 2018

Photo 180627\_001 -Box Culvert A on 27 June 2018

Photo 180627\_002 -Box Culvert A on 27 June 2018

Photo 180627\_003 – Open sea near Box Culvert A on 27 June 2018

**4.2.2** Follow-up action to the complaint received by *Highways Department* on 13 June 2018 and referred to the ENPO on 22 June 2018. Then the ENPO forwarded the complaint by email to the R.E. (AECOM), the Contractor (China Harbour) and the ET (ETS-Testconsult Ltd.) of Contract No. HY/2013/02 at 10:42 on 25 June 2018. After received the details of the complaint from the ENPO on 25 June 2018, a related follow-up inspection was conducted by ET and the Contractor of Contract No. HY/2013/02 to investigate this event. The inspection was concentrated to check if there is any improper discharge by Contract No. HY/2013/02. After checked with the Contractor of Contract No. HY/2013/02, only Box Culvert A is within our site boundary. There was no any muddy water discharge observed during inspection on 25 June 2018. Besides, during weekly environmental site inspection on 27 June 2018, Box Culvert A was checked and inspected. No muddy water discharge was observed. Besides, the capital works were substantially completed on 28 March 2018 and no construction activities that would generate wastewater with high concentrations of suspended solid were conducted on 13 June 2018. Moreover, as discussed with the contractor, all the washing/de-silting/removal of grit works inside manholes has been completed before 30 April 2018 and no exposed earth ground was observed during the inspection. Hence, the complaint received on 13 June 2018 was found non-related to Contract No. HY/2013/02.
