**CHINA HARBOUR ENGINEERING CO.
LTD.**

**CONTRACT NO.: HY/2013/02
HONG KONG – ZHUHAI- MACAO BRIDGE
HONG KONG BOUNDARY CROSSING
FACILITIES – INFRASTRUCTURE
WORKS STAGE I
(WESTERN PORTION)
MONTHLY EM&A REPORT
NO. 44
(01 JULY – 31 JULY 2018)**

Report No.: ENA85506

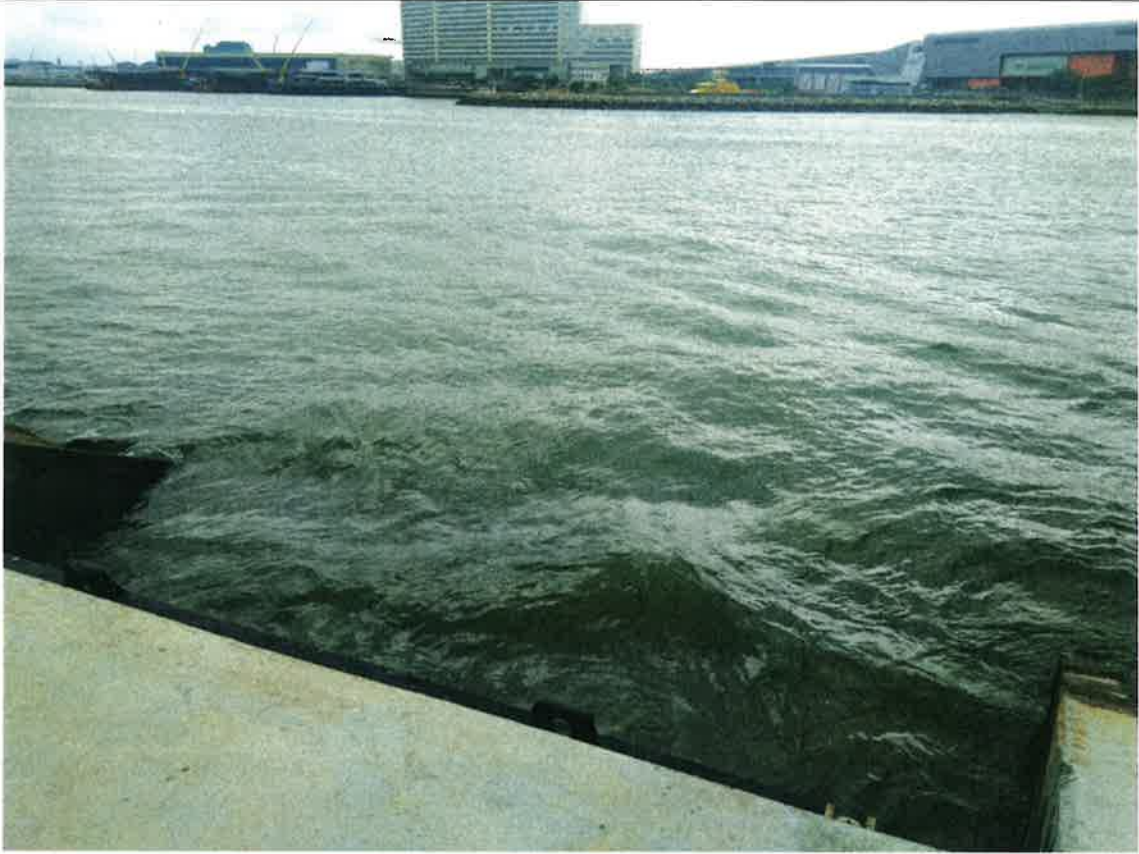
Culvert A is within our site boundary. There was no any muddy water discharge observed during inspection on 25 June 2018. Besides, during weekly environmental site inspection on 27 June 2018, Box Culvert A was checked and inspected. No muddy water discharge was observed. Besides, the capital works were substantially completed on 28 March 2018 and no construction activities that would generate wastewater with high concentrations of suspended solid were conducted on 13 June 2018. Moreover, as discussed with the contractor, all the washing/de-silting/removal of grit works inside manholes has been completed before 30 April 2018 and no exposed earth ground was observed during the inspection. Hence, the complaint received on 13 June 2018 was found non-related to Contract No. HY/2013/02. The complaint investigation report (Log No. 019) was provided in **Appendix J**.

Photo 180625_001 –Box Culvert A on 25 June 2018

Refer to the above mentioned inspection, since providing of appropriate water pollution mitigation measures were launched, the complaint was found non-related to Contract No. HY/2013/02.

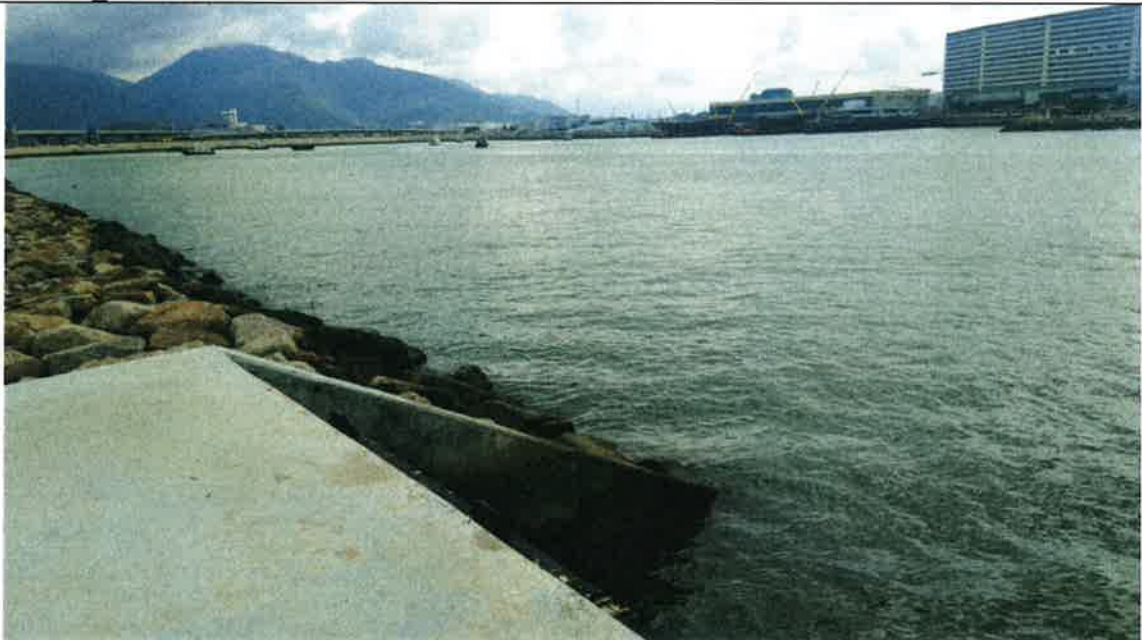
Photo 180625_002 –Box Culvert A on 25 June 2018

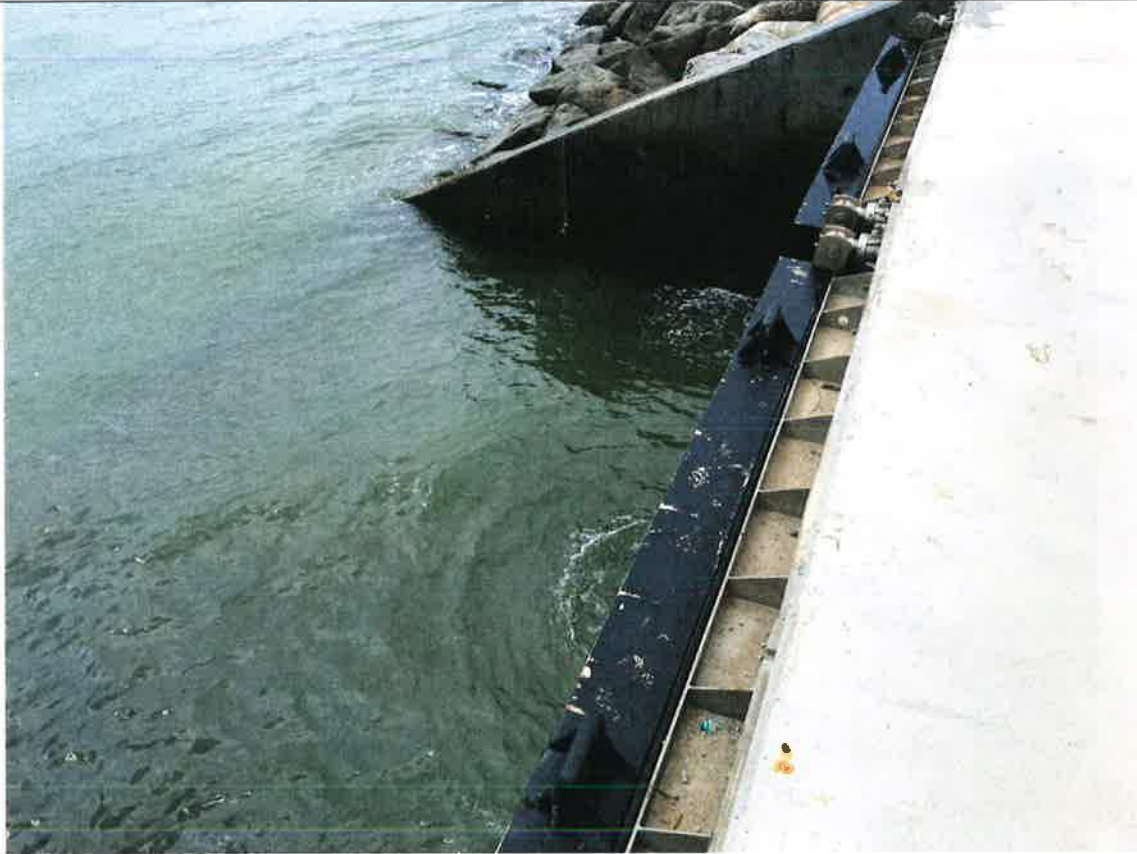
Photo 180627_001 –Box Culvert A on 27 June 2018

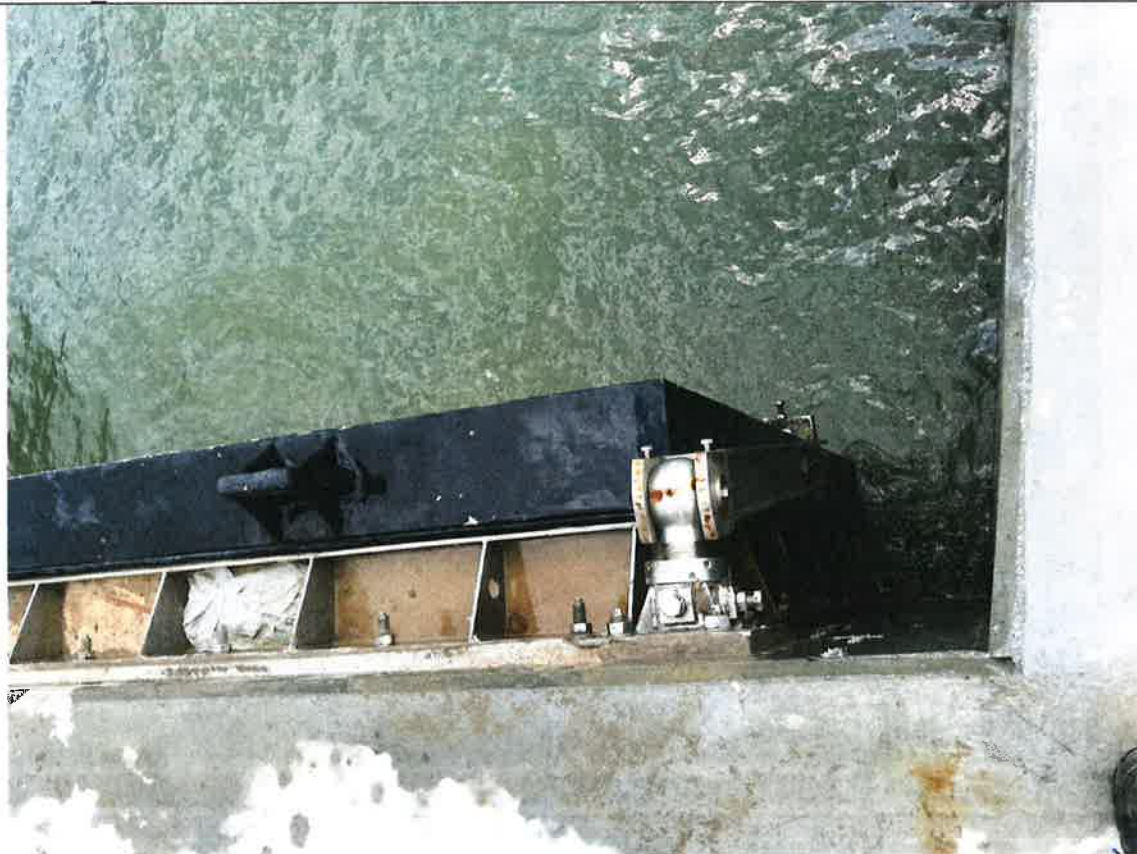
Photo 180627_002 –Box Culvert A on 27 June 2018

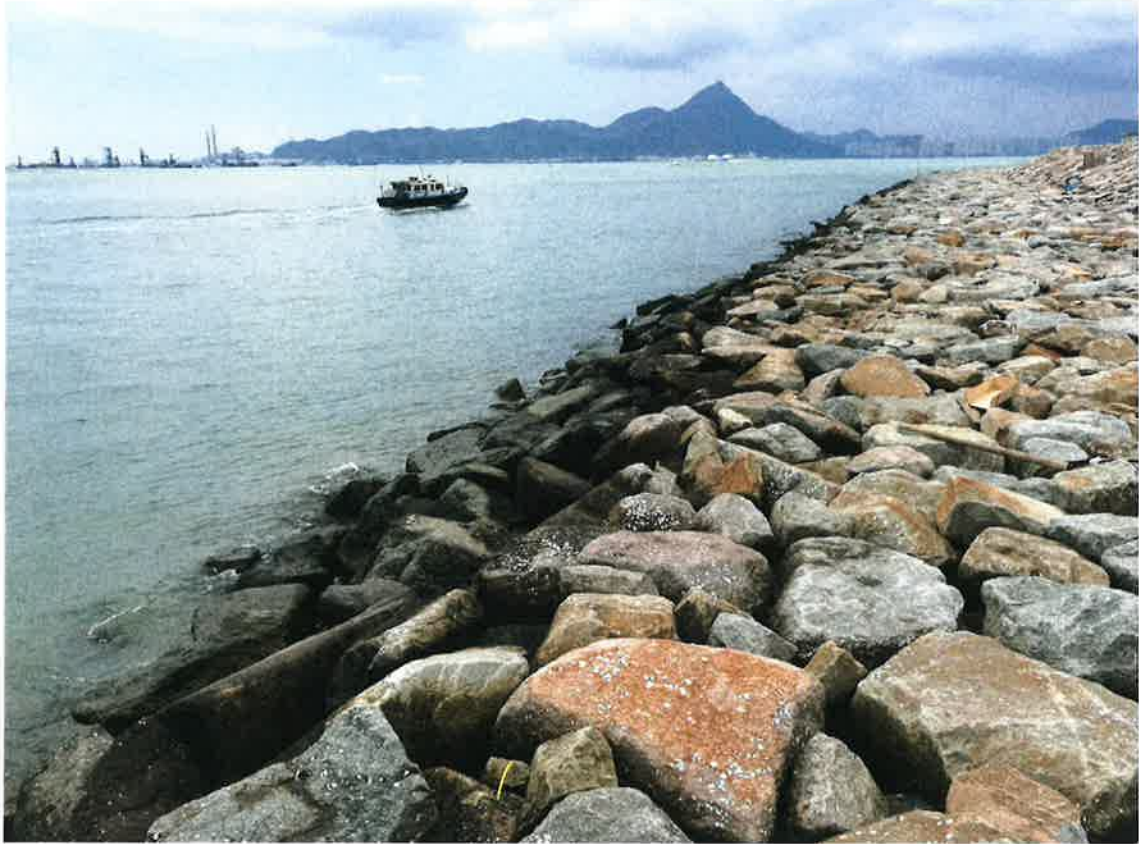
After received the details of the complaint from the ENPO on 25 June 2018, a related follow-up inspection was conducted by ET and the Contractor of Contract No. HY/2013/02 to investigate this event. The inspection was concentrated to check if there is any improper discharged by Contract No. HY/2013/02. After checked with the Contractor of Contract No. HY/2013/02, only Box Culvert A is within our site boundary. There was no any muddy water discharge observed during inspection (see attached photo 180625_001 & 002) on 25 June 2018. Besides, during weekly environmental site inspection on 27 June 2018, Box Culvert A was checked and inspected. No muddy water discharge was observed (see attached photo 180627_001, 002 & 003). Besides, the capital works were substantially completed on 28 March 2018 and no construction activities that would generate wastewater with high concentrations of suspended solid were conducted on 13 June 2018. Moreover, as discussed with the contractor, all the washing/de-silting/removal of grit works inside manholes has been completed before 30 April 2018 and no exposed earth ground was observed during the inspection. Hence, the complaint received on 13 June 2018 was found non-related to Contract No. HY/2013/02.

Photo 180627_003 – Open sea near Box Culvert A on 27 June 2018
