**Contract No. HY/2013/01
Hong Kong – Zhuhai – Macao Bridge
Hong Kong Boundary Crossing Facilities – Passenger Clearance Building
Certification of Monthly EM&A Report No. 50**

**Hong Kong-Zhuhai-Macao Bridge
Hong Kong Boundary Crossing Facilities – Passenger Clearance
Building**

**Monthly EM&A Report No. 50
(Covering the Period from 1 November 2018 to 30 November 2018)**

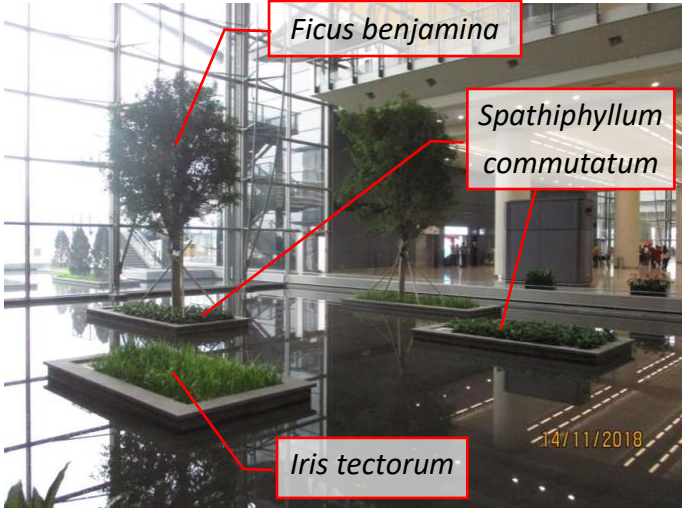
Photo 6	Photo 7					
Photo 8	Photo 9

<p><i>Ficus benjamina</i></p> <p><i>Iris tectorum</i></p> <p><i>Spathiphyllum commutatum</i></p> <p>14/11/2018</p>

<p><i>Ficus benjamina</i></p> <p><i>Spathiphyllum commutatum</i></p> <p><i>Iris tectorum</i></p> <p>14/11/2018</p>
