**Contract No. HY/2013/01
Hong Kong – Zhuhai – Macao Bridge
Hong Kong Boundary Crossing Facilities – Passenger Clearance Building
Certification of Monthly EM&A Report No. 51**

Atkins China Limited certifies, in the capacity of Environmental Team Leader, that Monthly EM&A Report No. 51 (Revision 4) conforms the requirements provided in Condition 5.4 of the Environmental Permit No. EP-353/2009/K.

**Contract No. HY/2013/01
HZMB HKBCF – Passenger Clearance Building
Monthly Environmental Monitoring & Audit Report for December 2018**

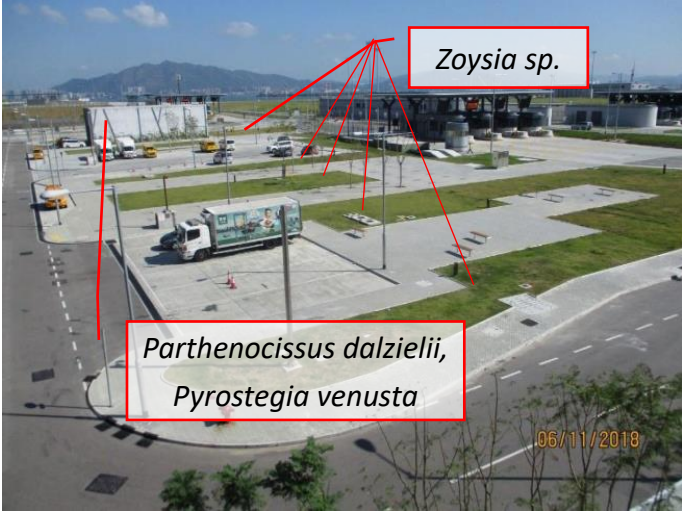
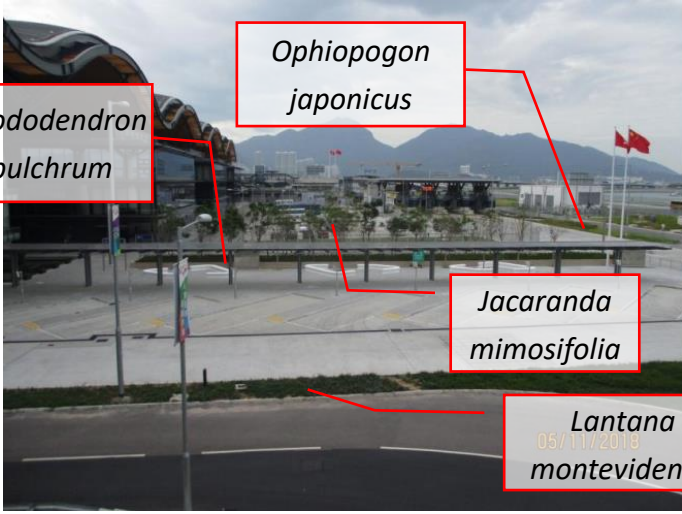
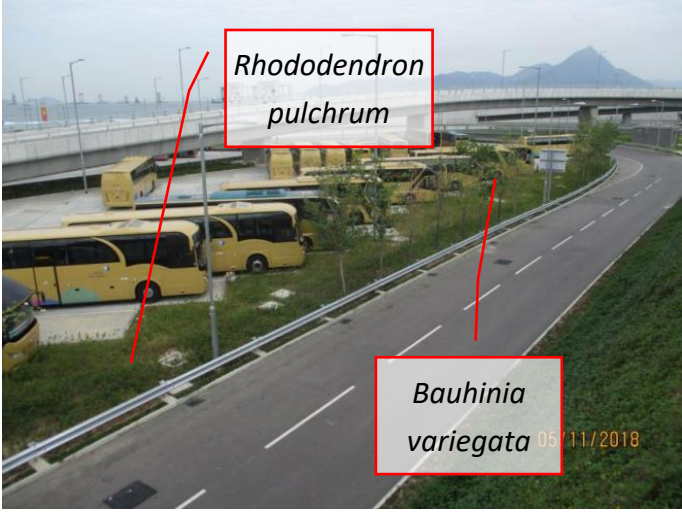
N/A or not observed	Yes	No	Remarks / Photo
1	At-grade planting west of Passenger Clearance Building				
1.1	Is watering provided to all plants to ensure satisfactory growth and health (manual and automatic irrigation)?	<input type="checkbox"/>	<input checked="" type="checkbox"/>	<input type="checkbox"/>	Remark [1]

1.10	Are the plants in satisfied condition?	<input type="checkbox"/>	<input checked="" type="checkbox"/>	<input type="checkbox"/>	Remark [1]
2	At-grade planting east of Passenger Clearance Building

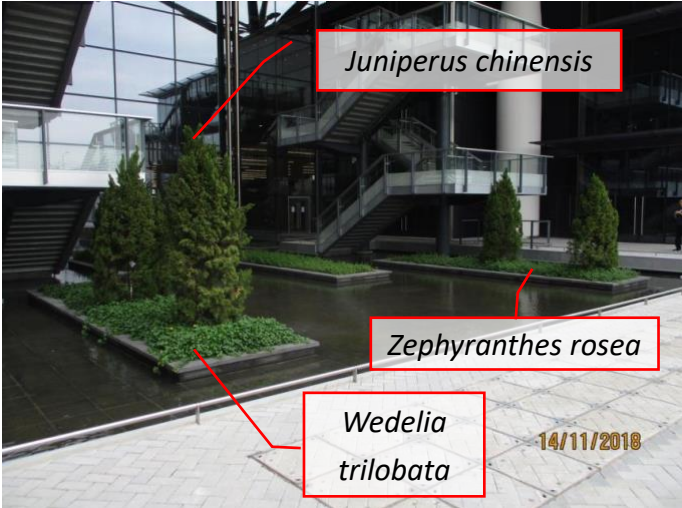
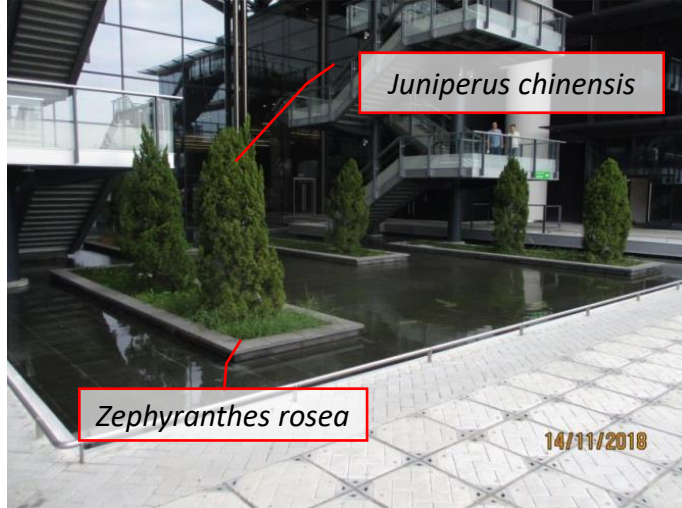
Location	Photo Record [1]					
<p>Planting in Outdoor Planters of Passenger Clearance Building</p> <table border="1" data-bbox="208 435 439 488"> <tr> <td>Photo 4</td> <td>Photo 5</td> </tr> </table>	Photo 4	Photo 5

<p><i>Juniperus chinensis</i></p> <p><i>Zephyranthes rosea</i></p> <p><i>Wedelia trilobata</i></p> <p>14/11/2018</p>

<p><i>Juniperus chinensis</i></p> <p><i>Zephyranthes rosea</i></p> <p>14/11/2018</p>		
Photo 4	Photo 5					
<p>Planting in Indoor Planters of Passenger Clearance Building</p> <table border="1" data-bbox="208 922 439 975"> <tr> <td>Photo 6</td> <td>Photo 7</td> </tr> </table> <table border="1" data-bbox="208 975 439 1027"> <tr> <td>Photo 8</td> <td>Photo 9</td> </tr> </table>	Photo 6	Photo 7	Photo 8	Photo 9

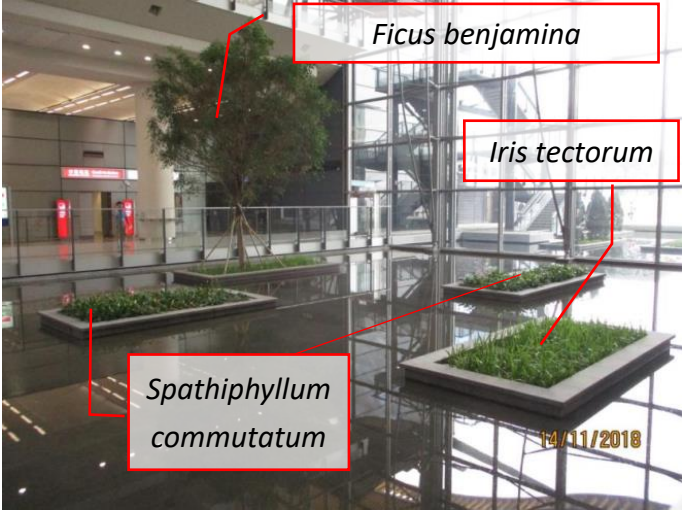
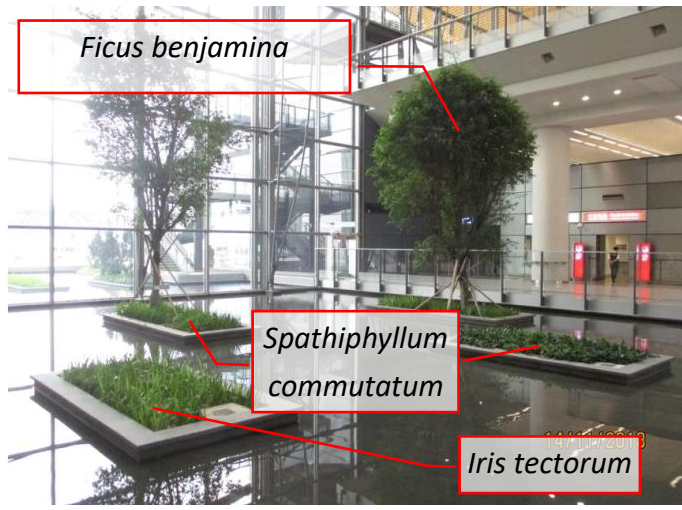
Photo 6	Photo 7					
Photo 8	Photo 9

<p><i>Ficus benjamina</i></p> <p><i>Iris tectorum</i></p> <p><i>Spathiphyllum commutatum</i></p> <p>14/11/2018</p>

<p><i>Ficus benjamina</i></p> <p><i>Spathiphyllum commutatum</i></p> <p><i>Iris tectorum</i></p> <p>14/11/2018</p>

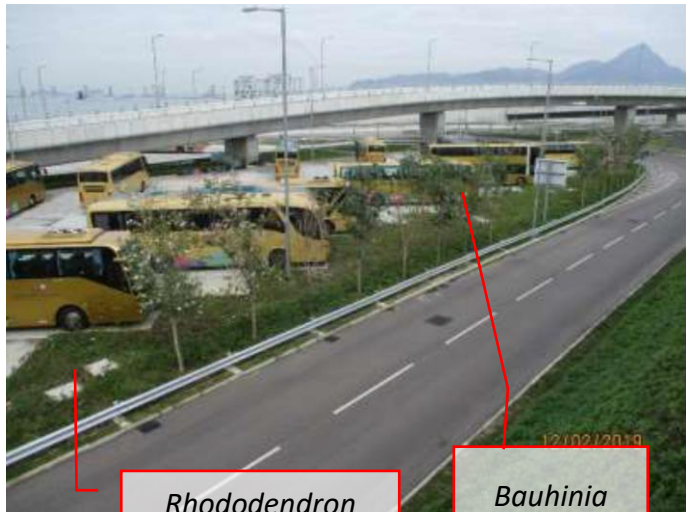
Location	Photo Record ^[1]

<p><i>Rhododendron pulchrum</i></p> <p><i>Ophiopogon japonicus</i></p> <p><i>Phyllanthus myrtifolius</i></p> <p><i>Jacaranda mimosifolia</i></p> <p><i>Lantana montevidensis</i></p>

<p><i>Rhododendron pulchrum</i></p> <p><i>Bauhinia variegata</i></p>

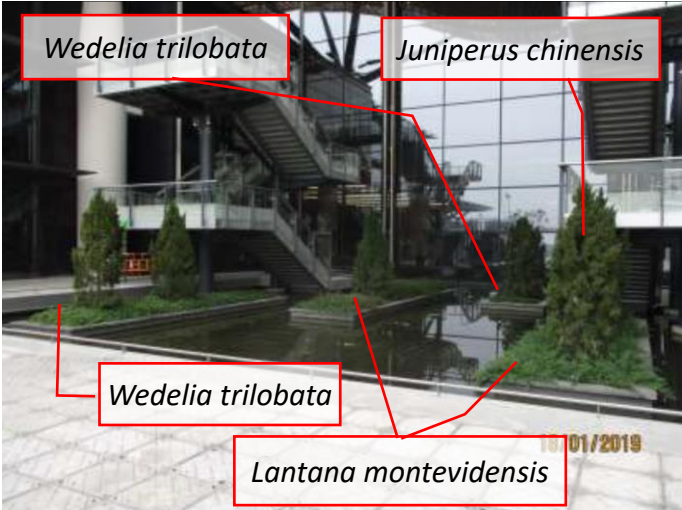
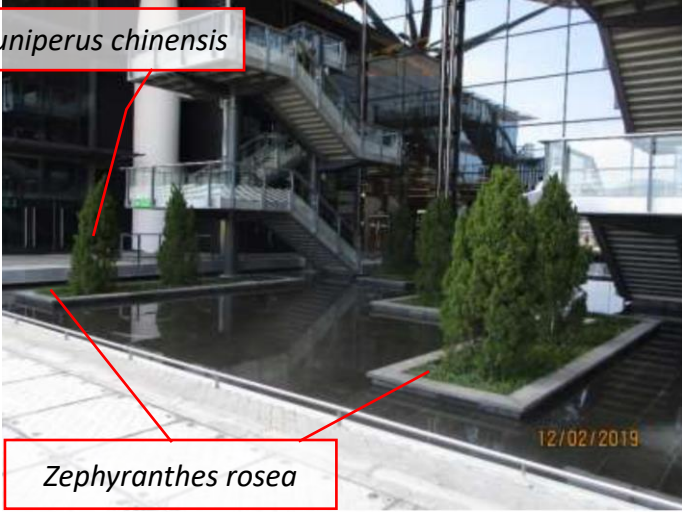
Location	Photo Record ^[1]					
<p>Planting in Outdoor Planters of Passenger Clearance Building</p> <table border="1" data-bbox="208 387 439 488"> <tr> <td>Photo 7</td> <td>Photo 8</td> </tr> <tr> <td>Photo 9</td> <td>Photo 10</td> </tr> </table>	Photo 7	Photo 8	Photo 9	Photo 10

<p>Wedelia trilobata</p> <p>Juniperus chinensis</p> <p>Wedelia trilobata</p> <p>Lantana montevidensis</p> <p>18/01/2019</p>

<p>Juniperus chinensis</p> <p>Wedelia trilobata</p> <p>Zephyranthes rosea</p> <p>18/01/2019</p>
Photo 7	Photo 8					
Photo 9	Photo 10

<p>Juniperus chinensis</p> <p>Zephyranthes rosea</p> <p>12/02/2019</p>

<p>Juniperus chinensis</p> <p>Wedelia trilobata</p> <p>Zephyranthes rosea</p> <p>12/02/2019</p>
