Contract No. HY/2013/04
Hong Kong-Zhuhai-Macao Bridge
Hong Kong Boundary Crossing Facilities –
Infrastructure Works Stage II (Southern Portion)

Monthly EM&A Report for December 2018

This is the 42nd Monthly EM&A Report summarising the findings of EM&A activities conducted under the Contract from 1 to 31 December 2018 (the “reporting period”) and is submitted to fulfil Condition 5.4 of the EP.

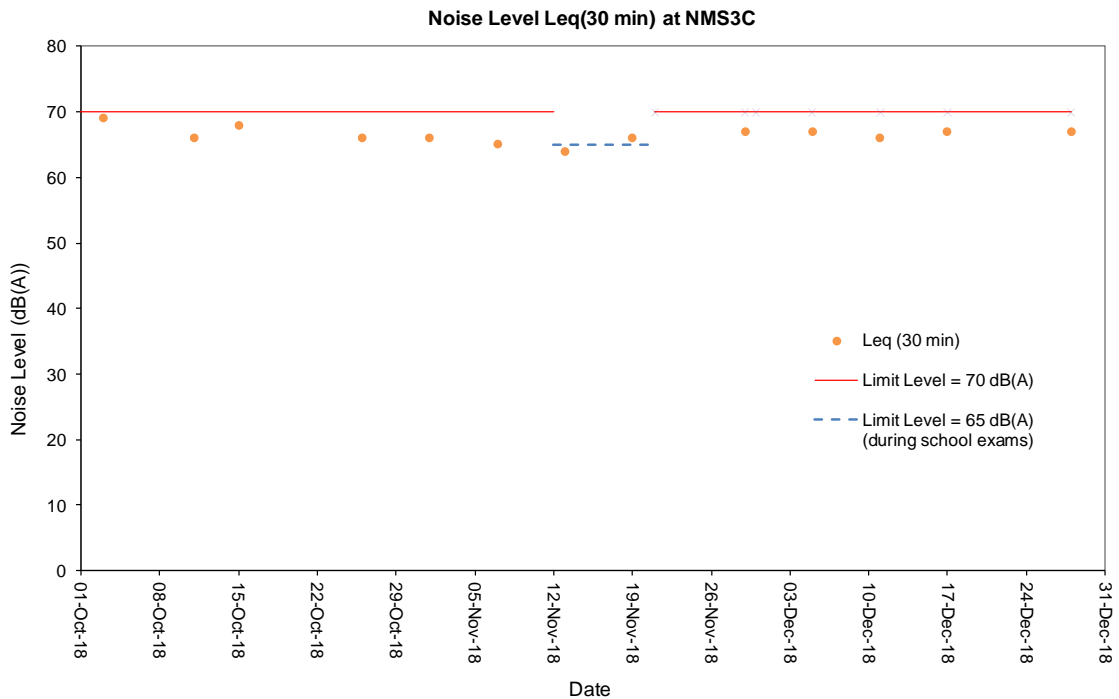
Remark: The measured noise level on 19 November 2018 at NMS3C exceeded the noise Limit Level of 65 dB(A) during examination period at Ho Yu College but it was below the baseline level. Therefore, it is not considered as an exceedance. As such the Event and Action Plan was not triggered.

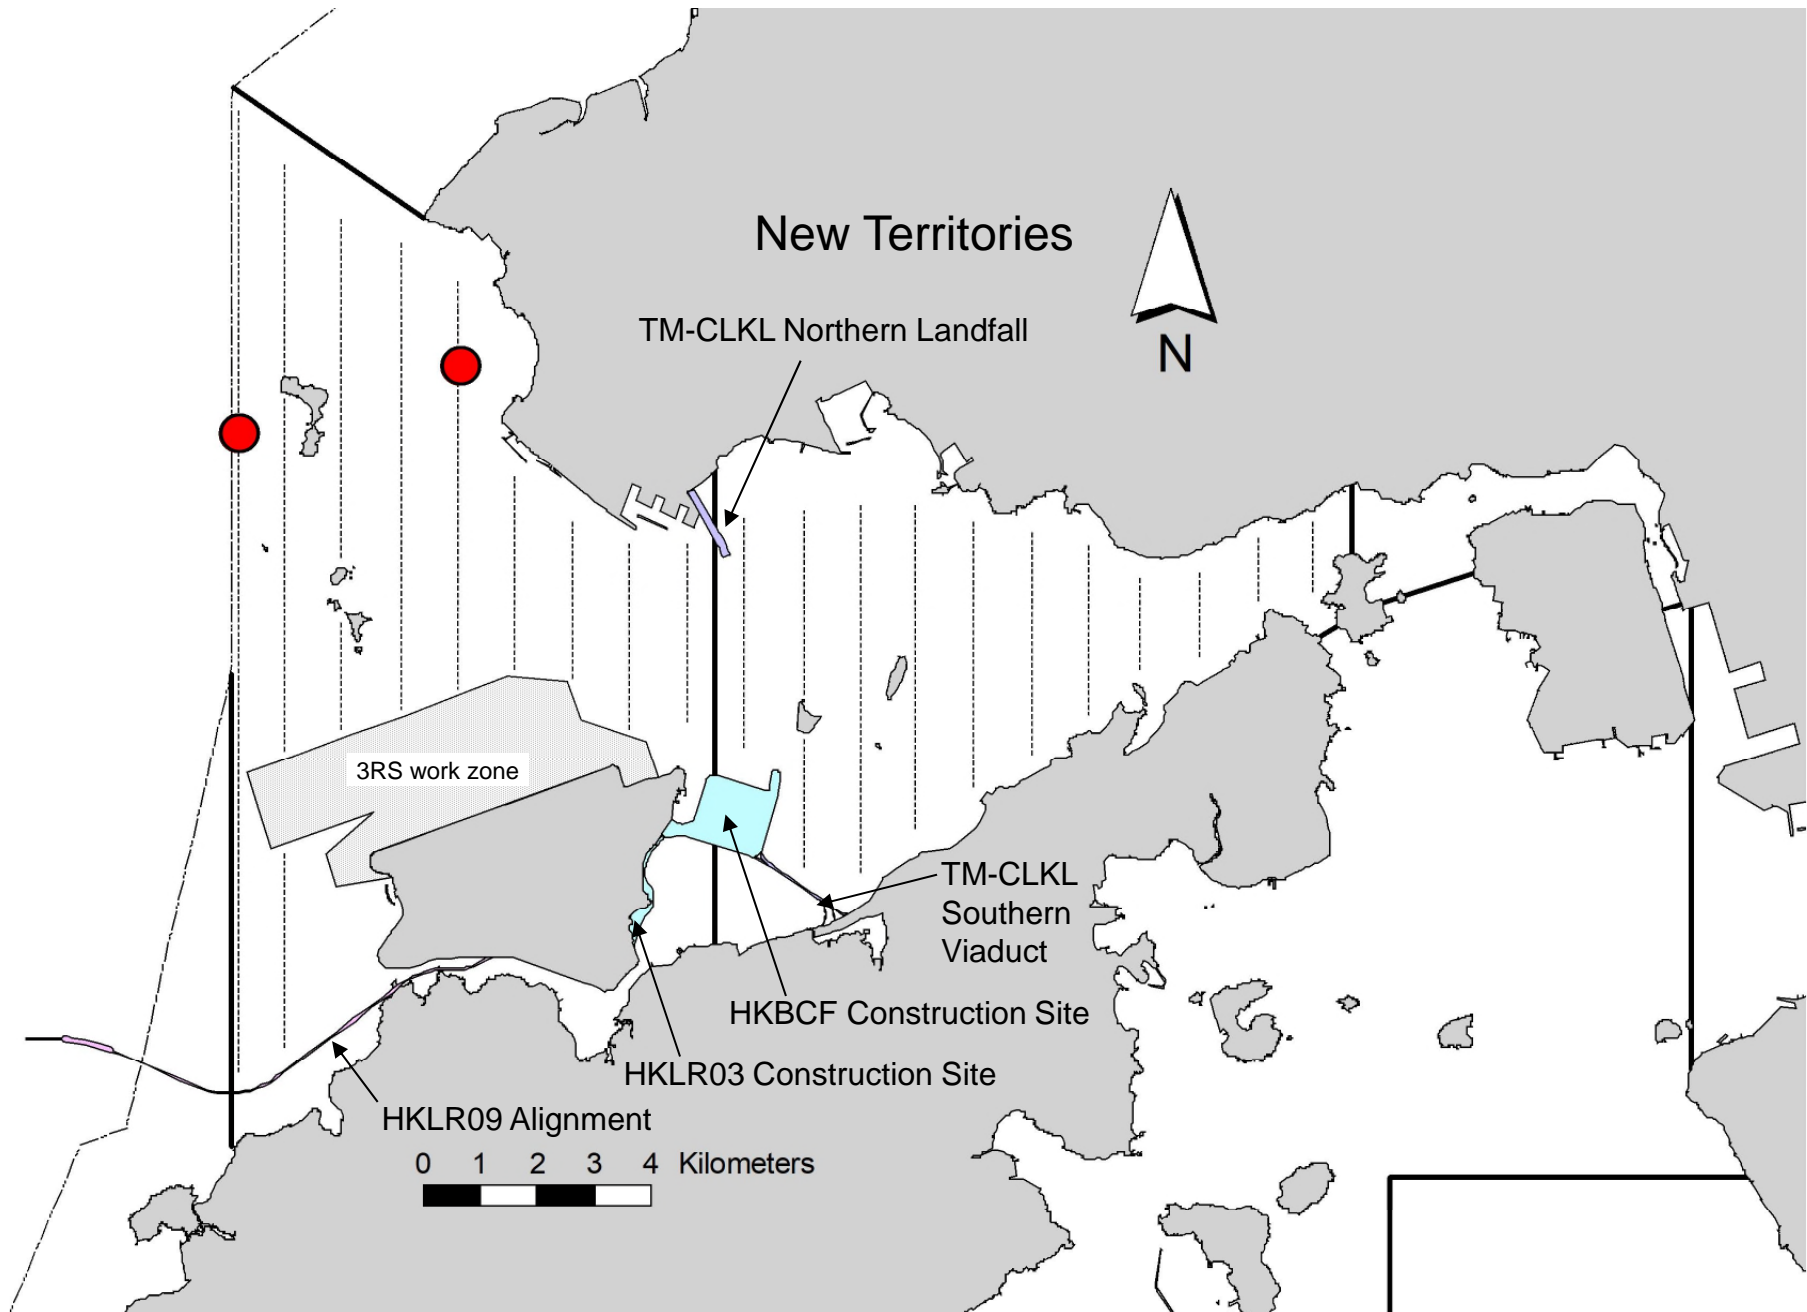
Figure 6. Distribution of Chinese White Dolphin Sightings during December 2018 HKLR03 Monitoring Surveys

For dolphin monitoring, dolphin surveys were conducted on 3, 5, 10 and 12 December 2018. A total of 261.96 km of survey effort was collected, with 90.3% of the total survey effort being conducted under favourable weather conditions. Only two groups of six Chinese White Dolphins were sighted. Both dolphin groups were sighted in NWL, while no dolphin was sighted at all in NEL.
