**Contract No. HY/2013/04 Hong Kong-Zhuhai-Macao Bridge (HZMB)  
Hong Kong Boundary Crossing Facilities – Infrastructure Works Stage II  
(Southern Portion)**

**Quarterly EM&A Report for December 2018 to February 2019**

**Contract No. HY/2013/04 – HZMB HKBCF – Infrastructure Works Stage II  
(Southern Portion)  
Quarterly EM&A Report for December 2018 to February 2019**

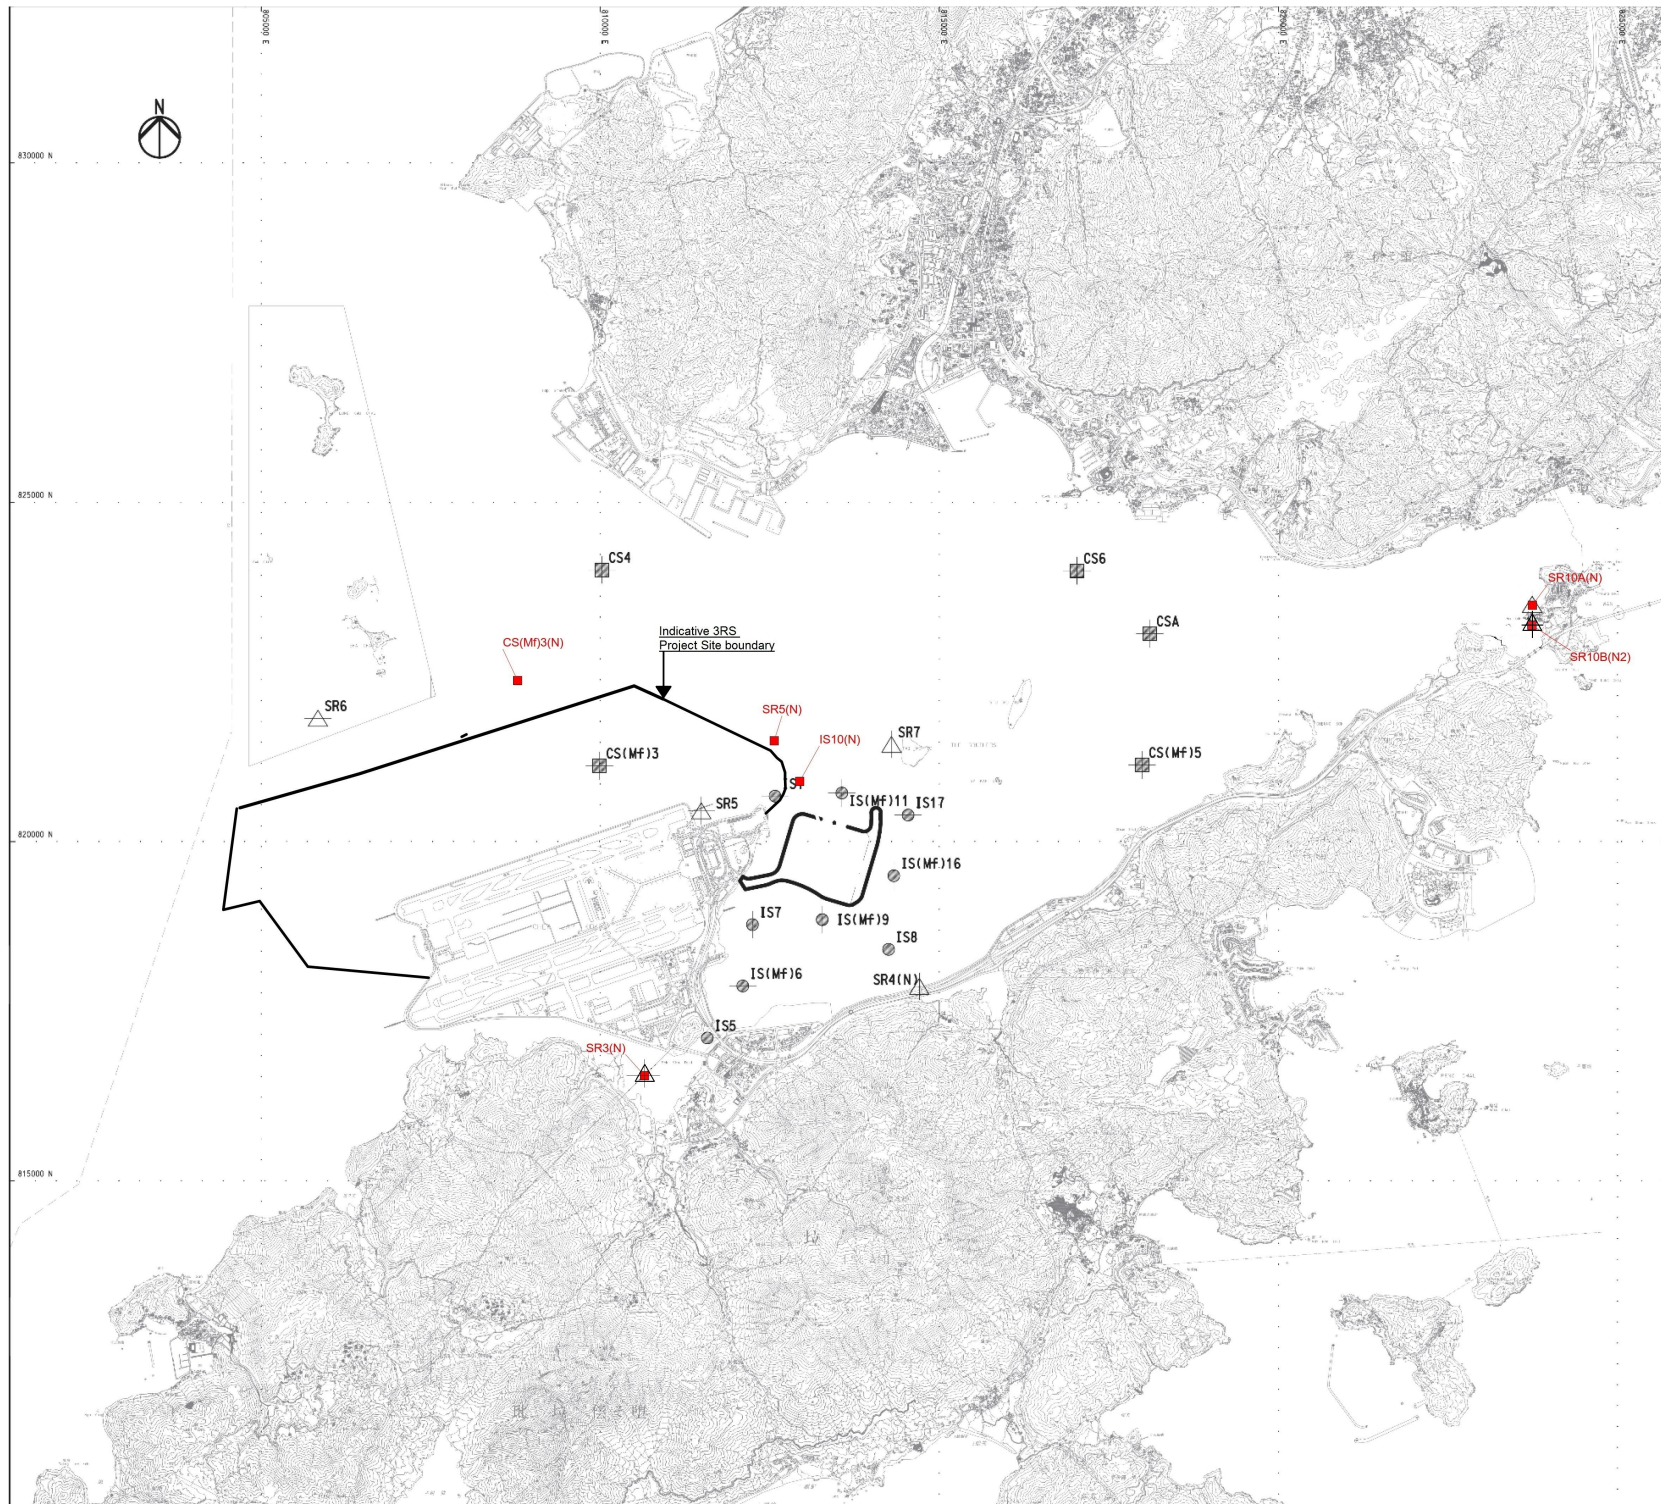
FIGURE 2.3 – LOCATION OF WATER QUALITY MONITORING STATIONS

Station	East	North
IS5	811579	817106
IS(Mf)6	812101	817873
IS7	812244	818777
IS8	814251	818412
IS(Mf)9	813273	818850
IS10(N)	812942	820881
IS(Mf)11	813562	820716
IS(Mf)16	814328	819497
IS17	814539	820391
SR3(N)	810689	816591
SR4(N)	814705	817859
SR5(N)	812569	821475
SR6	805837	821818
SR7	814293	821431
SR10A(N)	823644	823484
SR10B(N2)	823689	823159
CS(Mf)3(N)	808814	822355
CS(Mf)5	817990	821129
CS4	810025	824004
CS6	817028	823992
CSA	818103	823064
