**Contract No. HY/2013/04 Hong Kong-Zhuhai-Macao Bridge (HZMB)
Hong Kong Boundary Crossing Facilities – Infrastructure Works Stage II
(Southern Portion)**

Monthly EM&A Report for February 2019 (Revision 1)

**Contract No. HY/2013/04 – HZMB HKBCF – Infrastructure Works Stage II
(Southern Portion)
Monthly Environmental Monitoring & Audit Report for February 2019 (Revision 1)**

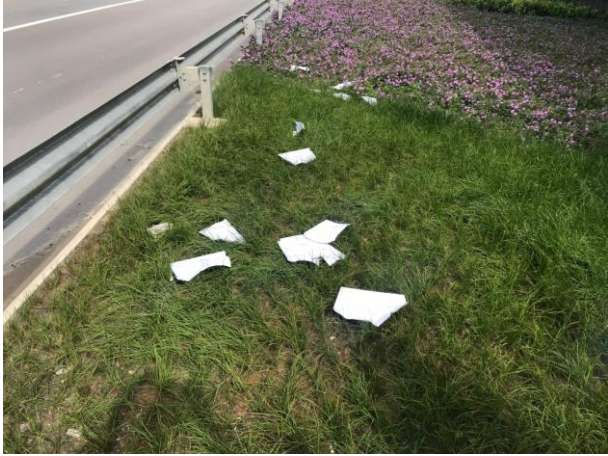
<p data-bbox="674 858 1207 890">Item 1 – Improper disposal of general refuse</p>
