Contract No. HY/2013/04
Hong Kong-Zhuhai-Macao Bridge
Hong Kong Boundary Crossing Facilities –
Infrastructure Works Stage II (Southern Portion)

Monthly EM&A Report for March 2019 (Revision 1)

This is the 45th Monthly EM&A Report summarising the findings of EM&A activities conducted under the Contract from 1 to 31 March 2019 (the “reporting period”) and is submitted to fulfil Condition 5.4 of the EP.

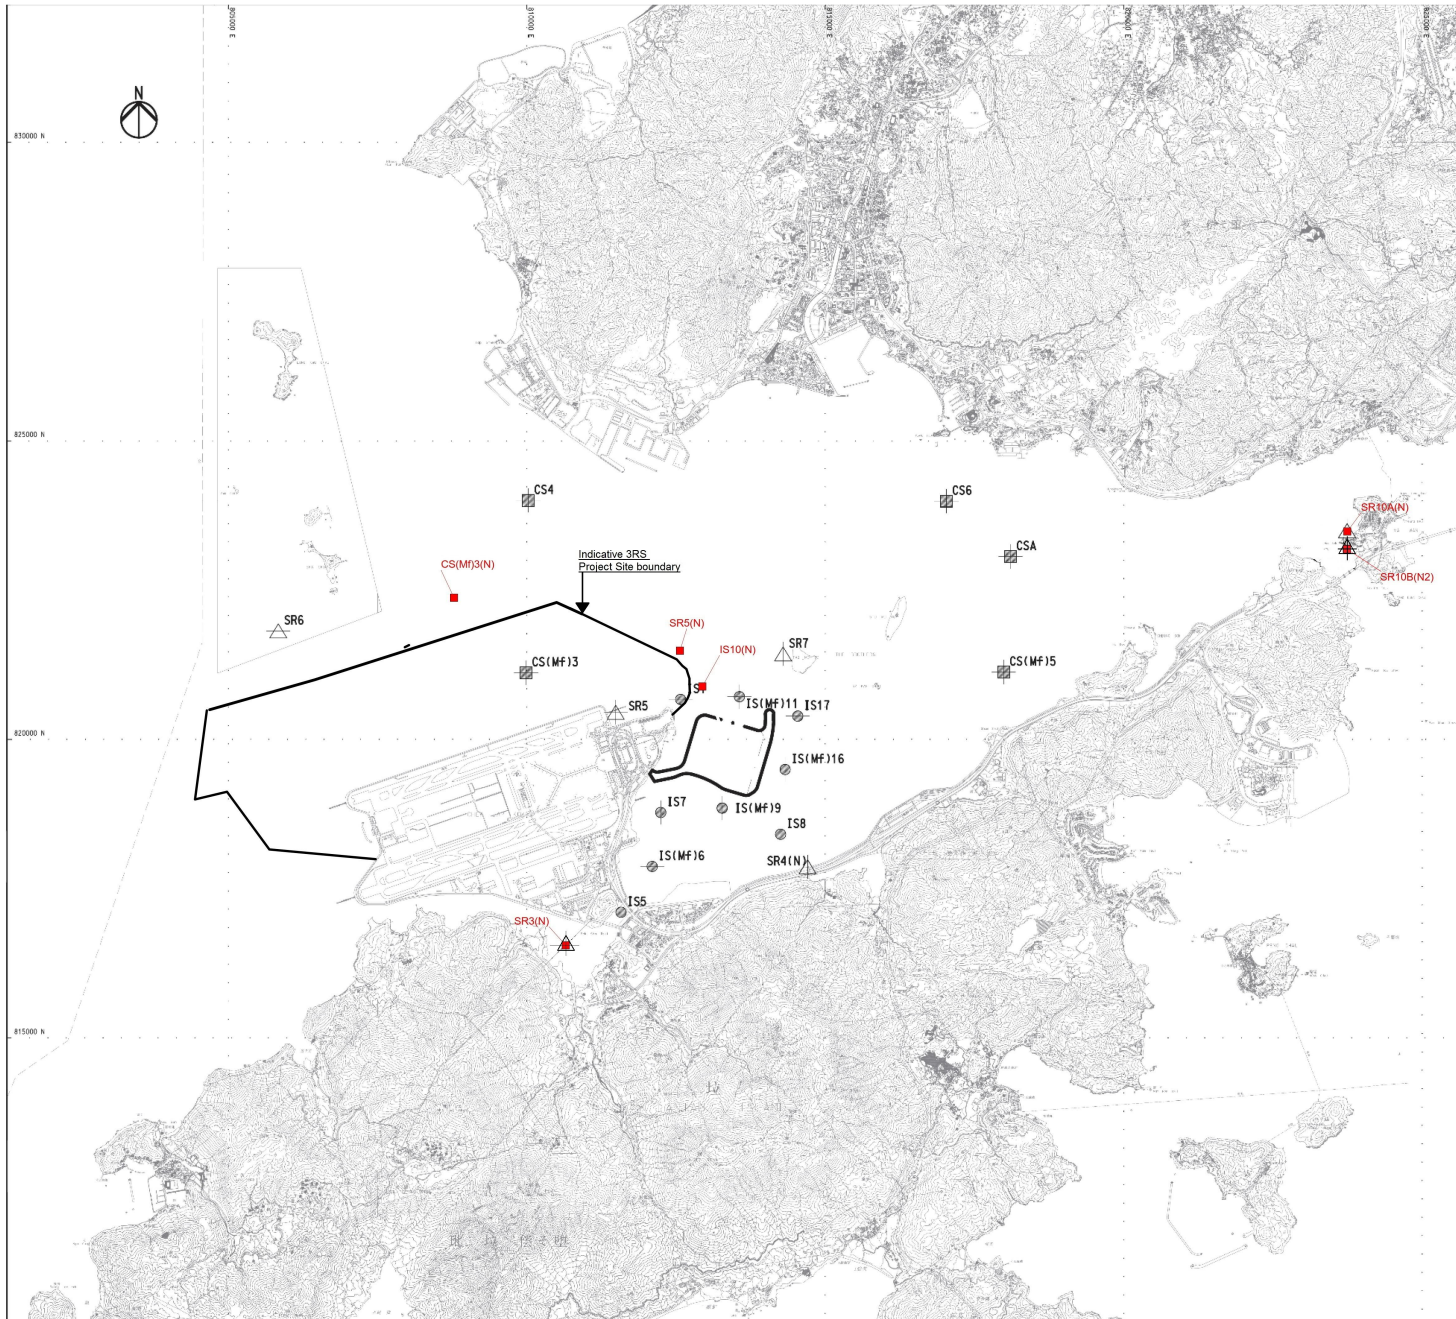
FIGURE 4.1— LOCATION OF WATER QUALITY MONITORING STATIONS

The nine Impact Stations (IS) were chosen on the basis of their proximity to the reclamation and thus the greatest potential for water quality impacts, the seven Sensitive Receiver Stations (SR) were chosen as they are close to the key sensitive receives and the five Control/ Far Field Stations (CS) were chosen to facilitate comparison of the water quality of the IS stations with less influence by the Project/ ambient water quality conditions.

Station	East	North
IS5	811579	817106
IS(Mf)6	812101	817873
IS7	812244	818777
IS8	814251	818412
IS(Mf)9	813273	818850
IS10(N)	812942	820881
IS(Mf)11	813562	820716
IS(Mf)16	814328	819497
IS17	814539	820391
SR3(N)	810689	816591
SR4(N)	814705	817859
SR5(N)	812569	821475
SR6	805837	821818
SR7	814293	821431
SR10A(N)	823644	823484
SR10B(N2)	823689	823159
CS(Mf)3(N)	808814	822355
CS(Mf)5	817990	821129
CS4	810025	824004
CS6	817028	823992
CSA	818103	823064
