**Contract No. HY/2013/04 Hong Kong-Zhuhai-Macao Bridge (HZMB)
Hong Kong Boundary Crossing Facilities – Infrastructure Works Stage II
(Southern Portion)**

Quarterly EM&A Report for March to May 2019 (Revision 0)

Contract No. HY/2013/04 HZMB HKBCF –
Infrastructure Works Stage II (Southern Portion)
Quarterly EM&A Report for March to May 2019

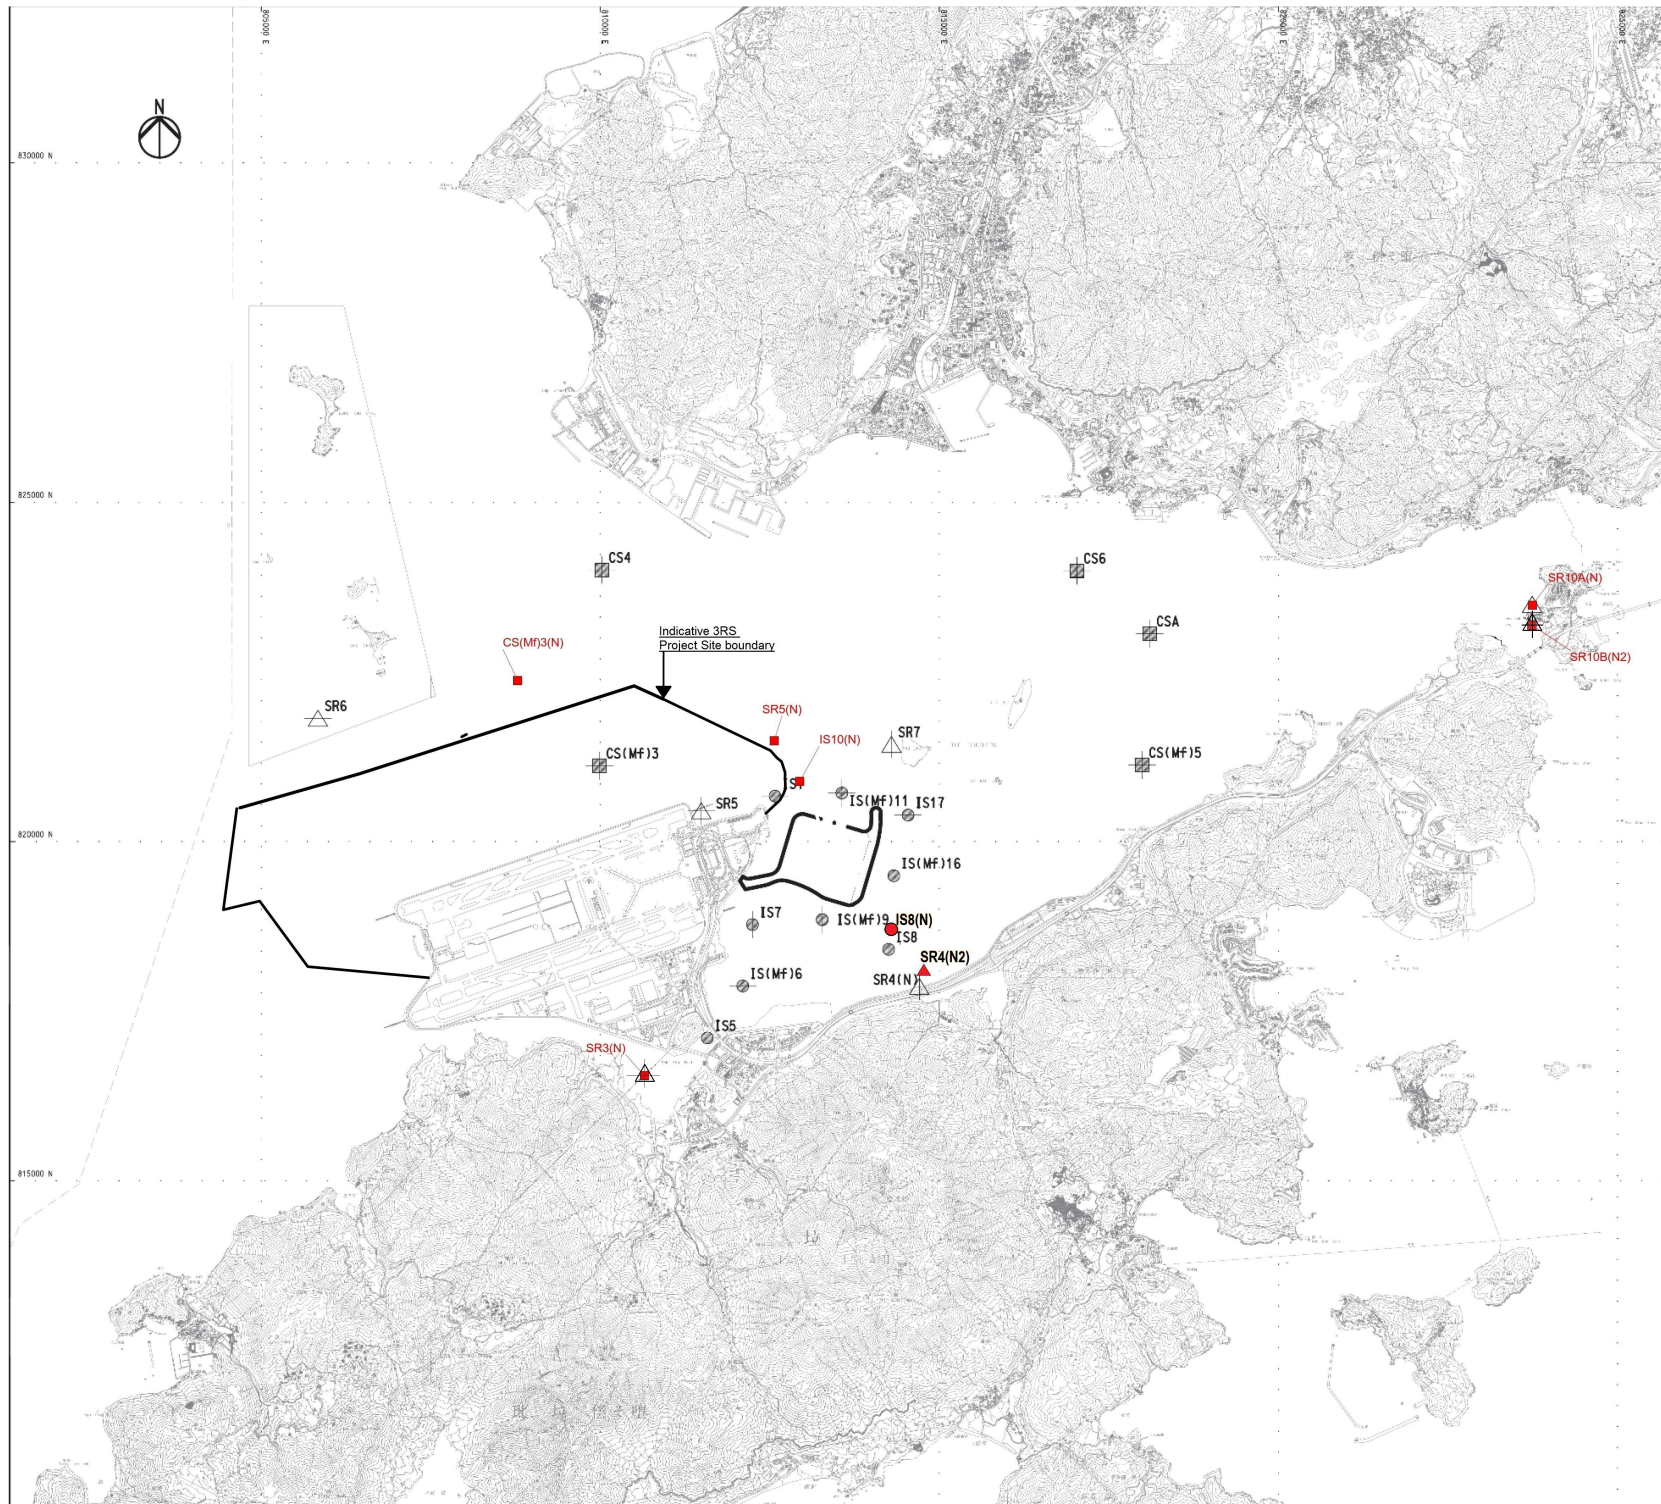
FIGURE 2.3 – LOCATION OF WATER QUALITY MONITORING STATIONS

Station	East	North
IS5	811579	817106
IS(Mf)6	812101	817873
IS7	812244	818777
IS8	814251	818412
IS(Mf)9	813273	818850
IS10(N)	812942	820881
IS(Mf)11	813562	820716
IS(Mf)16	814328	819497
IS17	814539	820391
SR3(N)	810689	816591
SR4(N)	814705	817859
SR5(N)	812569	821475
SR6	805837	821818
SR7	814293	821431
SR10A(N)	823644	823484
SR10B(N2)	823689	823159
CS(Mf)3(N)	808814	822355
CS(Mf)5	817990	821129
CS4	810025	824004
CS6	817028	823992
CSA	818103	823064
● IS8(N)	814413	818570
▲ SR4(N2)	814688	817996

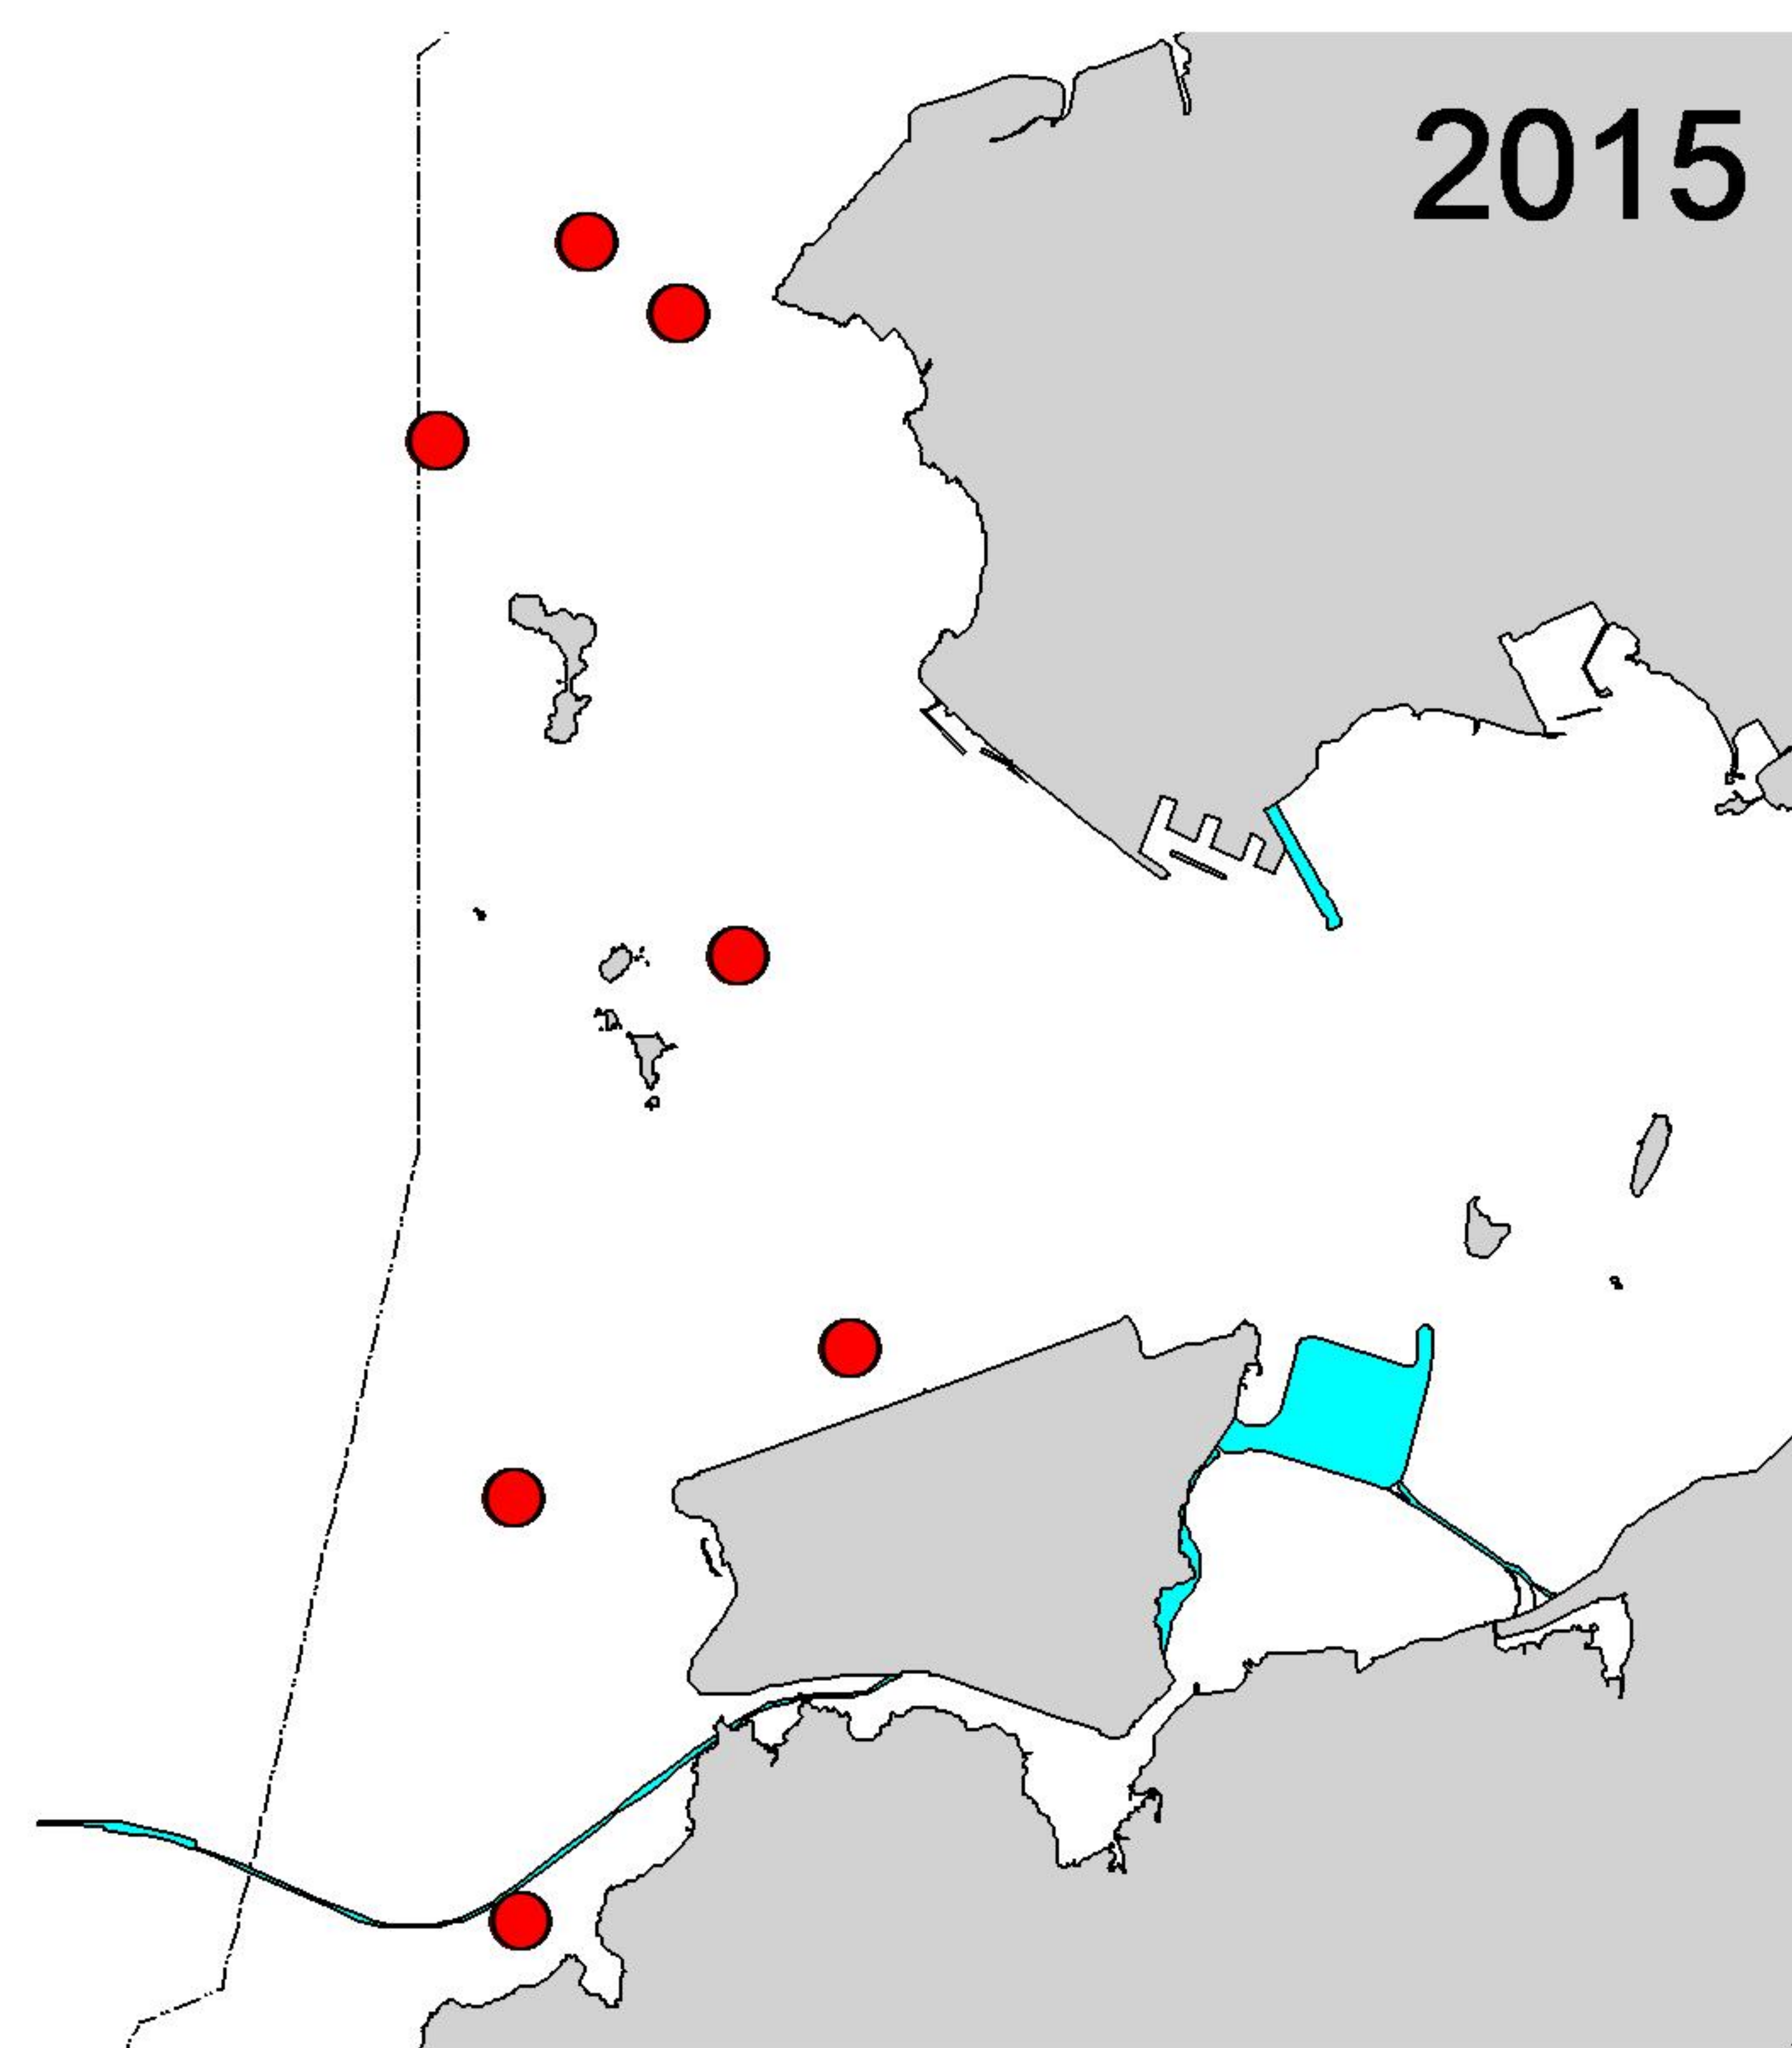
Figure 2. Distribution of Chinese white dolphin sightings in Northwest and Northeast Lantau during the past six spring quarters (March-May) of HKLR03 monitoring in 2014-19
