Contract No. HY/2013/04
Hong Kong–Zhuhai–Macao Bridge
Hong Kong Boundary Crossing Facilities –
Infrastructure Works Stage II (Southern Portion)

Monthly EM&A Report for April 2019

This is the 46th Monthly EM&A Report summarising the findings of EM&A activities conducted under the Contract from 1 to 30 April 2019 (the “reporting period”) and is submitted to fulfil Condition 5.4 of the EP.

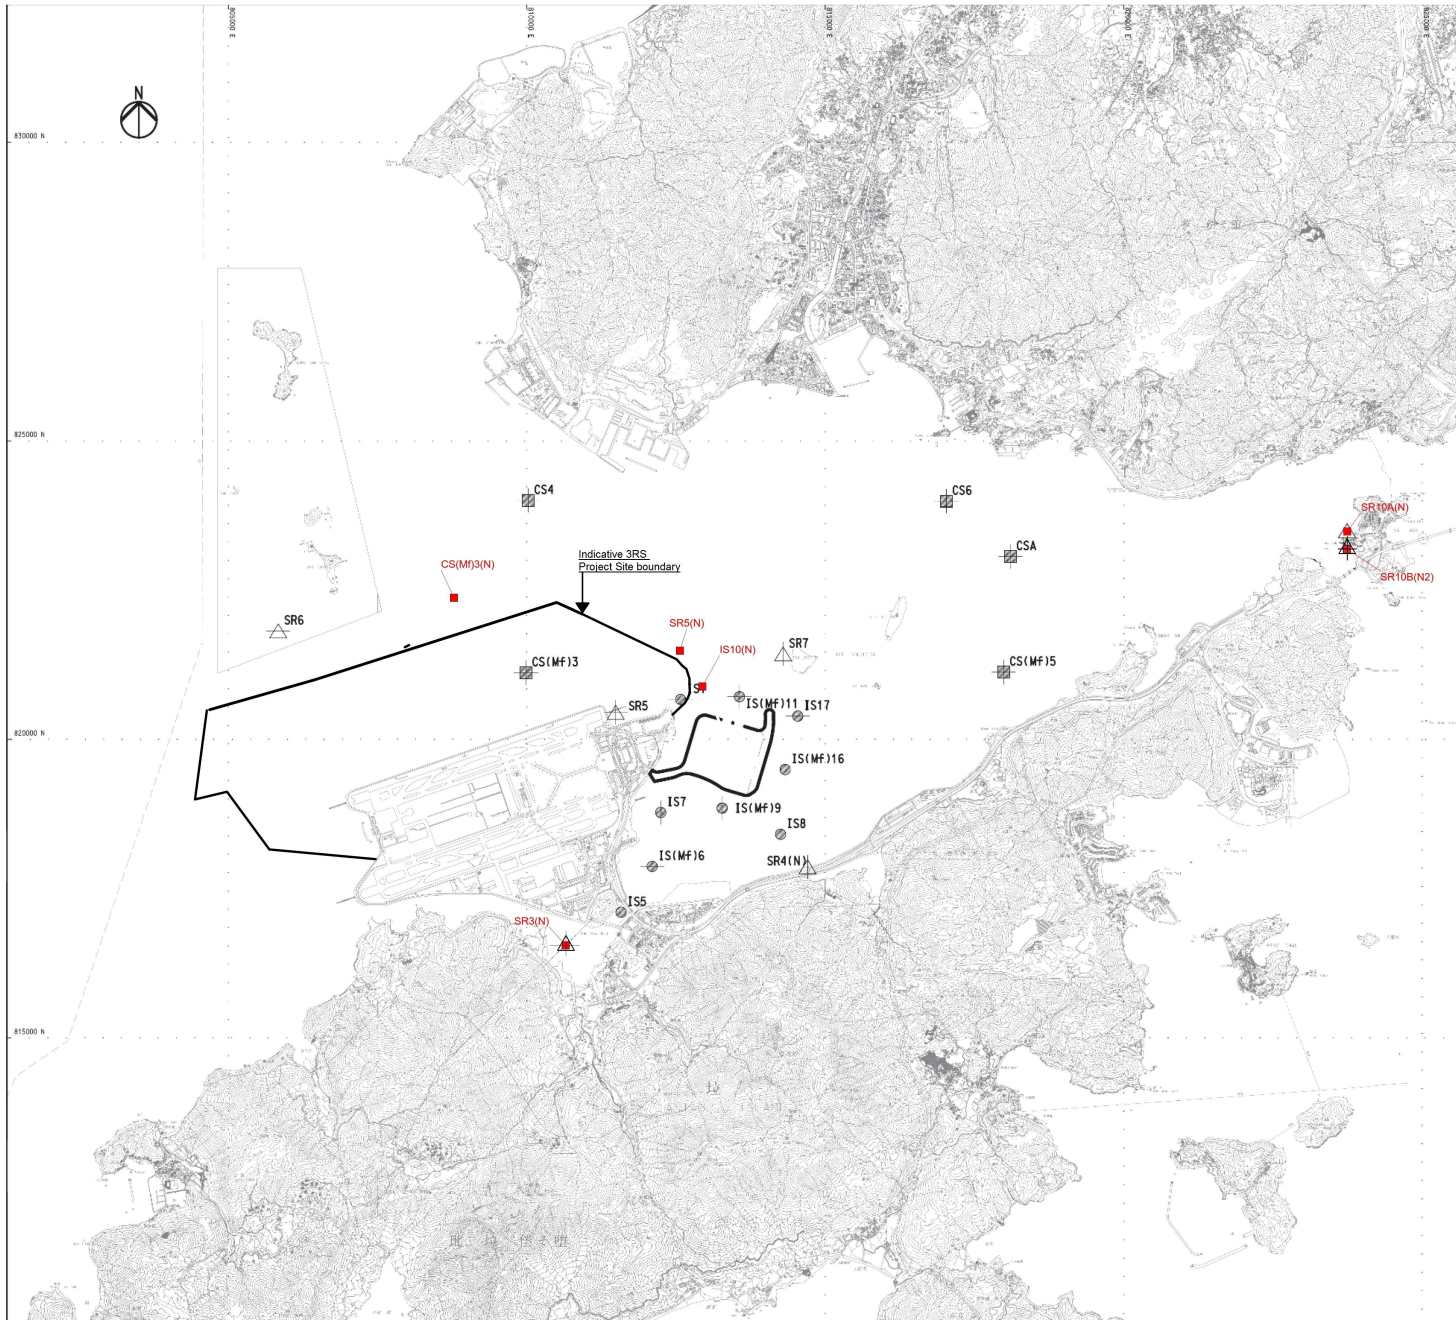
FIGURE 4.1— LOCATION OF WATER QUALITY MONITORING STATIONS

The nine Impact Stations (IS) were chosen on the basis of their proximity to the reclamation and thus the greatest potential for water quality impacts, the seven Sensitive Receiver Stations (SR) were chosen as they are close to the key sensitive receives and the five Control/ Far Field Stations (CS) were chosen to facilitate comparison of the water quality of the IS stations with less influence by the Project/ ambient water quality conditions.

Station	East	North
IS5	811579	817106
IS(Mf)6	812101	817873
IS7	812244	818777
IS8	814251	818412
IS(Mf)9	813273	818850
IS10(N)	812942	820881
IS(Mf)11	813562	820716
IS(Mf)16	814328	819497
IS17	814539	820391
SR3(N)	810689	816591
SR4(N)	814705	817859
SR5(N)	812569	821475
SR6	805837	821818
SR7	814293	821431
SR10A(N)	823644	823484
SR10B(N2)	823689	823159
CS(Mf)3(N)	808814	822355
CS(Mf)5	817990	821129
CS4	810025	824004
CS6	817028	823992
CSA	818103	823064

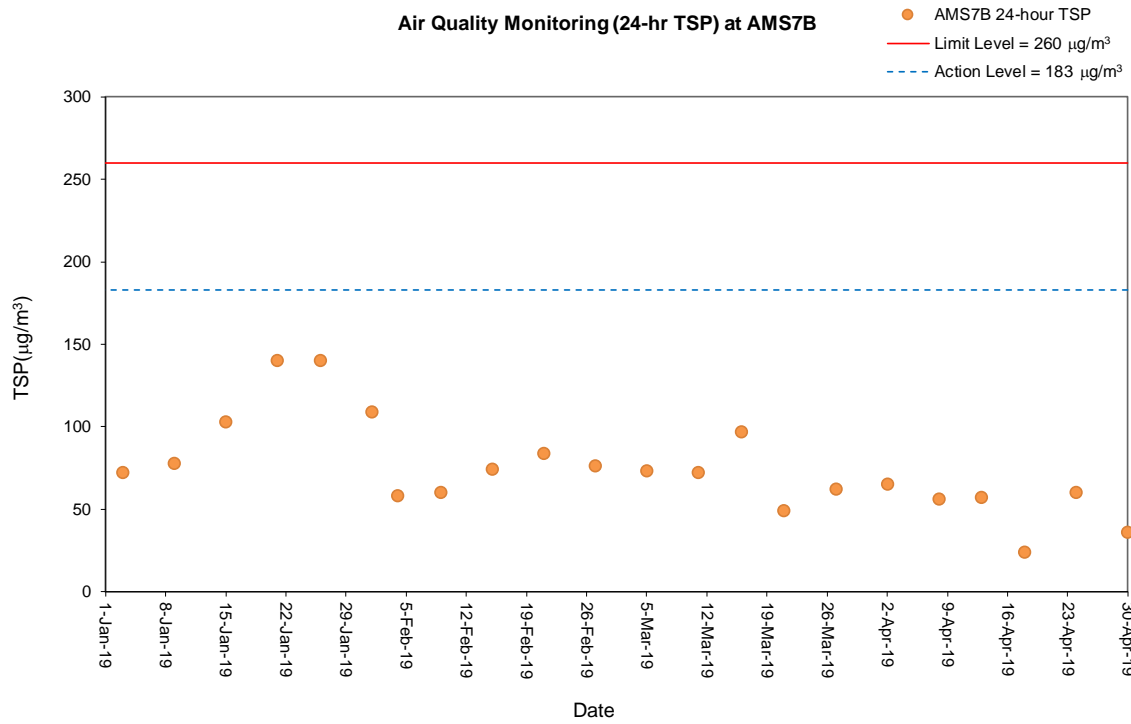
Air Quality Monitoring (24-hr TSP) at AMS7B

HKBCF	HY/2013/04	AMS7B 3RS Site Office	08-Apr-19	24-hr TSP	12:53	56	µg/m ³
HKBCF	HY/2013/04	AMS7B 3RS Site Office	13-Apr-19	24-hr TSP	12:19	57	µg/m ³
HKBCF	HY/2013/04	AMS7B 3RS Site Office	18-Apr-19	24-hr TSP	08:19	24	µg/m ³
HKBCF	HY/2013/04	AMS7B 3RS Site Office	24-Apr-19	24-hr TSP	12:23	60	µg/m ³
HKBCF	HY/2013/04	AMS7B 3RS Site Office	30-Apr-19	24-hr TSP	12:13	36	µg/m ³
