**Contract No. HY/2013/04 Hong Kong-Zhuhai-Macao Bridge (HZMB)
Hong Kong Boundary Crossing Facilities – Infrastructure Works Stage II
(Southern Portion)**

Monthly EM&A Report for June 2019

**Contract No. HY/2013/04
HZMB HKBCF – Infrastructure Works Stage II (Southern Portion)
Monthly Environmental Monitoring & Audit Report for June 2019**

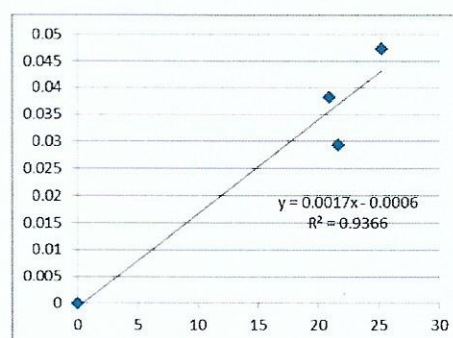
Linear Regression of Y or X

Slope (K-factor): 0.0017
Correlation Coefficient 0.9678
Date of Issue 28 December 2018

- Strong** Correlation ($R > 0.8$)
- Factor 0.0017 should be applied for TSP monitoring
