**Contract No. HY/2013/04 Hong Kong-Zhuhai-Macao Bridge (HZMB)
Hong Kong Boundary Crossing Facilities – Infrastructure Works Stage II
(Southern Portion)**

Monthly EM&A Report for June 2019 (Revision 1)

**Contract No. HY/2013/04 – HZMB HKBCF – Infrastructure Works Stage II
(Southern Portion)
Monthly Environmental Monitoring & Audit Report for June 2019 (Revision 1)**

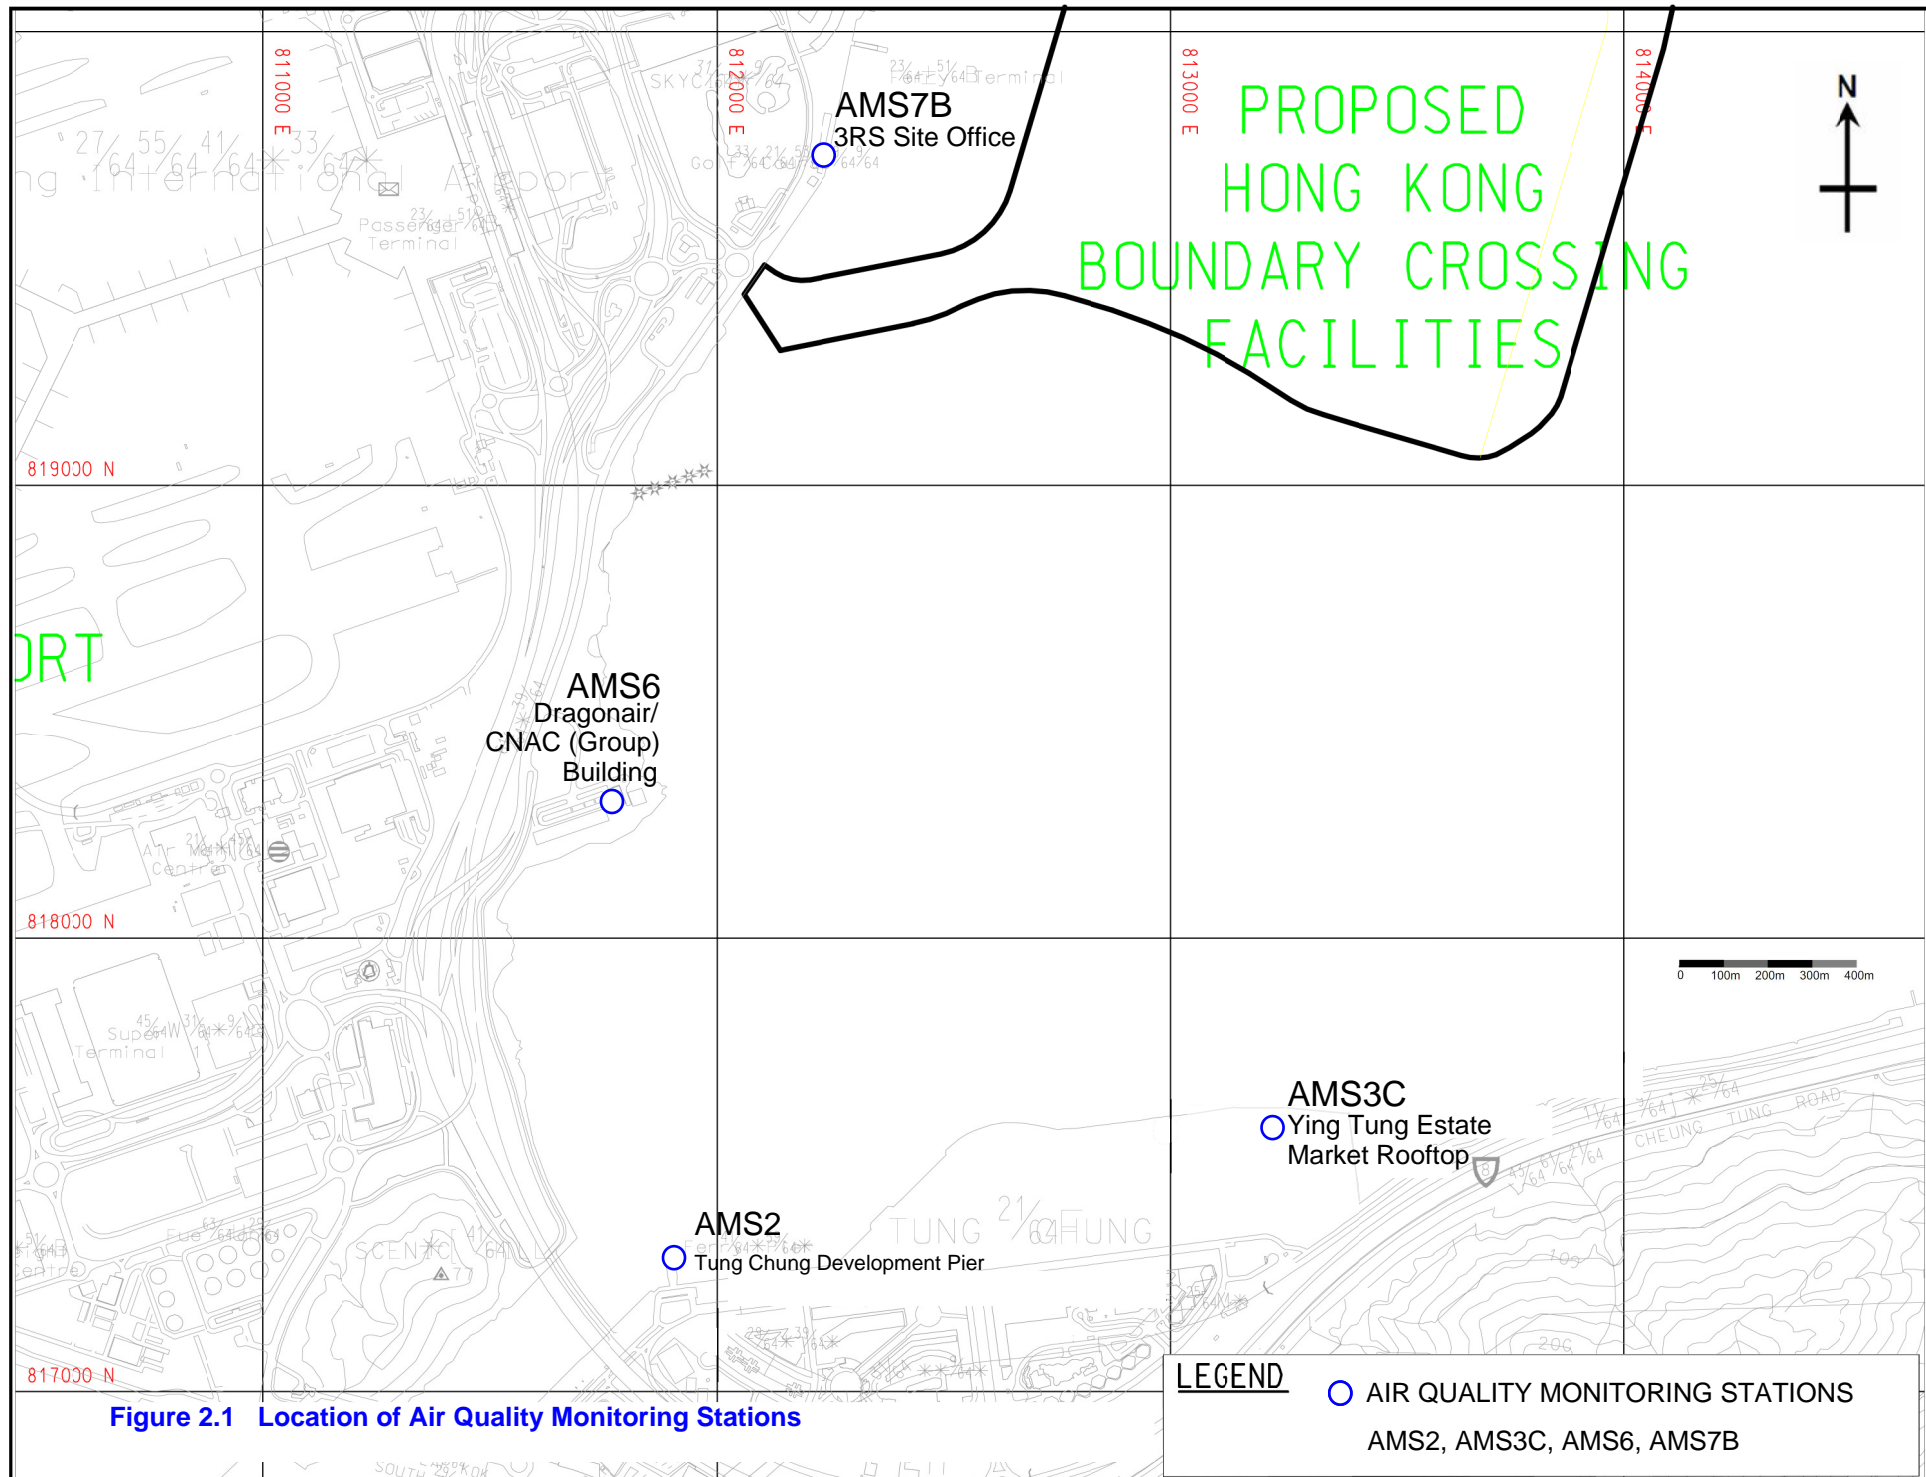
Figure 2.1 Location of Air Quality Monitoring Stations

Air quality monitoring stations AMS2, AMS3C and AMS7B are covered by this Contract. It should be noted that the air quality monitoring station AMS6 is covered by Contract No. HY/2011/03 “Hong Kong-Zhuhai-Macao Bridge Hong Kong Link Road (HZMB HKLR) – Section between Scenic Hill and HKBCF”. If the impact air quality monitoring at AMS6 is no longer covered under Contract No. HY/2011/03, it is required to continue such monitoring at AMS6 as part of EM&A programme. However, this is subject to ENPO’s final decision on which ET should carry out the monitoring work at these stations.

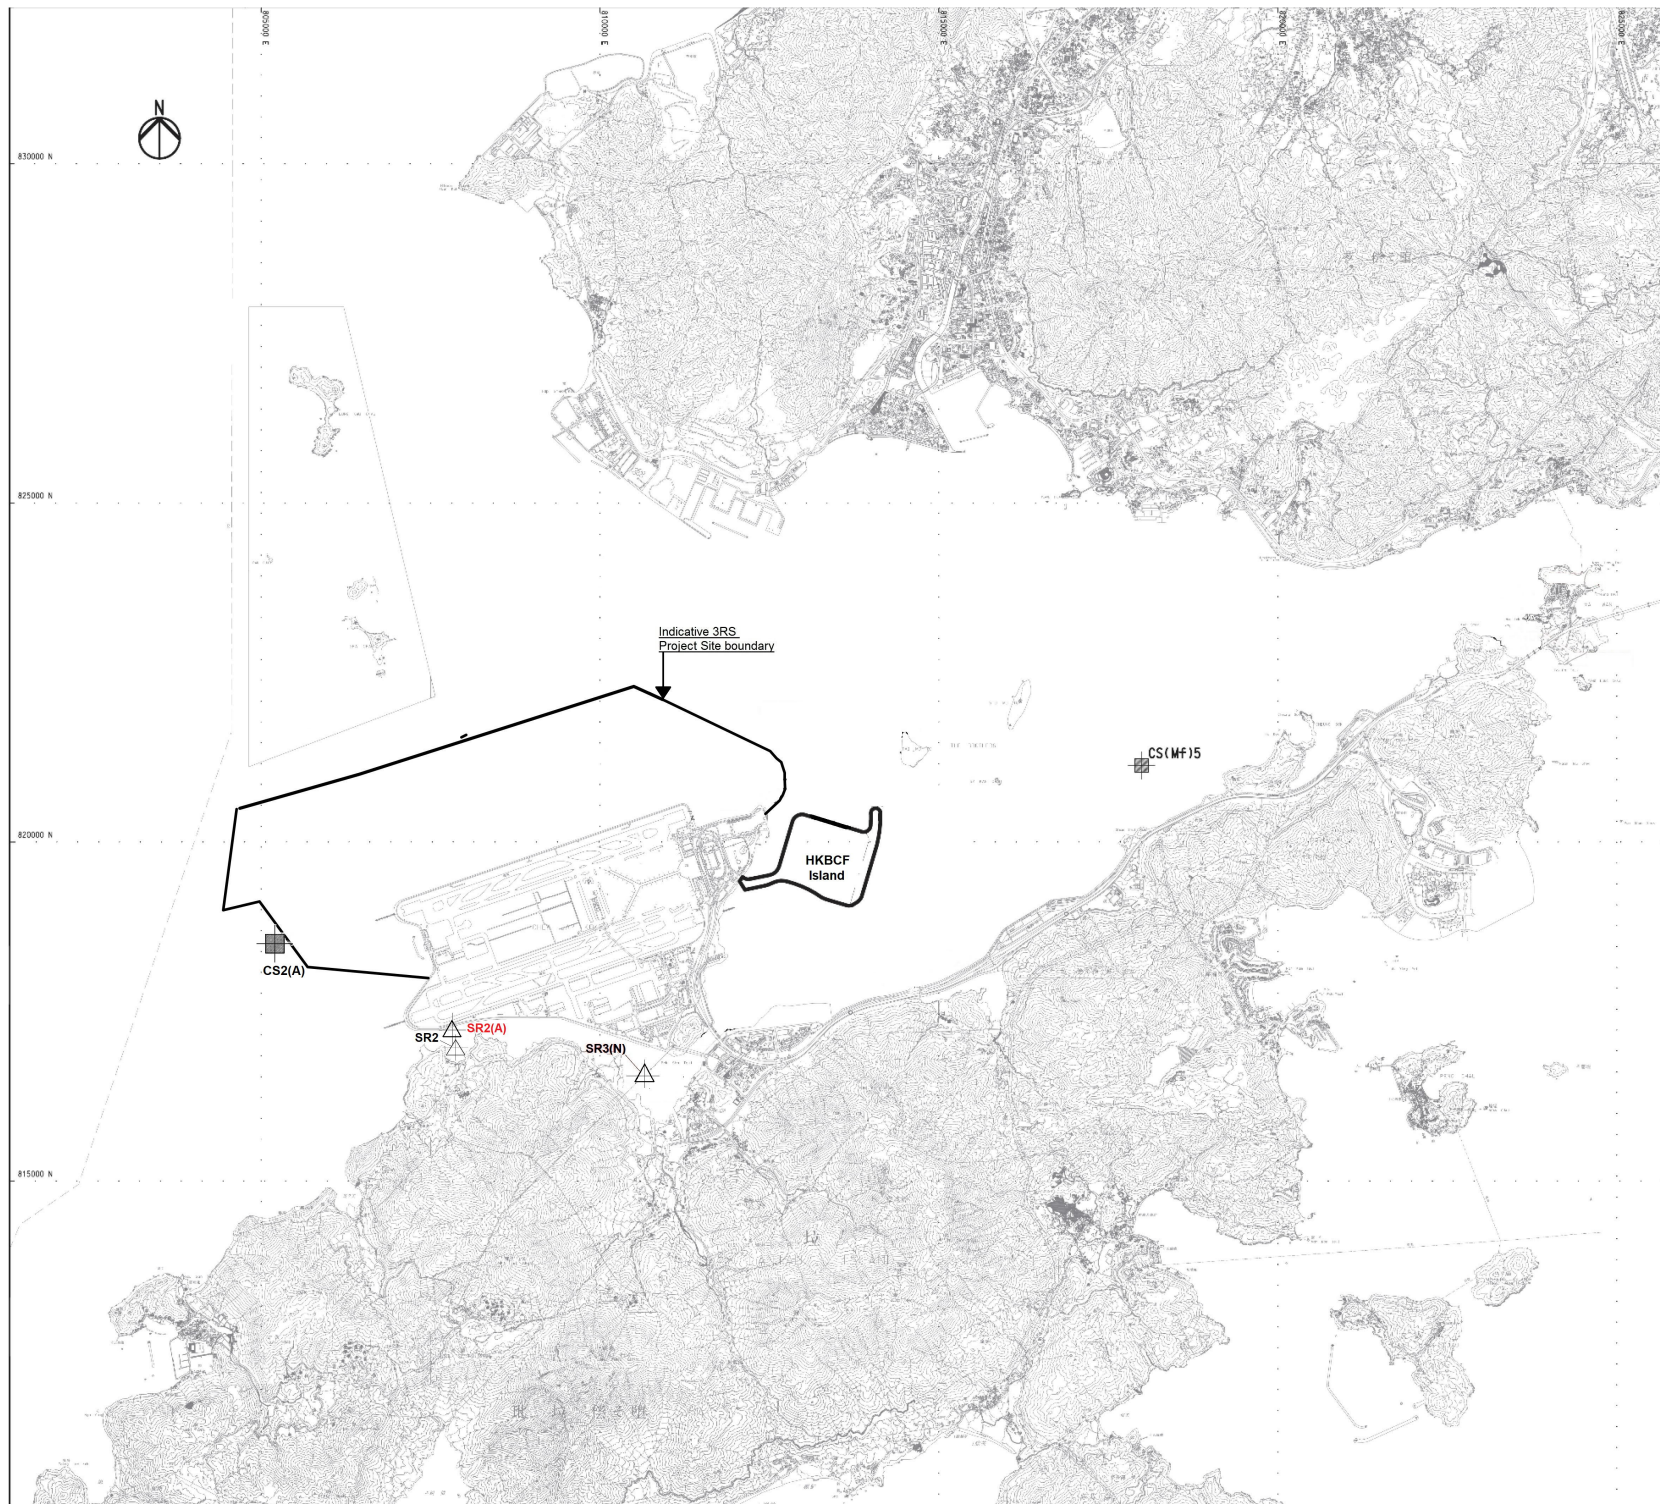
FIGURE 4.1— LOCATION OF WATER QUALITY MONITORING STATIONS

Remark: For the impact operational phase water quality programme, the ETL of this Contract proposed changes to the EM&A Programme regarding some water quality monitoring stations. These changes were justified by the ETL of this Contract on 14 May 2019, verified by the IEC on 15 May 2019 and submitted to EPD for record on 15 May 2019 for implementation with effect from June 2019. Monitoring station SR2 (marked *) was replaced by SR2(A) (marked #, shown in **bold red** font).

Station	East	North
SR2	807856	816953
SR2(A)	807810	817189
SR3(N)	810689	816591
CS2(A)	805232	818606
CS(Mf)5	817990	821129

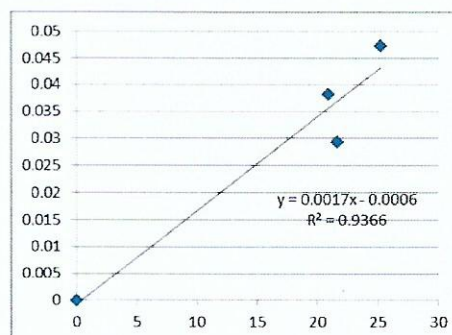
Linear Regression of Y or X

Slope (K-factor): 0.0017
 Correlation Coefficient 0.9678
 Date of Issue 28 December 2018

- Strong** Correlation ($R > 0.8$)
 - Factor 0.0017 should be applied for TSP monitoring
- *if $R < 0.5$, repair or re-verification is required for the equipment

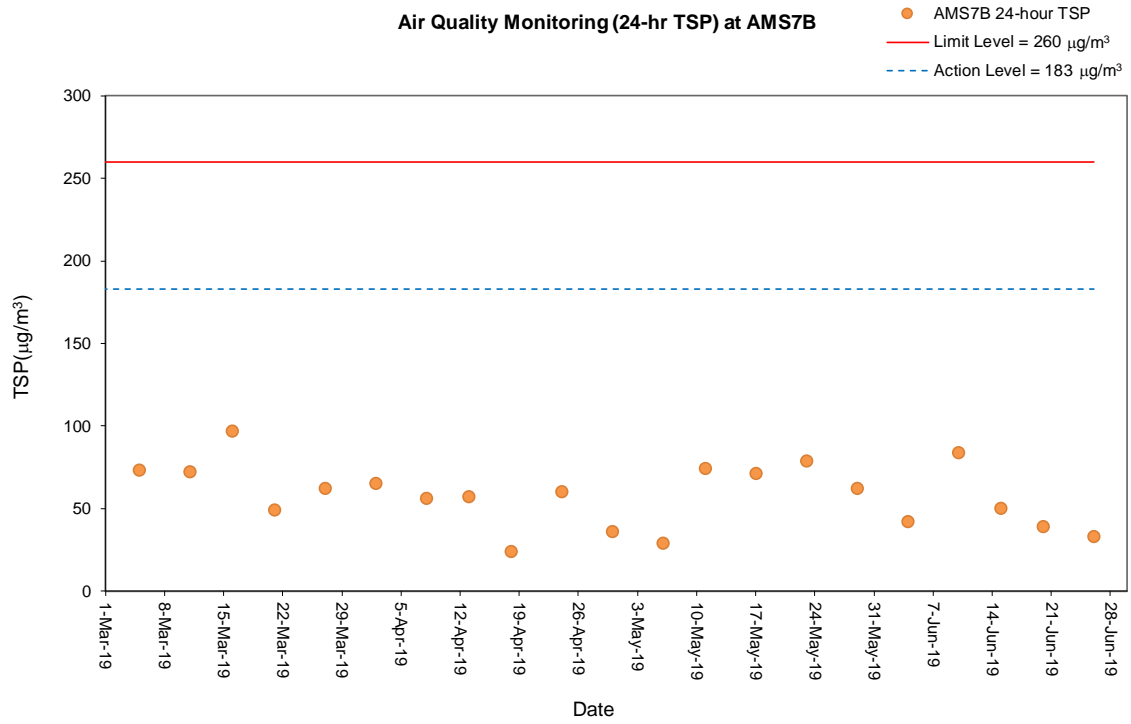
Air Quality Monitoring (24-hr TSP) at AMS7B

HKBCF	HY/2013/04	AMS7B 3RS Site Office	10-Jun-19	24-hr TSP	12:29	84	µg/m ³
HKBCF	HY/2013/04	AMS7B 3RS Site Office	15-Jun-19	24-hr TSP	12:37	50	µg/m ³
HKBCF	HY/2013/04	AMS7B 3RS Site Office	20-Jun-19	24-hr TSP	12:27	39	µg/m ³
HKBCF	HY/2013/04	AMS7B 3RS Site Office	26-Jun-19	24-hr TSP	18:00	33	µg/m ³

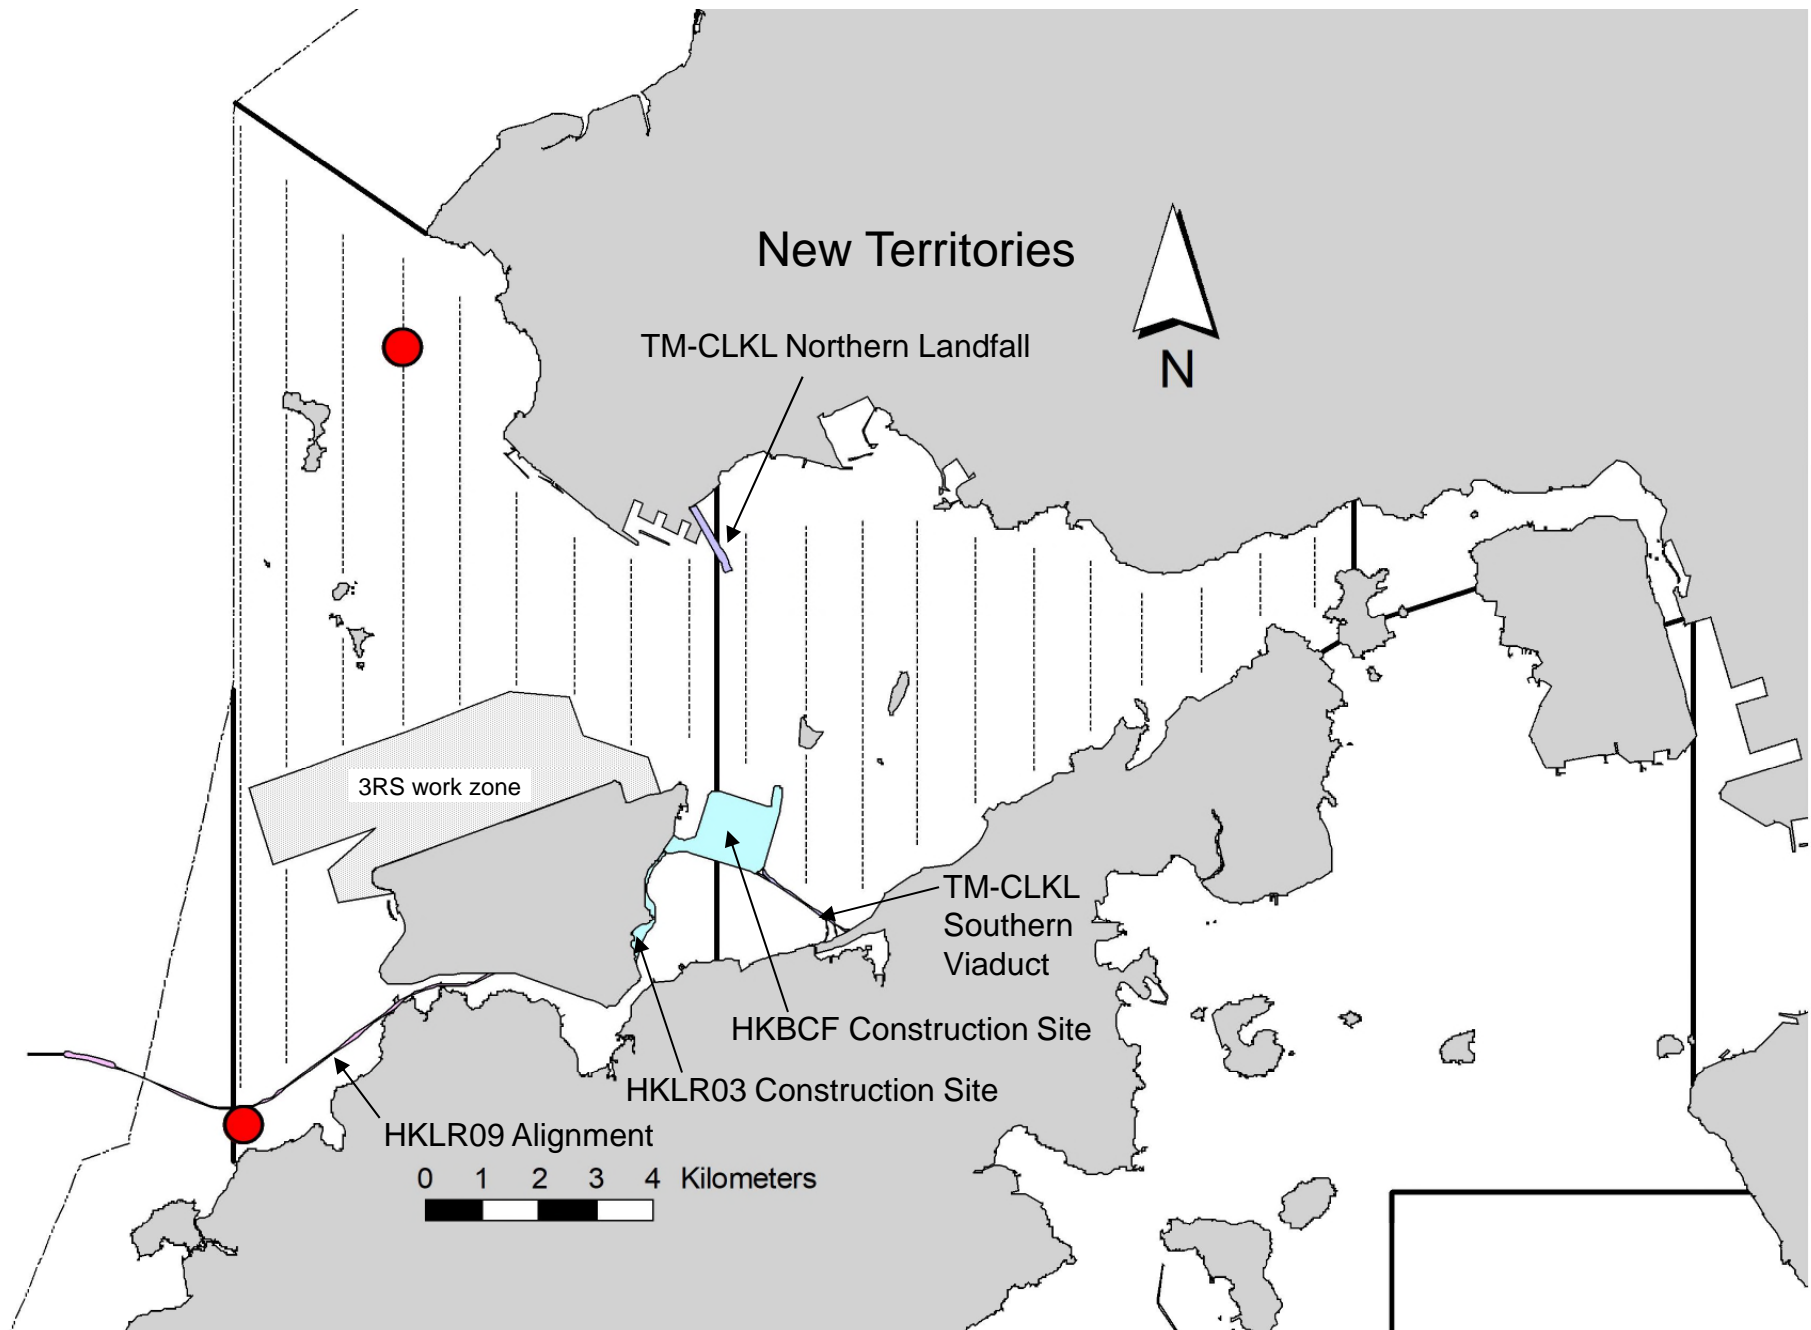
Figure 6. Distribution of Chinese White Dolphin Sightings during June 2019 HKLR03 Monitoring Surveys

For dolphin monitoring, dolphin surveys were conducted on 3, 6, 10 and 13 June 2019. A total of 262.12 km of survey effort was collected, with 91.7% of the total survey effort being conducted under favourable weather conditions. Only two groups of five Chinese White Dolphins were sighted (**Annex II of Appendix L**). Both dolphin groups were sighted in NWL, while no dolphin was sighted at all in NEL.
