**Contract No. HY/2013/04 Hong Kong-Zhuhai-Macao Bridge (HZMB)  
Hong Kong Boundary Crossing Facilities – Infrastructure Works Stage II  
(Southern Portion)**

**Quarterly EM&A Report for June to August 2019 (Revision 0)**

**Contract No. HY/2013/04 – HZMB HKBCF – Infrastructure Works Stage II  
(Southern Portion)  
Quarterly EM&A Report for June 2019 to August 2019**

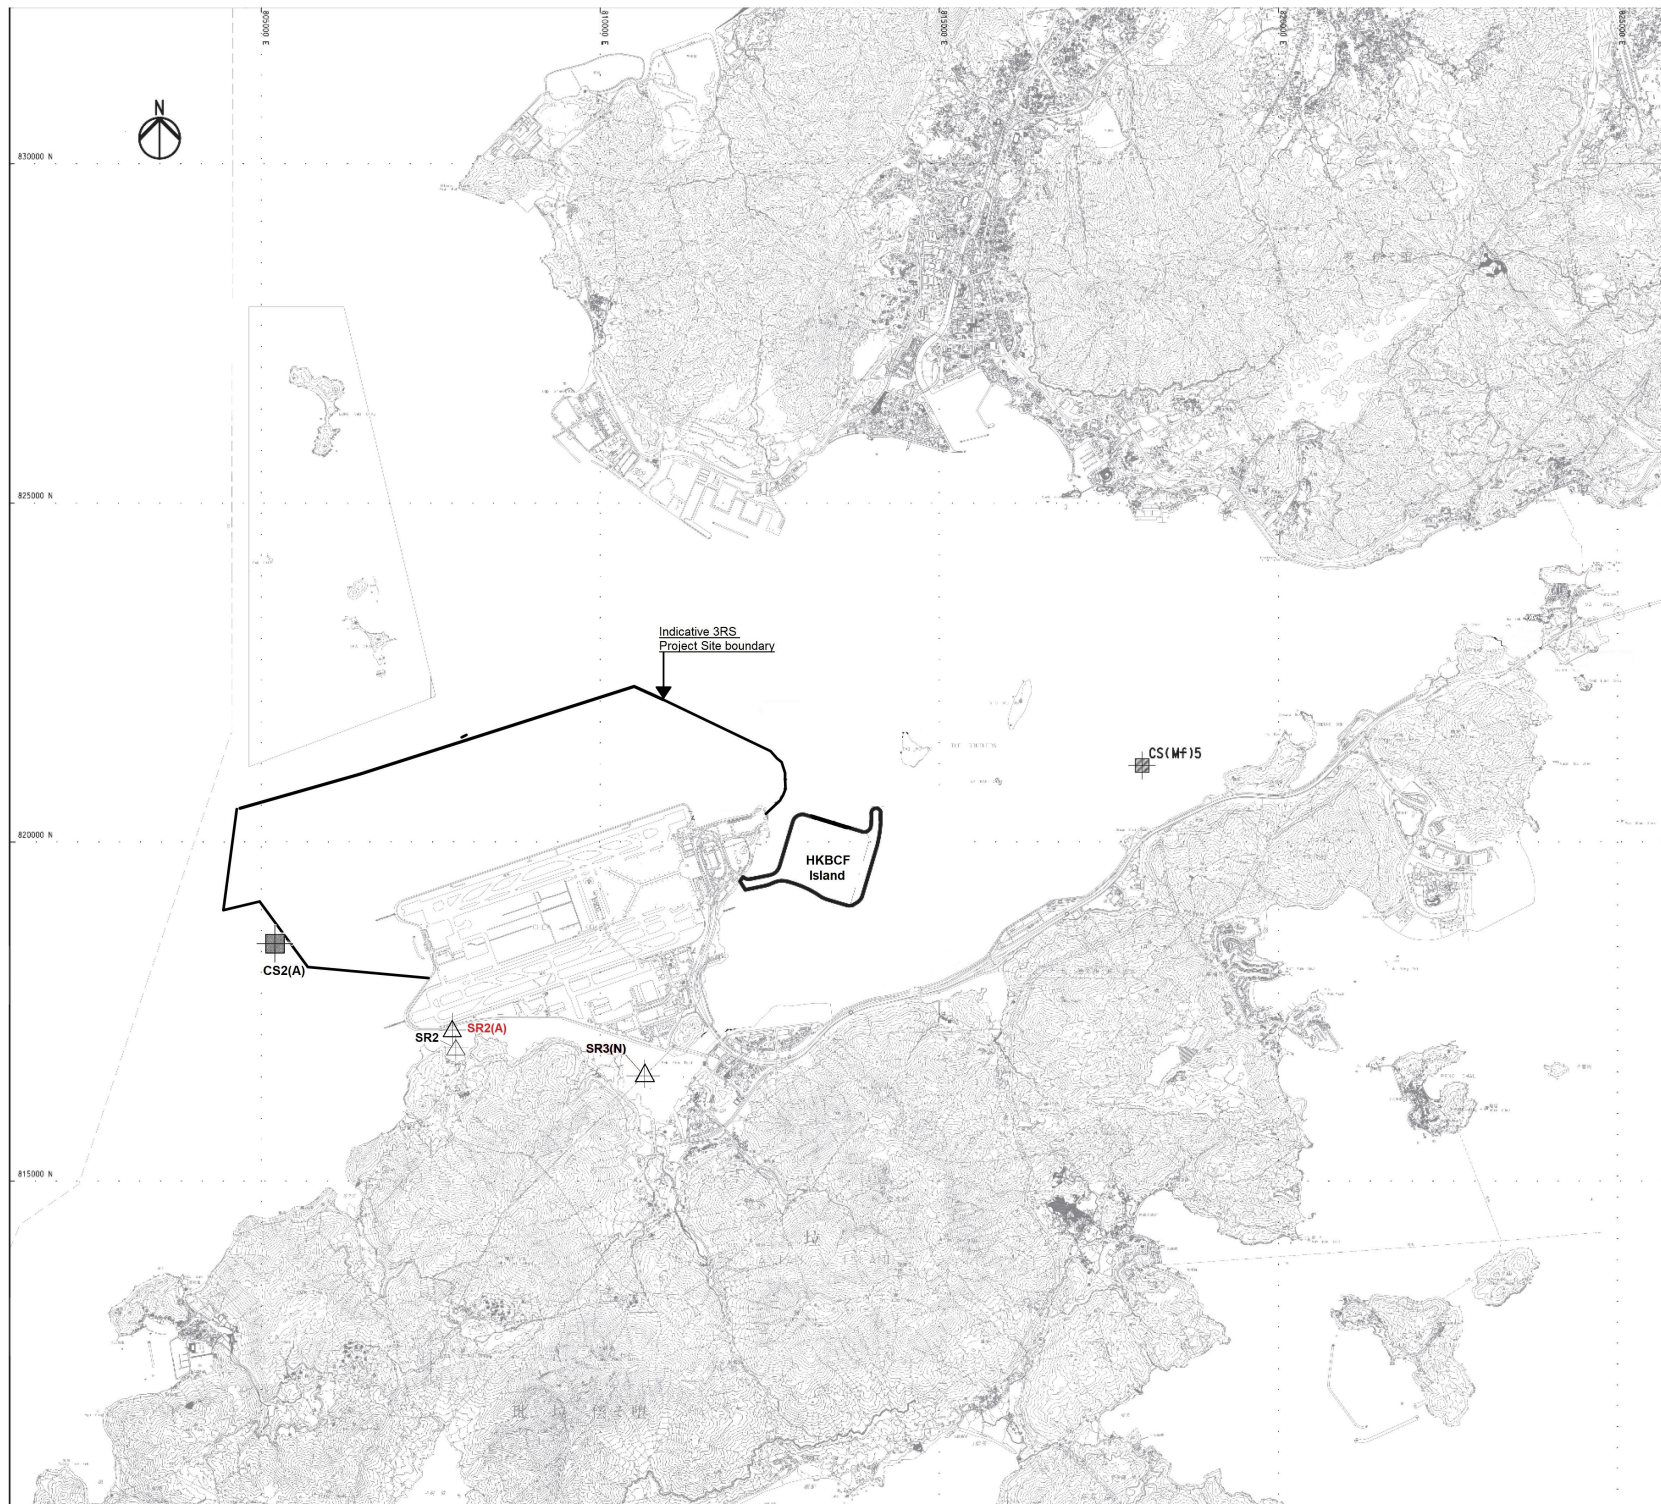
FIGURE 2.3 – LOCATION OF WATER QUALITY MONITORING STATIONS

Station	East	North
SR2	807856	816953
SR2(A)	807810	817189
SR3(N)	810689	816591
CS2(A)	805232	818606
CS(Mf)5	817990	821129
