**Contract No. HY/2013/04 Hong Kong-Zhuhai-Macao Bridge (HZMB)  
Hong Kong Boundary Crossing Facilities – Infrastructure Works Stage II  
(Southern Portion)**

**Monthly EM&A Report for September 2019**

**Contract No. HY/2013/04  
HZMB HKBCF – Infrastructure Works Stage II (Southern Portion)  
Monthly Environmental Monitoring & Audit Report for September 2019**

This is the 51<sup>st</sup> Monthly EM&A Report summarising the findings of EM&A activities conducted under the Contract from 1 to 30 September 2019 (the “reporting period”) and is submitted to fulfil Condition 5.4 of the EP.

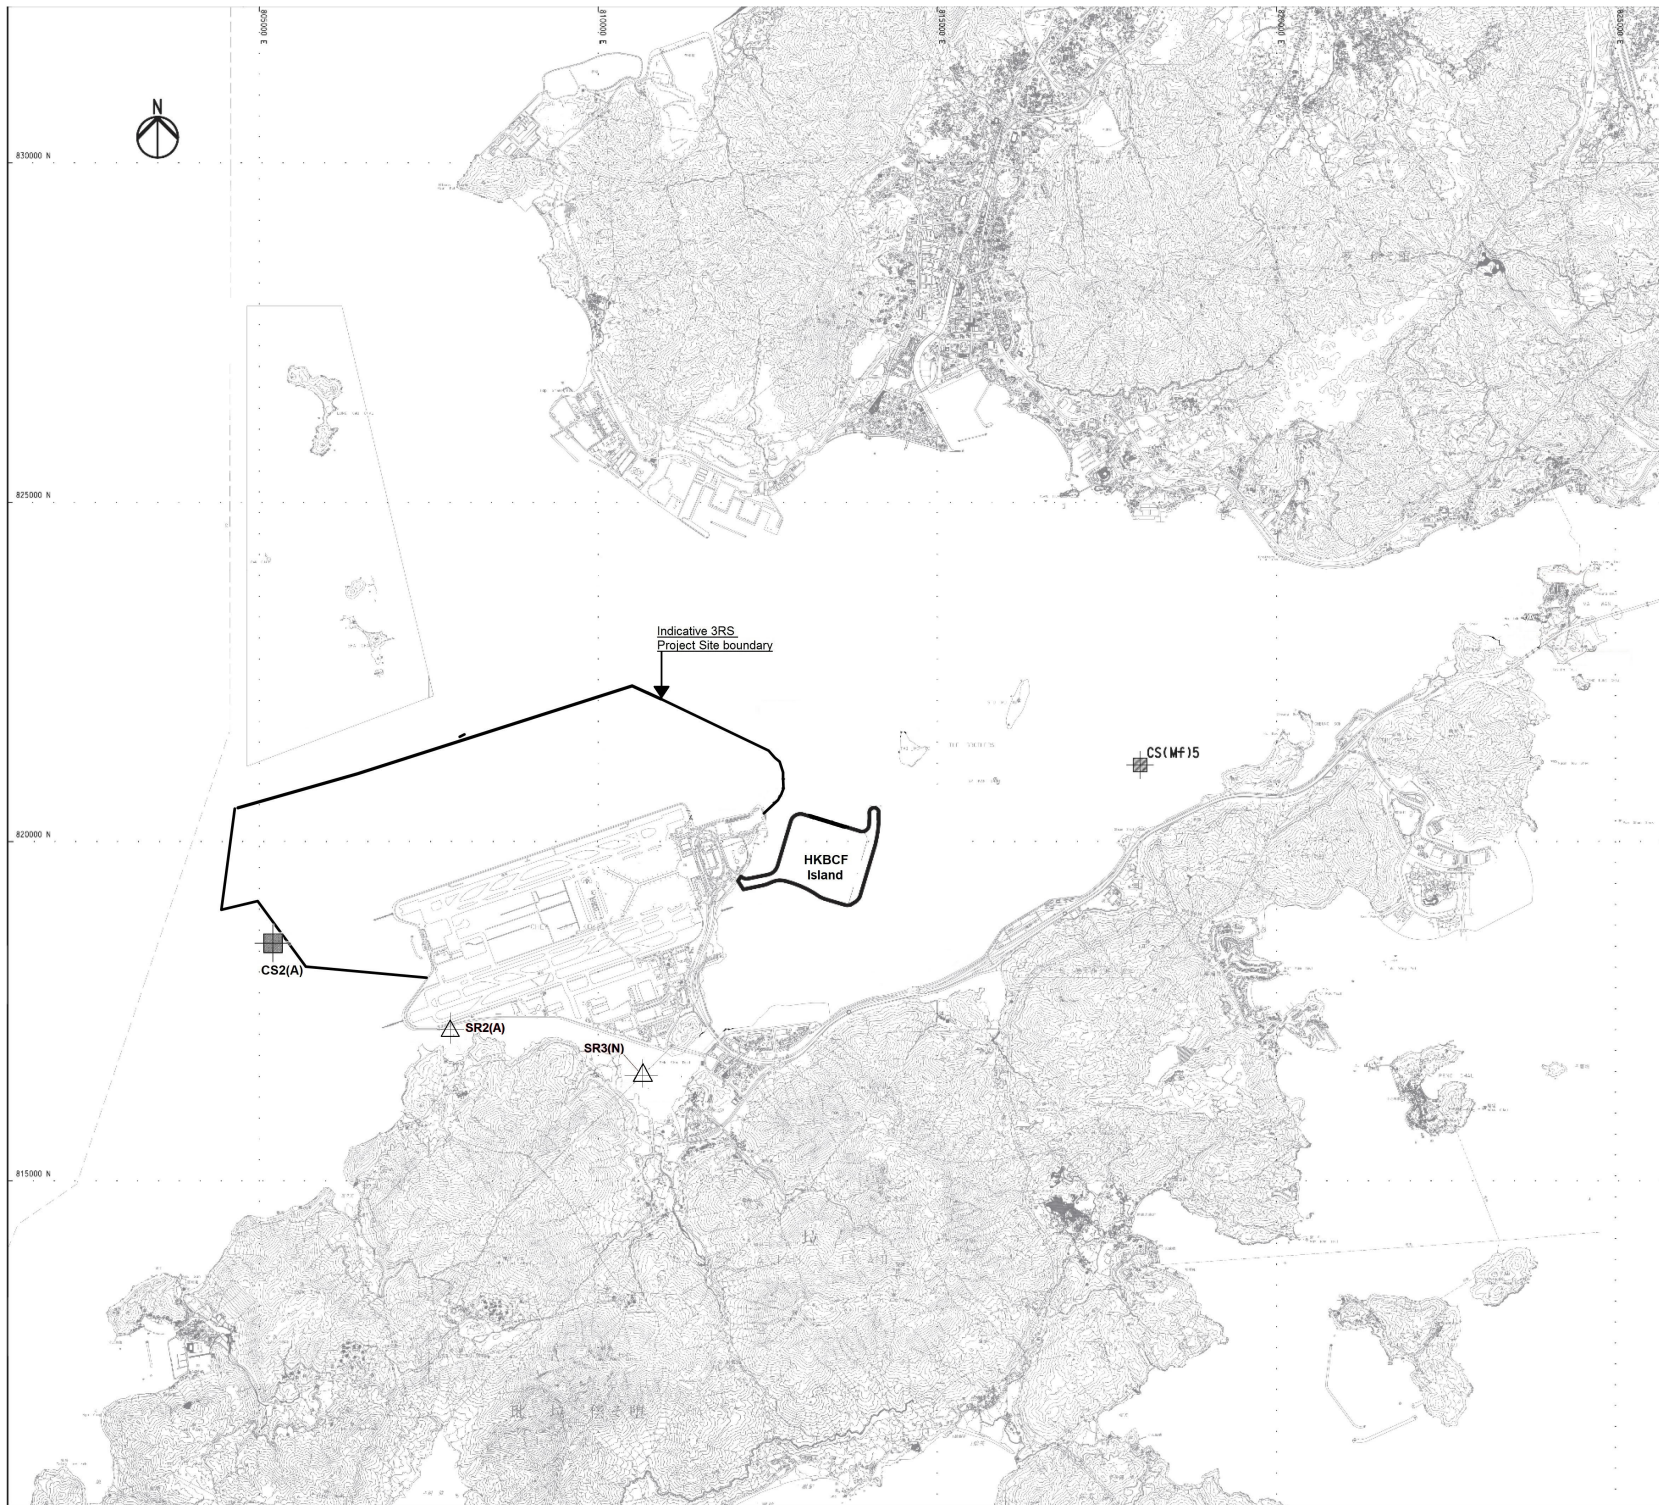
FIGURE 4.1— LOCATION OF WATER QUALITY MONITORING STATIONS

Station	East	North
SR2(A)	807810	817189
SR3(N)	810689	816591
CS2(A)	805232	818606
CS(Mf)5	817990	821129

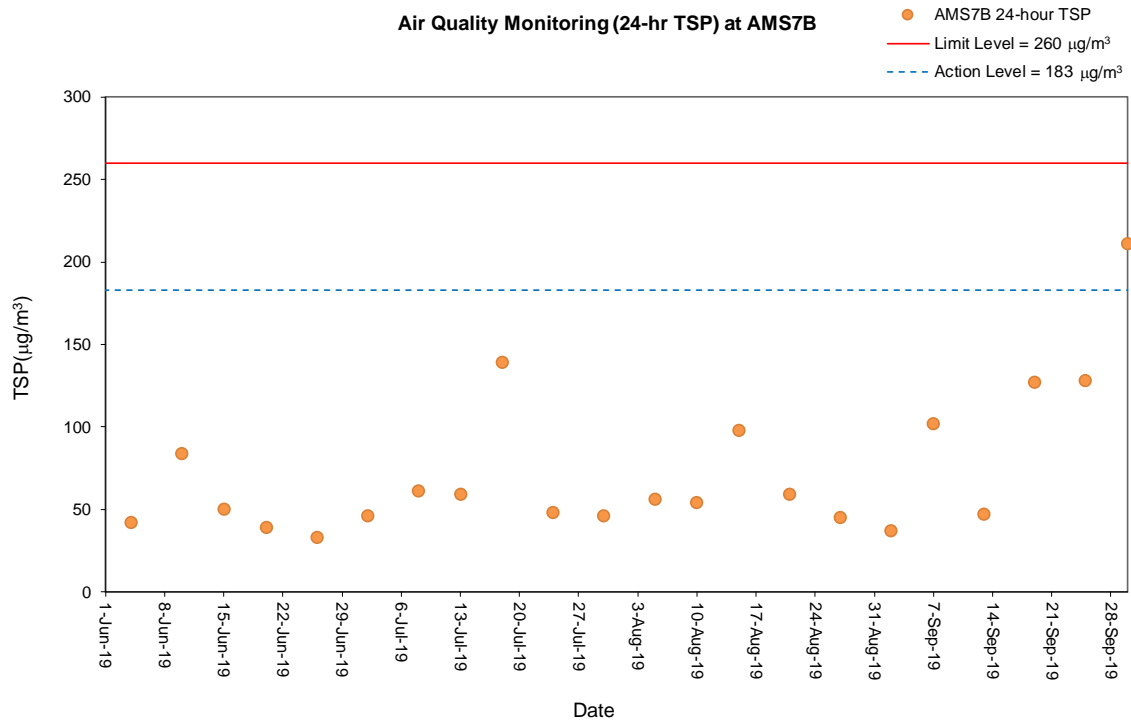
### Air Quality Monitoring (24-hr TSP) at AMS7B

HKBCF	HY/2013/04	AMS7B 3RS Site Office	25-Sep-19	24-hr TSP	08:22	128	µg/m <sup>3</sup>
HKBCF	HY/2013/04	AMS7B 3RS Site Office	30-Sep-19	24-hr TSP	12:17	211	µg/m <sup>3</sup>

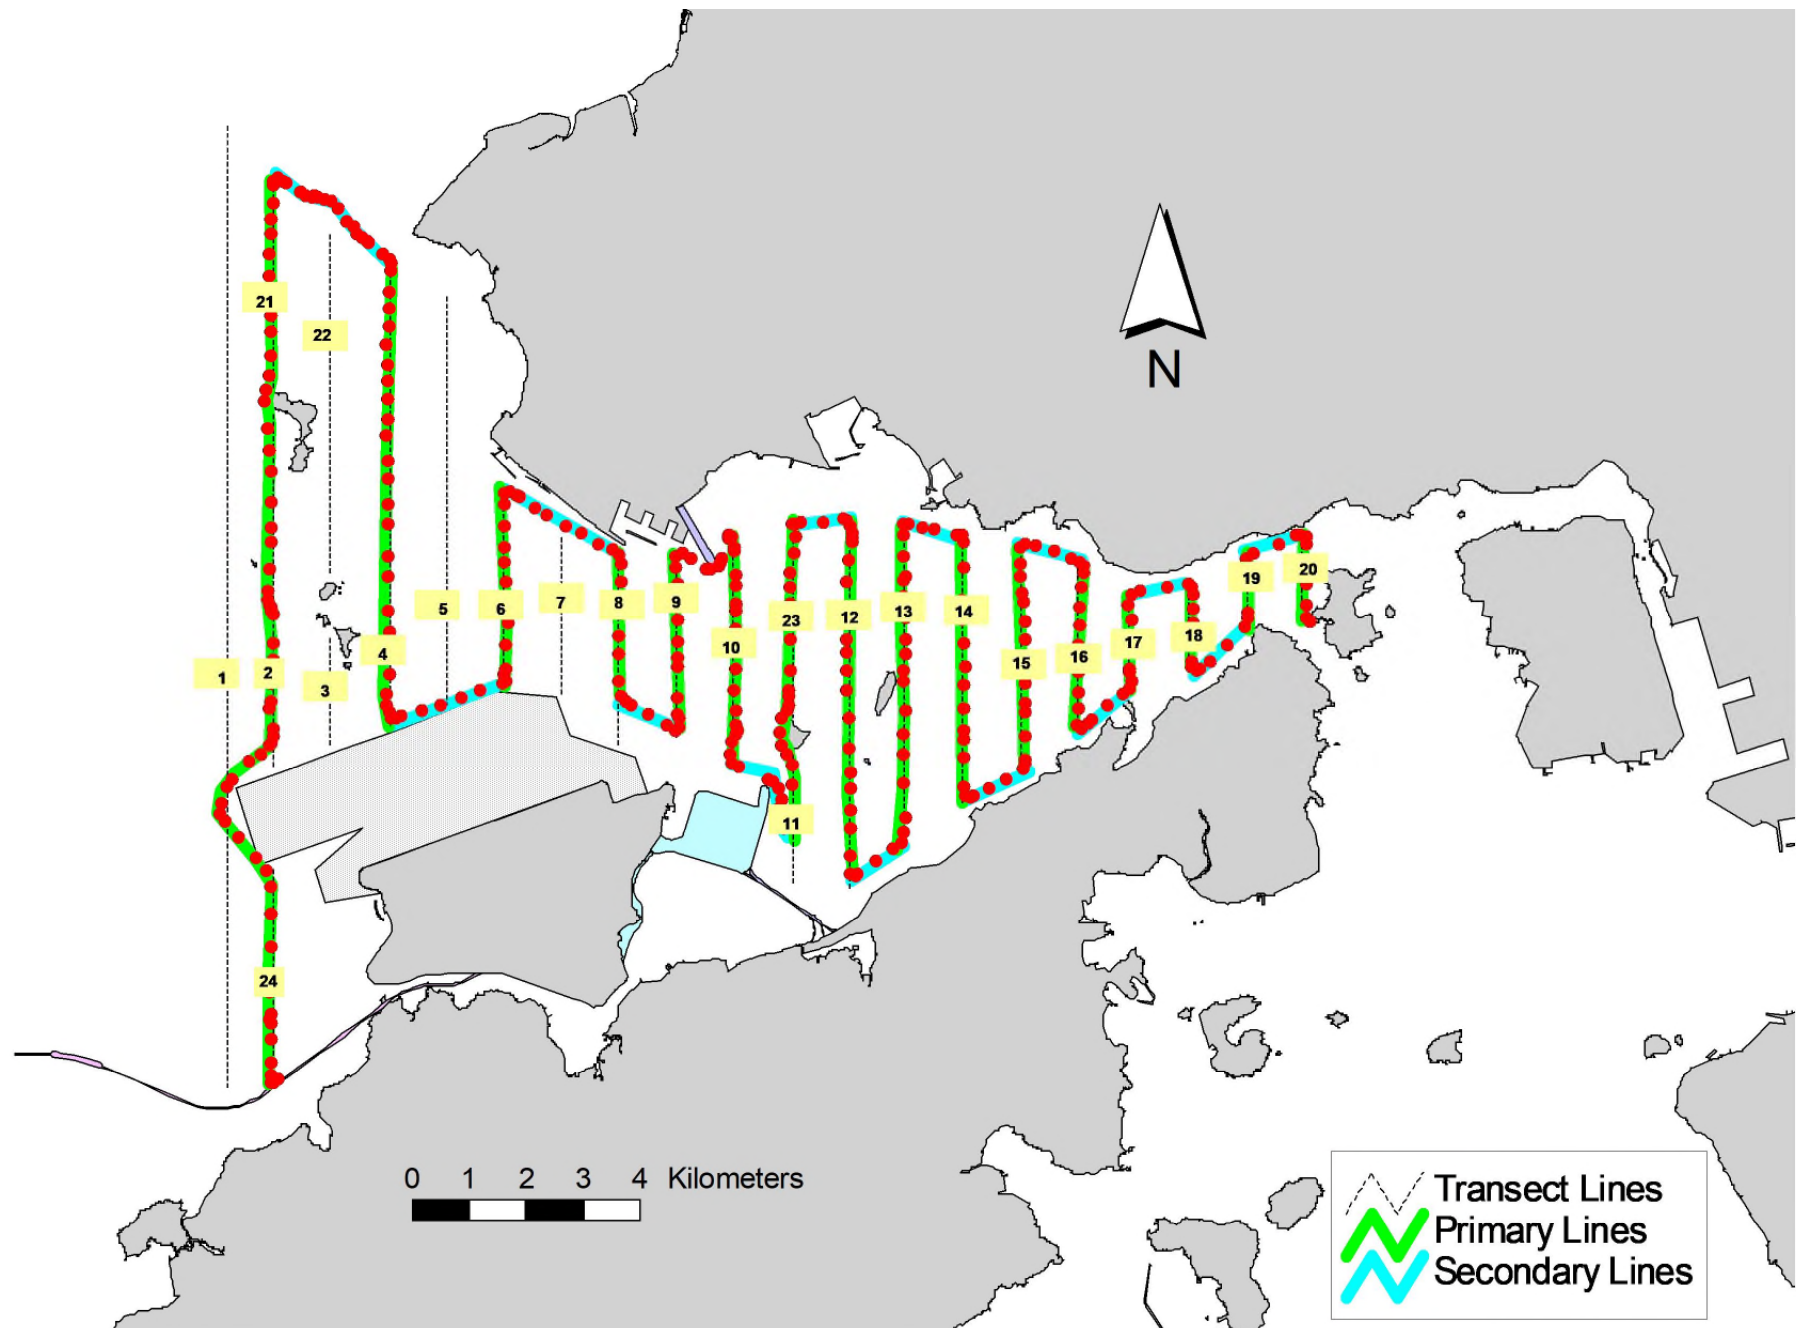
Figure 2. Survey Route on September 4<sup>th</sup>, 2019 (from HKLR03 project)

However, during the first set of monitoring survey in the reporting period on 4 September 2019, some vessels performing construction works under other nearby projects were observed at the southern end of transect line no. 11. The survey team determined that it was unsafe to navigate through this area to conduct the usual vessel survey in full. The survey route performed on that day is presented in **Figure 2 of Appendix L**.

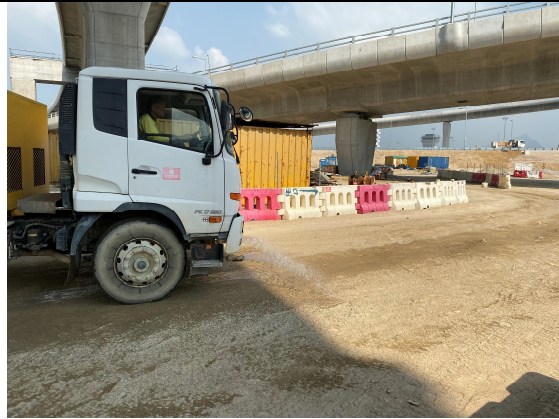
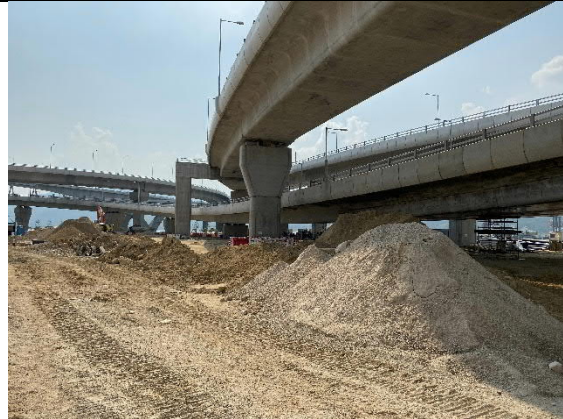
1. Water spray provided for haul roads in the HY/2013/04 site area. No fugitive dust generation was observed.

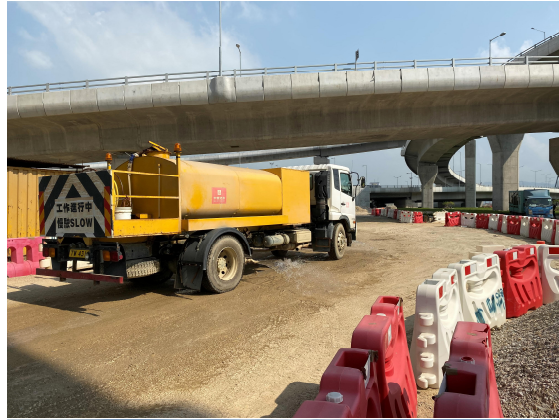
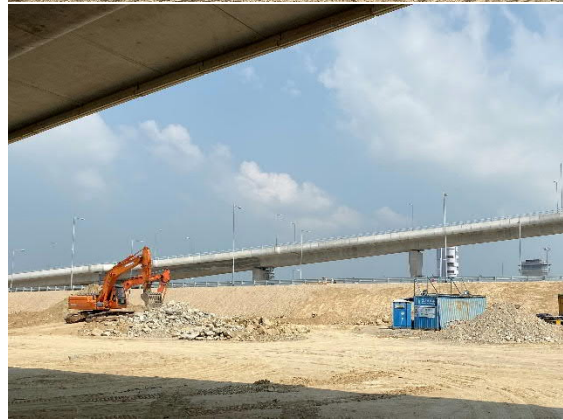
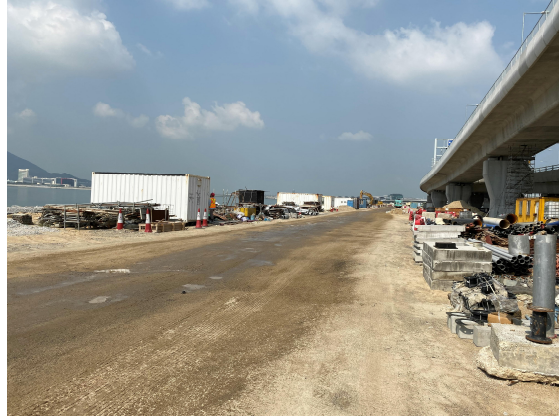
During ET's regular weekly site inspection on 25 September 2019 (between 09:30 and 10:30 a.m.), one air quality observation was recorded: namely, stockpiles and some exposed works areas were observed dry and dusty. The same observation was recorded during the next ET regular weekly site inspection on 2 October 2019 (between 14:15 and 15:00). Subsequently, the Contractor provided water spray for stockpiles and exposed works areas and the observation was closed during the subsequent ET regular weekly site inspection on 9 October 2019 (between 14:15 and 15:00). The remaining haul roads were observed to be watered and no fugitive dust generation from HY/2013/04 works was observed during this inspection. There was further no air quality observation associated with watering of site areas.

2. Air quality observation: Stockpiles and some exposed works areas were observed dry and dusty.

- a. Stockpiles and some exposed works areas were observed dry and dusty. The Contractor should implement sufficient water spraying for dust suppression. Follow-up action for the outstanding observation will be inspected during the upcoming site inspections and reported in the coming reporting period.

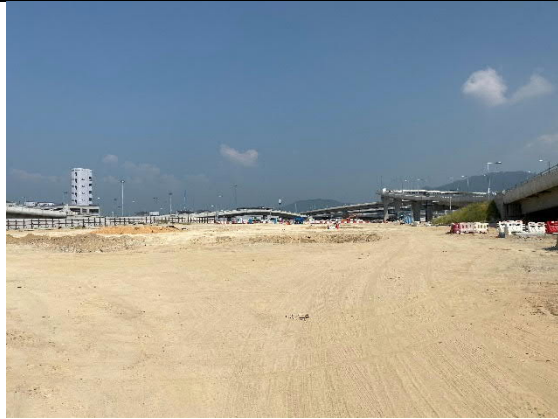
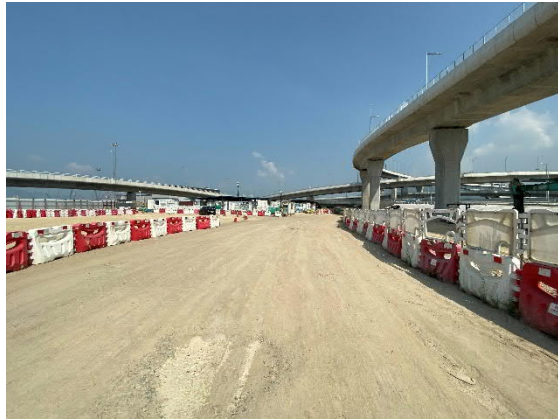
1. Air quality observation: Stockpiles and some exposed works areas were observed dry and dusty.
