**Contract No. HY/2013/04 Hong Kong-Zhuhai-Macao Bridge (HZMB)
Hong Kong Boundary Crossing Facilities – Infrastructure Works Stage II
(Southern Portion)**

Monthly EM&A Report for September 2019 (Revision 1)

This is the 51st Monthly EM&A Report summarising the findings of EM&A activities conducted under the Contract from 1 to 30 September 2019 (the “reporting period”) and is submitted to fulfil Condition 5.4 of the EP.

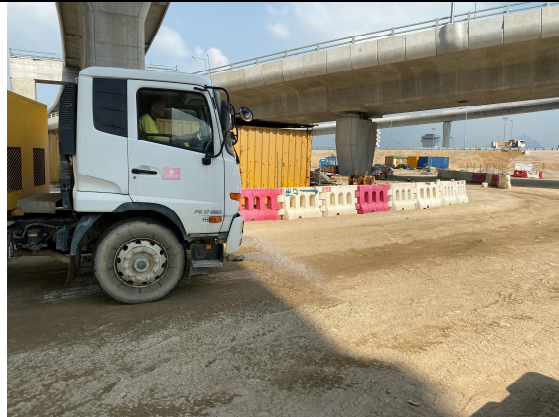
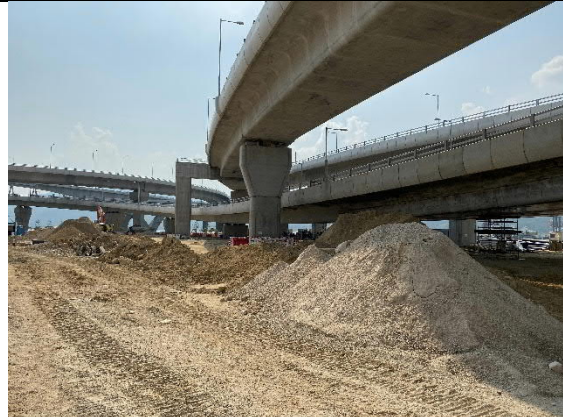
25 September 2019

1. Water spray provided for haul roads in the HY/2013/04 site area. No fugitive dust generation was observed.

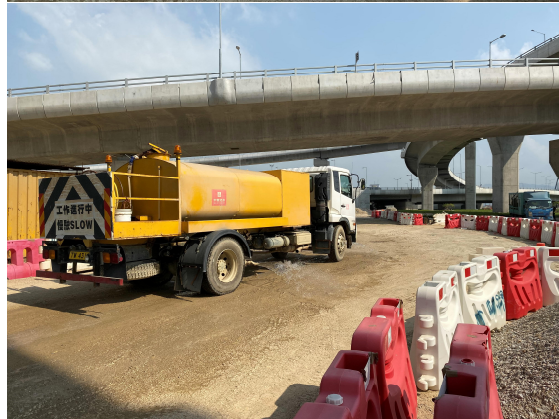
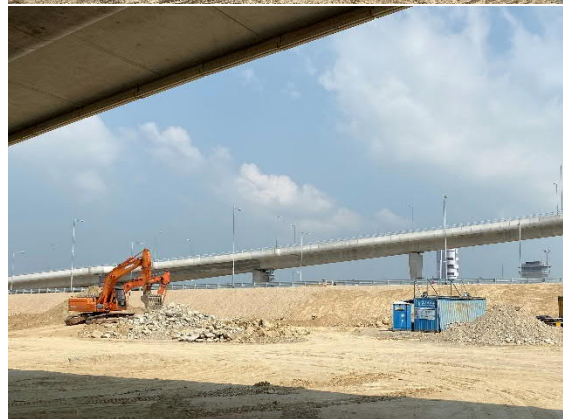
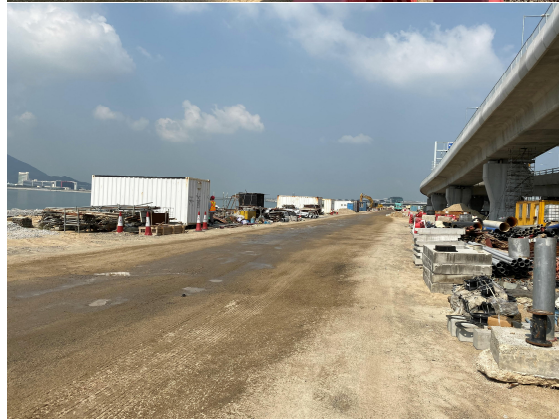
During ET’s regular weekly site inspection on 25 September 2019 (between 09:30 and 10:30 a.m.), one air quality observation was recorded: namely, stockpiles and some exposed works areas were observed dry and dusty. The same observation was recorded during the next ET regular weekly site inspection on 2 October 2019 (between 14:15 and 15:00). Subsequently, the Contractor provided water spray for stockpiles and exposed works areas and the observation was closed during the subsequent ET regular weekly site inspection on 9 October 2019 (between 14:15 and 15:00). The remaining haul roads were observed to be watered and no fugitive dust generation from HY/2013/04 works was observed during this inspection. There was further no air quality observation associated with watering of site areas.

2. Air quality observation: Stockpiles and some exposed works areas were observed dry and dusty.

- a. Stockpiles and some exposed works areas were observed dry and dusty. The Contractor should implement sufficient water spraying for dust suppression. Follow-up action for the outstanding observation will be inspected during the upcoming site inspections and reported in the coming reporting period.

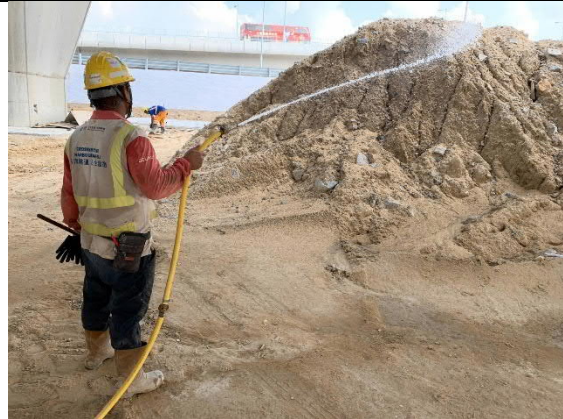
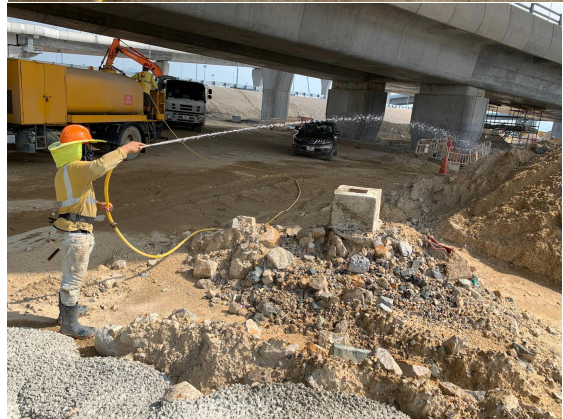
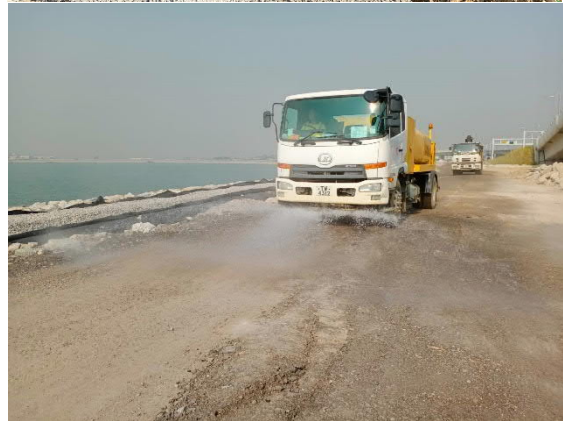
9 October 2019

1. Contractor's follow-up action: Water spray provided for haul roads in the HY/2013/04 site area. No fugitive dust generation and no air quality site observation was observed.
