**Contract No. HY/2013/04 Hong Kong-Zhuhai-Macao Bridge (HZMB)
Hong Kong Boundary Crossing Facilities – Infrastructure Works Stage II
(Southern Portion)**

Monthly EM&A Report for November 2019

**Contract No. HY/2013/04
HZMB HKBCF – Infrastructure Works Stage II (Southern Portion)
Monthly Environmental Monitoring & Audit Report for November 2019**

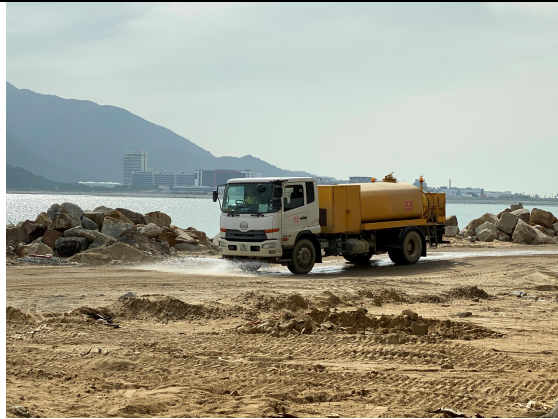
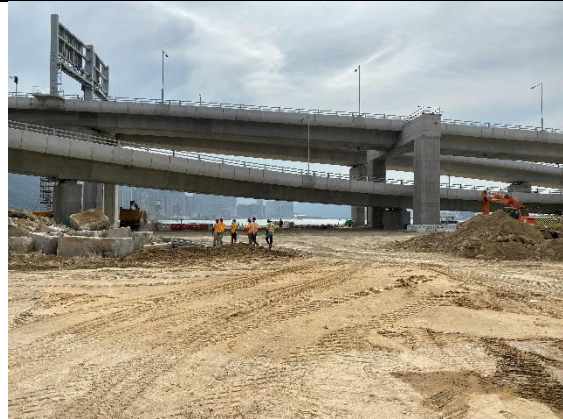
30 October 2019

1. Water spray provided for haul roads in the HY/2013/04 site area. No fugitive dust generation was observed at haul roads.

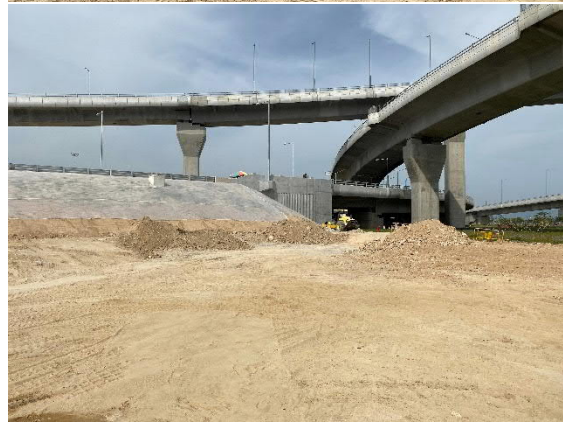
During ET's regular weekly site inspections on 30 October 2019 (between 14:15 and 15:00) and 6 November 2019 (14:15-15:00), one air quality observation was recorded: namely, an exposed works area was observed dry and dusty.

2. Air quality observation: The exposed works area was observed dry and dusty.

- a. The exposed works area was observed dry and dusty. The Contractor should ensure provision of water spraying for dust suppression. Follow-up action for the outstanding observation will be inspected during the upcoming site inspections and reported in the coming reporting period.

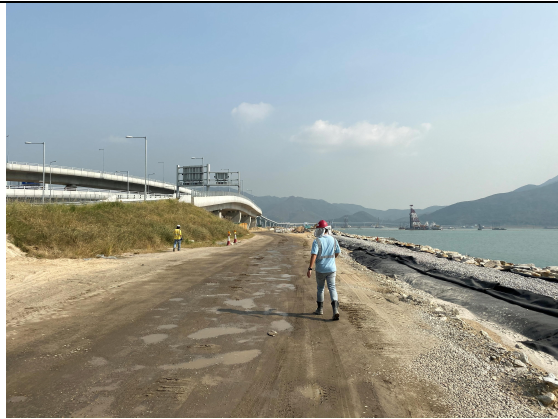
6 November 2019

1. Water spray provided for haul roads in the HY/2013/04 site area. No fugitive dust generation was observed at haul roads.

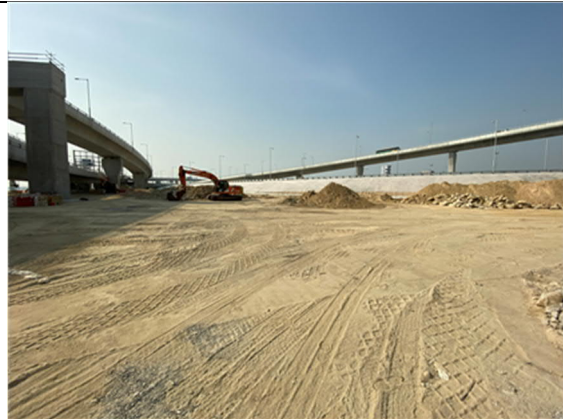
2. Air quality observation: The exposed works area was observed dry and dusty.

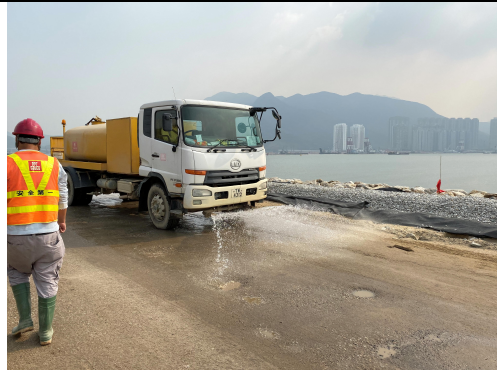
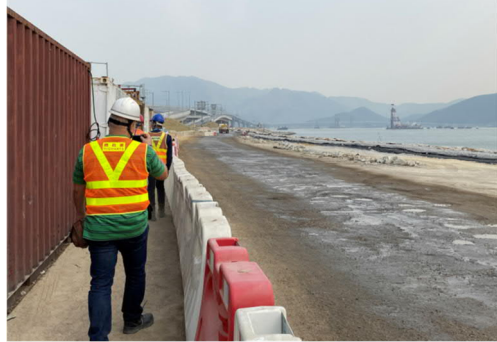
18 November 2019

1. Water spray provided for haul roads in the HY/2013/04 site area. No fugitive dust generation was observed at haul roads.

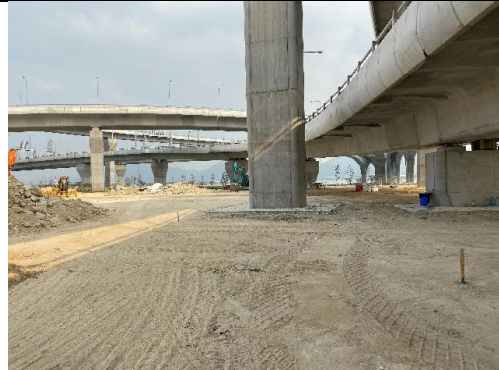
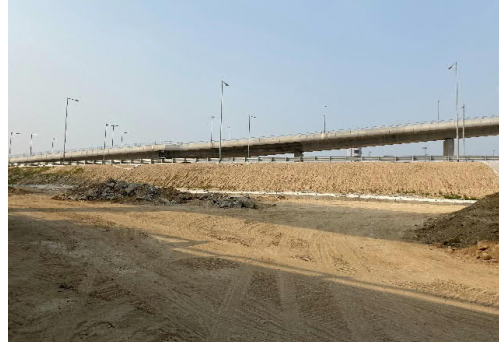
During ET's regular weekly site inspections on 18 November 2019 (14:30-15:30) and 27 November 2019 (14:45-15:45), one air quality observation was recorded: namely, an exposed works area was observed dry and dusty.

2. Air quality observation: The exposed works area was observed dry and dusty.

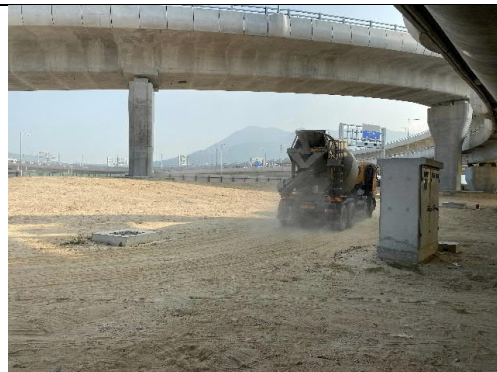
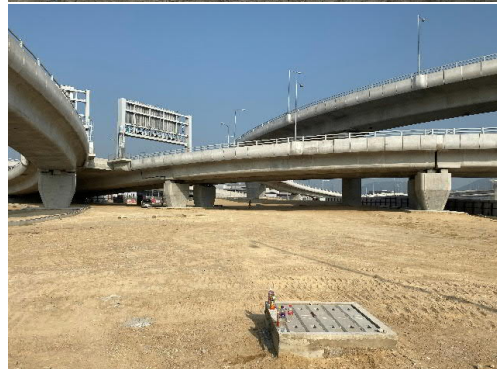
27 November 2019

1. Air quality observation: The exposed works area was observed dry and dusty.
