Contract No. HY/2013/04
Hong Kong-Zhuhai-Macao Bridge
Hong Kong Boundary Crossing Facilities –
Infrastructure Works Stage II (Southern Portion)

Monthly EM&A Report for December 2019

This is the 54th Monthly EM&A Report summarising the findings of EM&A activities conducted under the Contract from 1 to 31 December 2019 (the “reporting period”) and is submitted to fulfil Condition 5.4 of the EP.

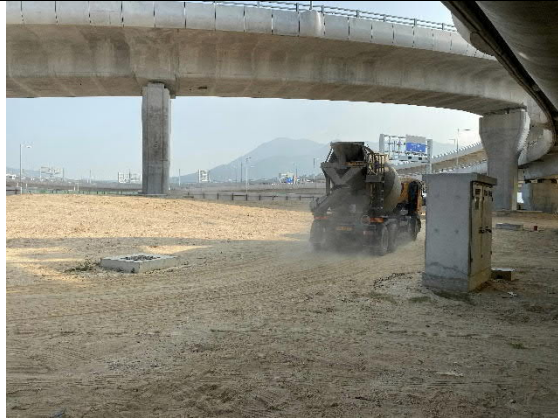
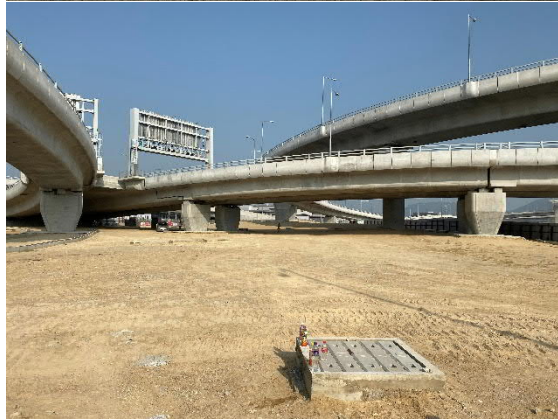
During ET's regular weekly site inspections on 27 November 2019 (14:45-15:45) and 4 December 2019 (14:30-15:30), one air quality observation was recorded: namely, an exposed works area was observed dry and dusty.

1. Air quality observation: The exposed works area was observed dry and dusty.

- a. The exposed works area was observed dry and dusty. Subsequently, as informed by the Contractor, the dry exposed works areas were handed over to another works contract. The observation was closed on 16 December 2019.

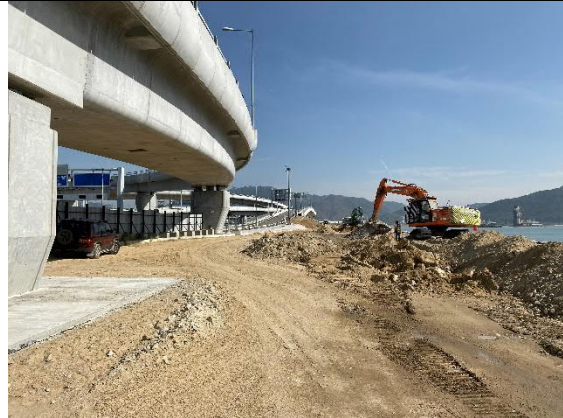
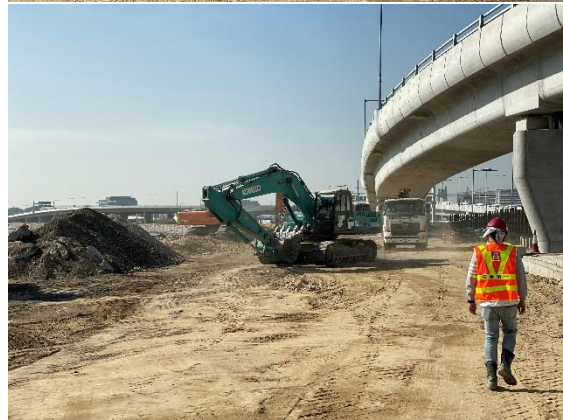
4 December 2019

1. Air quality observation: The exposed works area was observed dry and dusty.
