**Contract No. HY/2019/01
HZMB HKBCF – Phase 2 and Other Works
Quarterly EM&A Report for September 2020 - November 2020**

**Quarterly EM&A Report for
Hong Kong-Zhuhai-Macao Bridge Hong Kong Boundary Crossing Facilities - Phase 2 and
Other Works (Contract No. HY/2019/01)**

Quarterly EM&A Report (September 2020 - November 2020)

Contact No. HY/2019/01 Hong Kong-Zhuhai-Macao Bridge Hong Kong Boundary Crossing Facilities – Phase 2 and Other Works

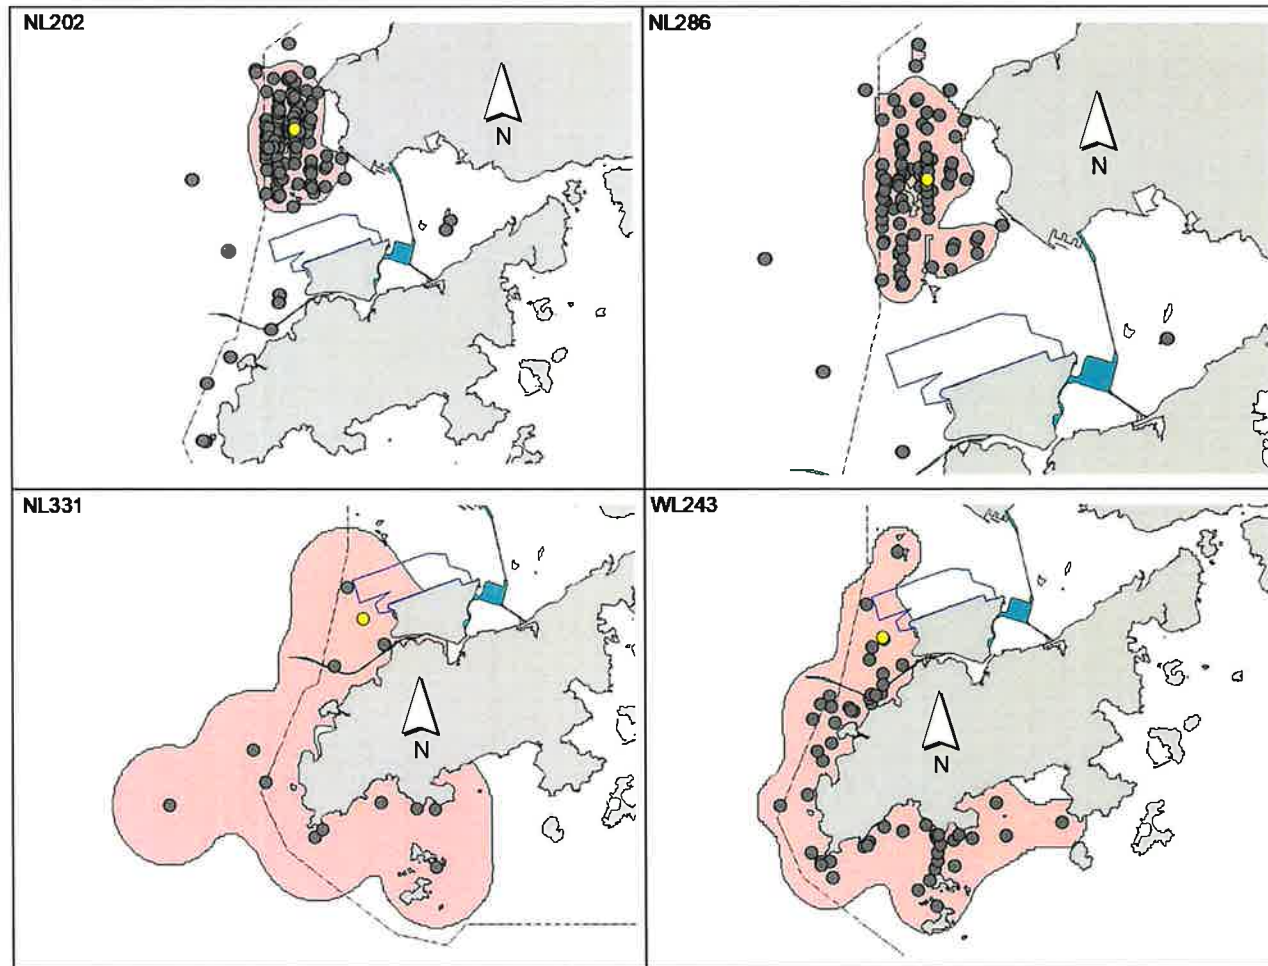
Appendix V. Ranging patterns (95% kernel ranges) of four individual dolphins that were sighted during the present TMCLKL08 monitoring period
(note: yellow dots indicate sightings made in September-November 2020 during TMCLKL08 monitoring surveys)

3.9.2. All four identified dolphins sighted in the present quarter were utilizing NWL waters only, but have completely avoided NEL waters where many of them have utilized as their core areas in the past (Appendix V). This is in contrary to the extensive movements between NEL and NWL survey areas observed in the earlier impact monitoring quarters as well as the baseline period.
