**Contract No. HY/2019/01
HZMB HKBCF – Phase 2 and Other Works
Monthly EM&A Report for February 2022**

**EP Condition 5.4 – Monthly EM&A Report for
Hong Kong-Zhuhai-Macao Bridge Hong Kong Boundary Crossing Facilities – Phase 2 and
Other Works (Contract No. HY/2019/01)**

- 1.1.3 This is the 25th Monthly EM&A report to document the findings of site inspection activities and EM&A programme carried out by the Contractor of Contract No. HY/2019/01 from 1 February 2022 to 28 February 2022 (reporting period) and is submitted to fulfil Condition 5.4 of the EP.

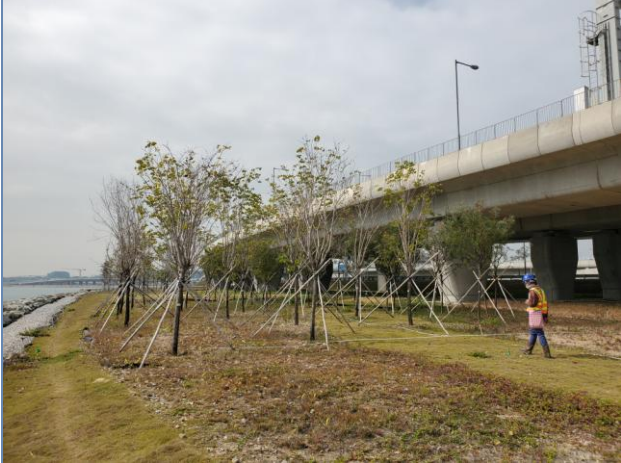
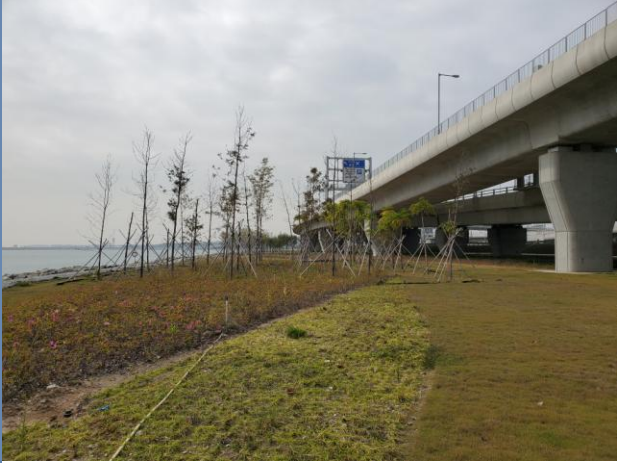
Location	Photo Record	
Portion A-1

TG46: 2 <i>Grevillea banksii</i> (GB) and 4 <i>Bauhinia variegata</i> (BV) are found dead, replacement is necessary.	TG47: 20 <i>Grevillea robusta</i> (GR) are found dead/poor conditions, replacement is necessary.

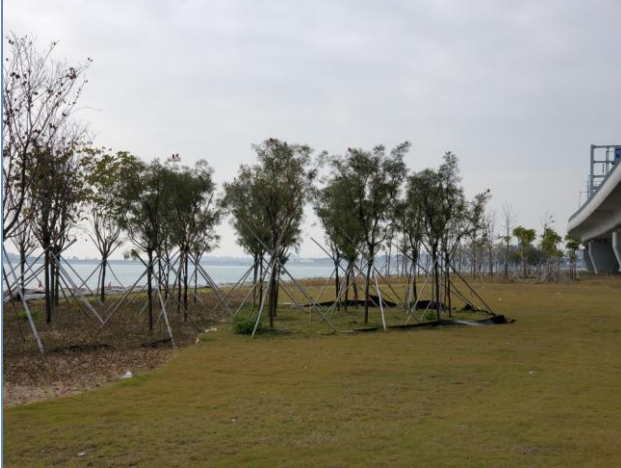
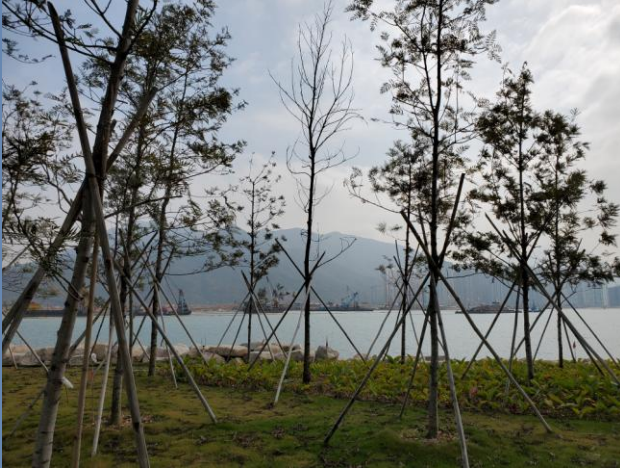
TG48: 18 <i>Grevillea banksii</i> (GB) are found on site. To be replaced by 18 <i>Plumeria rubra</i> (PR).	TG49: 1 <i>Grevillea robusta</i> is found dead, replacement is necessary.

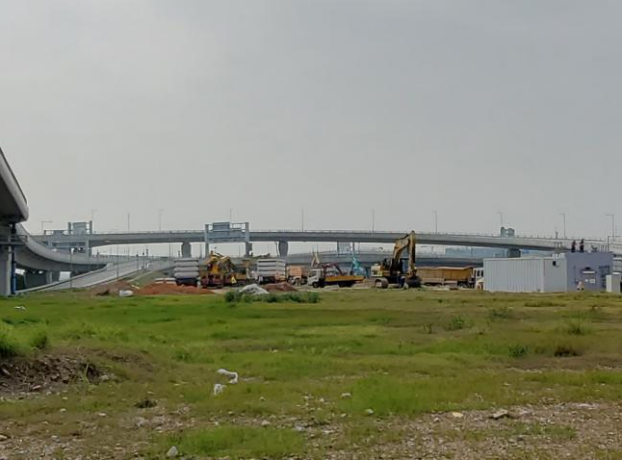
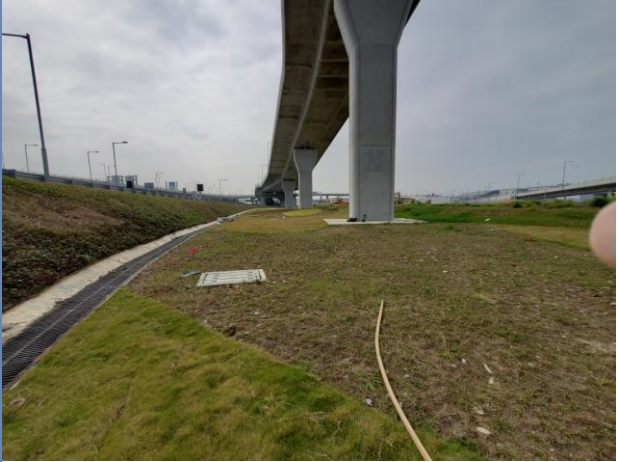
Location	Photo Record	
<p>Portion A-2</p>

<p>Portion A-2 area C33 is currently undergoing construction of disease control facilities.</p>	<p>Other areas in Portion A-2 have no particular findings.</p>
<p>Portion A-3</p>

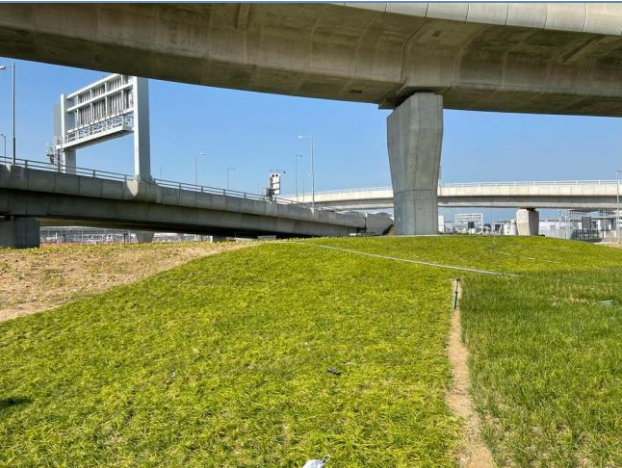
<p>Portion A-3 has no particular findings.</p>

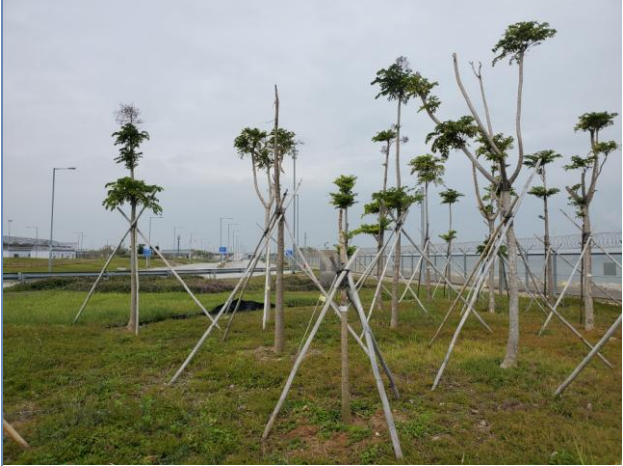
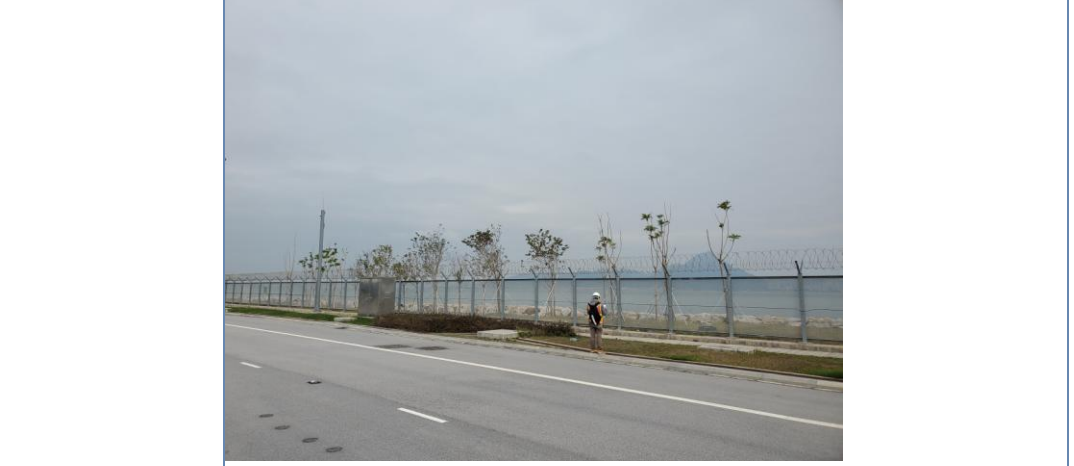
Location	Photo Record	
Portion D

TG02: 2 <i>Heteropanax fragrans</i> (HF) are found dead.	TG03: 1 <i>Heteropanax fragrans</i> (HF) is found missing; 8 <i>Heteropanax fragrans</i> (HF) are dead/poor conditions, replacement is necessary

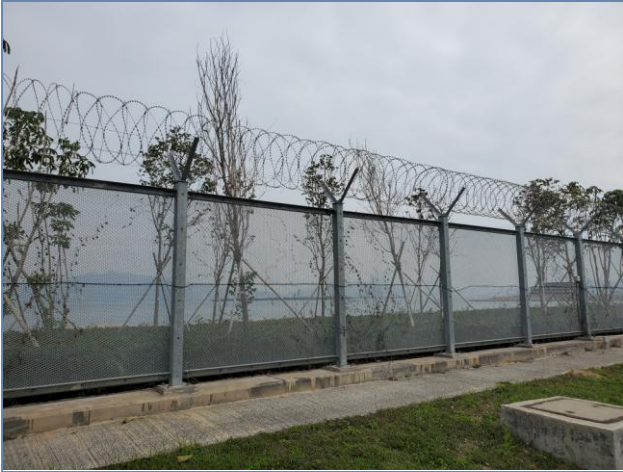
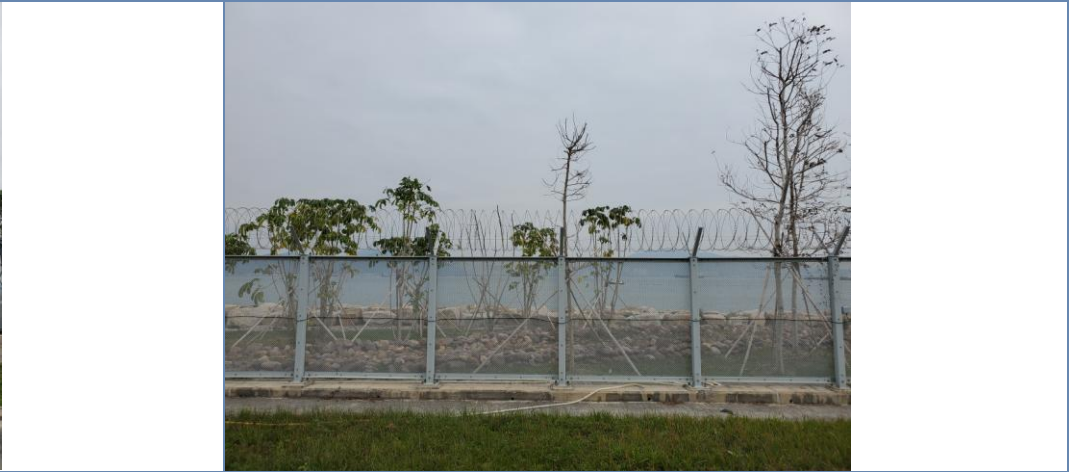
TG05: 3 <i>Bauhinia variegata</i> (BV) are found dead, replacement is necessary.	TG06: 1 <i>Bauhinia variegata</i> and 1 <i>Cassia siamea</i> (CS) are found dead, replacement is necessary.

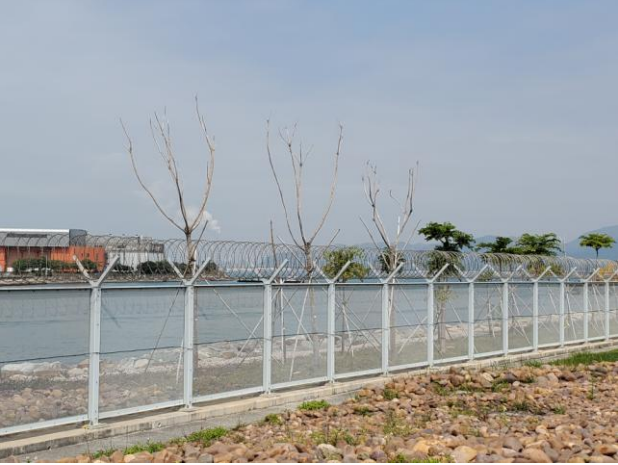
Location	Photo Record	
Portion D

TG16: 3 <i>Bauhinia variegata</i> are found dead, replacement is necessary.	
Portion E

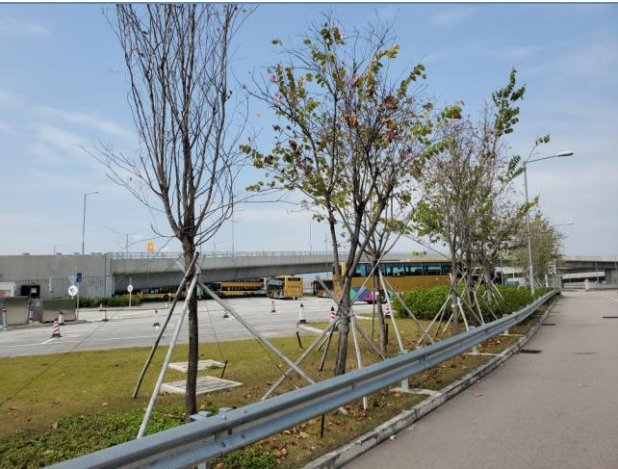
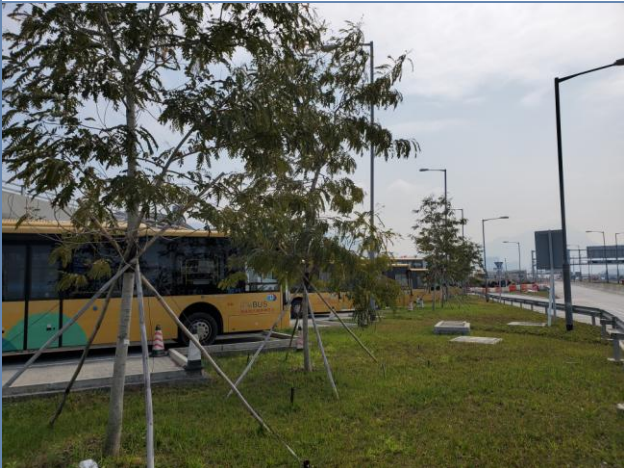
TG42: 1 <i>Bauhinia variegata</i> is found dead, replacement is necessary.	TG11: Loose guy wire is observed. Rectifying is recommended.

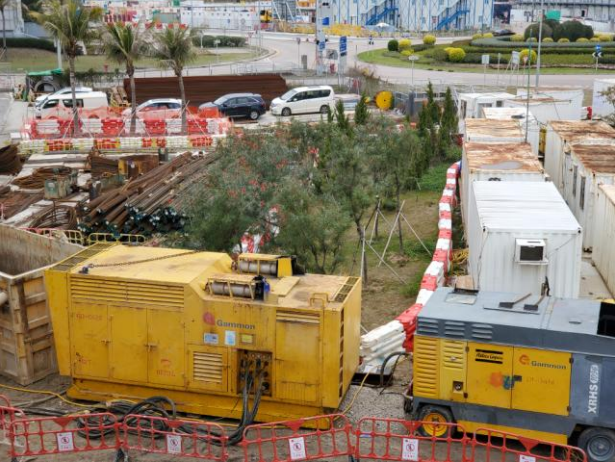
Location	Photo Record	
<p>Portion H</p>

<p>TG17: Overall and has no particular findings.</p>

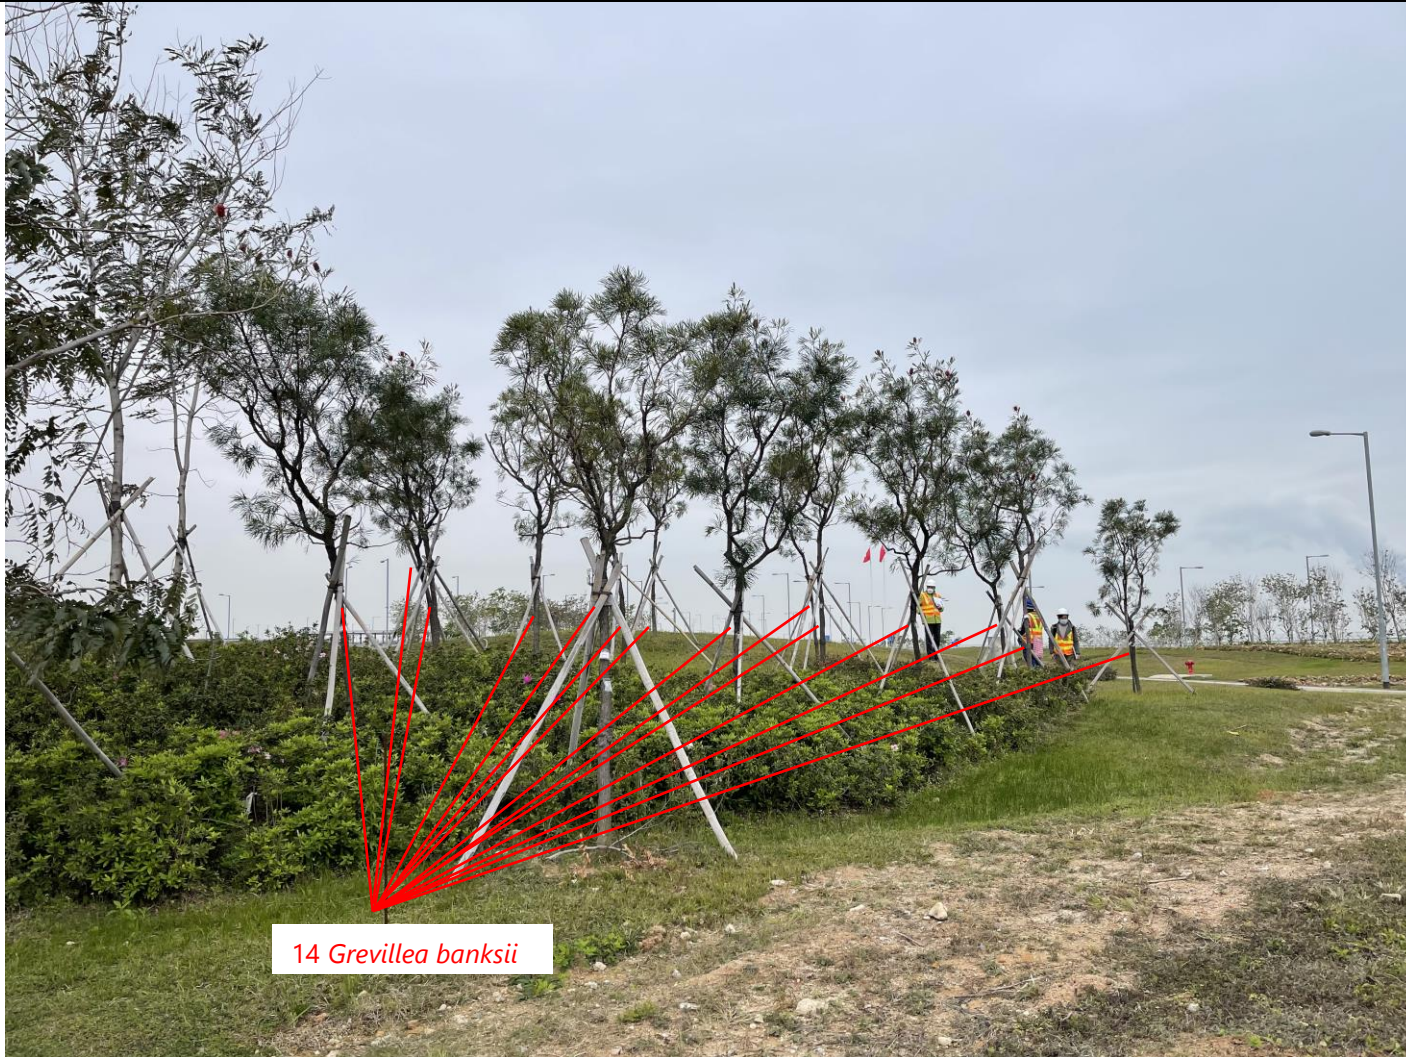
Portion C – TG22

- No particular findings.
Portion C
- TG20: 1 <i>Heteropanax fragrans</i> (HF) is found missing.
- TG22: 2 <i>Cassia siamea</i> (GS) is found missing.
Portion D

14 *Grevillea banksii*

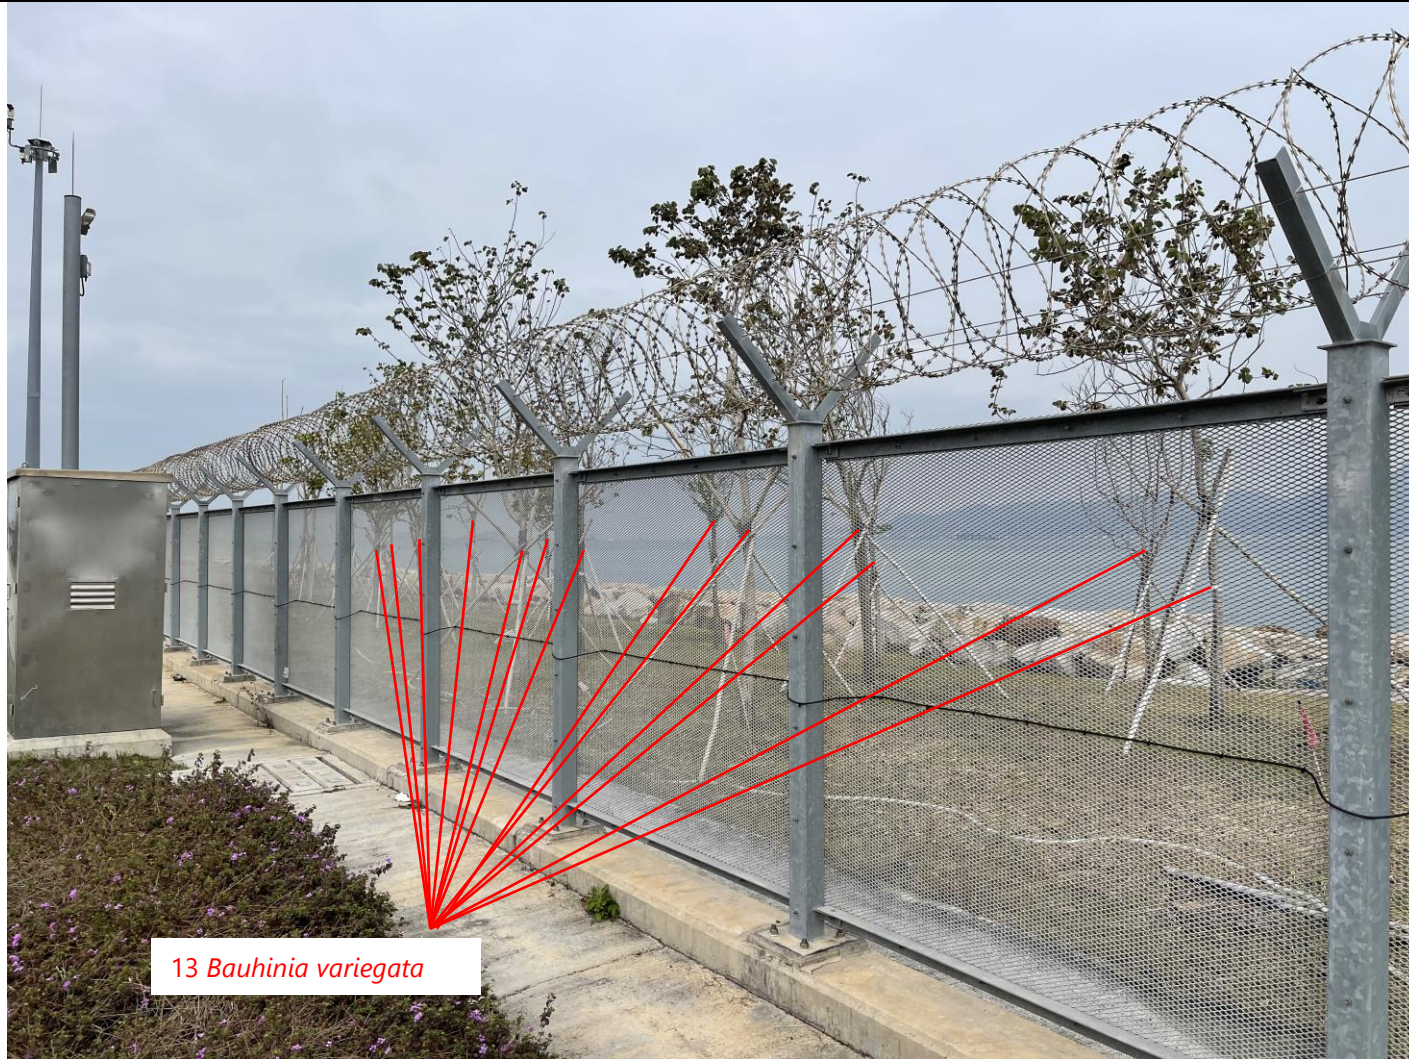
Portion D – TG03

- TG02: 2 <i>Heteropanax fragrans</i> (HF) are found dead, replacement is necessary.
- TG03: 1 <i>Heteropanax fragrans</i> (HF) is found missing; 8 <i>Heteropanax fragrans</i> are dead/poor conditions, replacement is necessary.

13 *Bauhinia variegata*

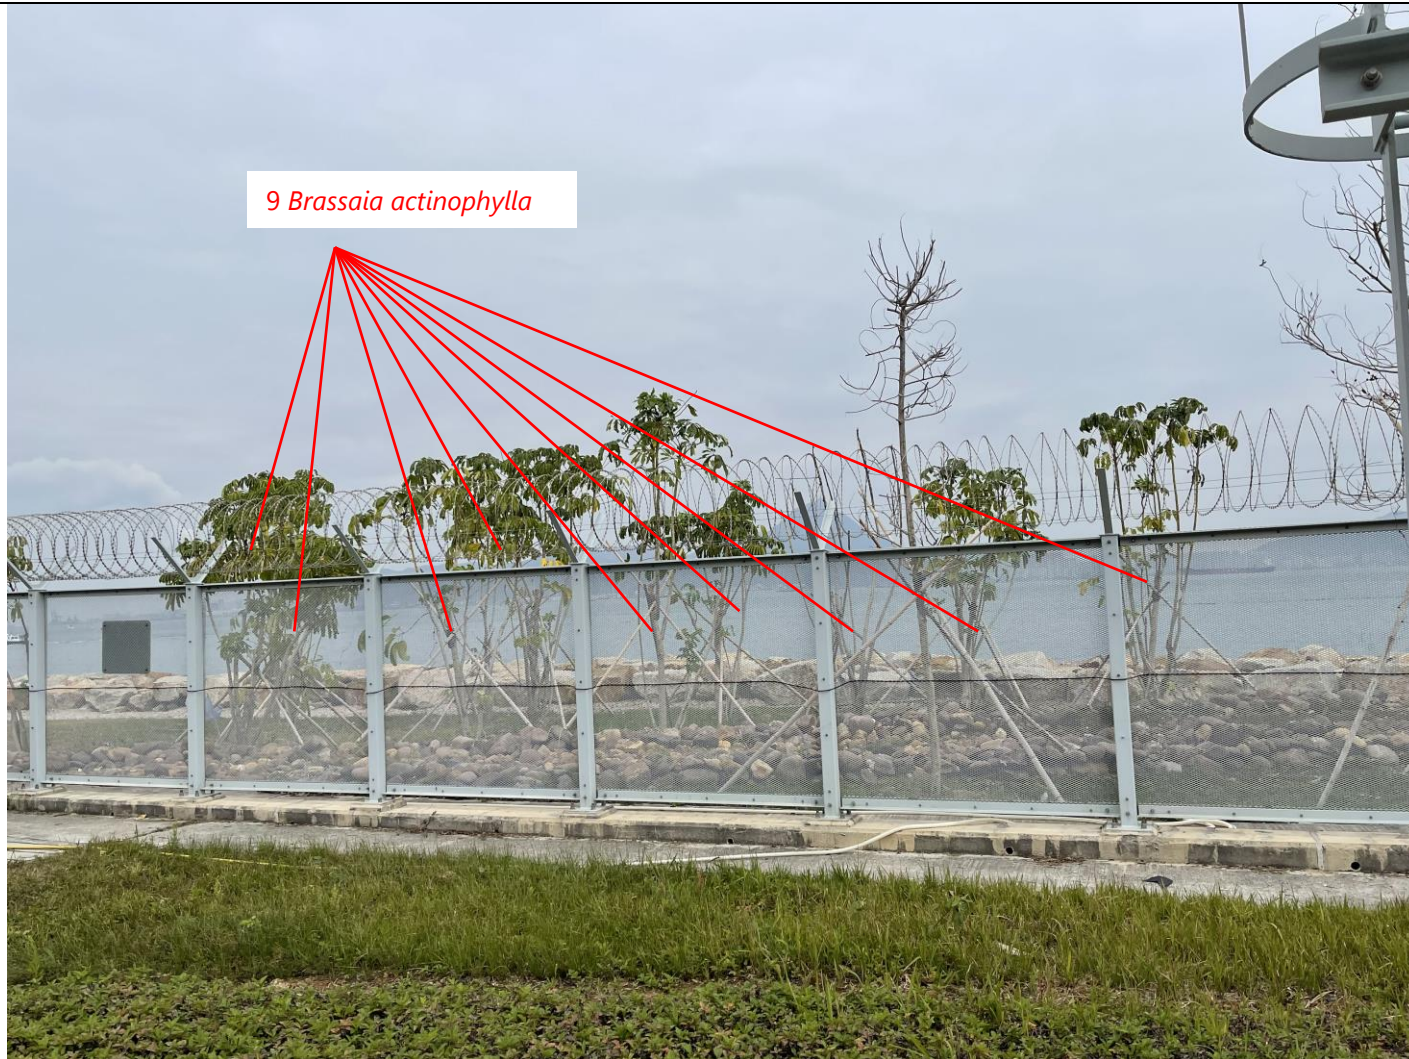
Portion D – TG06

- TG05: 3 <i>Bauhinia variegata</i> (BV) are found dead, replacement is necessary.
- TG06: 1 <i>Bauhinia variegata</i> (BV) and 1 <i>Cassia siamea</i> (CS) are found dead, replacement is necessary.

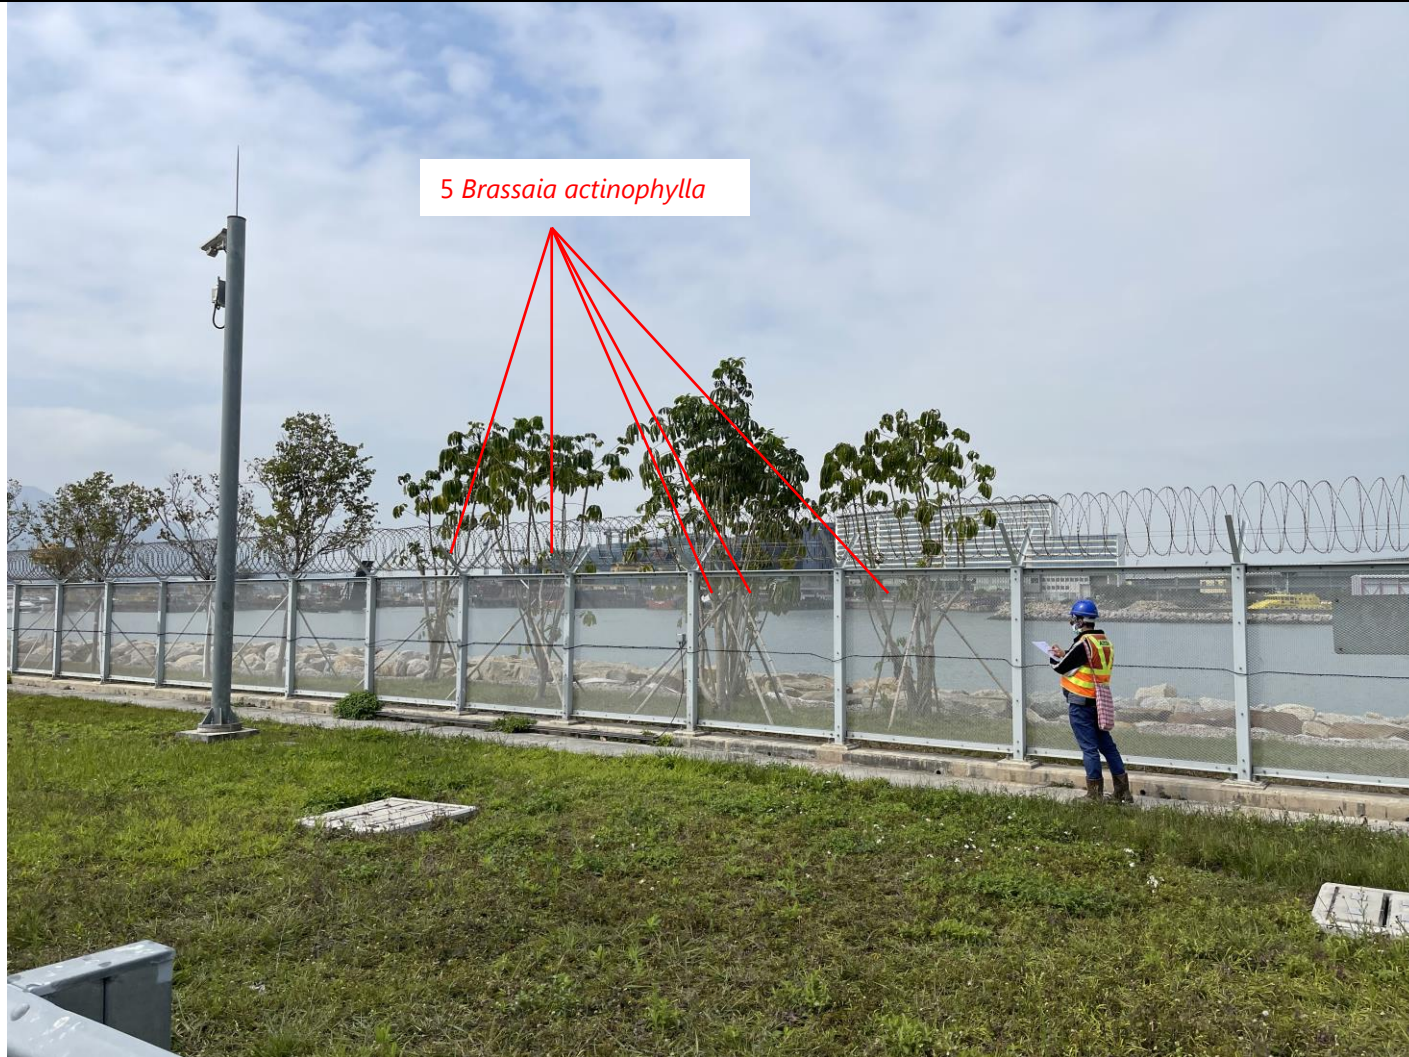
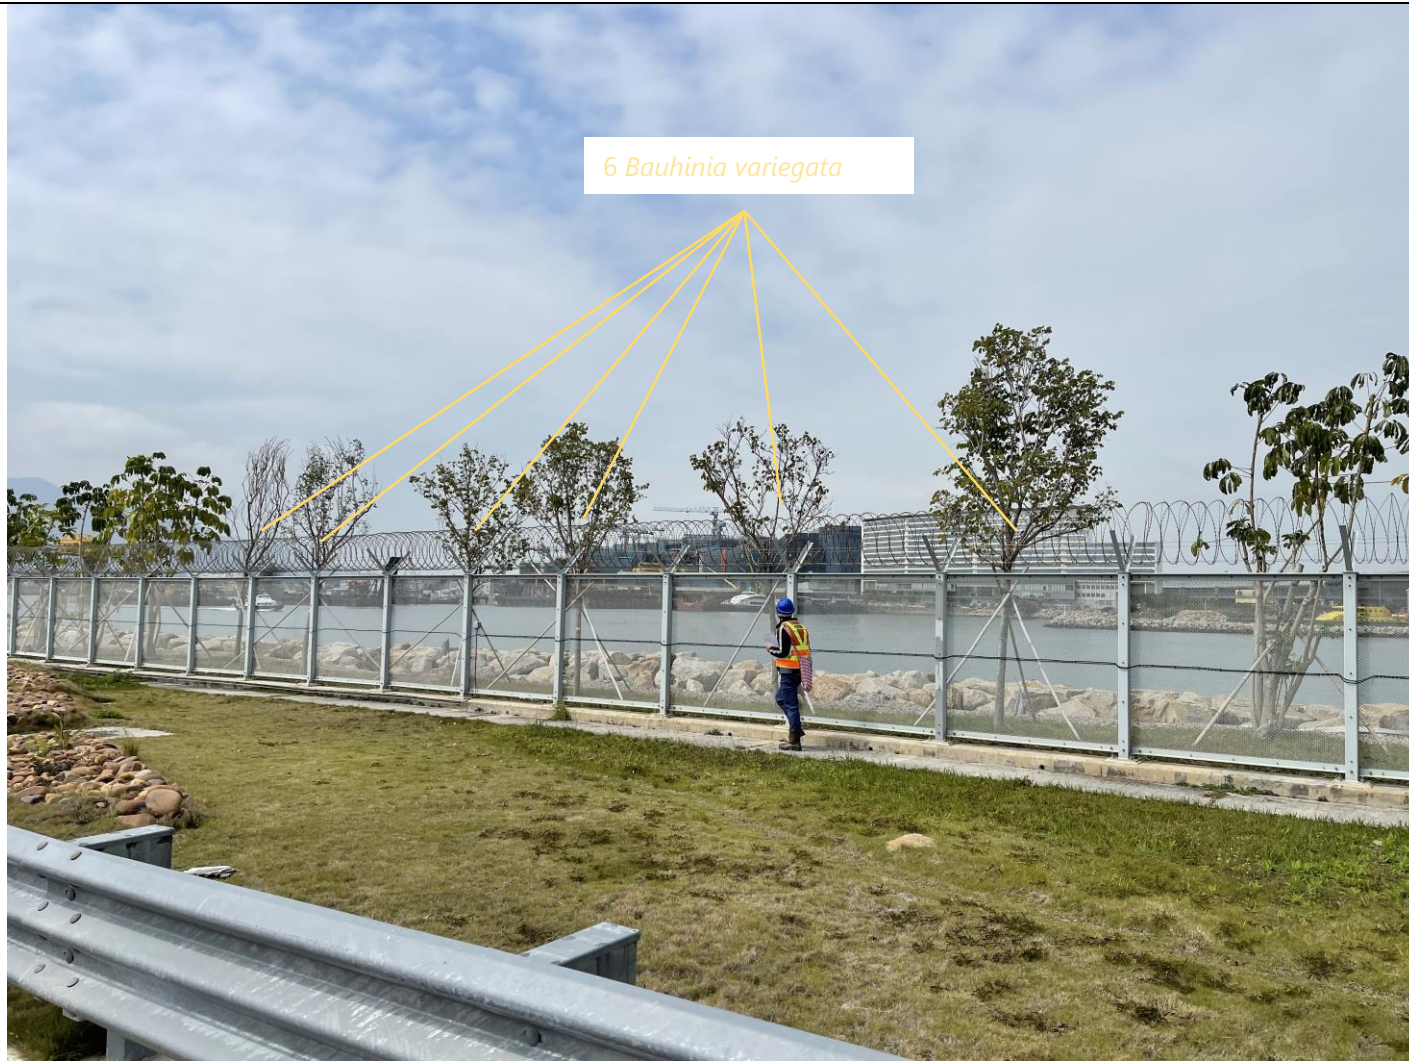
Portion D – TG13

- TG13: 1 <i>Bauhinia variegata</i> (BV) is found dead, replacement is necessary.
- TG15: 10 <i>Heteropanax fragrans</i> (HF) are found dead, replacement is necessary.

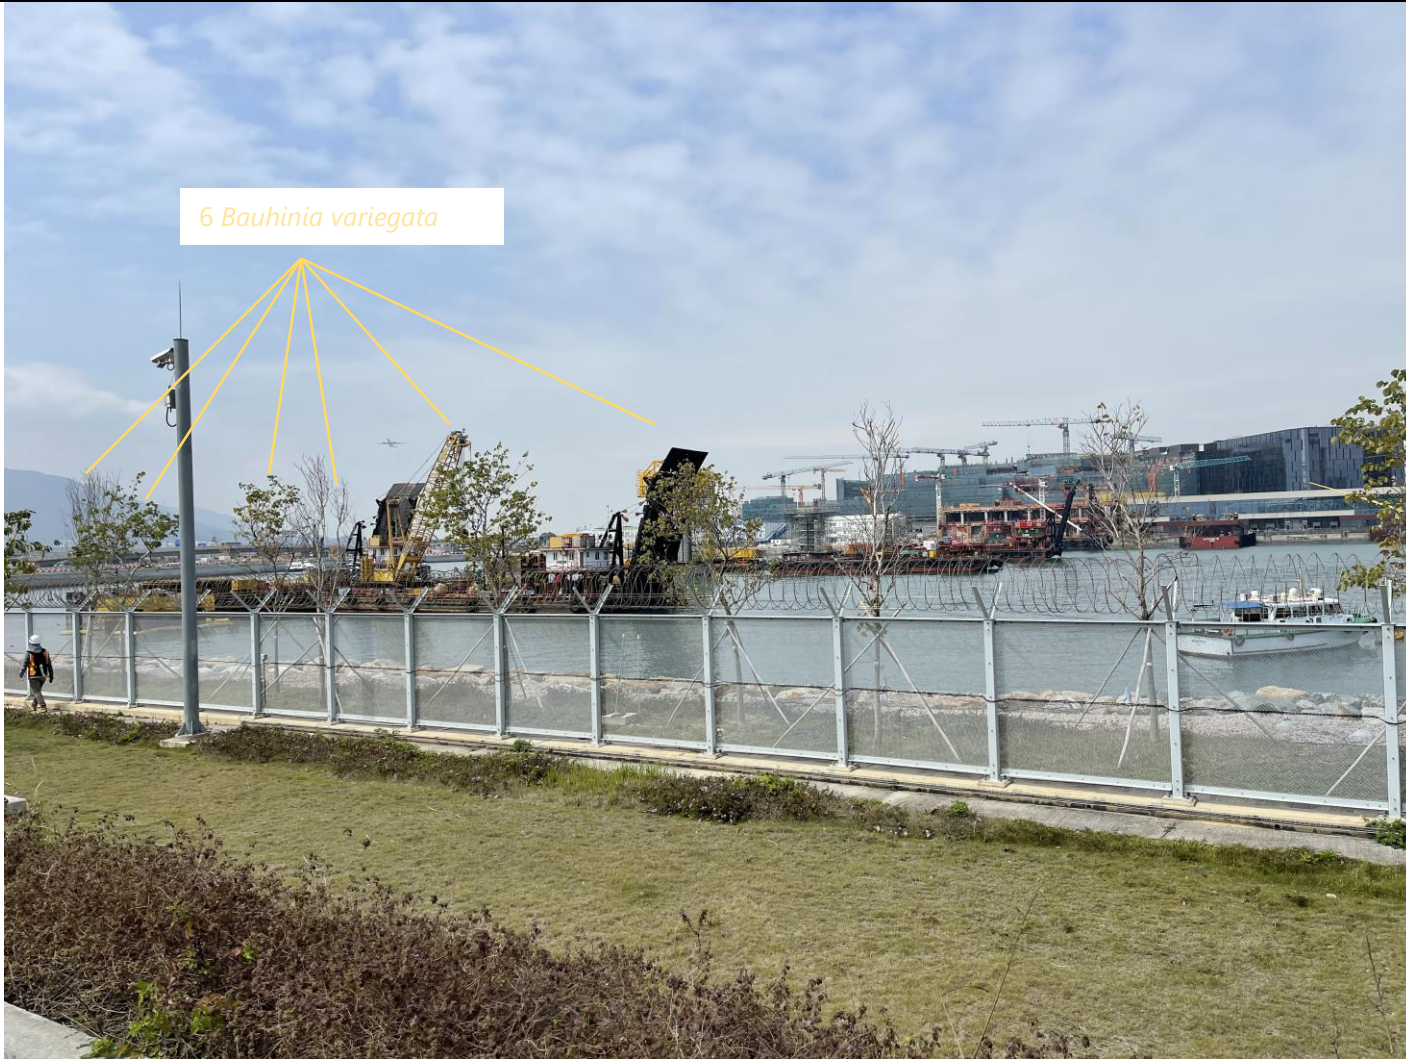
Portion D – TG16

- TG16: 3 <i>Bauhinia variegata</i> (HF) are found dead, replacement is necessary.
Portion E
- TG11: loose guy wire is observed. Rectifying is recommended.

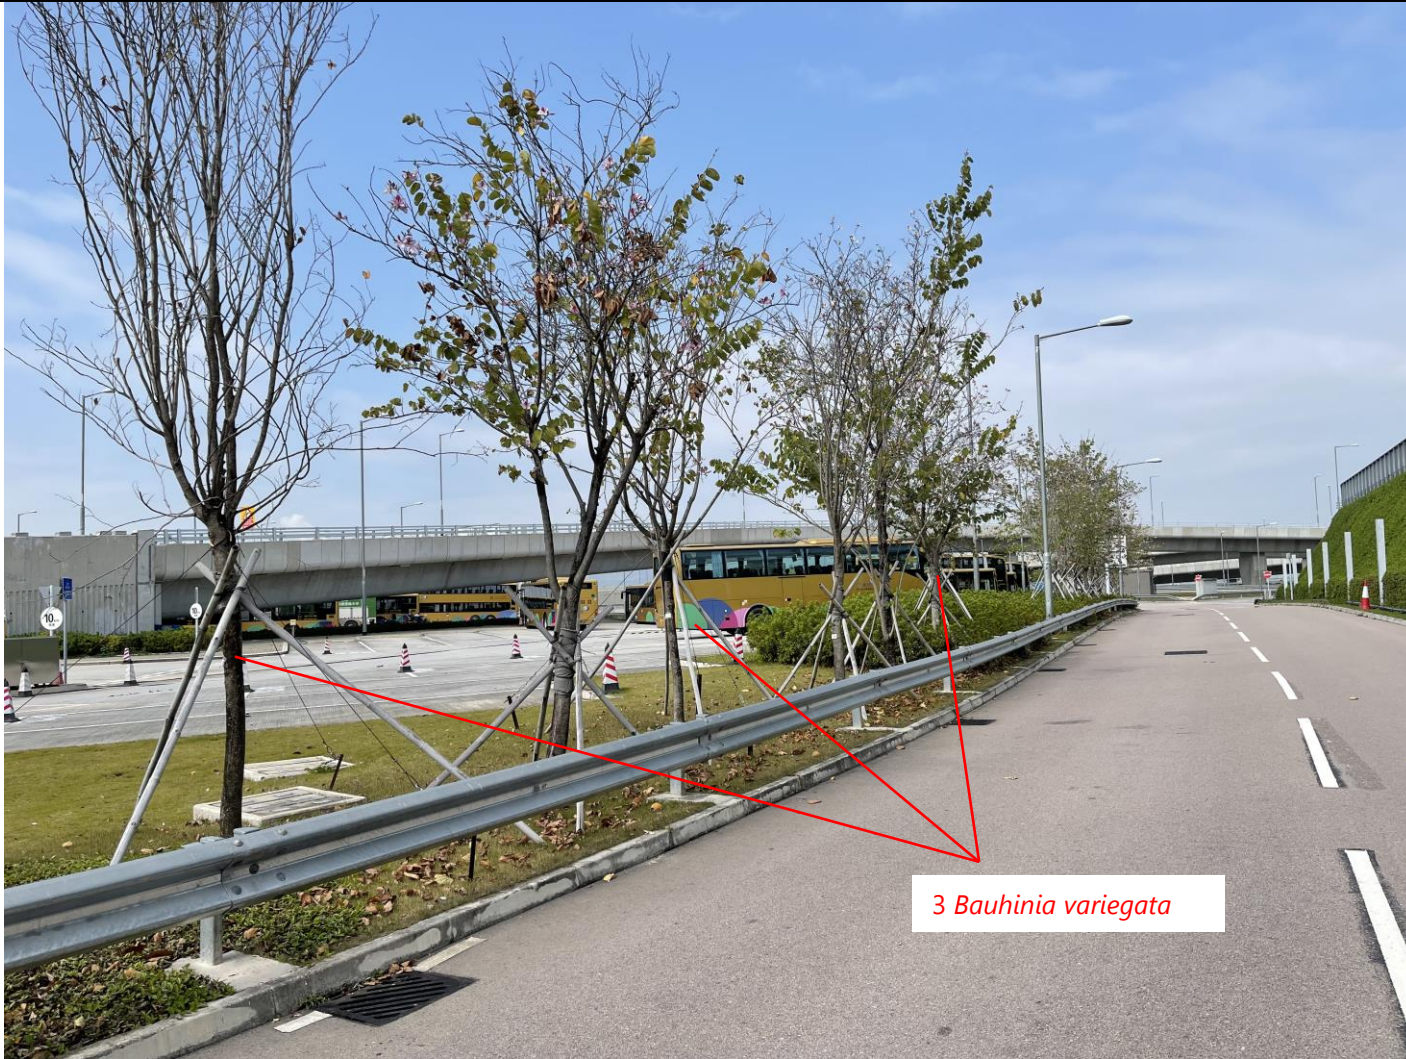
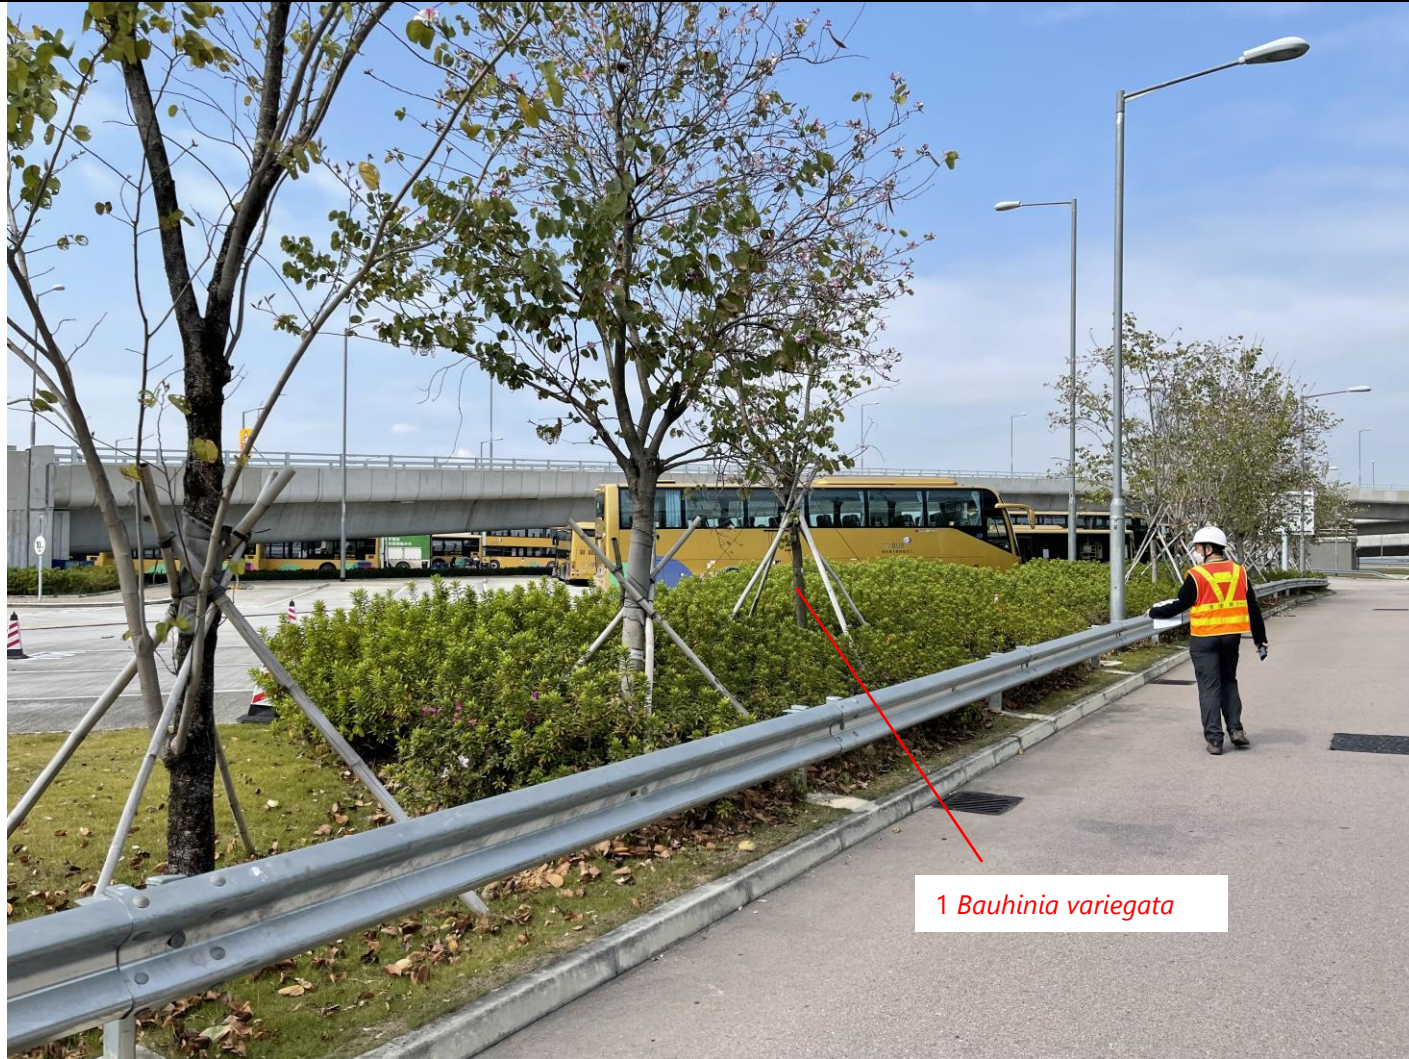
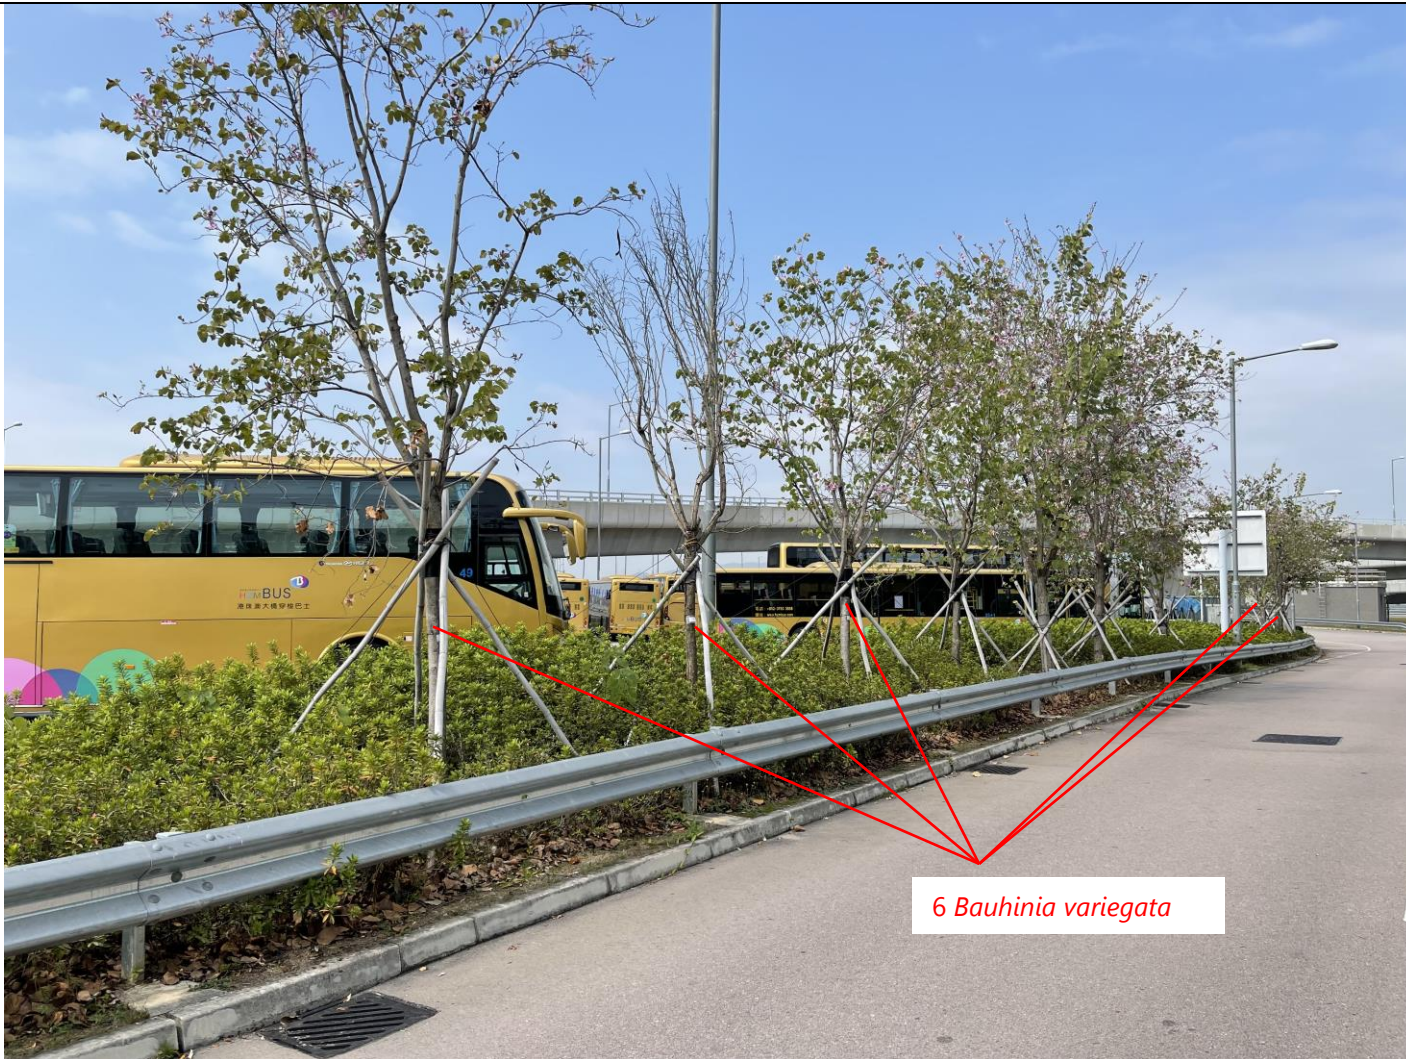
Portion E – TG42

- TG42: 1 <i>Bauhinia variegata</i> (HF) is found dead, replacement is necessary.
Portion F
- No particular findings.
Portion G
- No particular findings.
Portion H

1 *Bauhinia variegata*

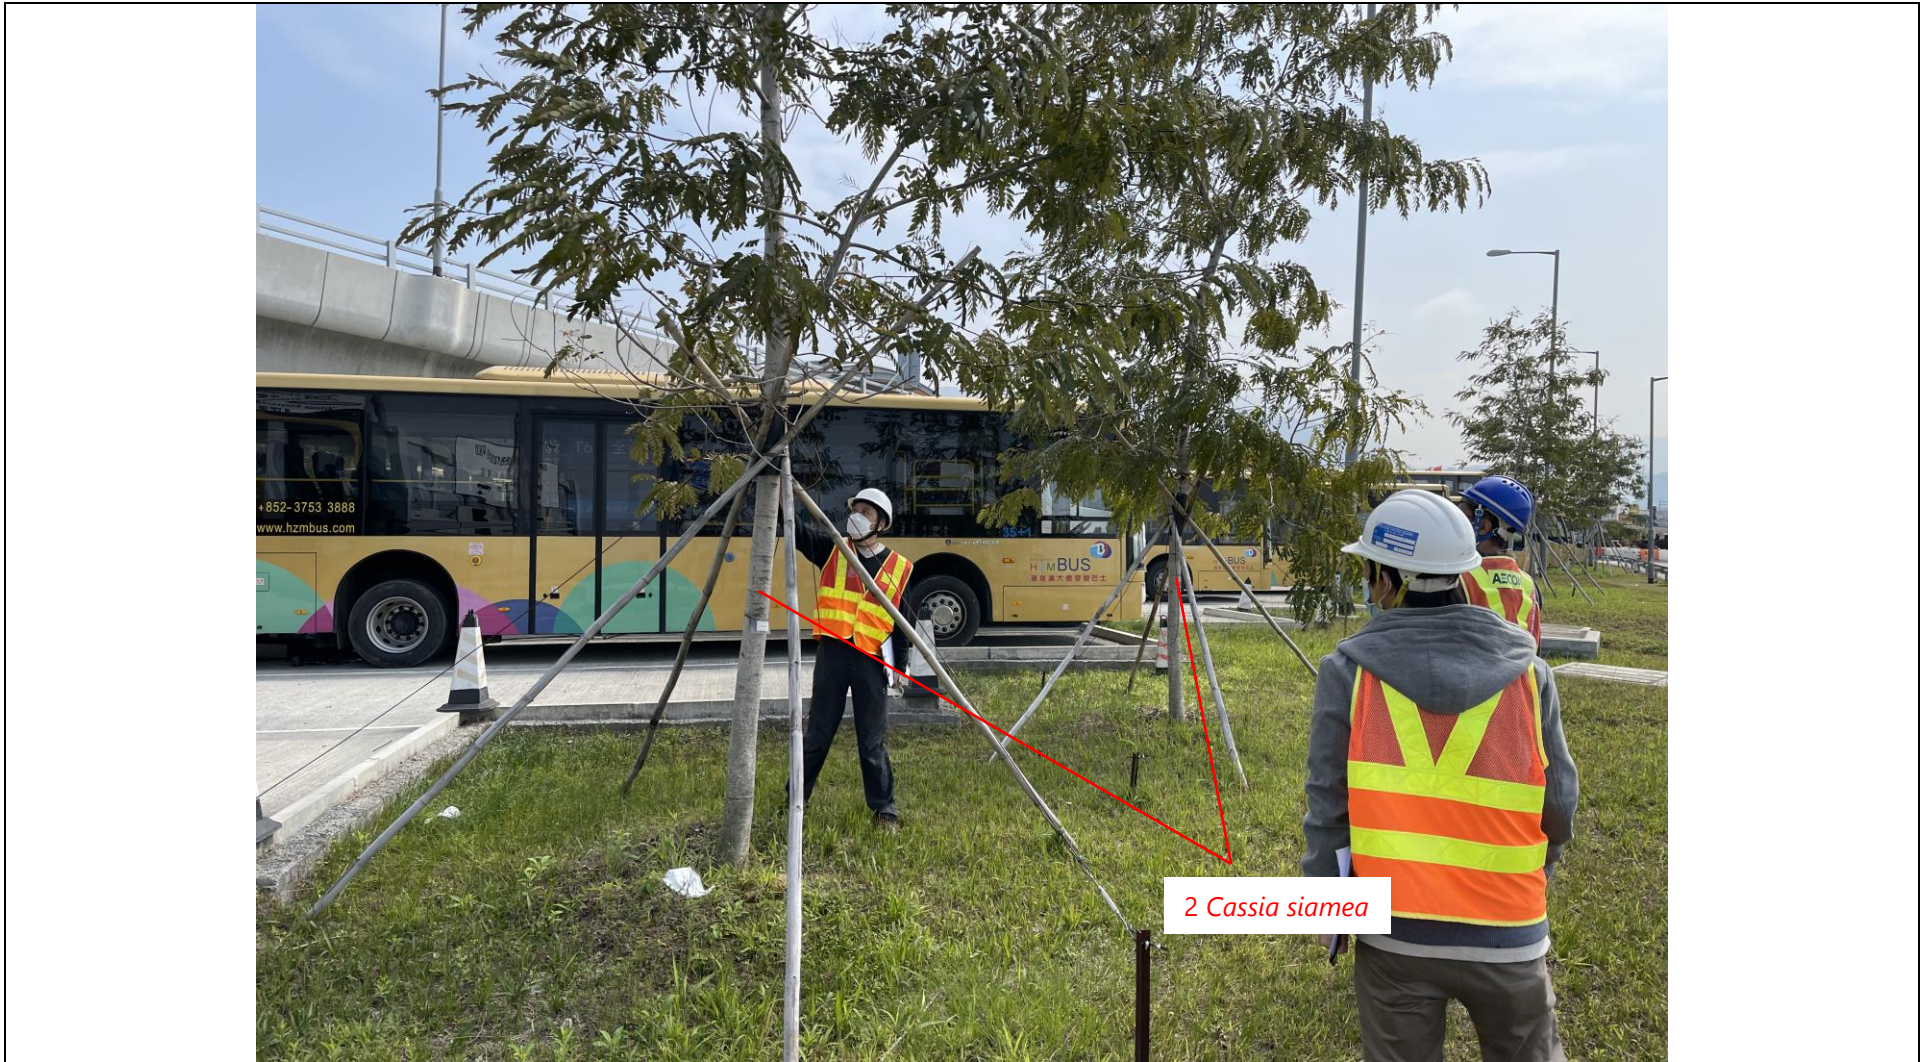
Portion E – TG11

2 *Cassia siamea*
