**Contract No. HY/2019/01
HZMB HKBCF – Phase 2 and Other Works
Quarterly EM&A Report for June 2020 - August 2020**

**Quarterly EM&A Report for
Hong Kong-Zhuhai-Macao Bridge Hong Kong Boundary Crossing Facilities - Phase 2 and
Other Works (Contract No. HY/2019/01)**

Quarterly EM&A Report (June 2020 - August 2020)

Contact No. HY/2019/01 Hong Kong-Zhuhai-Macao Bridge Hong Kong Boundary Crossing Facilities – Phase 2 and Other Works

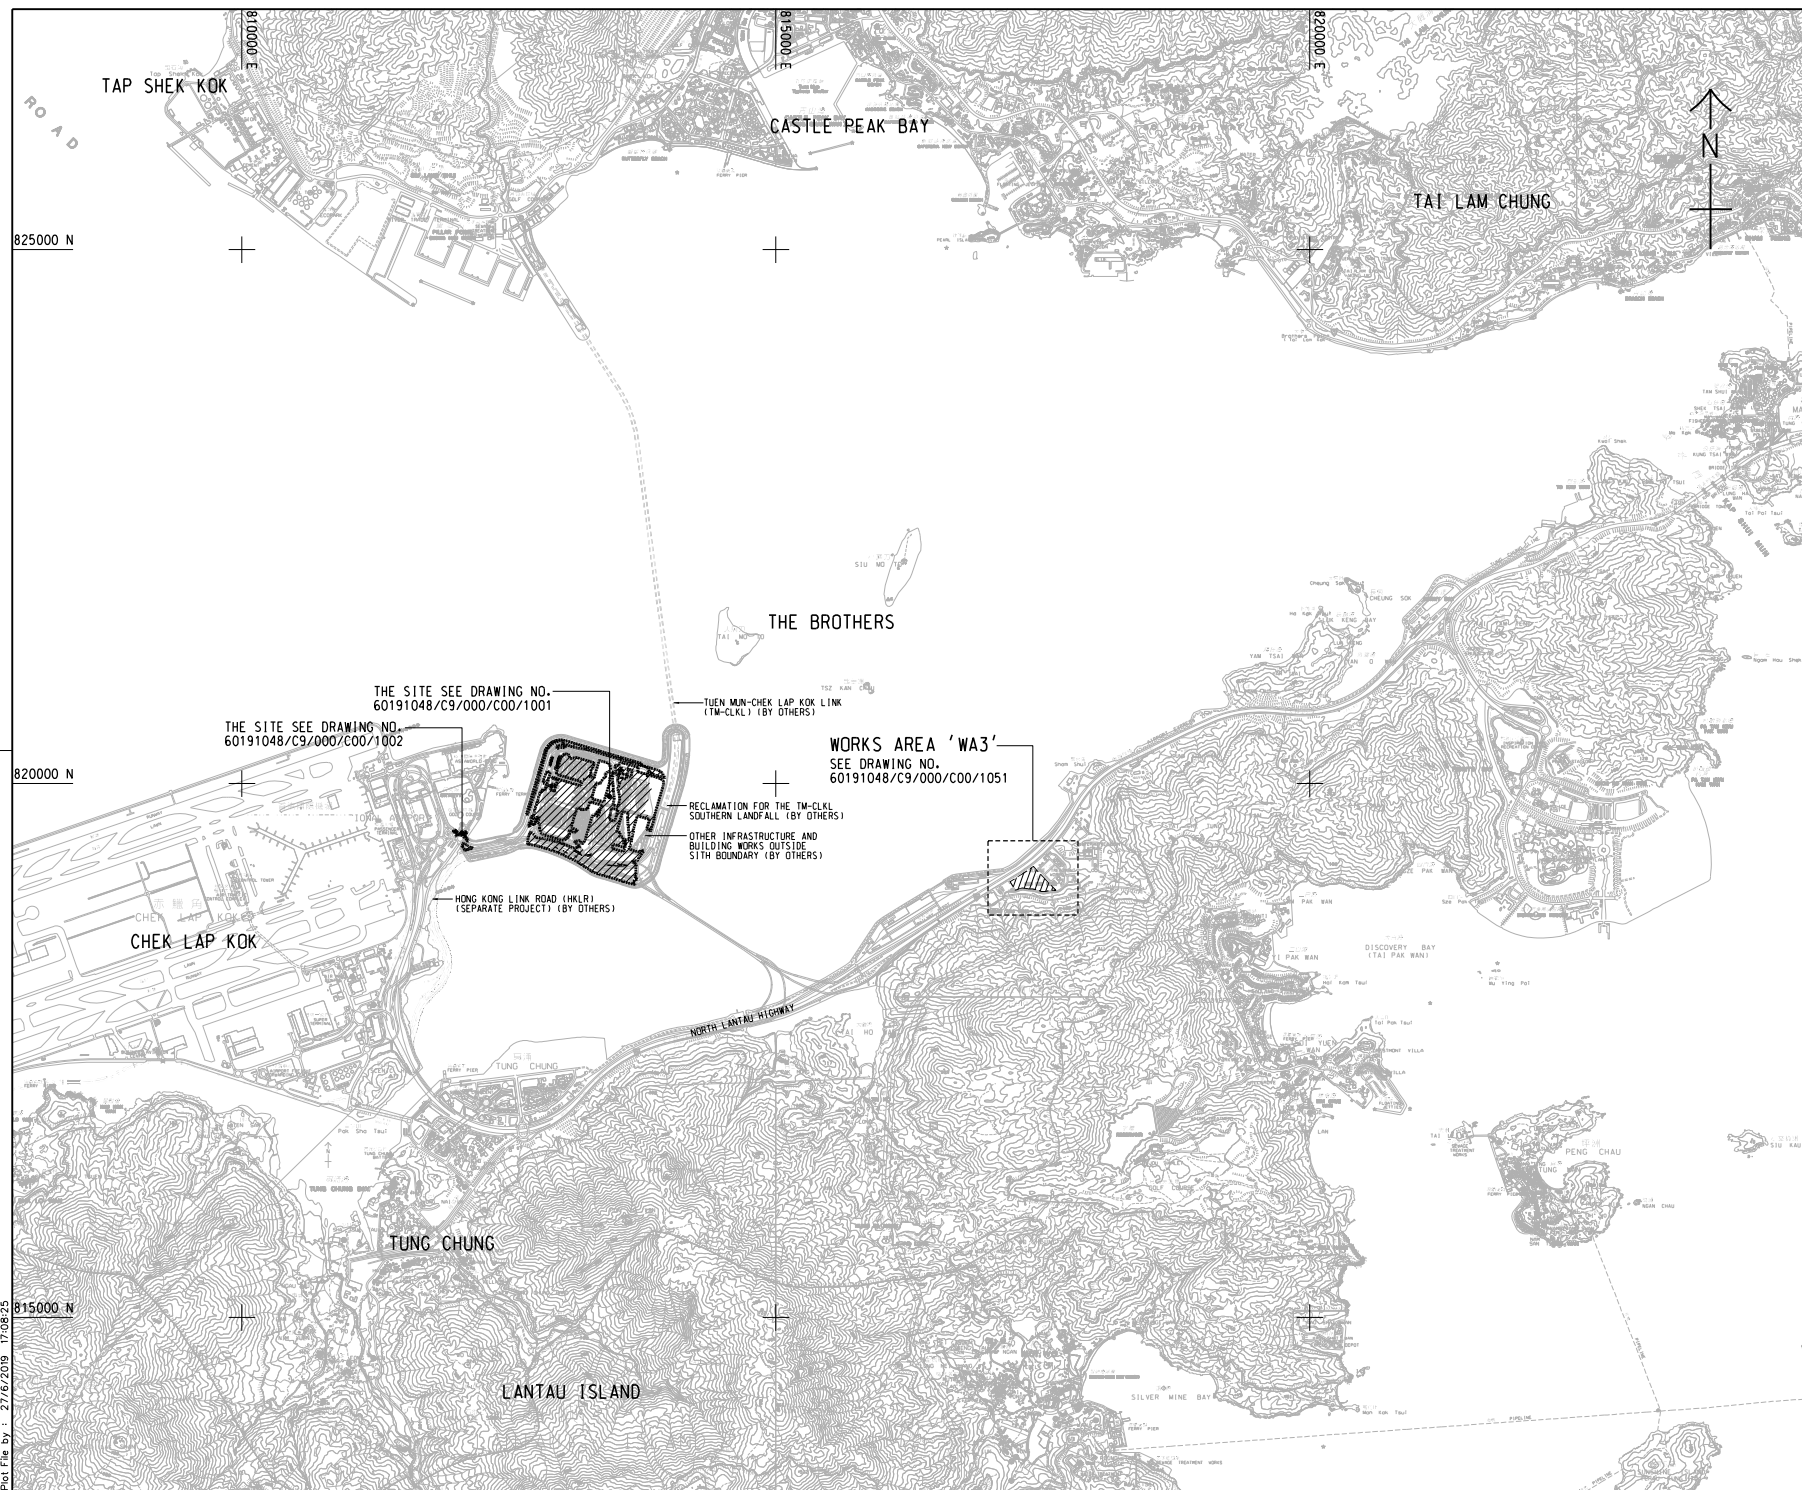
Figure 1

The Site Layout Plan of the Contract

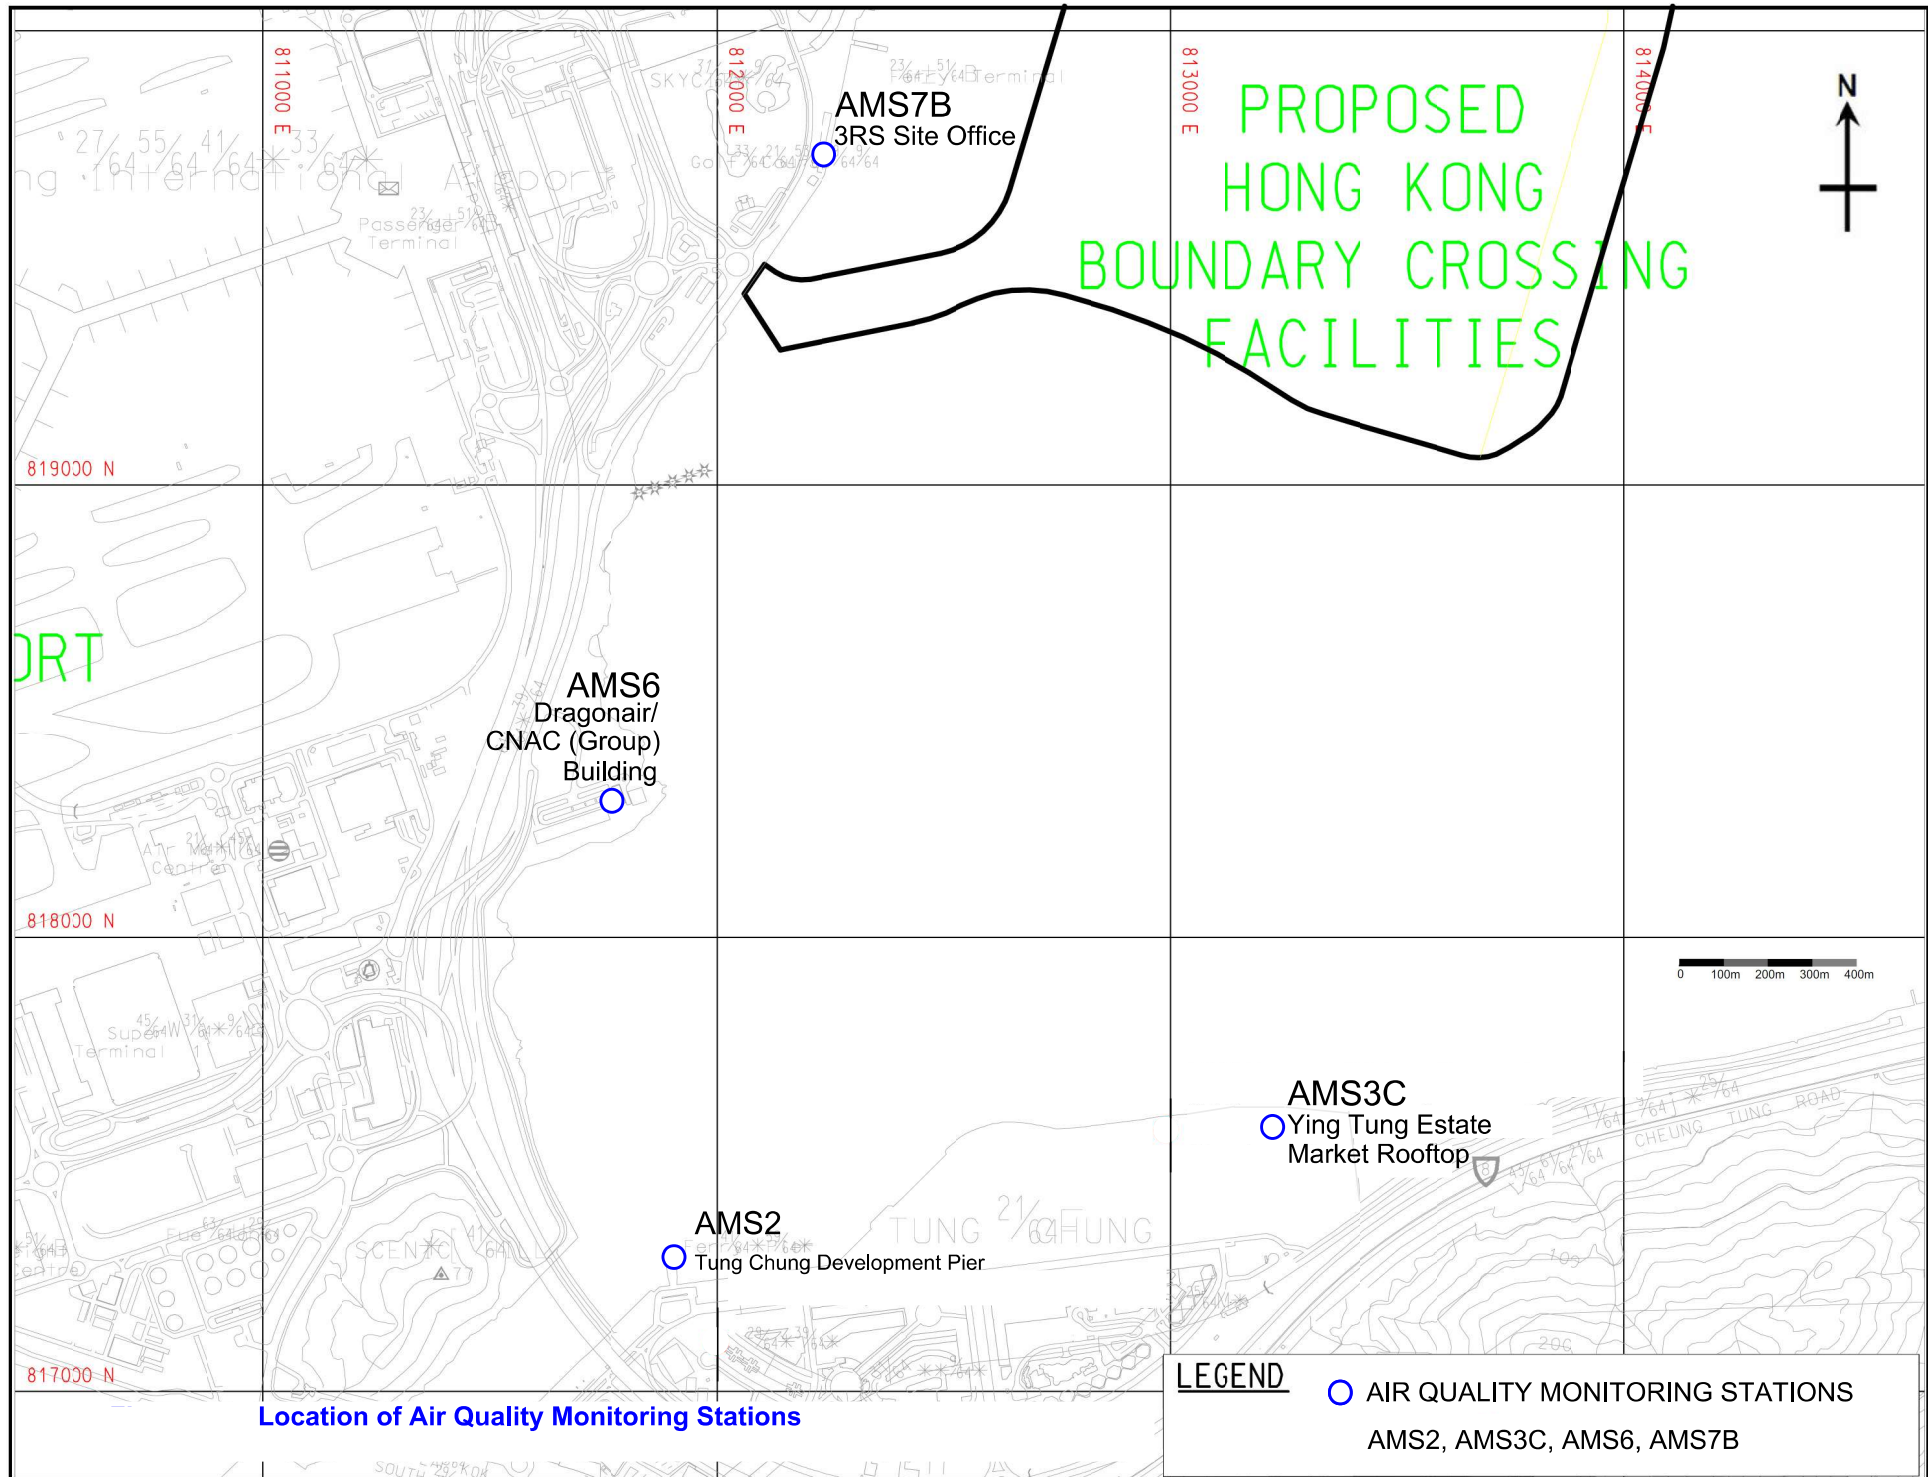
Figure 2

The Location of the Air Quality Monitoring Station

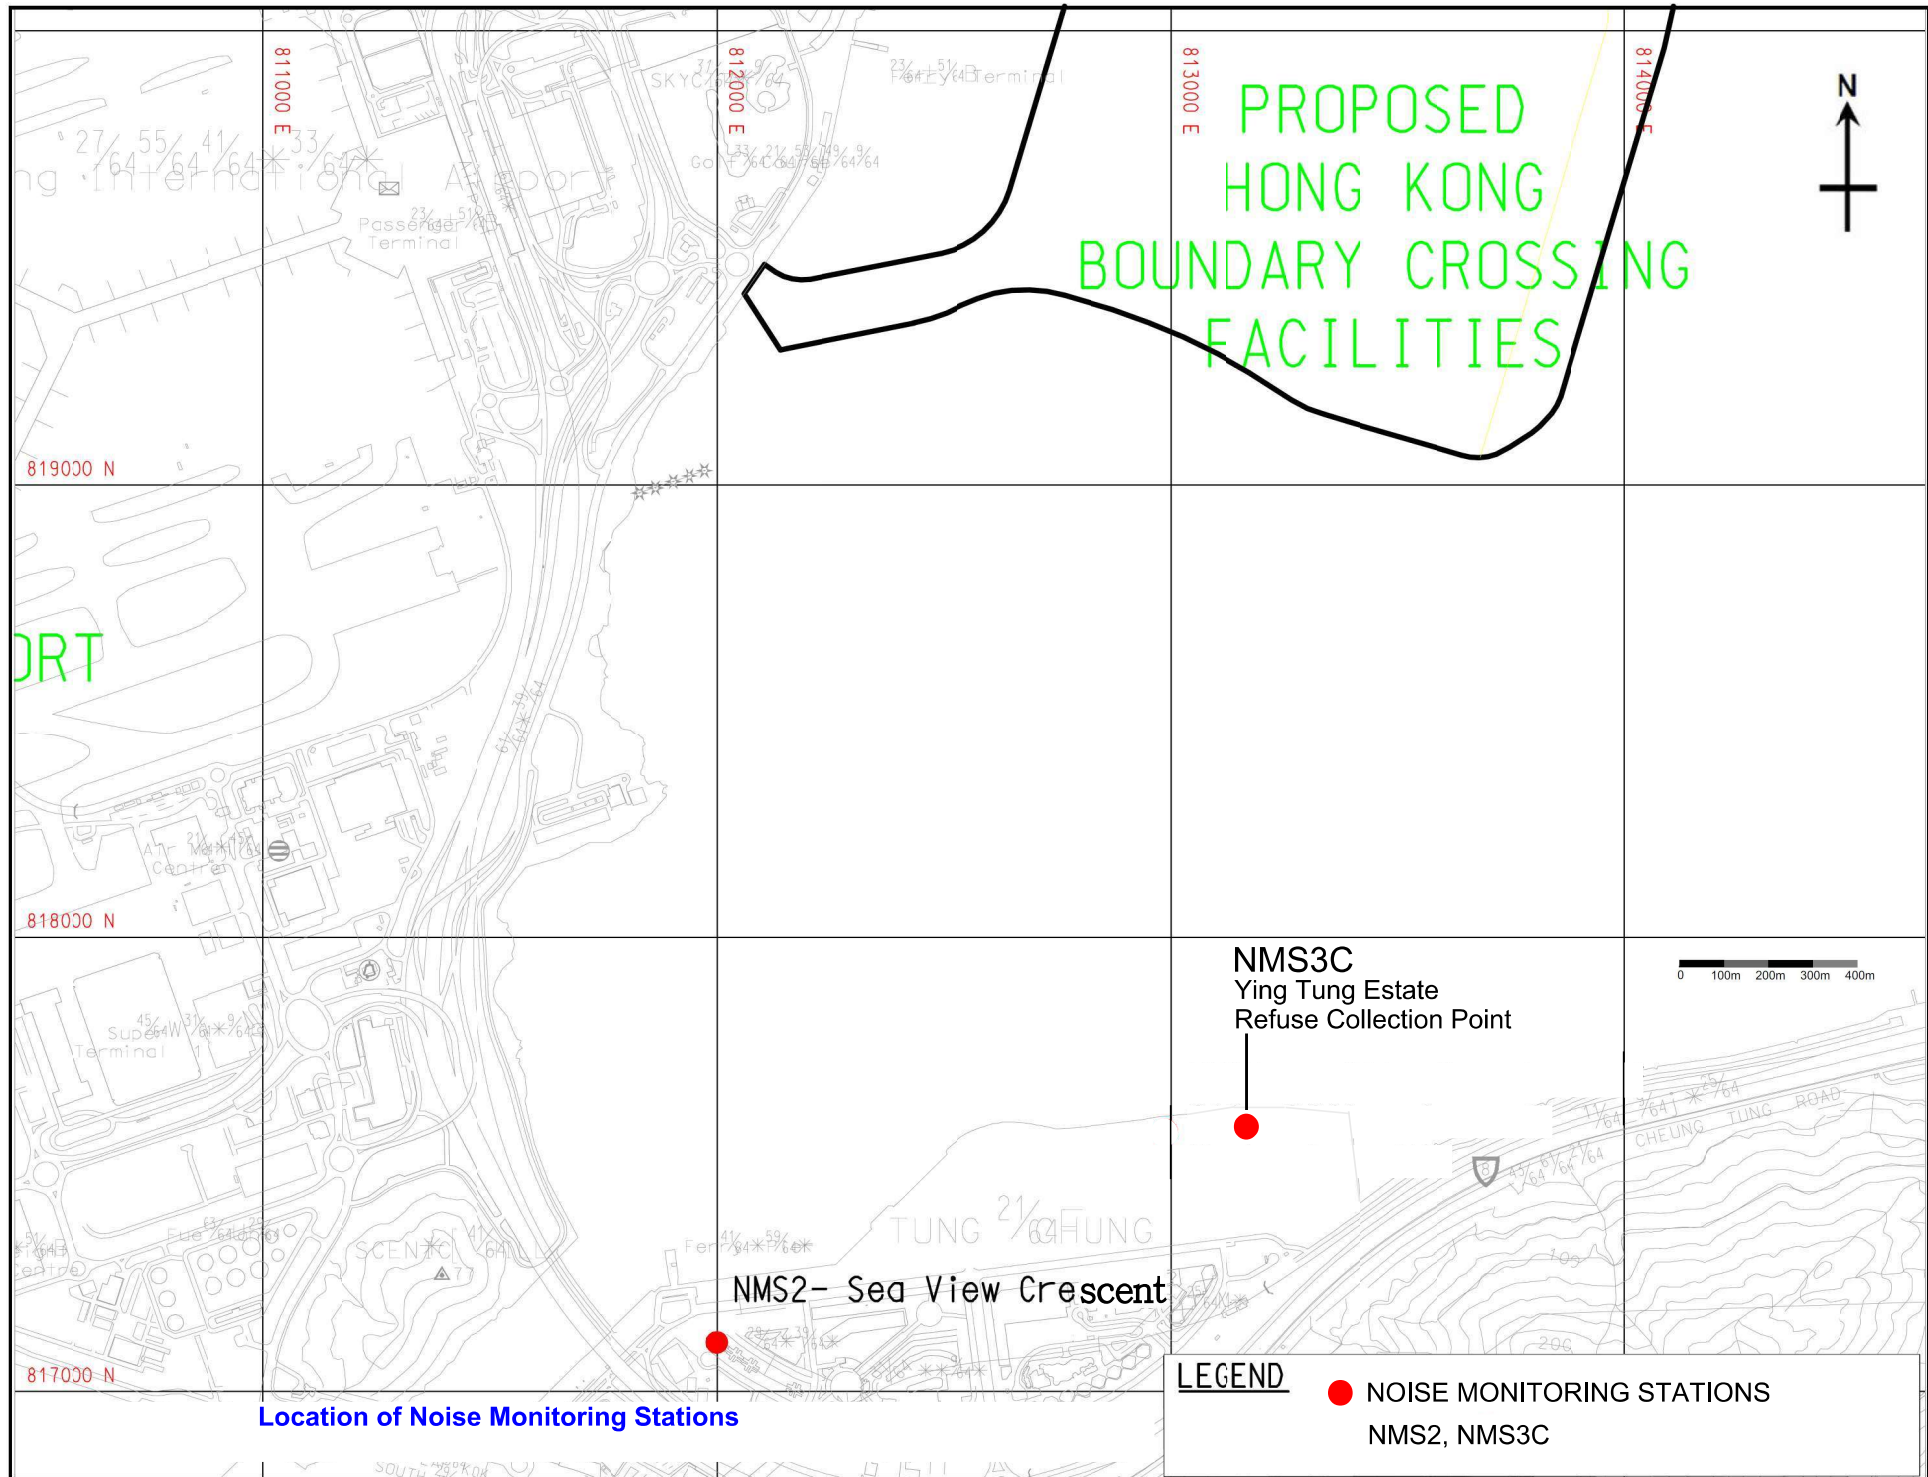
Figure 3

The Location of the Noise Monitoring Station

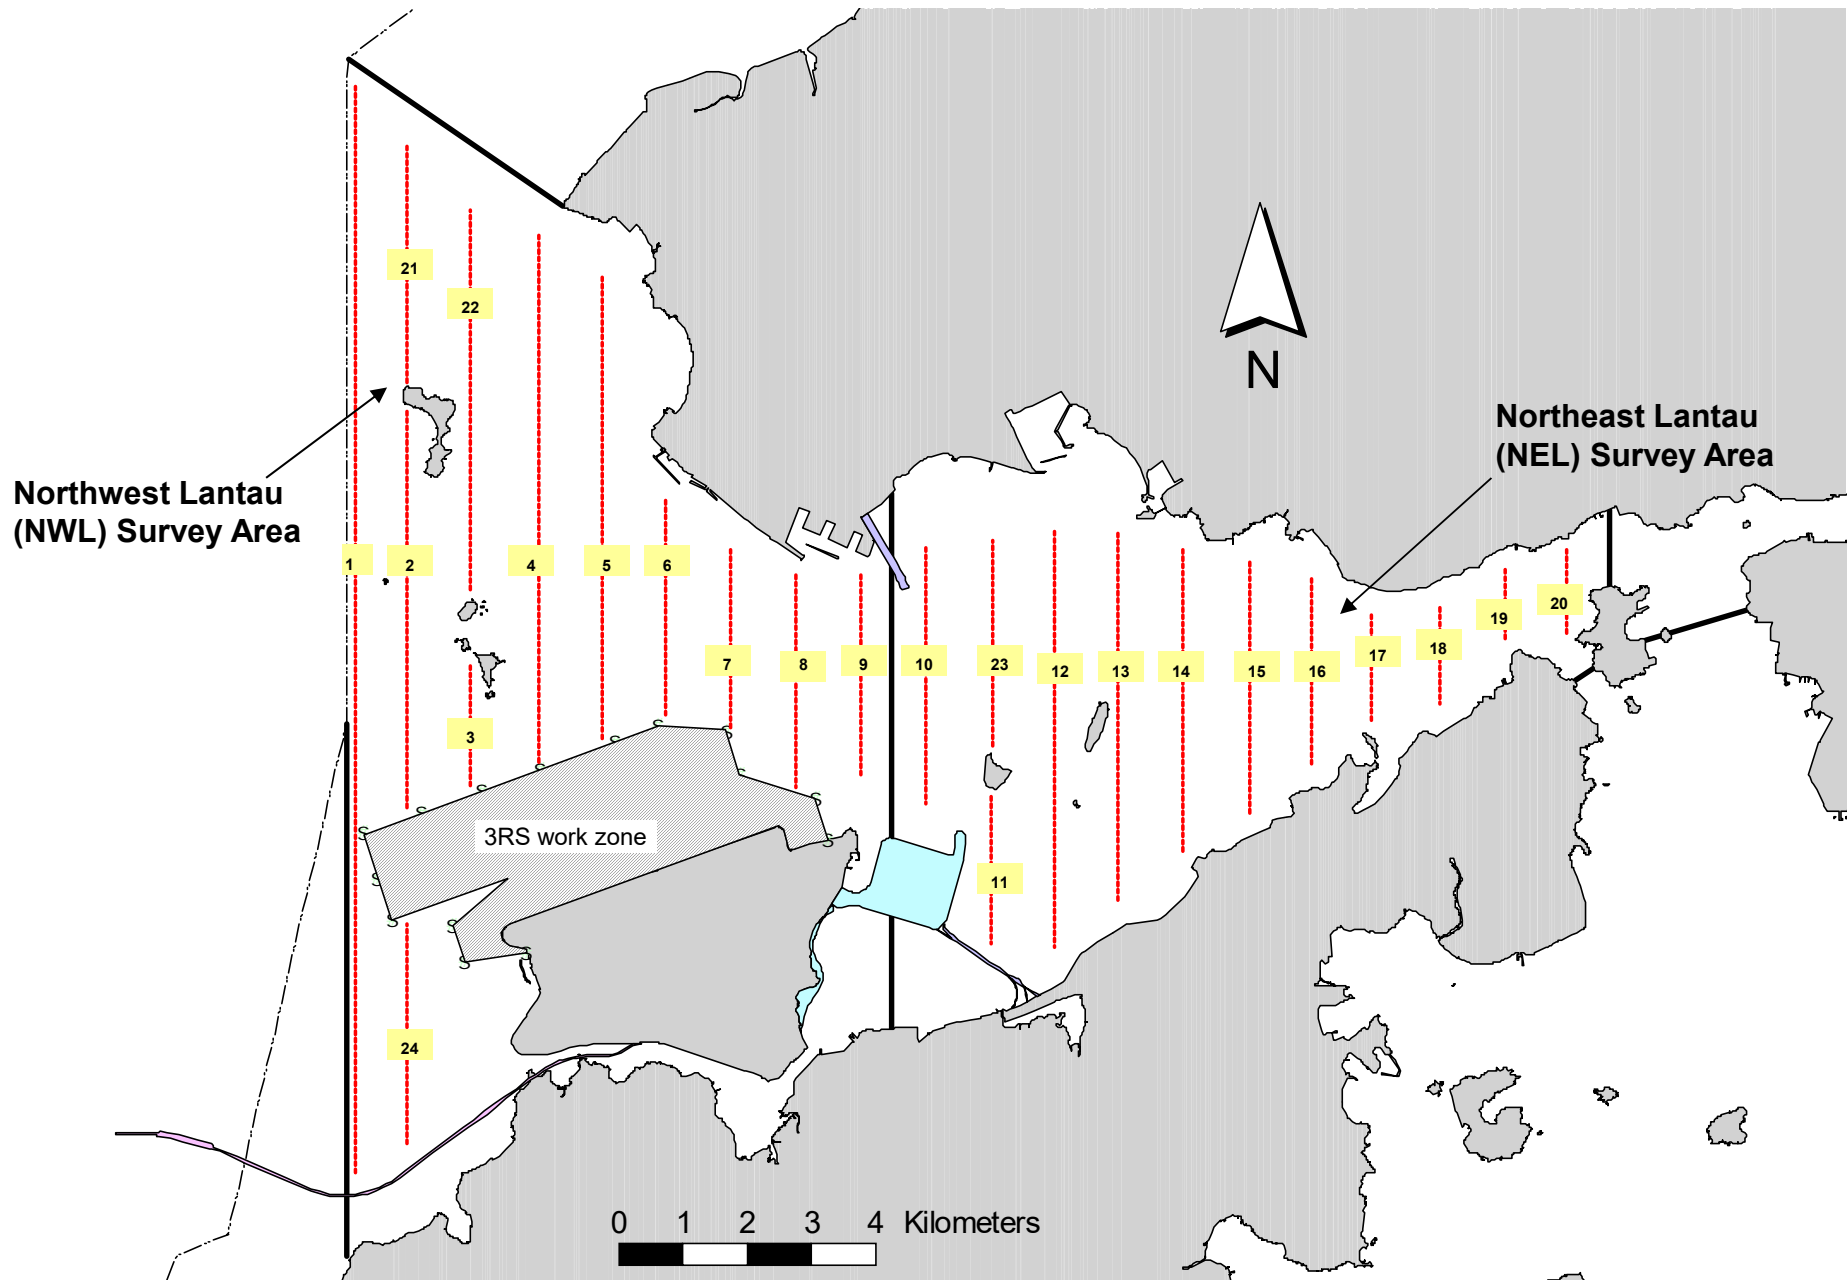
Figure 4

Post-Construction Dolphin Monitoring Line Transect
Layout Map

Transect Line Layout in Northwest and Northeast Lantau Survey Areas

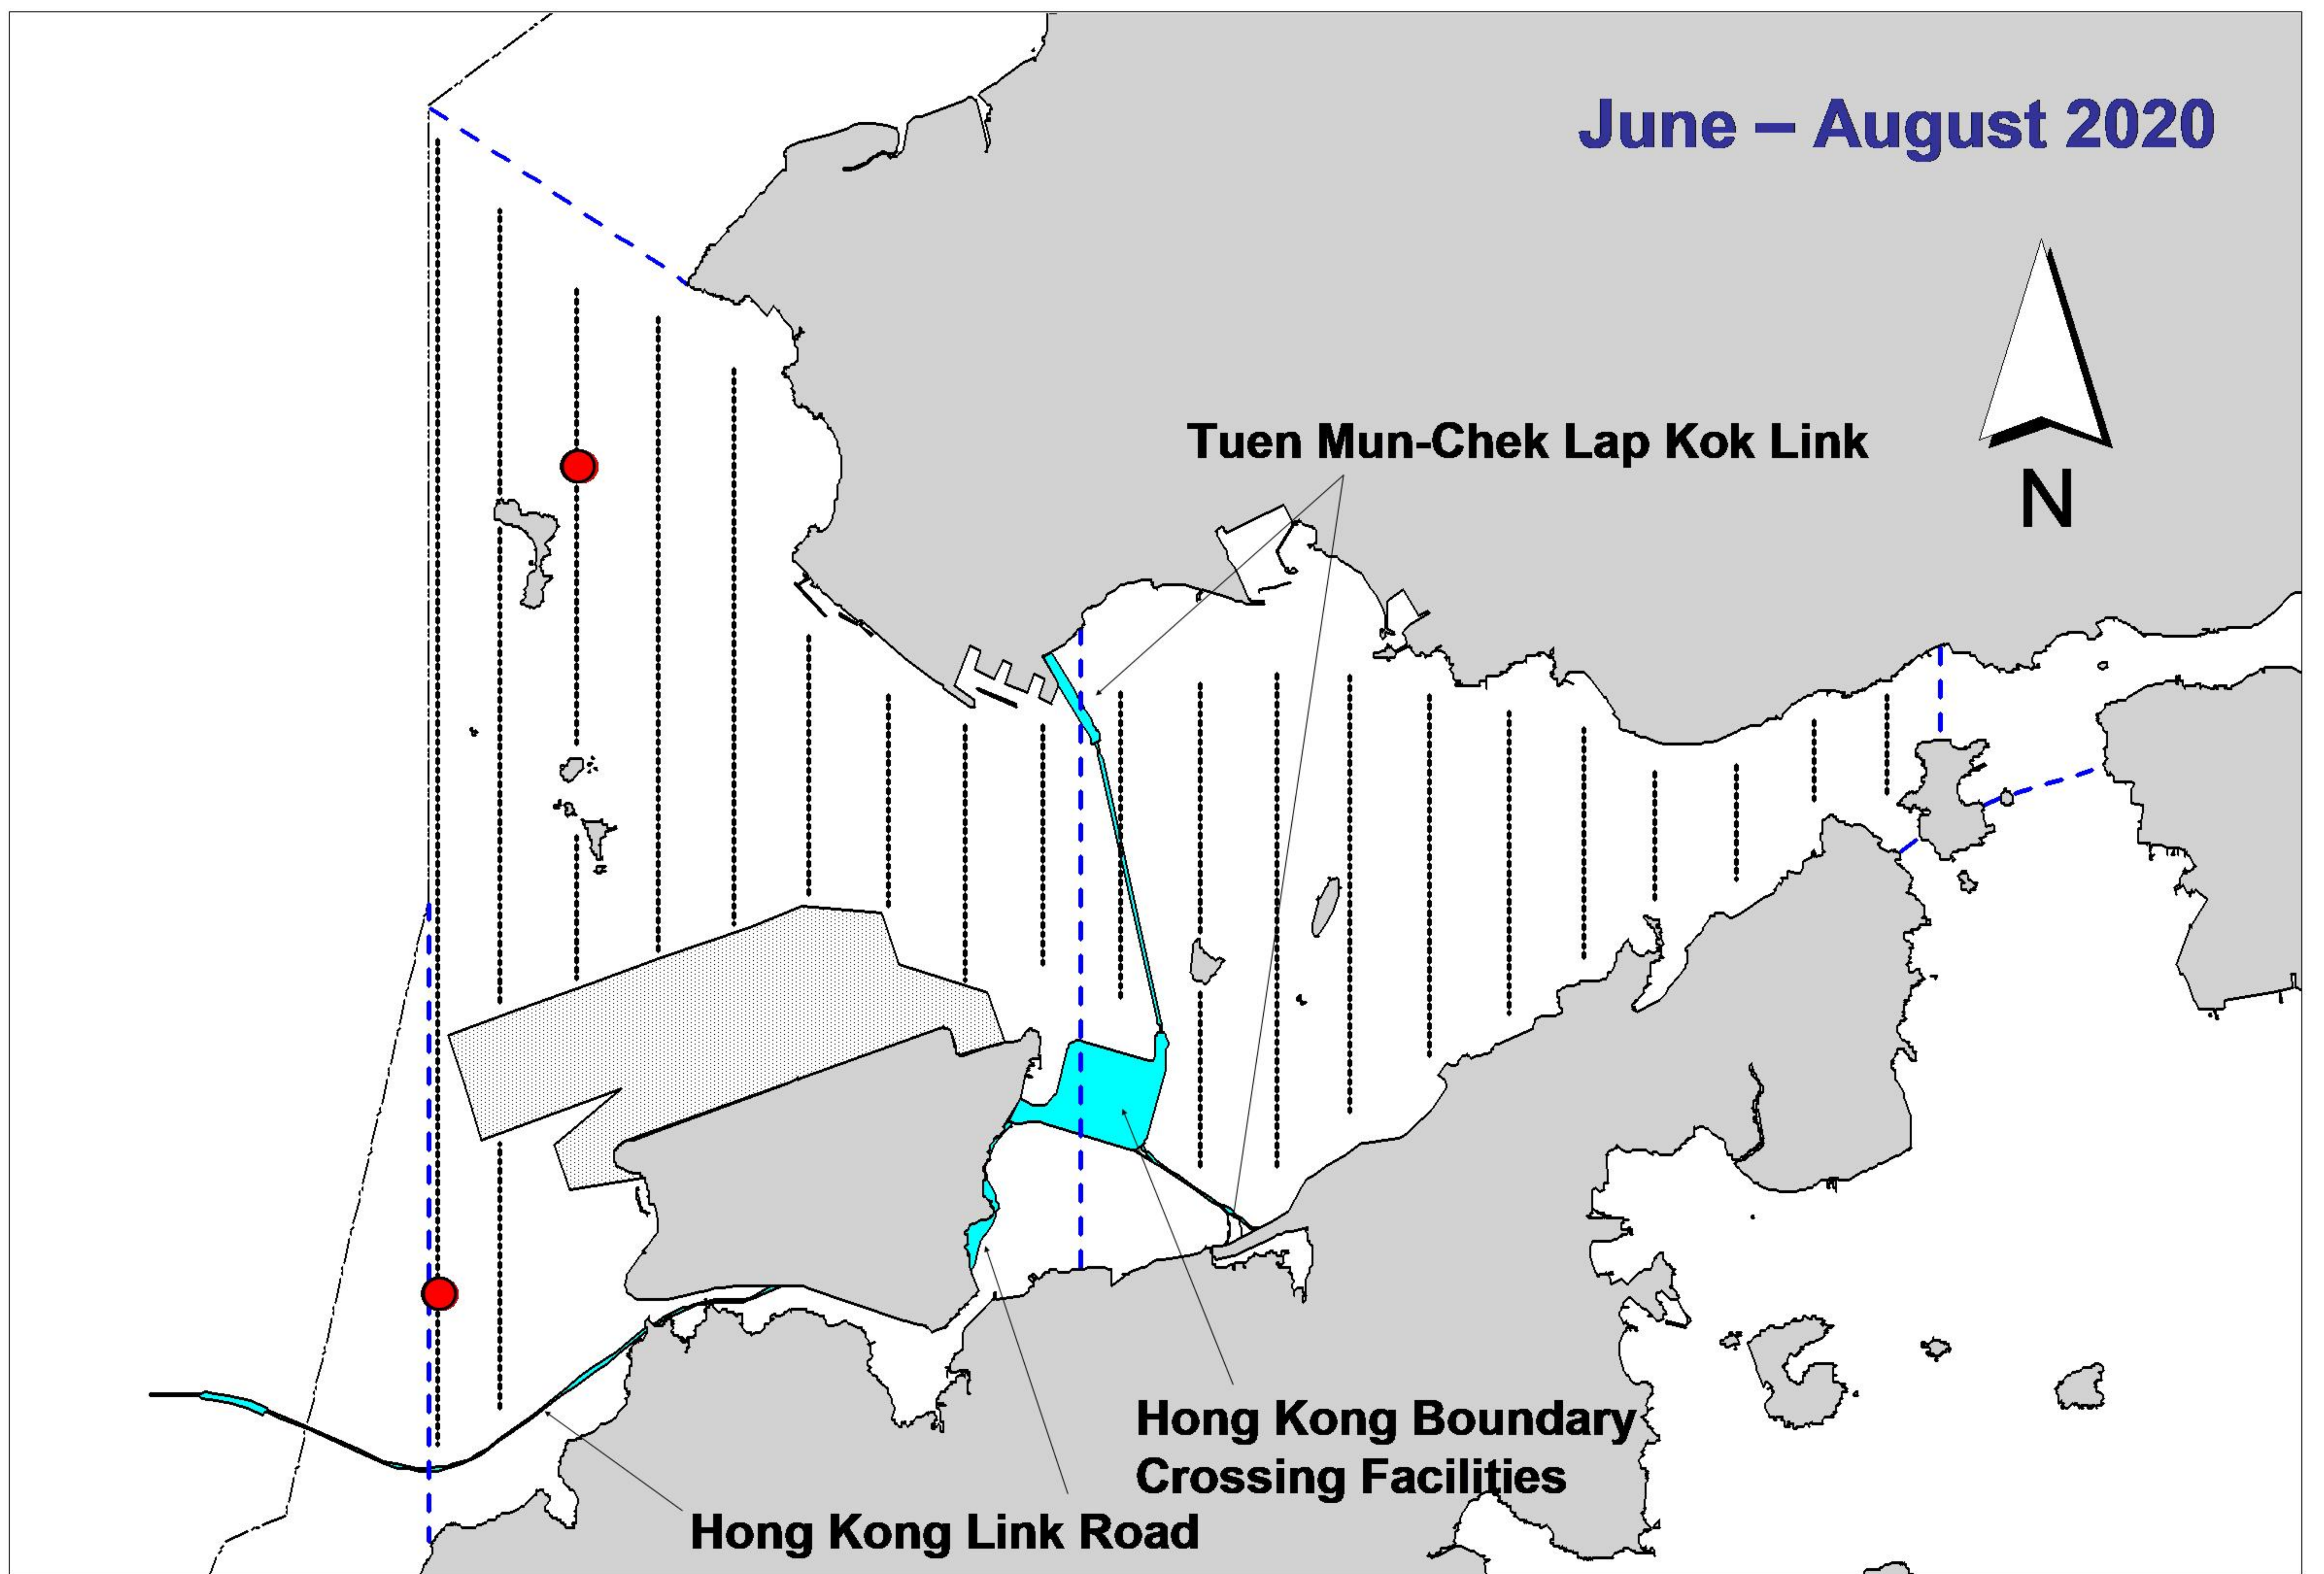
Figure 1. Distribution of Chinese white dolphin sightings in Northwest and Northeast Lantau during the present TMCLKL08 monitoring period (top) and the baseline period in 2011 (bottom)
