**Contract No. HY/2019/01
HZMB HKBCF – Phase 2 and Other Works
Quarterly EM&A Report for June 2020 - August 2020**

**Quarterly EM&A Report for
Hong Kong-Zhuhai-Macao Bridge Hong Kong Boundary Crossing Facilities - Phase 2 and
Other Works (Contract No. HY/2019/01)**

Quarterly EM&A Report (June 2020 - August 2020)

Contact No. HY/2019/01 Hong Kong-Zhuhai-Macao Bridge Hong Kong Boundary Crossing Facilities – Phase 2 and Other Works

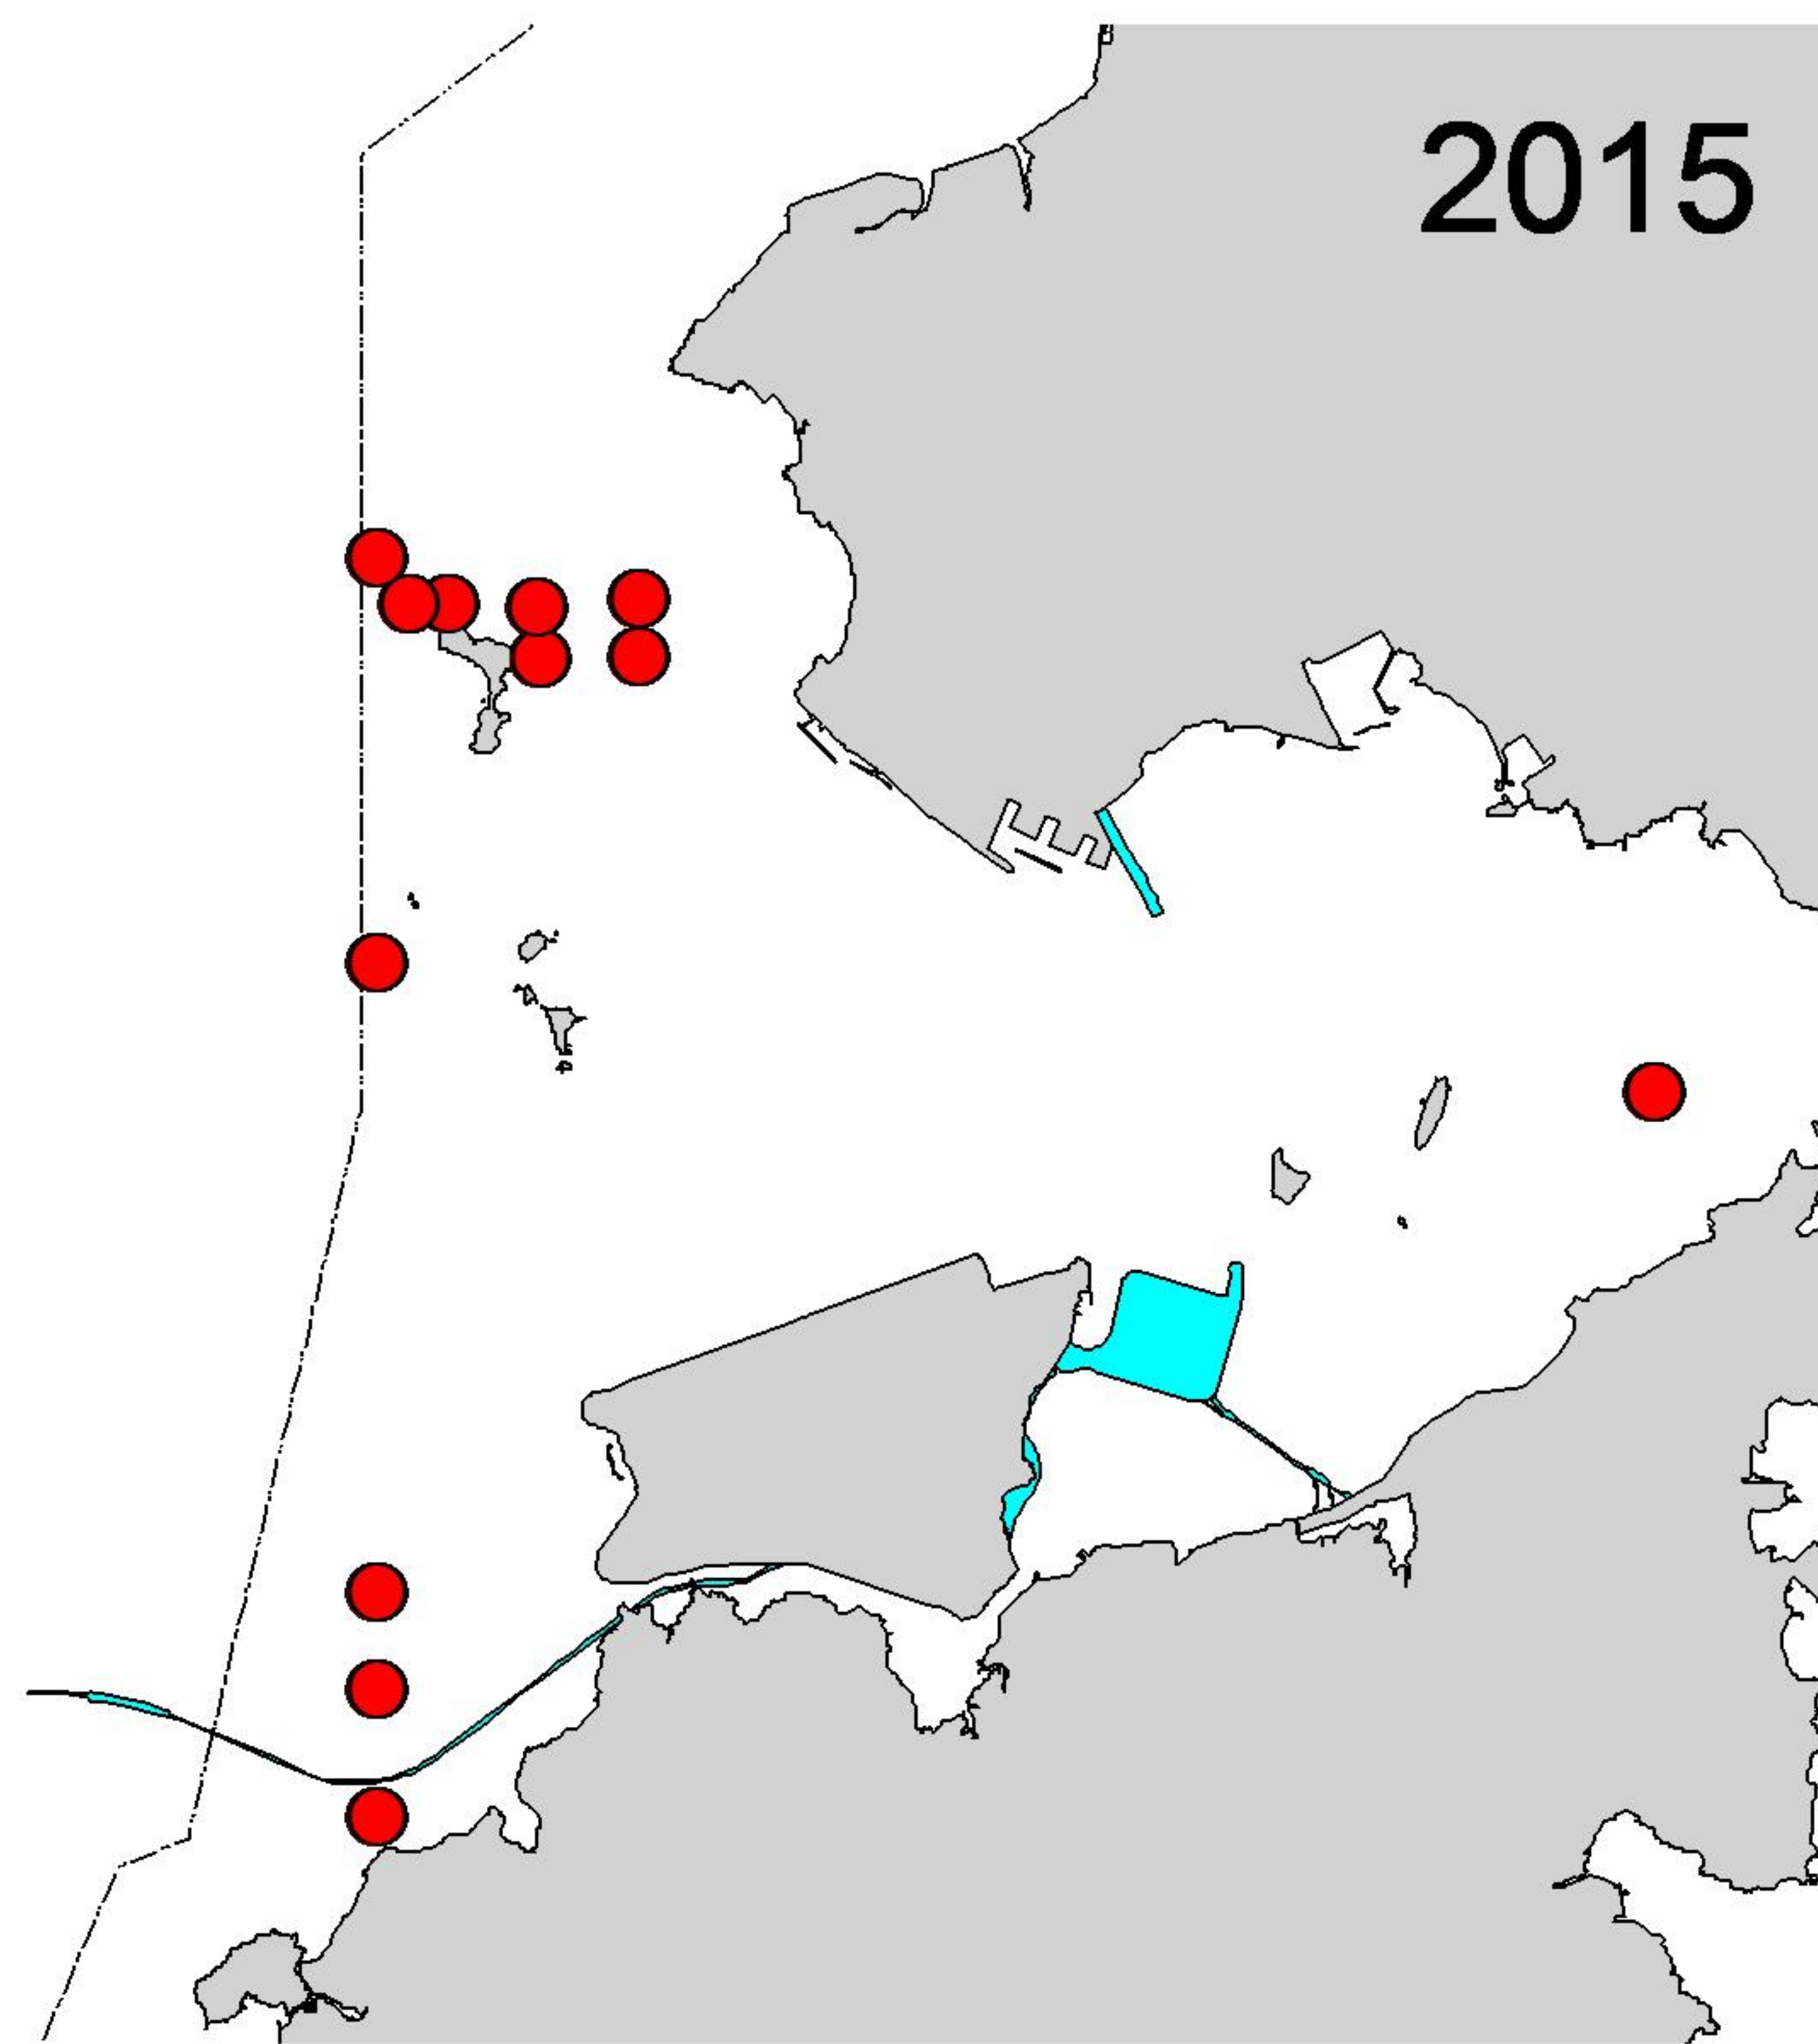
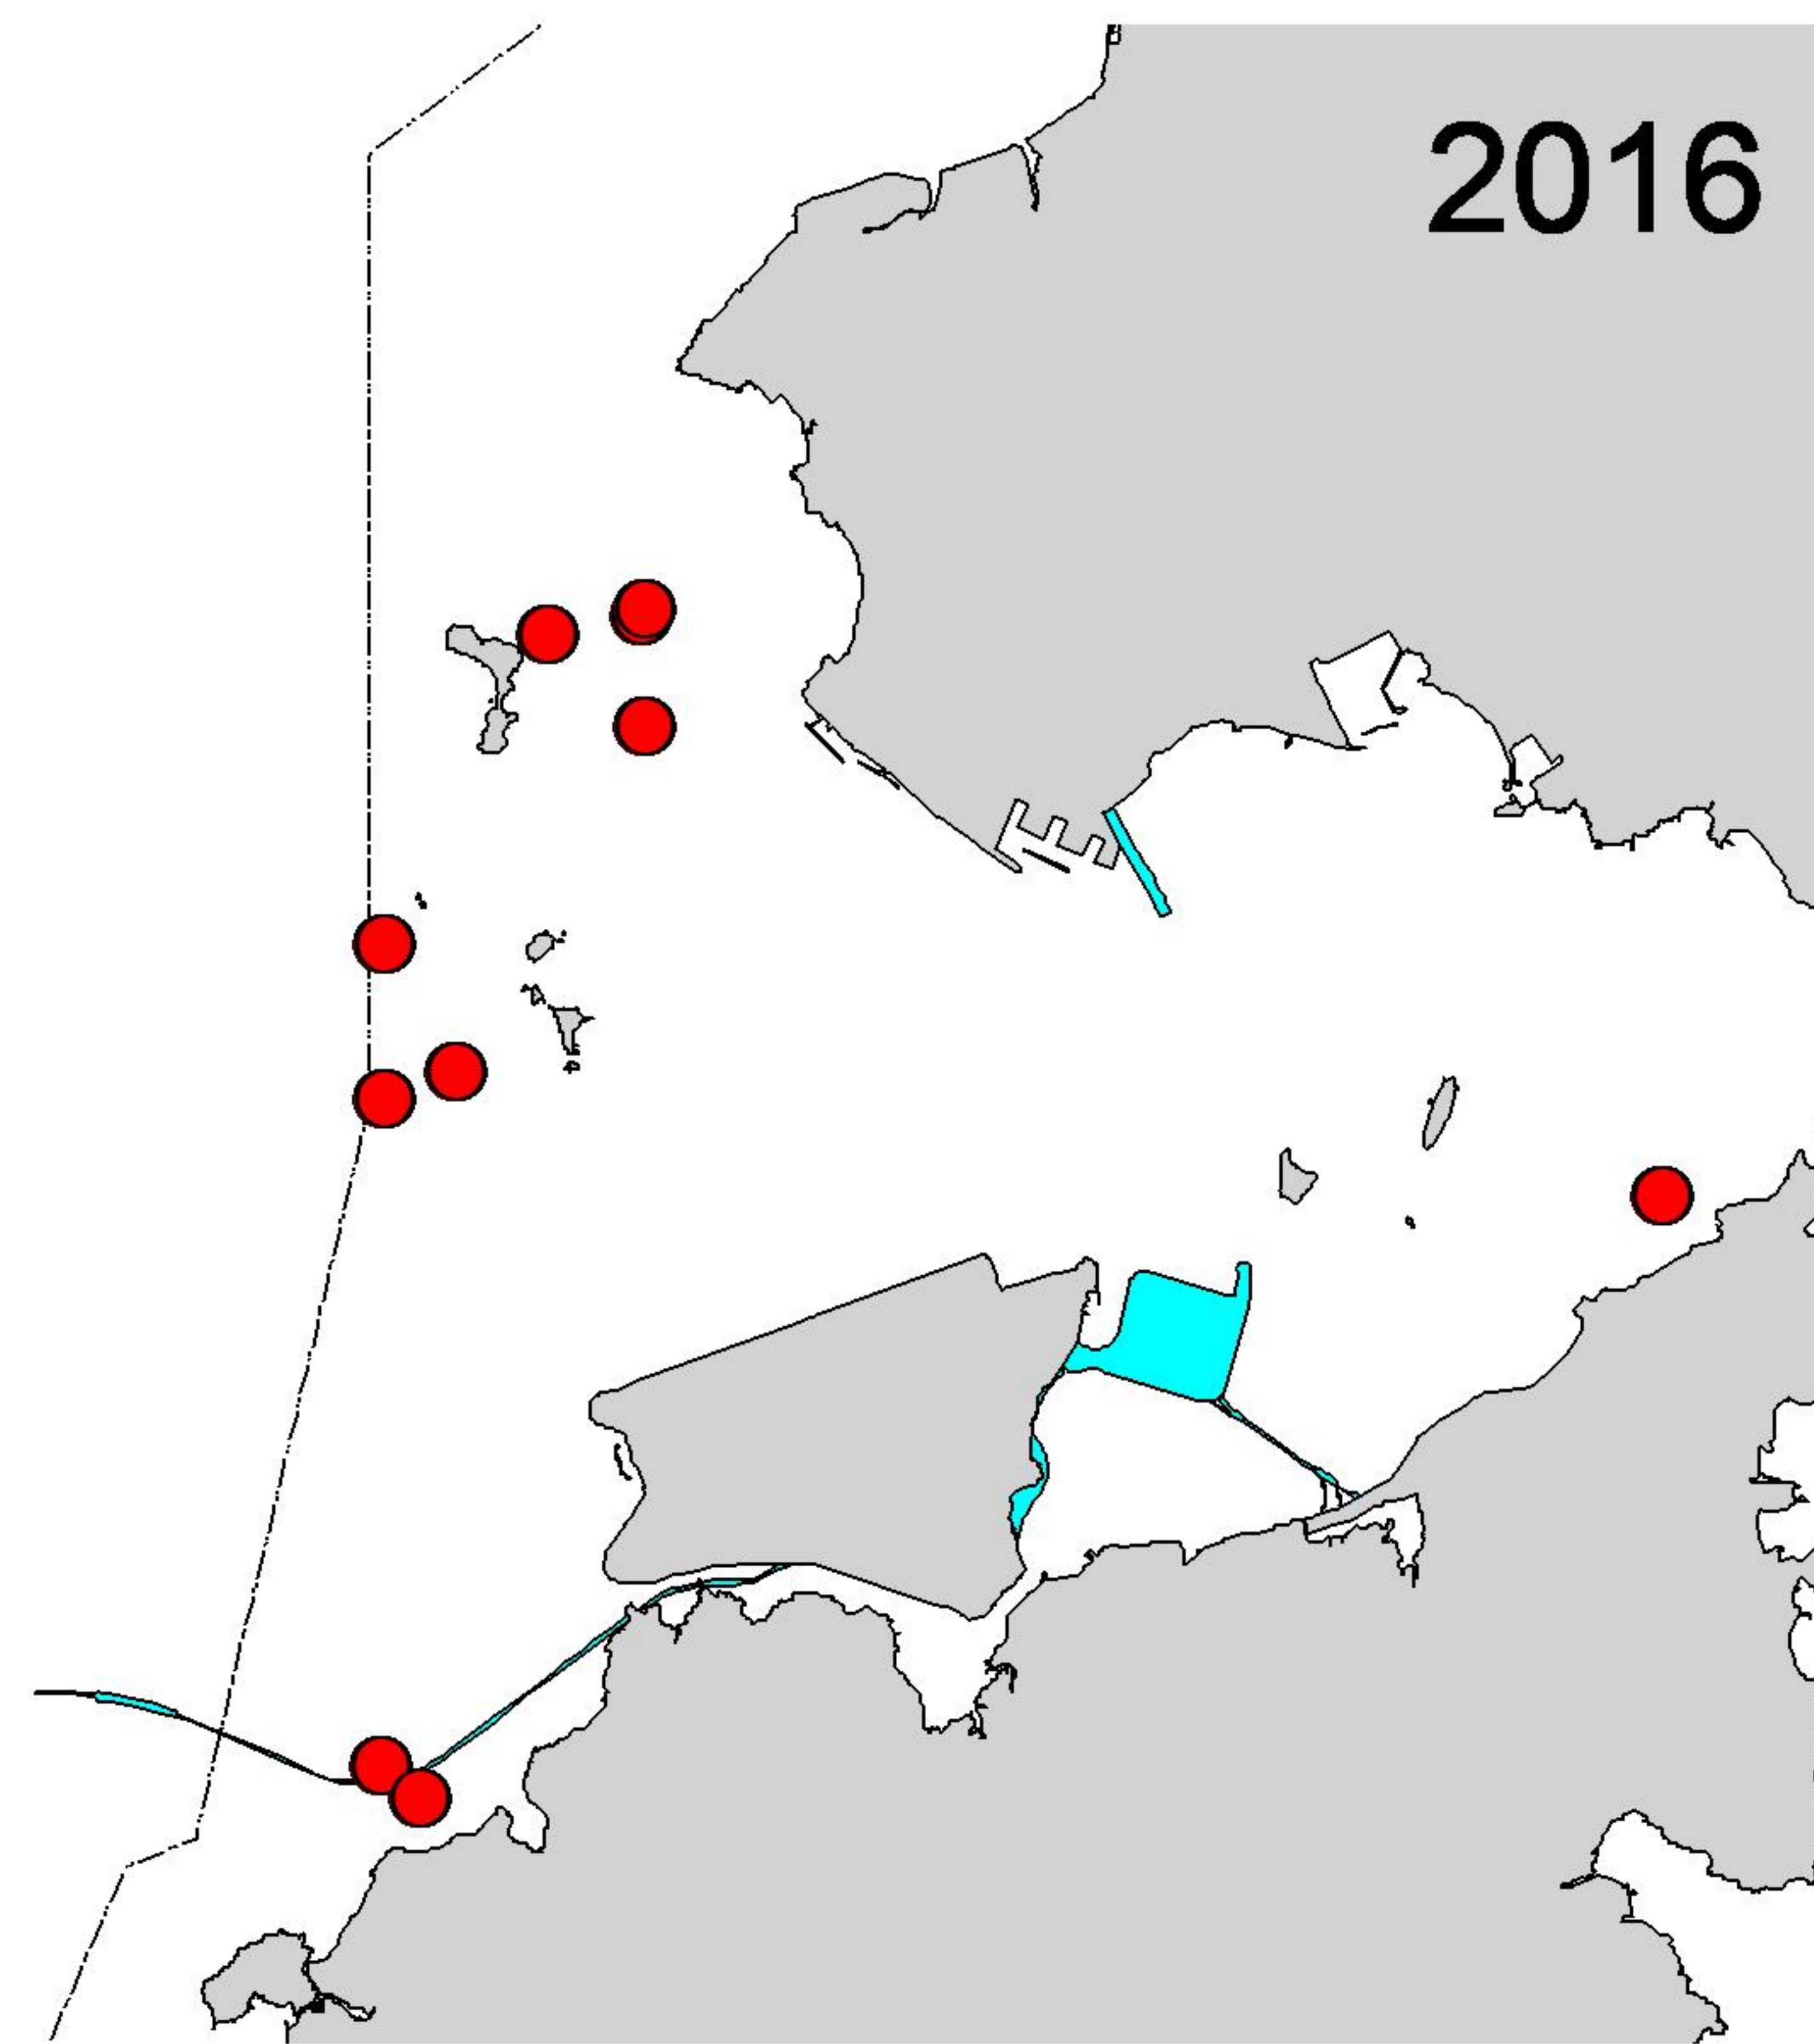
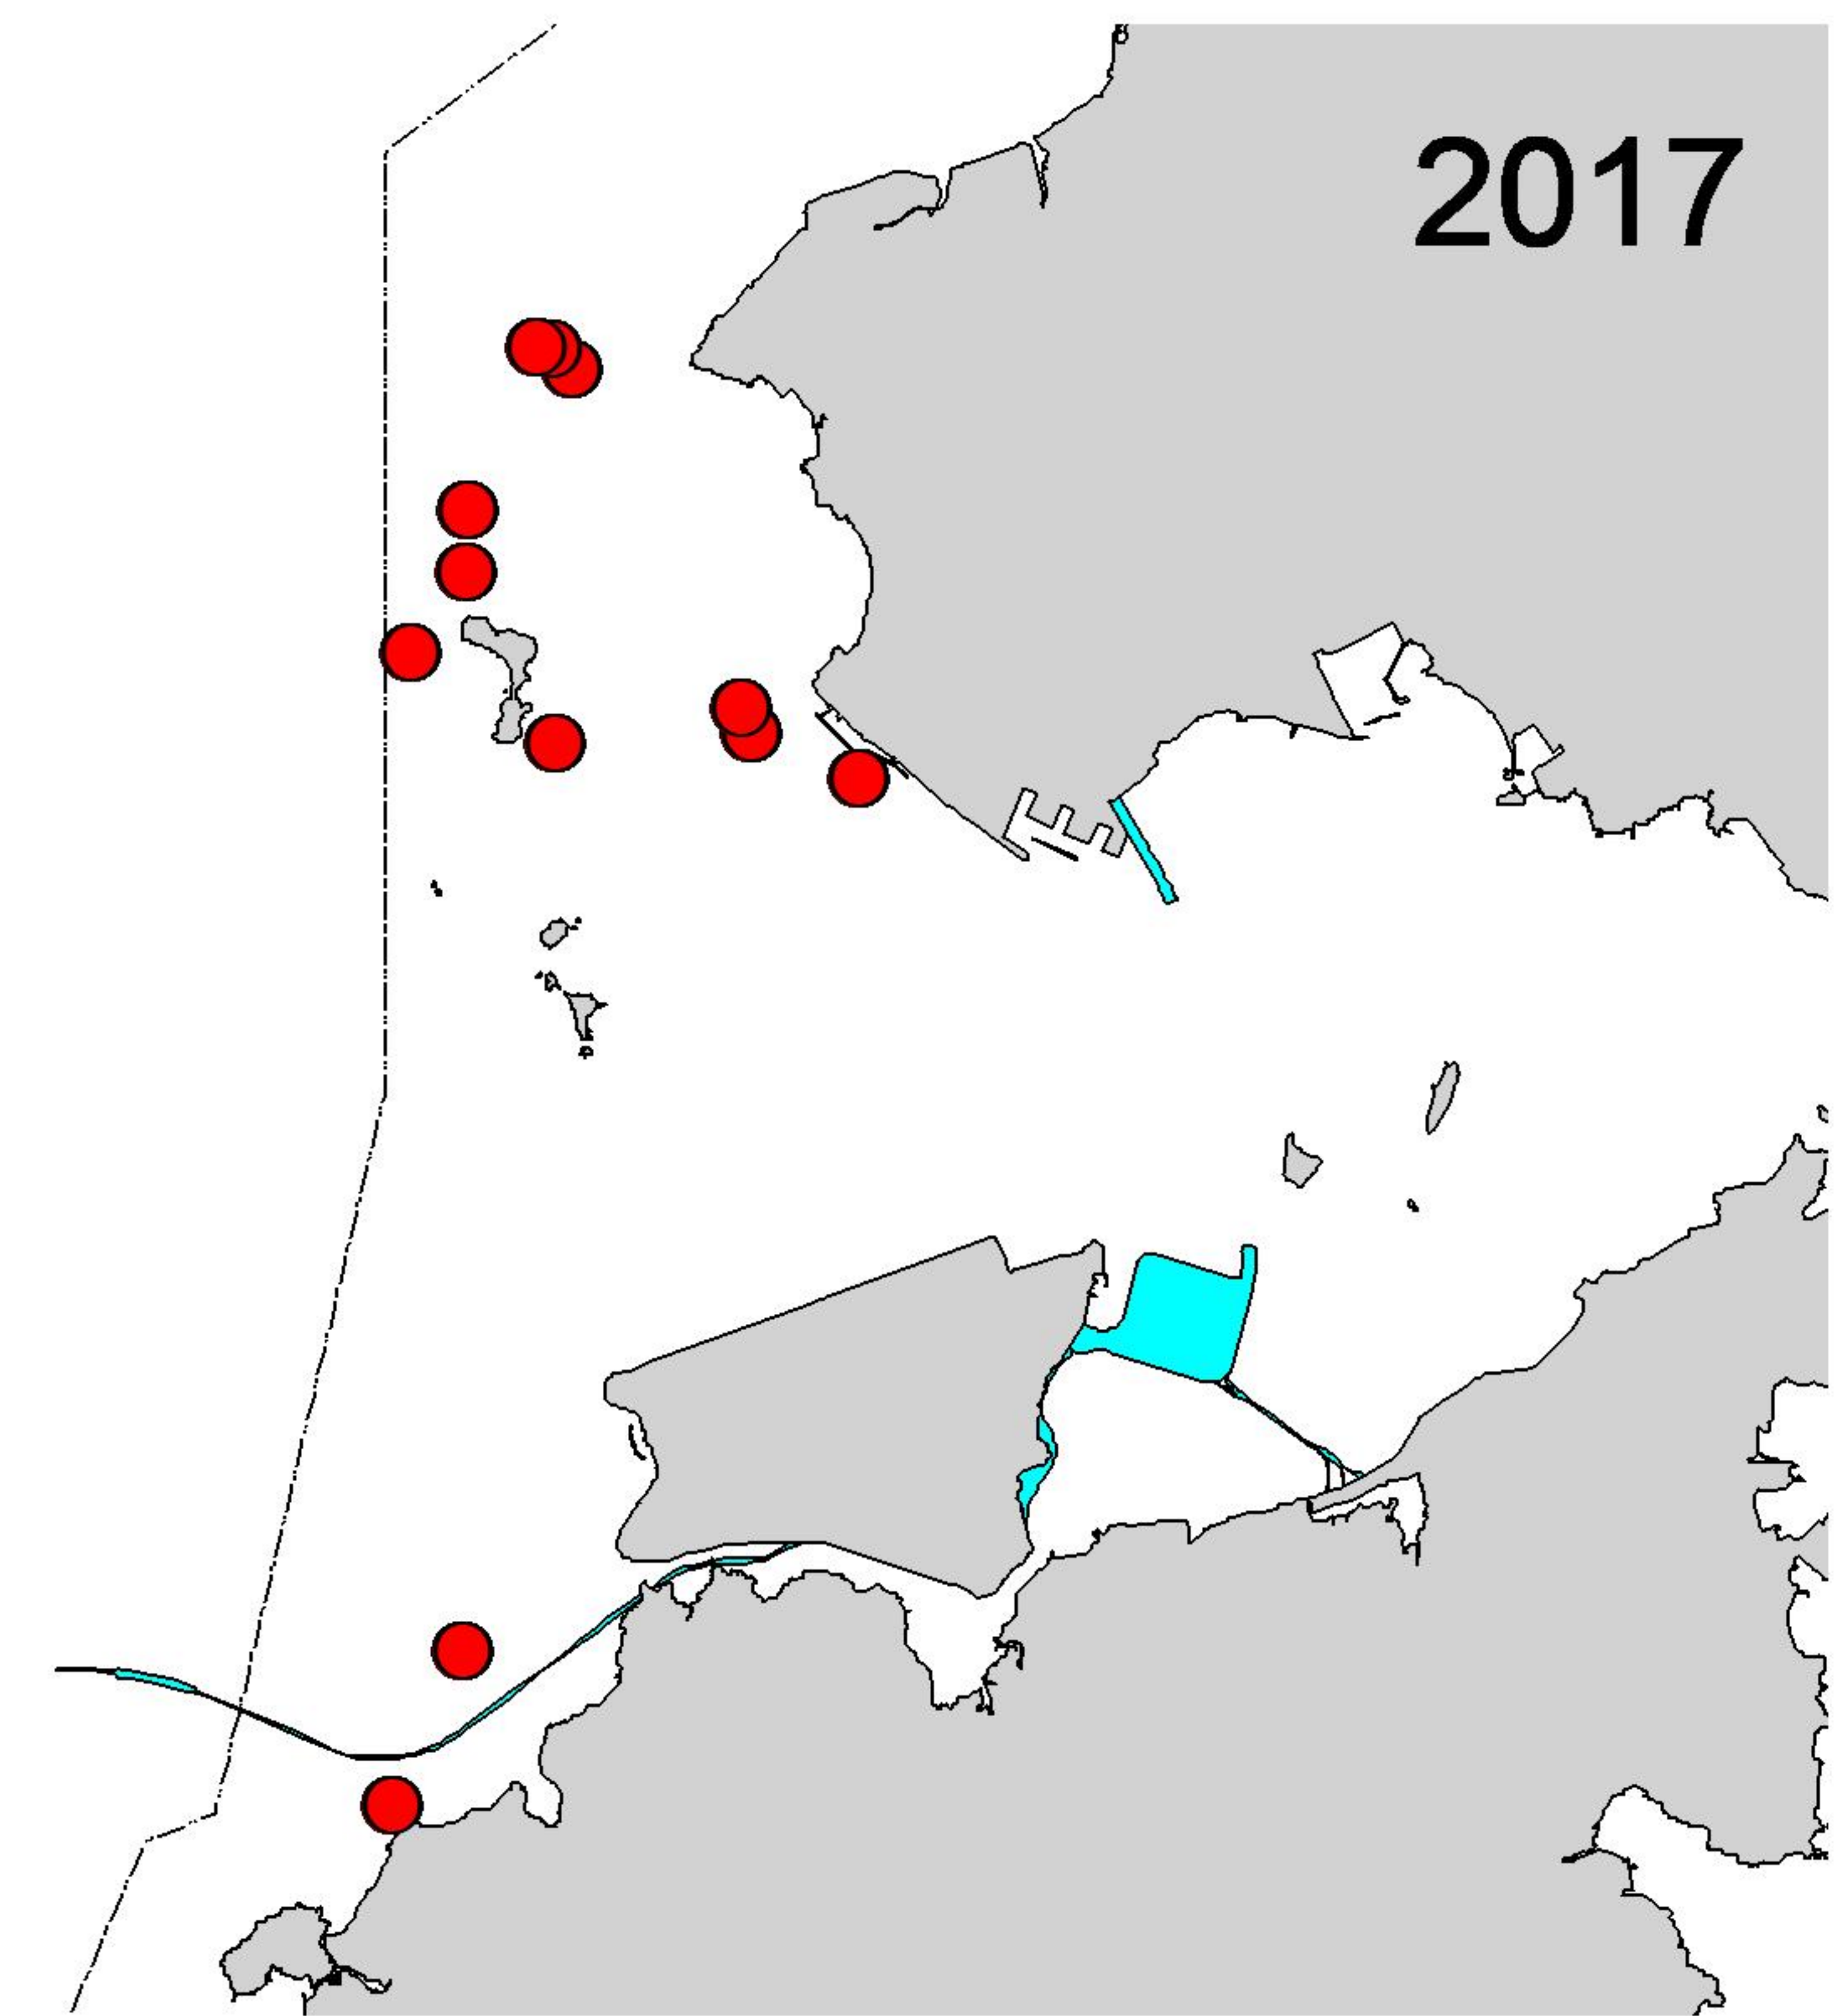
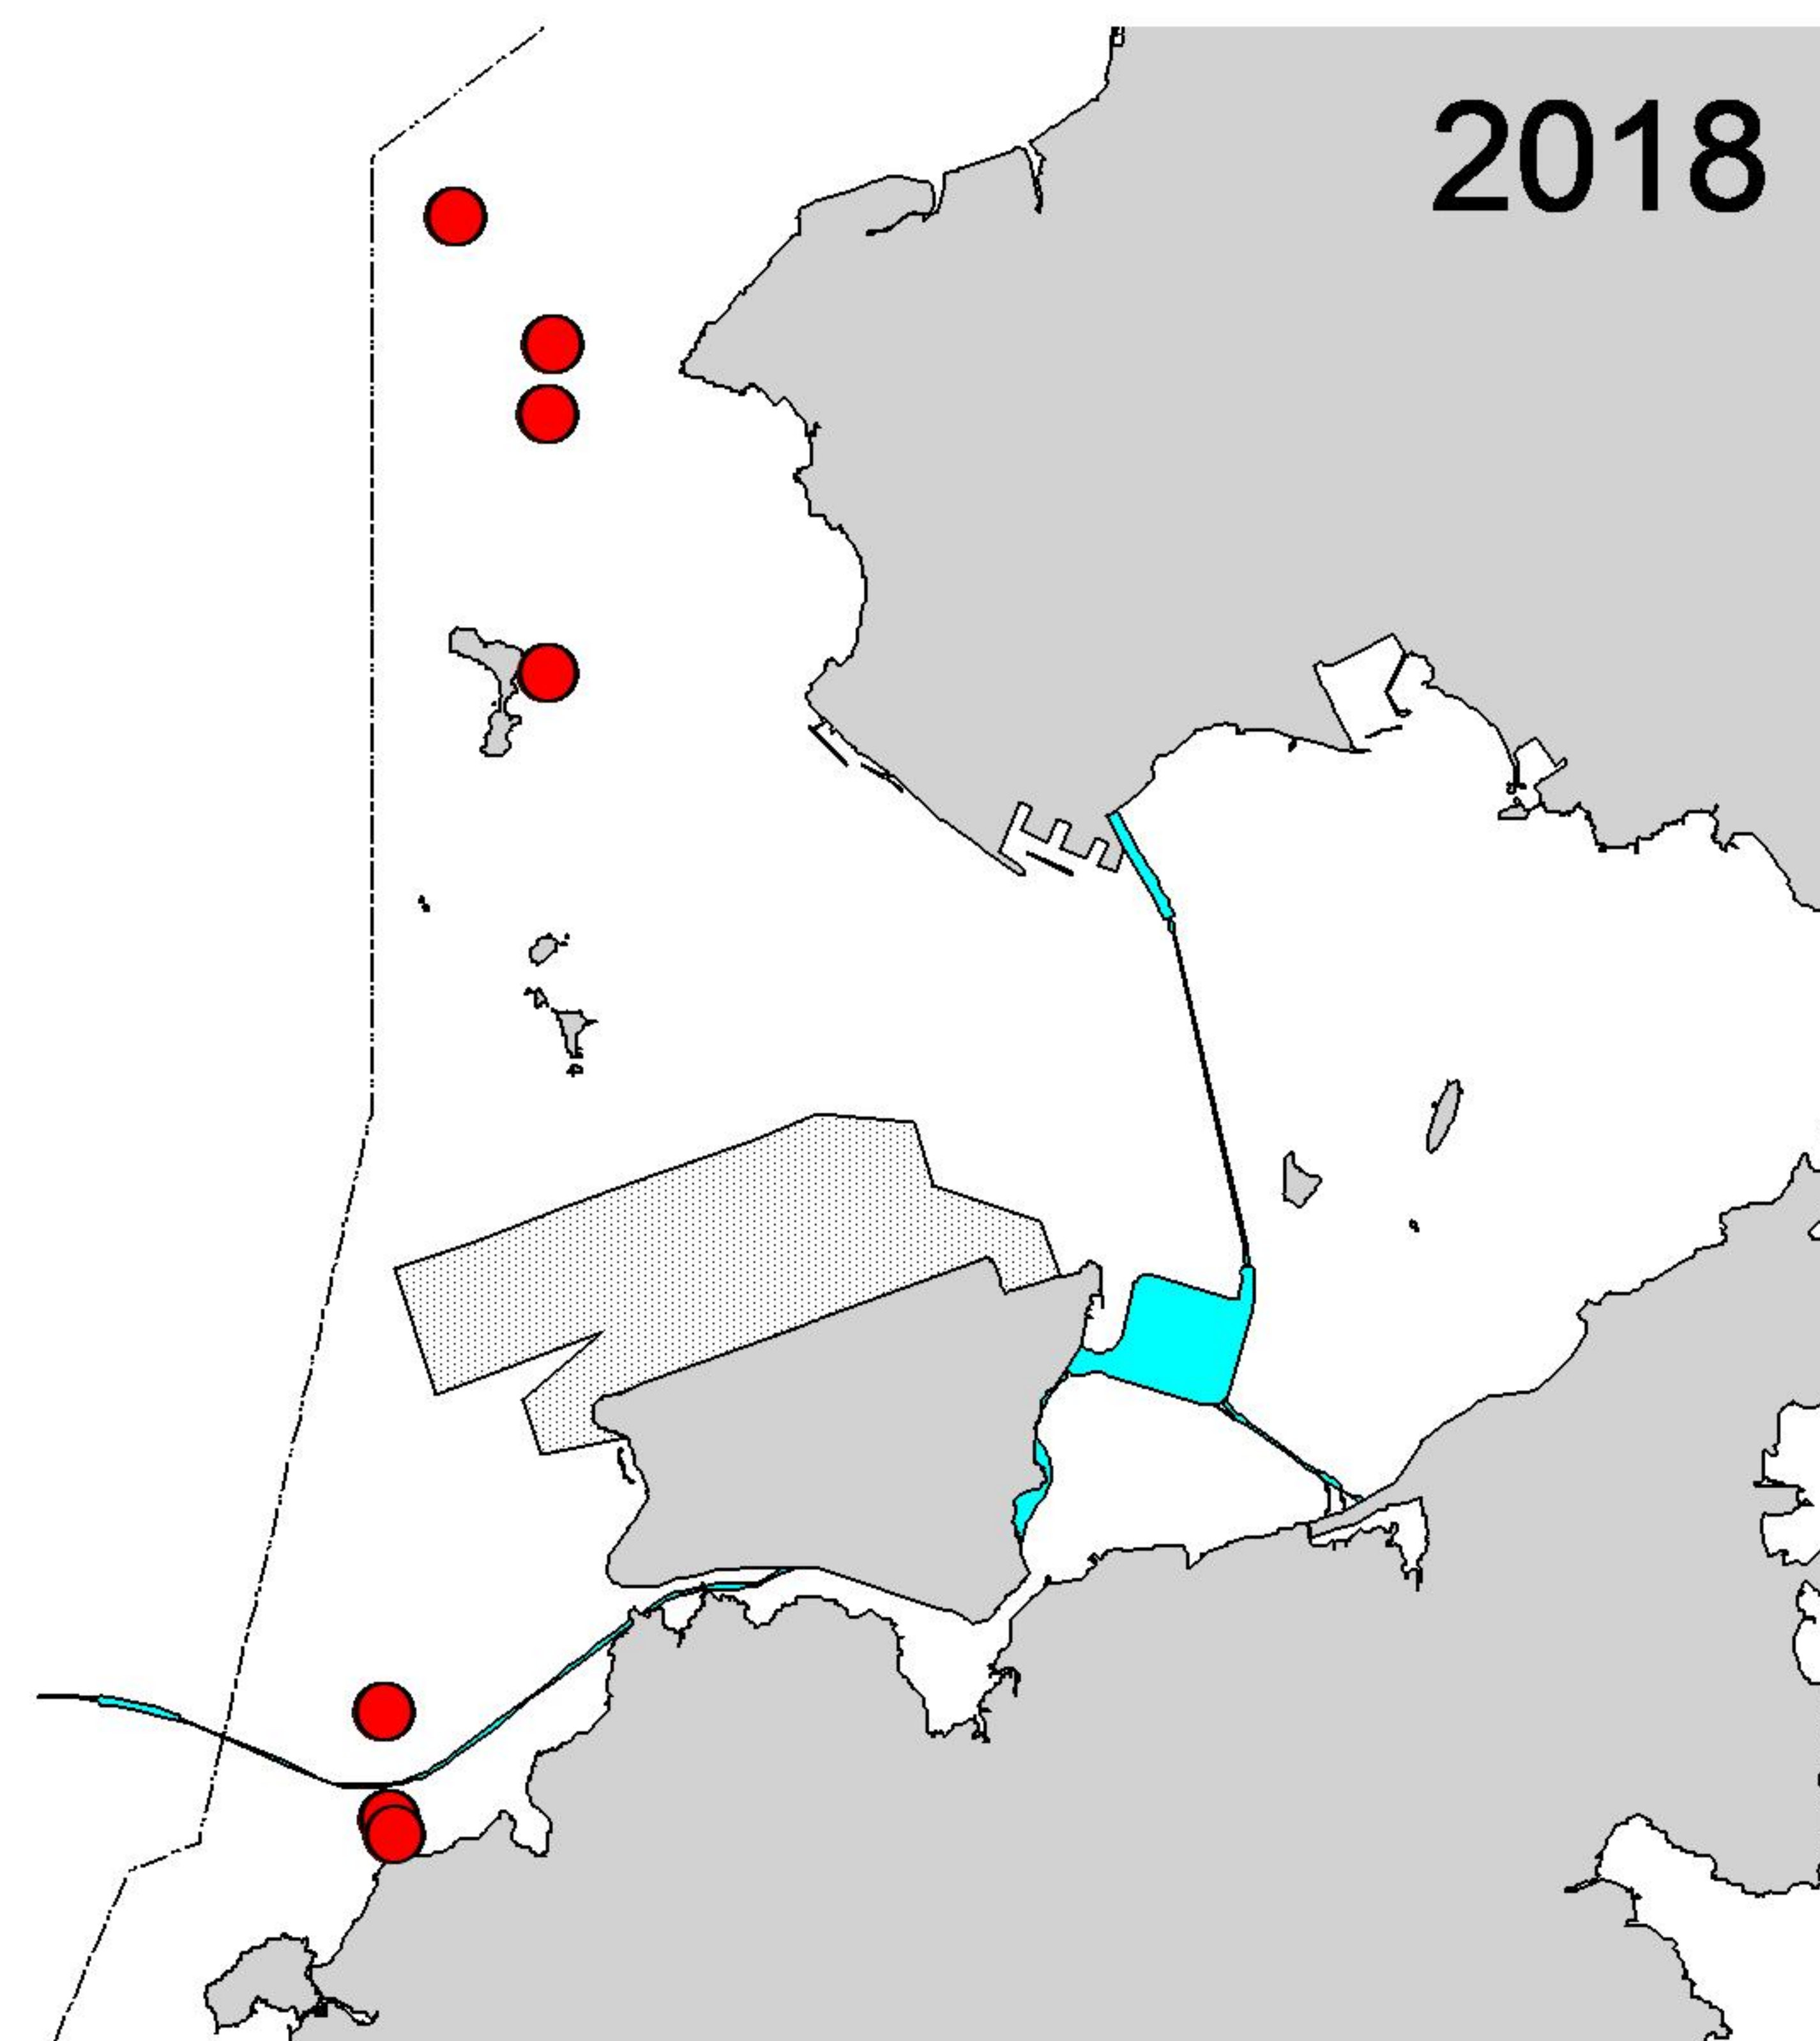
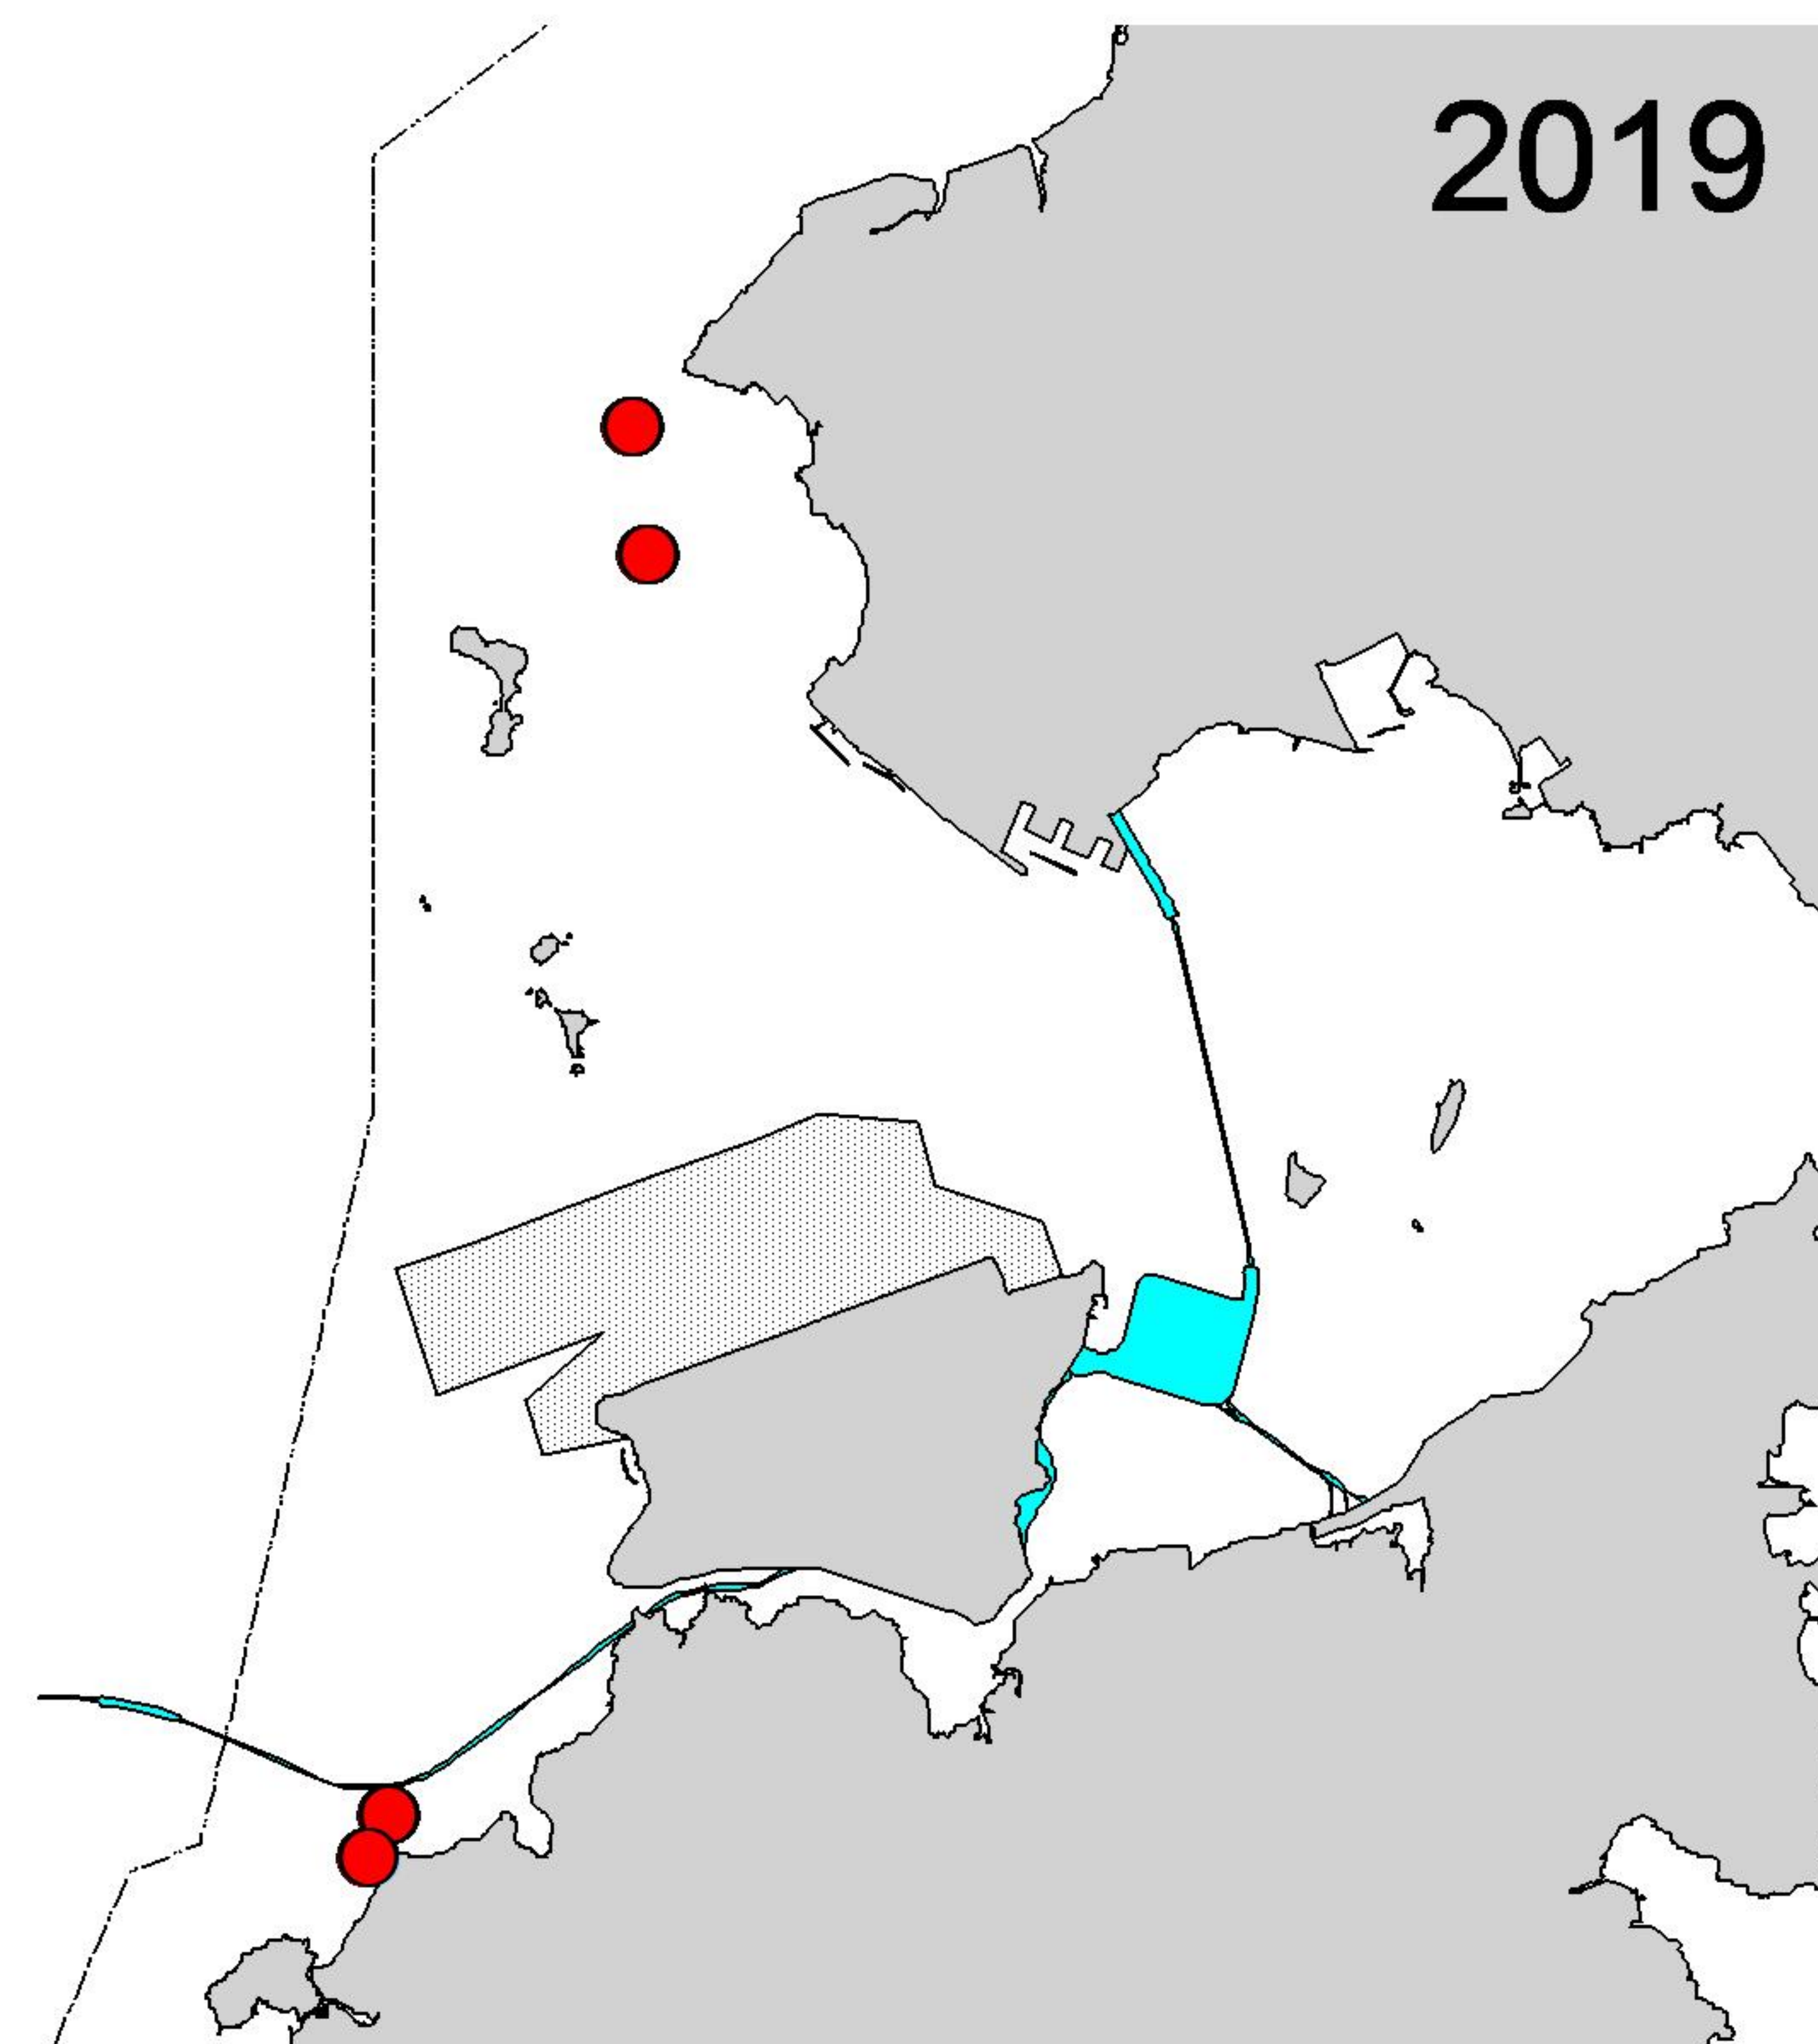
Figure 2. Distribution of Chinese White Dolphin sightings in Northwest and Northeast Lantau during the past six summer quarters (June-August) of HKLR03/TMCLKL08 monitoring period in 2015-20

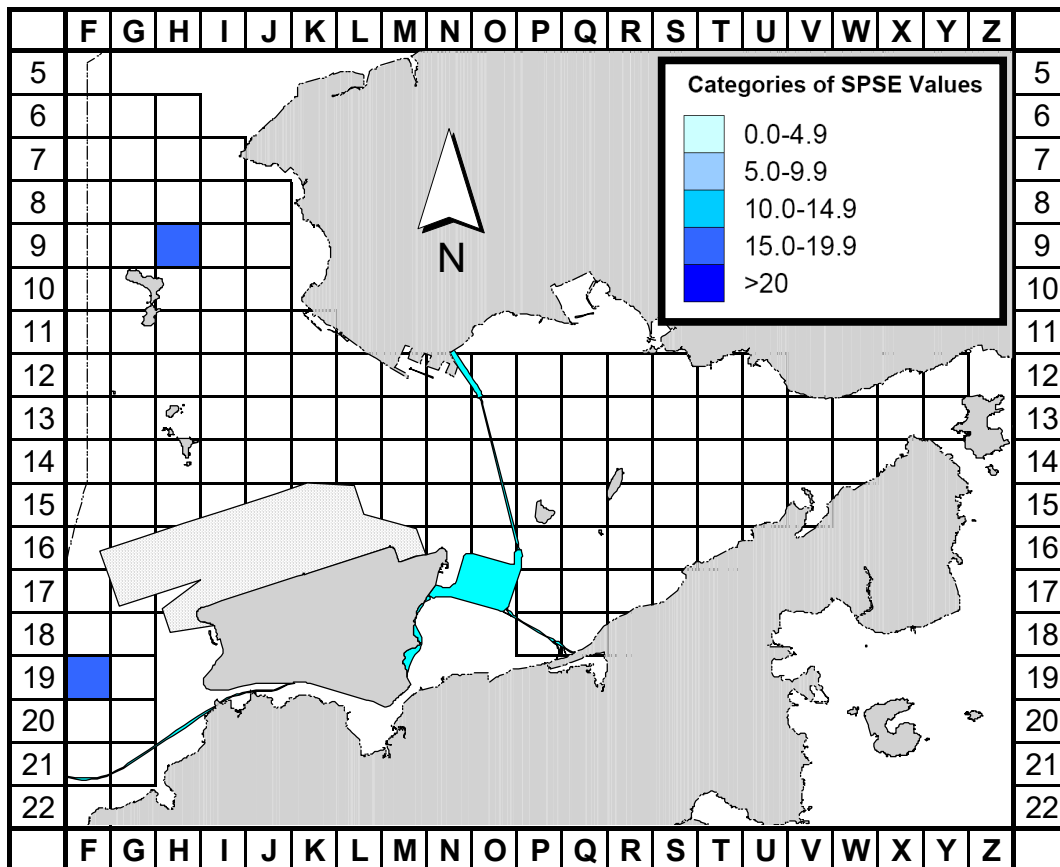
Figure 3a. Sighting density of Chinese White Dolphins with corrected survey effort per km² in Northeast and Northwest Lantau survey areas, using data collected during the TMCLKL08 monitoring period in June-August 2020 (SPSE = no. of on-effort sightings per 100 units of survey effort)

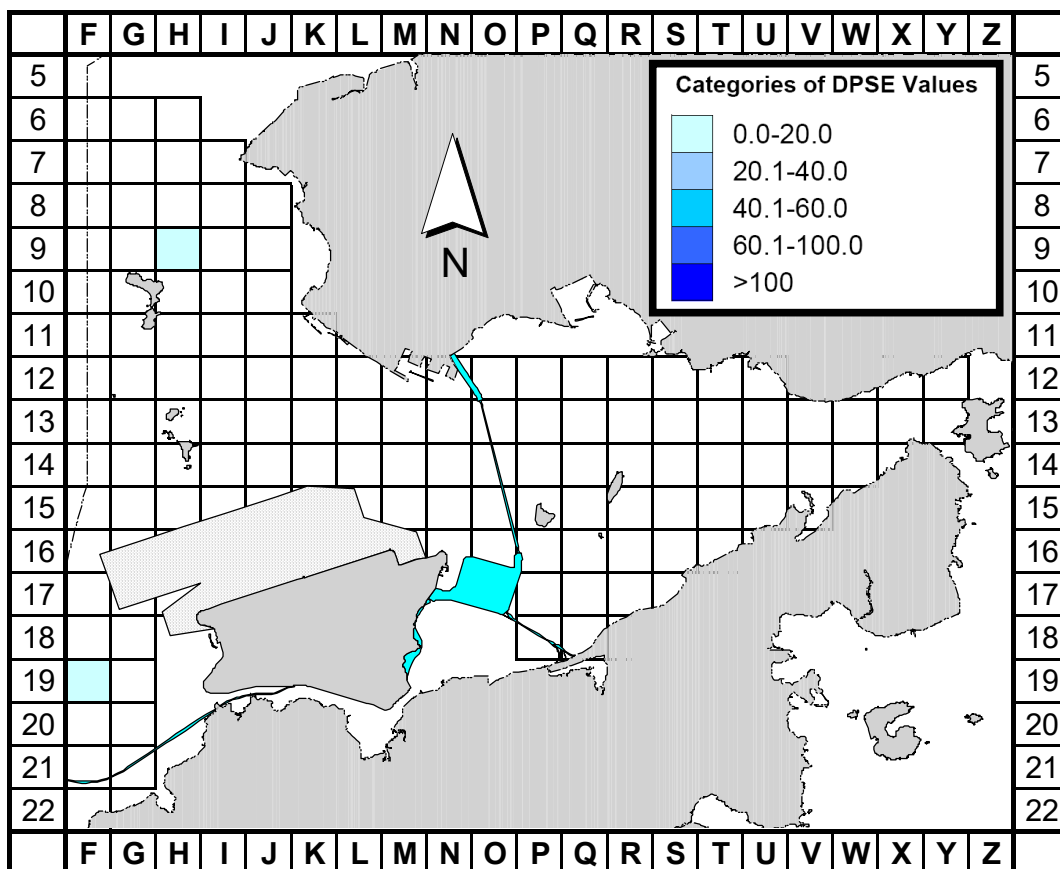
Figure 3b. Density of Chinese White Dolphins with corrected survey effort per km² in Northeast and Northwest Lantau survey areas, using data collected during the TMCLKL08 monitoring period in June-August 2020 (DPSE = no. of dolphins per 100 units of survey effort)

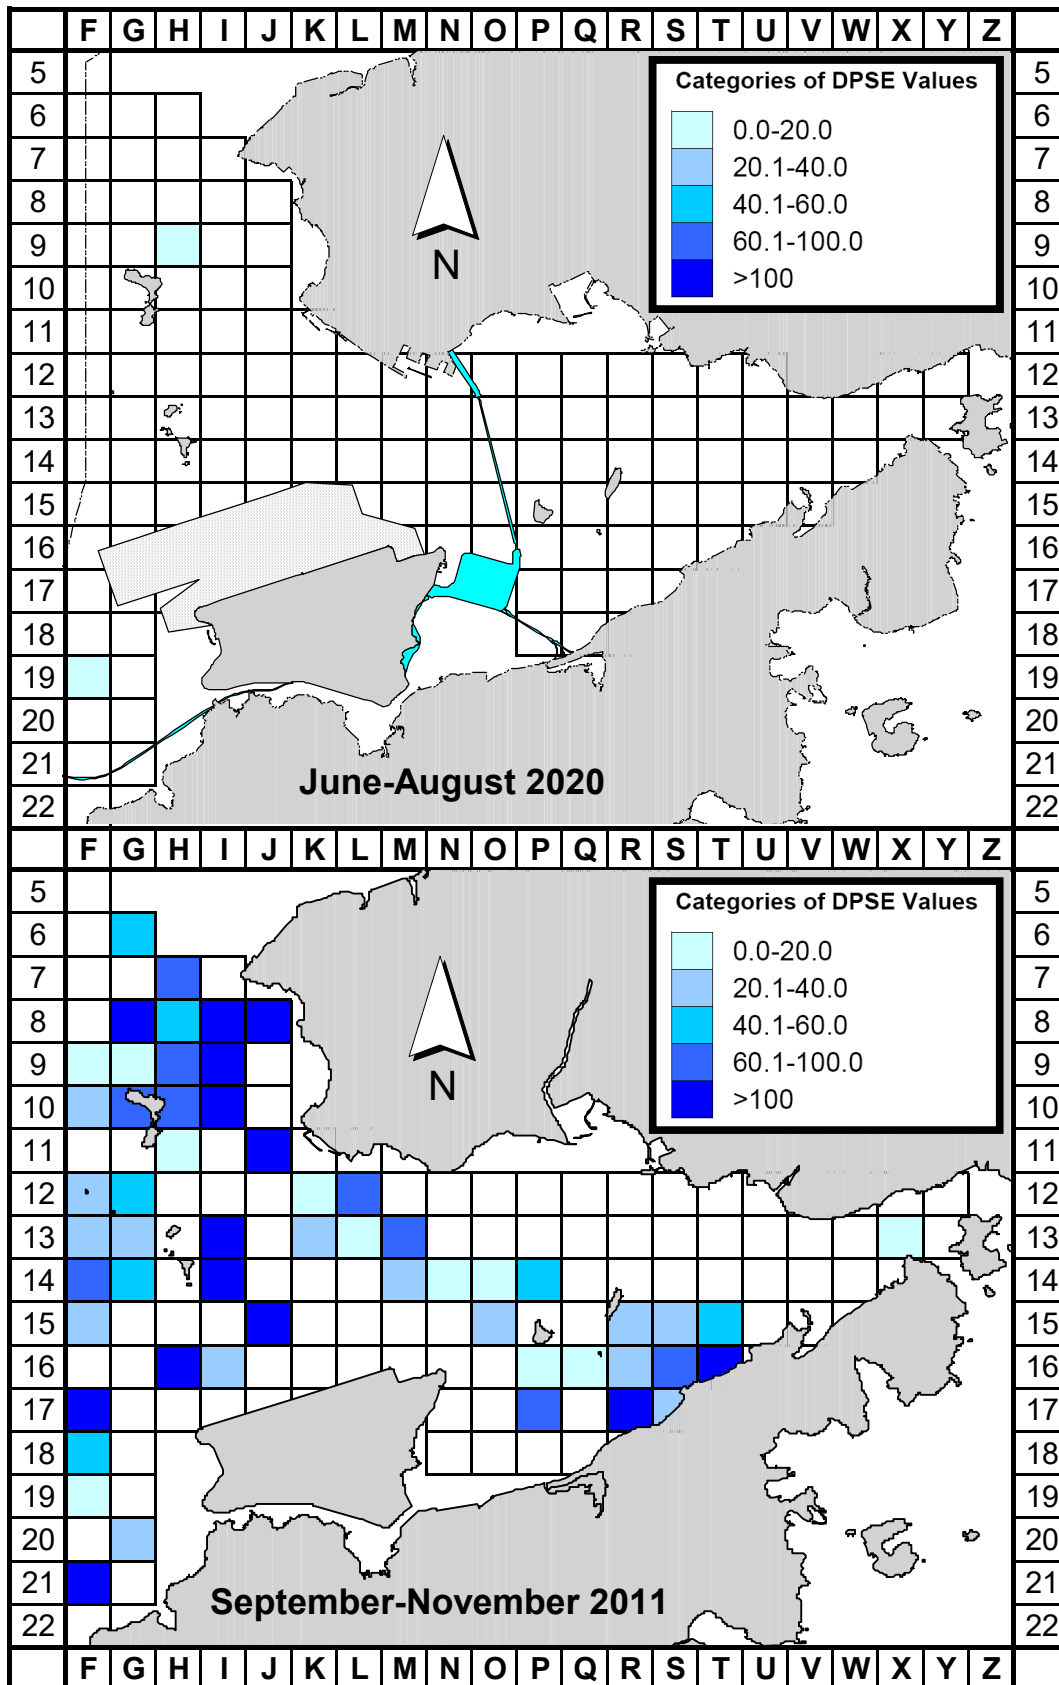
Figure 4. Comparison of density of Chinese White Dolphins with corrected survey effort per km² in Northwest and Northeast Lantau survey areas between the present TMCLKL08 monitoring period (June-August 2020) and baseline monitoring period (September-November 2011) (DPSE = no. of dolphins per 100 units of survey effort)
