**Contract No. HY/2019/01
HZMB HKBCF – Phase 2 and Other Works
Quarterly EM&A Report for June 2020 - August 2020**

**Quarterly EM&A Report for
Hong Kong-Zhuhai-Macao Bridge Hong Kong Boundary Crossing Facilities - Phase 2 and
Other Works (Contract No. HY/2019/01)**

Quarterly EM&A Report (June 2020 - August 2020)

Contact No. HY/2019/01 Hong Kong-Zhuhai-Macao Bridge Hong Kong Boundary Crossing Facilities – Phase 2 and Other Works

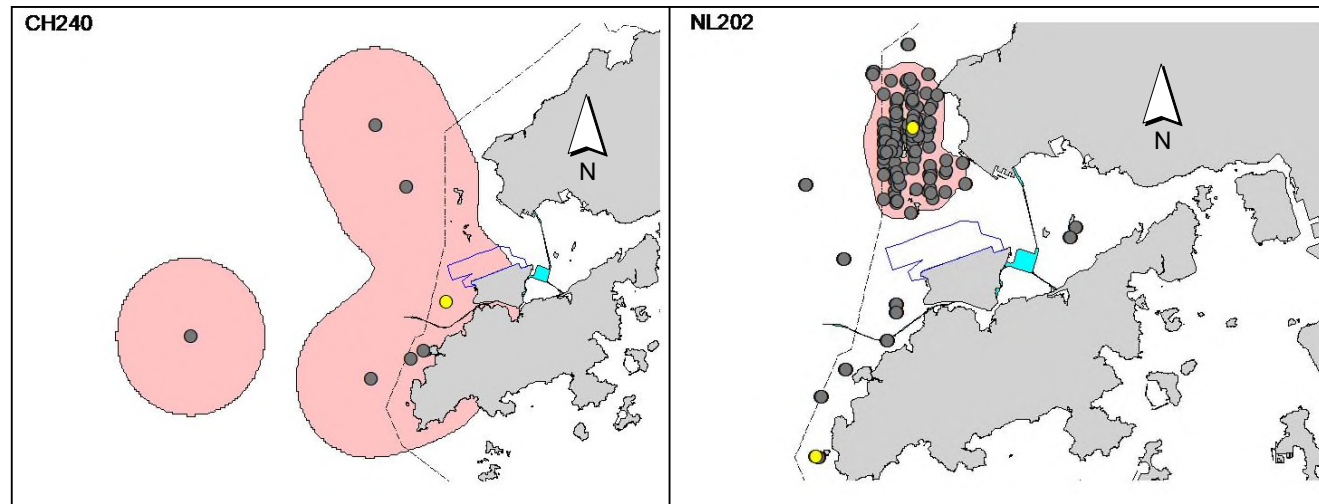
Appendix V. Ranging patterns (95% kernel ranges) of two individual dolphins that were sighted during the present TMCLKL08 monitoring period
(note: yellow dots indicate sightings made in June-August 2020 during TMCLKL08 monitoring surveys)

- 3.9.2. Both identified dolphins sighted in the present quarter were utilizing NWL waters only, but have completely avoided NEL waters where many of them have utilized as their core areas in the past (Appendix V). This is in contrary to the extensive movements between NEL and NWL survey areas observed in the earlier impact monitoring quarters as well as the baseline period.
