Contract No. HY/2011/03

**Hong Kong-Zhuhai-Macao Bridge Hong Kong Link Road
Section between Scenic Hill and Hong Kong Boundary Crossing
Facilities**

Quarterly EM&A Report No. 33 (September 2020 to November 2020)

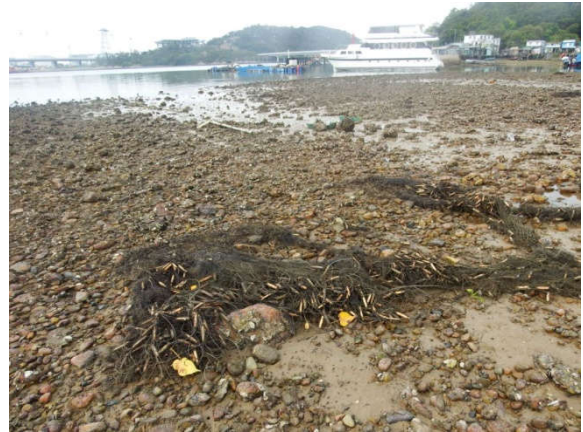
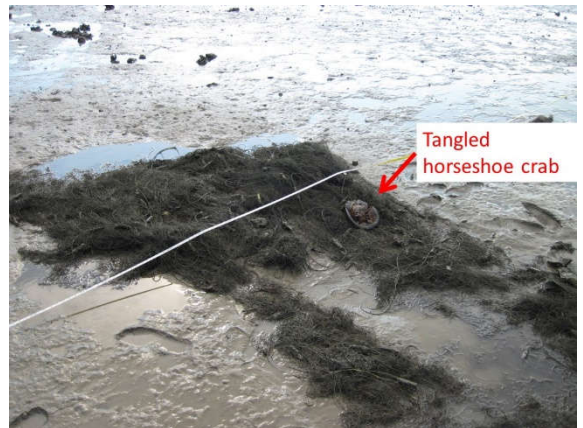
Figure 2.3 *Examples of photographic record of the big trashes found on the mudflat.*

Plastic waste

Trash gill net

A tangled horseshoe crab on a trash net
(record in June 2017)

- 3.6.7 Since the field survey of June 2016, increasing number of trashes and even big trashes (**Figure 2.3 of Appendix O**) were found in every sampling zone. It raised a concern about the solid waste dumping and current-driven waste issues in Tung Chung Wan. Respective measures (e.g. manual clean-up) should be implemented by responsible governmental agency units.

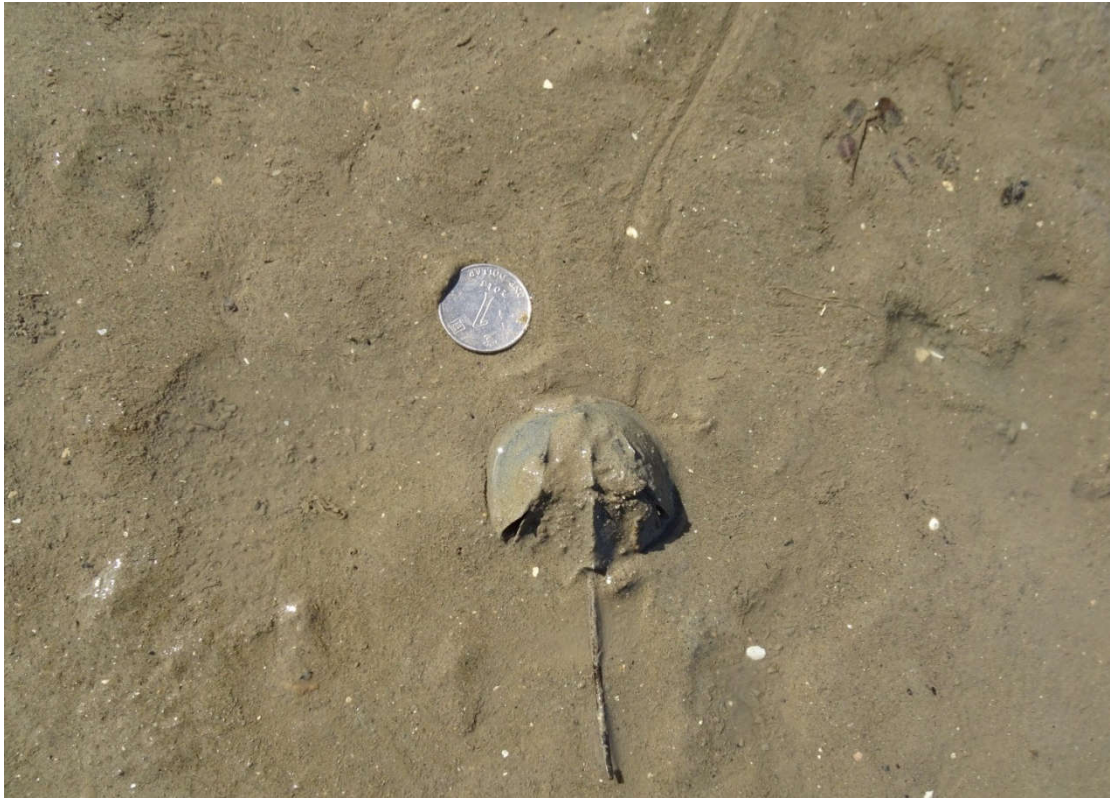
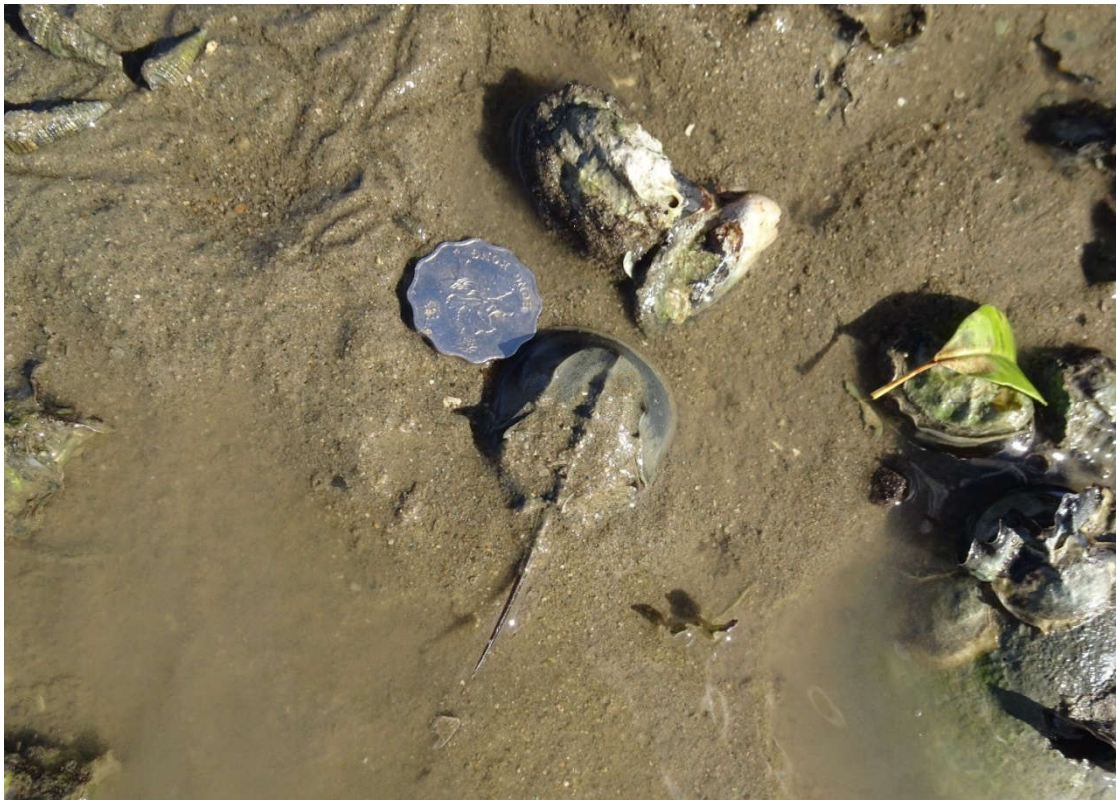
Figure 3.1 Examples of photographic records of horseshoe crab (September 2020)

ST *Carcinoscorpius rotundicauda*

ST *Tachypleus tridentatus*

- 3.6.16 In total of 39 and 28 individuals of *Carcinoscorpius rotundicauda* and *Tachypleus tridentatus* were found in present survey. The recorded individuals were mainly distributed along the shoreline in ST. All of them were observed on similar substratum (fine sand or soft mud, slightly submerged). Photo records of the observed horseshoe crab are shown in **Figure 3.1 of Appendix O** and the present survey result regarding horseshoe crab are presented in **Table 3.1 of Appendix O**. The complete survey records are presented in **Annex II of Appendix O**.

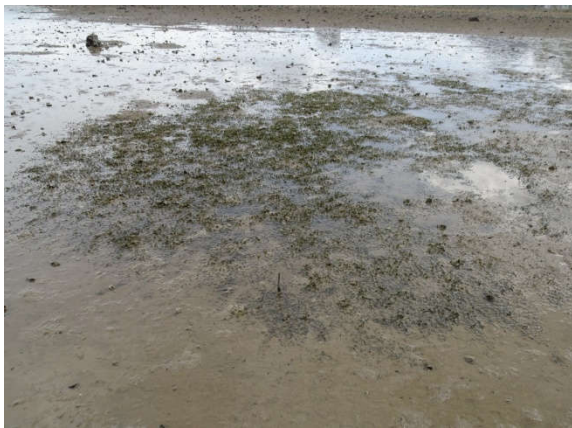
Figure 3.9 *Photographic record of seagrass beds in present survey.*

***Halophila ovalis* in TC3**

- 3.6.40 Only seagrass species *Halophila ovalis* was found in present survey, which was found in TC3 and ST. In ST, there were two small sized and one large sized of seagrass beds found at tidal zone 1.5 m above C.D nearby mangroves plantation. The larger strand had area ~930 m² in high vegetation coverage (90 – 100%). At close vicinity, two small sized (~4 and 36 m²) of *Halophila ovalis* beds were observed at tidal zone 1.5 above C.D. The ~4m² of *Halophila ovalis* beds were in low vegetation coverage (20%) while the ~36m² and ~930m² of *Halophila ovalis* beds were in high vegetation coverage (90 – 100%) respectively. In TC3, three small patches of *Halophila ovalis* were found at tidal zone 1.5 – 2.0m above C.D. These seagrass patch had area 20 m² – 30m². They were in moderate to high vegetation coverage (50 – 100%). Another seagrass species *Zostera japonica* was not found in present survey. **Table 3.2 of Appendix O** summarizes the results of present seagrass beds survey and the photograph records of the seagrass are shown on **Figure 3.9 of Appendix O**. The complete record throughout the monitoring period is presented in **Annex III of Appendix O**.
