Contract No. HY/2011/03

**Hong Kong-Zhuhai-Macao Bridge Hong Kong Link Road
Section between Scenic Hill and Hong Kong Boundary Crossing
Facilities**

Quarterly EM&A Report No. 34 (December 2020 to February 2021)

25 March 2021

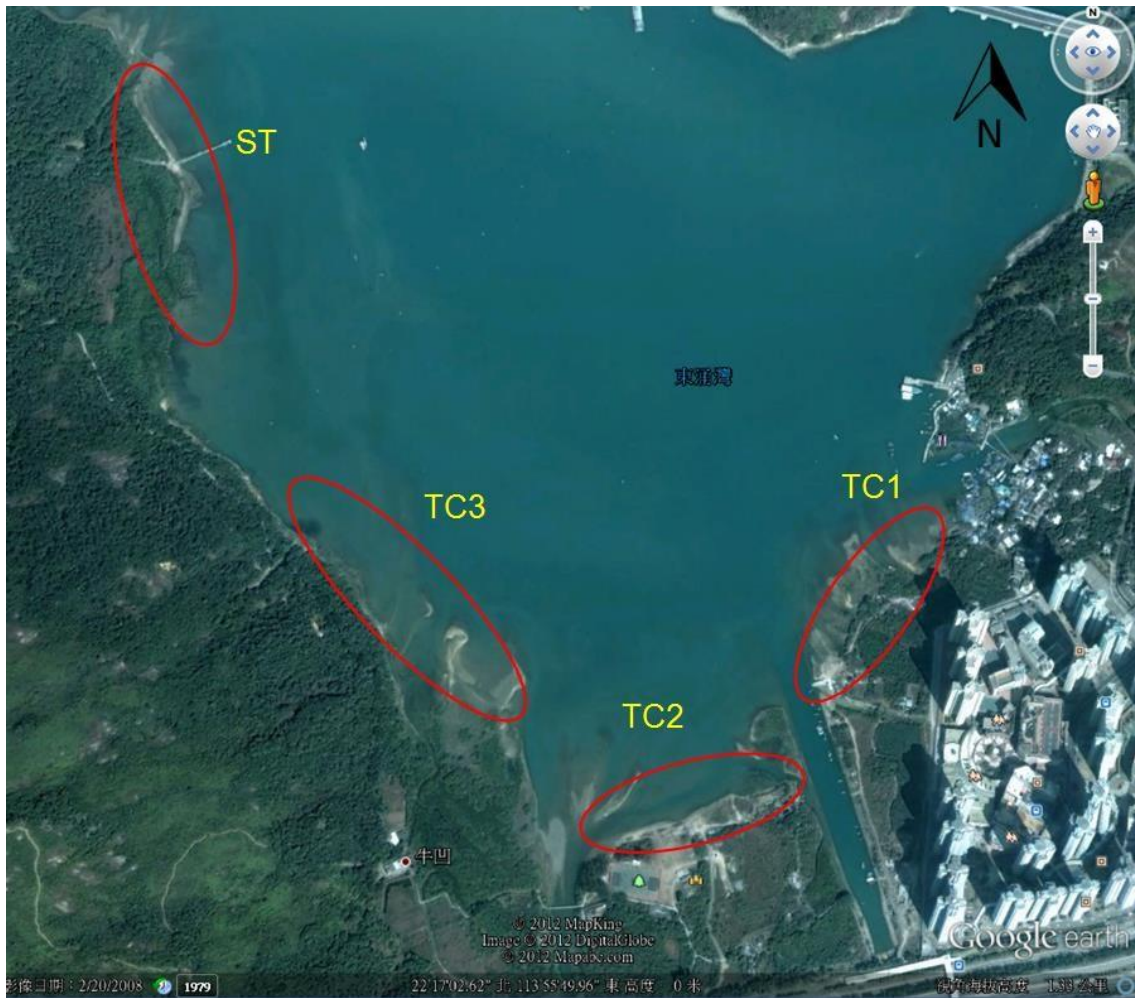
Figure 2.1. Locations of sampling zones. The study site was divided into three sampling zones (TC1, TC2, TC3) in Tung Chung Bay and one zone in San Tau (ST) (map generated from Google Map).

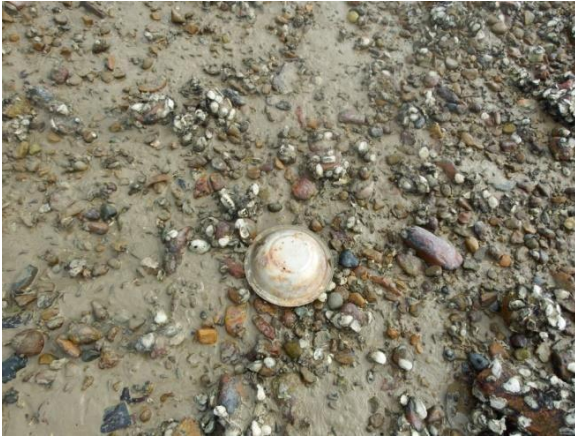
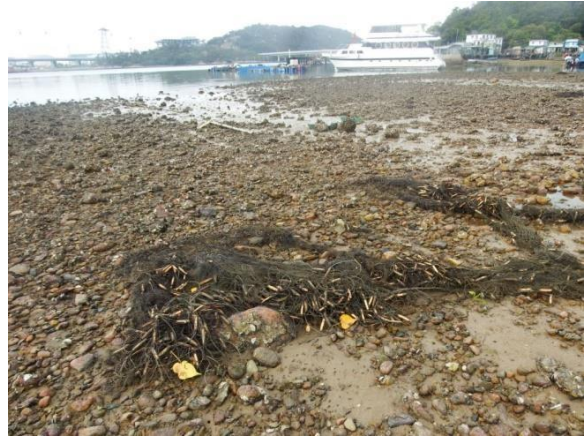
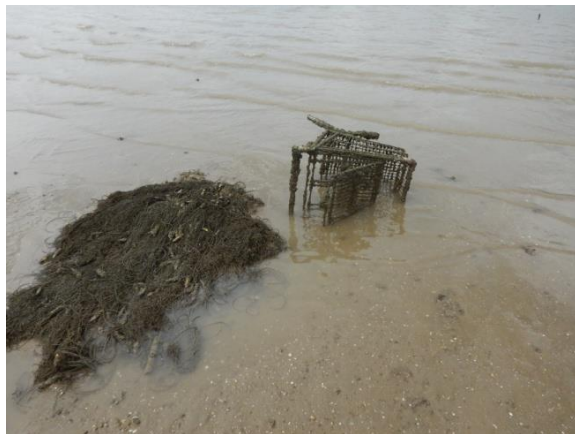
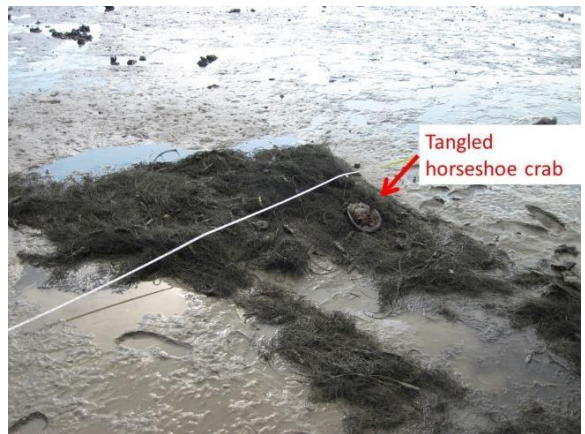
Plastic waste

Trash gill net

Boat wreckage

Trash gill net and hand trolley

A tangled horseshoe crab on a trash net (record in June 2017)

Figure 2.3 *Examples of photographic record of the big trashes found on the mudflat.*

- 3.6.7 Since the field survey of June 2016, increasing number of trashes and even big trashes (**Figure 2.3 of Appendix O**) were found in every sampling zone. It raised a concern about the solid waste dumping and current-driven waste issues in Tung Chung Wan. Respective measures (e.g. manual clean-up) should be implemented by responsible governmental agency units.

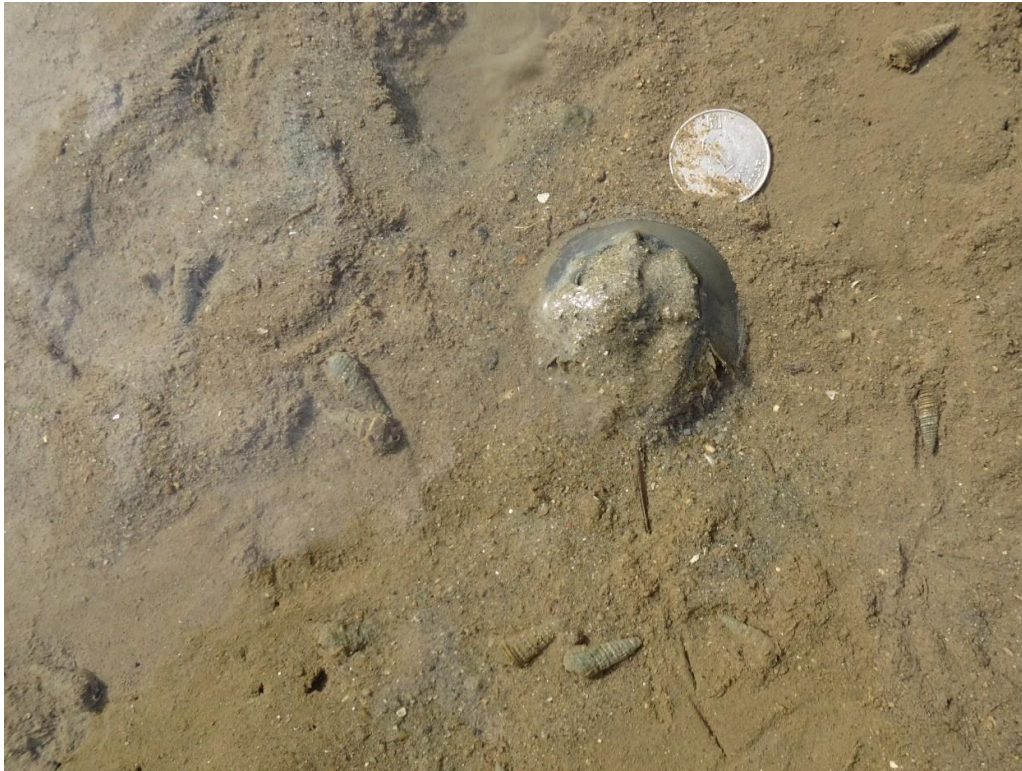
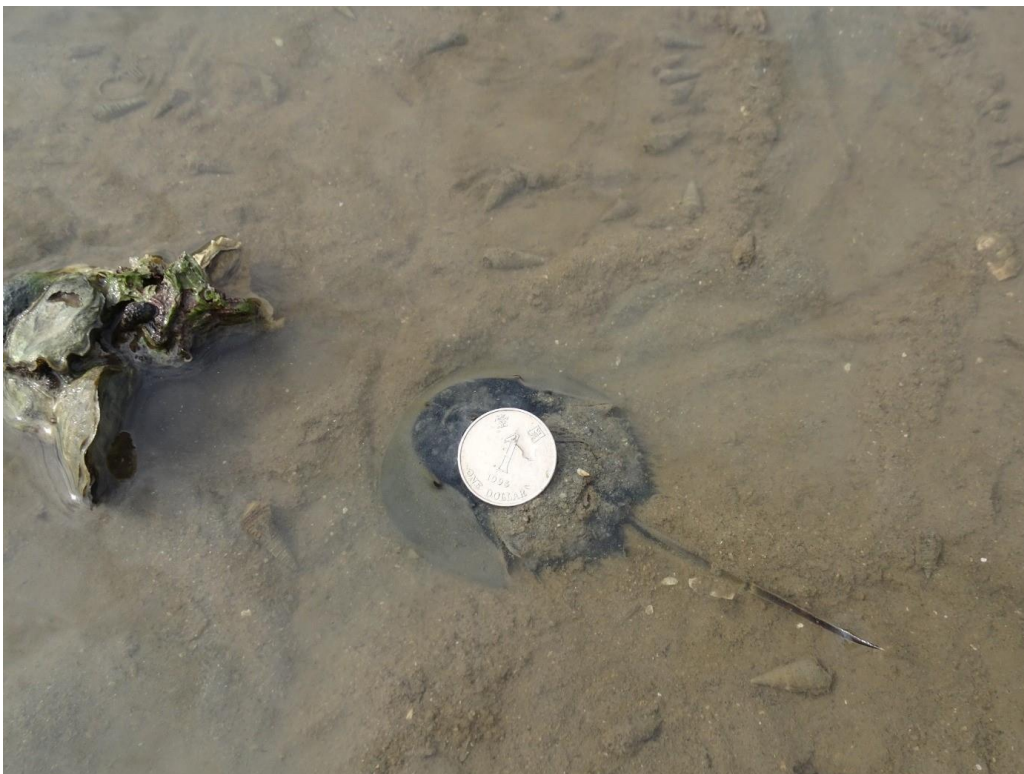
Figure 3.1 Examples of photographic records of horseshoe crab (December 2020)

- 3.6.16 In total of 3 and 7 individuals of *Carcinoscorpius rotundicauda* and *Tachypleus tridentatus* were found in present survey. The recorded individuals were mainly distributed along the shoreline in ST. All of them were observed on similar substratum (fine sand or soft mud, slightly submerged). Photo records of the observed horseshoe crab are shown in **Figure 3.1 of**

- 3.6.17 *Carcinoscorpius rotundicauda*, were only found in ST (3 ind.) with average body size 46.45 mm (prosomal width ranged 36.31 mm – 55.02 mm). The search records in ST was moderate (ST: 0.50 ind. hr⁻¹. Person⁻¹). No *Carcinoscorpius rotundicauda* was found in TC1, TC2 and TC3 in present survey.

- 3.6.18 For *Tachypleus tridentatus*, 7 individuals with average body size 41.13 mm (prosomal width ranged 28.34 – 56.49 mm) were found in ST. The search record in ST was moderate (1.17 ind. hr⁻¹. Person⁻¹). No *Tachypleus tridentatus* was found in TC1, TC2 and TC3 in present survey.

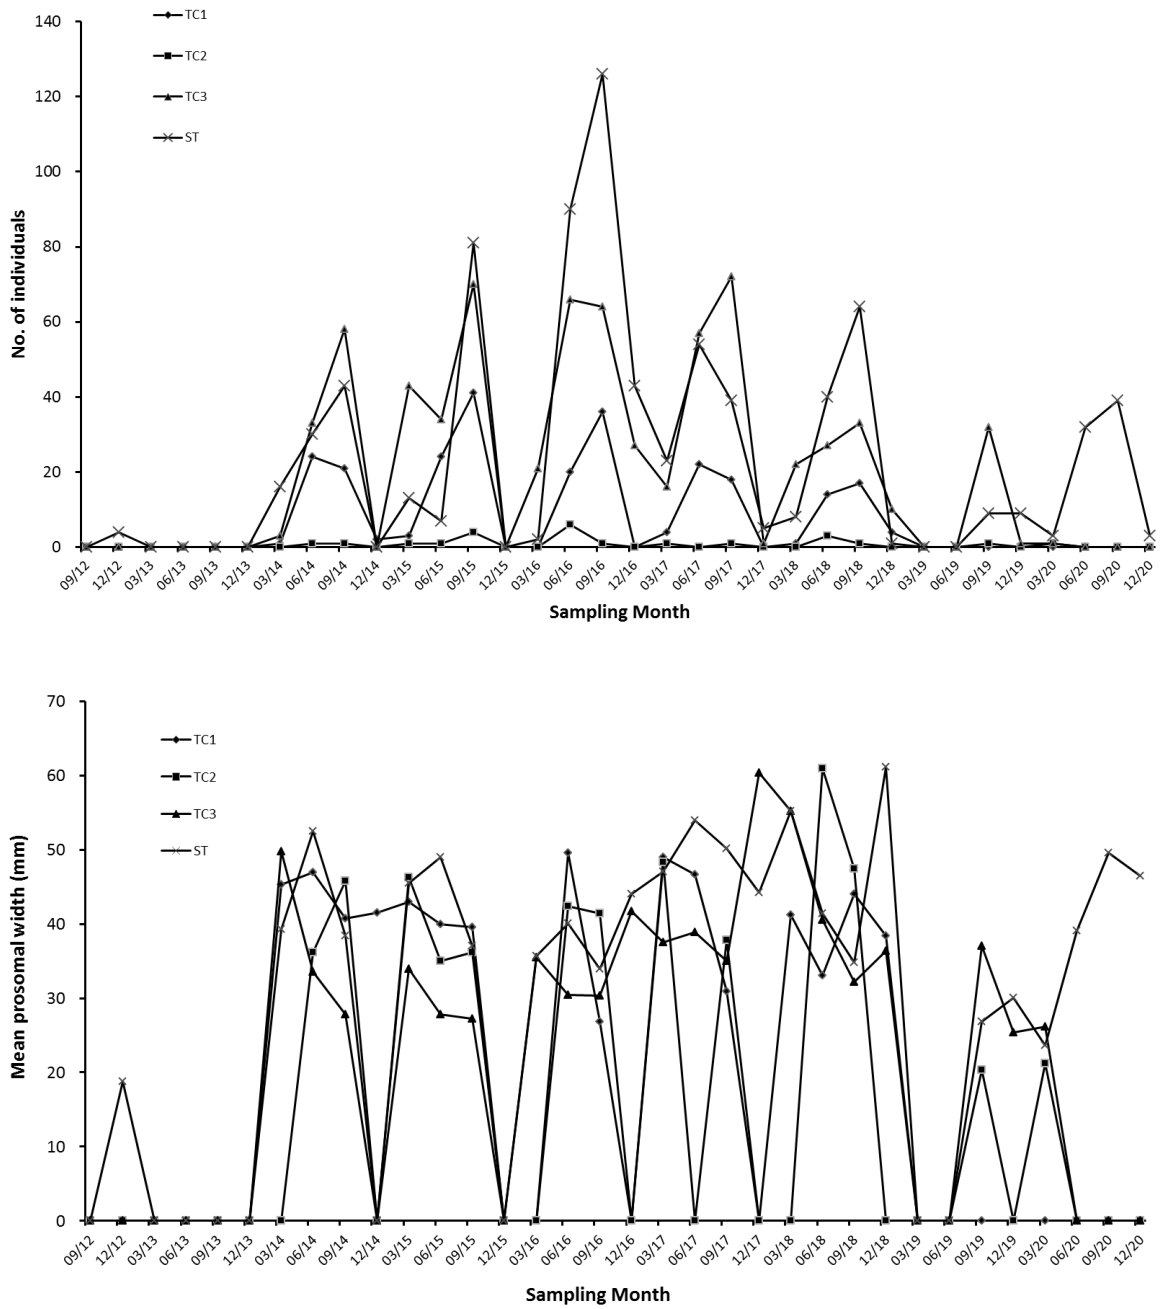
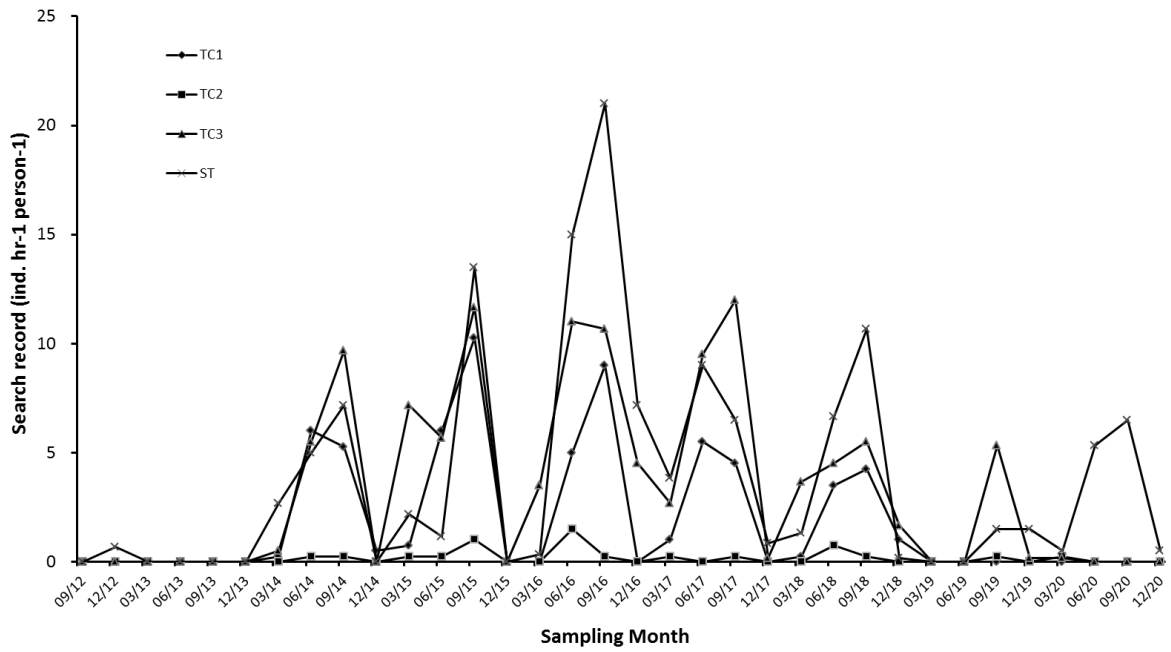
Figure 3.5 Changes of number of individuals mean prosomal width and search record of horseshoe crab *Carcinoscorpius rotundicauda* in every sampling zone along the sampling months

Figure 3.5 (Cont'd) Changes of number of individuals mean prosomal width and search record of horseshoe crab *Carcinoscorpius rotundicauda* in every sampling zone along the sampling months

- 3.6.28 Throughout the monitoring period, the search records of horseshoe crabs were fluctuated and at moderate – very low level in June (**Figures 3.5 and 3.6 of Appendix O**). Low – Very low search record was found in June 2013, totally 82 individuals of *Tachypleus tridentatus* and 0 ind. of *Carcinoscorpius rotundicauda* were found in TC1, TC3 and ST. Compare with the search record of June 2013, the numbers of *Tachypleus tridentatus* were gradually decreased in June 2014 and 2015 (55 ind. in 2014 and 18 ind. in 2015); the number of *Carcinoscorpius rotundicauda* raise to 88 and 66 individuals. in June 2014 and 2015 respectively. In June 2016, the search record increased about 3 times compare with June 2015. In total, 182 individuals of *Carcinoscorpius rotundicauda* and 47 individuals. of *Tachypleus tridentatus* were noted, respectively. Then, the search record was similar to June 2016. The number of recorded *Carcinoscorpius rotundicauda* (133 ind.) slightly dropped in June 2017. However, that of *Tachypleus tridentatus* rapidly increased (125 ind.). In June 2018, the search record was low to moderate while the numbers of *Tachypleus tridentatus* dropped sharply (39 ind.). In June 2019, 10 individuals of *Tachypleus tridentatus* were observed in TC3 and ST. All of them, however, were large individuals (prosomal width >100mm), their records are excluded from the data analysis to avoid mixing up with the juvenile population living on intertidal habitat. Until September 2020, the number of *Carcinoscorpius rotundicauda* and *Tachypleus tridentatus* gradually increased to 39 ind. and 28 ind., respectively. Throughout the monitoring period, similar distribution of horseshoe crabs population were found in September. Most of the horseshoe crabs were found in TC3 and ST.

- 3.6.30 The search record of horseshoe crab declined obviously in all sampling zones during dry season especially December (**Figures 3.5 and 3.6 of Appendix O**) throughout the monitoring period. Very low – low search record was found in December from 2012 to 2015 (0-4 ind. of *Carcinoscorpius rotundicauda* and 0-12 ind. of *Tachypleus tridentatus*). The horseshoe crabs were inactive and burrowed in the sediments during cold weather (<15 °C). Similar results of low search record in dry season were reported in a previous territory-wide survey of horseshoe crab. For example, the search records in Tung Chung Wan were 0.17 ind. hr⁻¹person⁻¹ and 0.00 ind. hr⁻¹ person⁻¹ in wet season and dry season respectively (details see Li, 2008). Compare with the search record of December from 2012 to 2015, which of December 2016 were much higher relatively. There were totally 70 individuals of *Carcinoscorpius rotundicauda* and 24 individuals of *Tachypleus tridentatus* in TC3 and ST. Since the survey was carried in earlier December with warm and sunny weather (~22 °C during dawn according to Hong Kong Observatory database, Chek Lap Kok station on 5 December 2016), the horseshoe crab was more active (i.e. move onto intertidal shore during high tide for foraging and breeding) and easier to be found. In contrast, there was no search record in TC1 and TC2 because the survey was conducted in mid-December with colder and cloudy weather (~20 °C during dawn on 19 December). The horseshoe crab activity would decrease gradually with the colder climate. In December of 2017, 2018 and 2019 very low search records were found again as mentioned above.

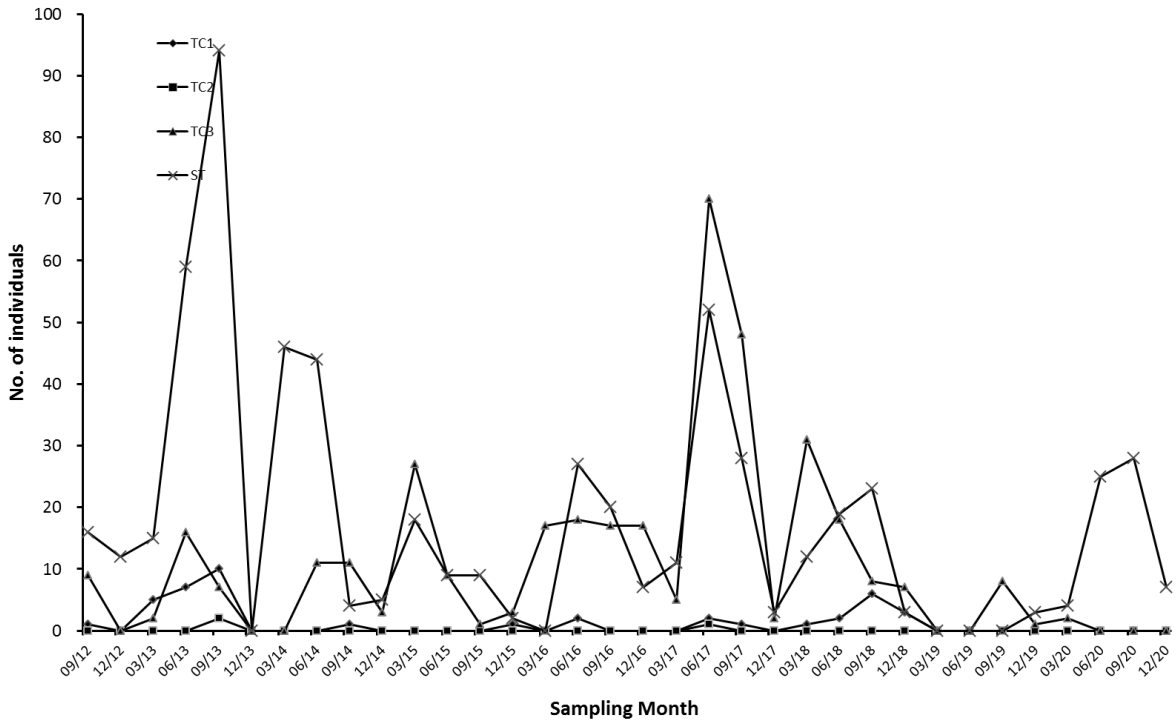
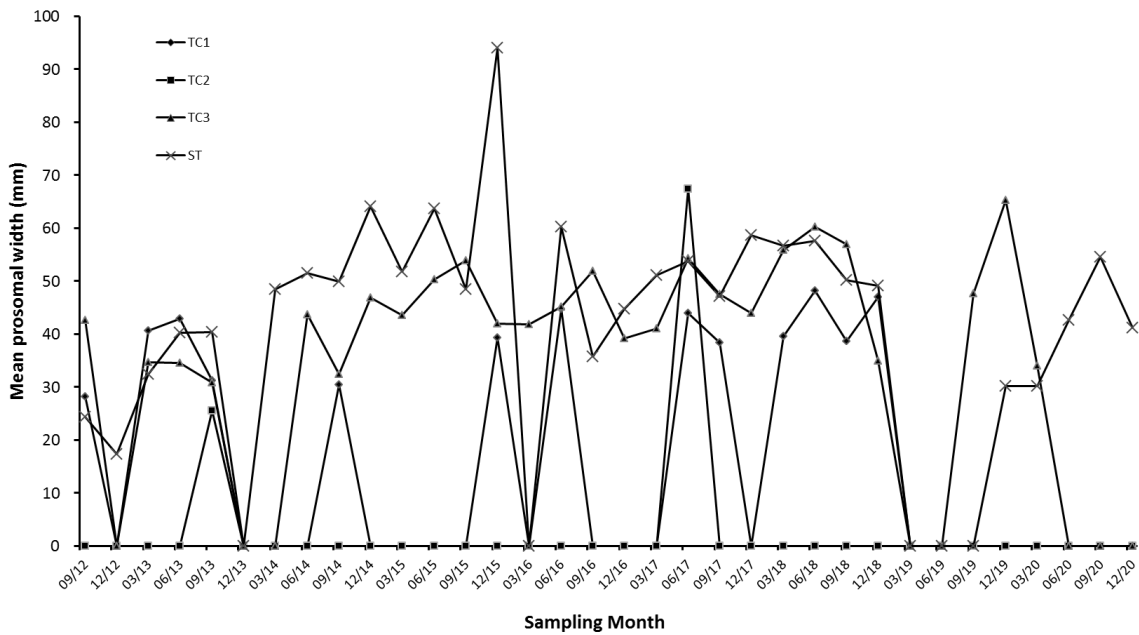
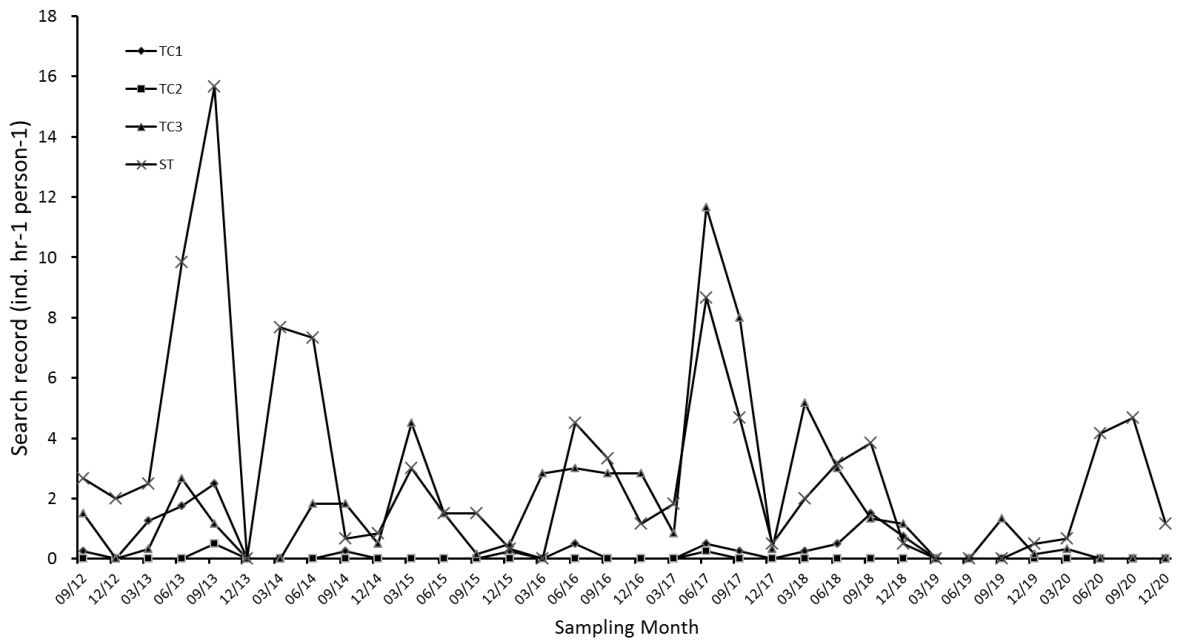
Figure 3.6 Changes of number of individuals mean prosomal width and search record of horseshoe crab *Tachypleus tridentatus* in every sampling zone along the sampling months

Figure 3.6 (Cont'd) Changes of number of individuals mean prosomal width and search record of horseshoe crab *Tachypleus tridentatus* in every sampling zone along the sampling months

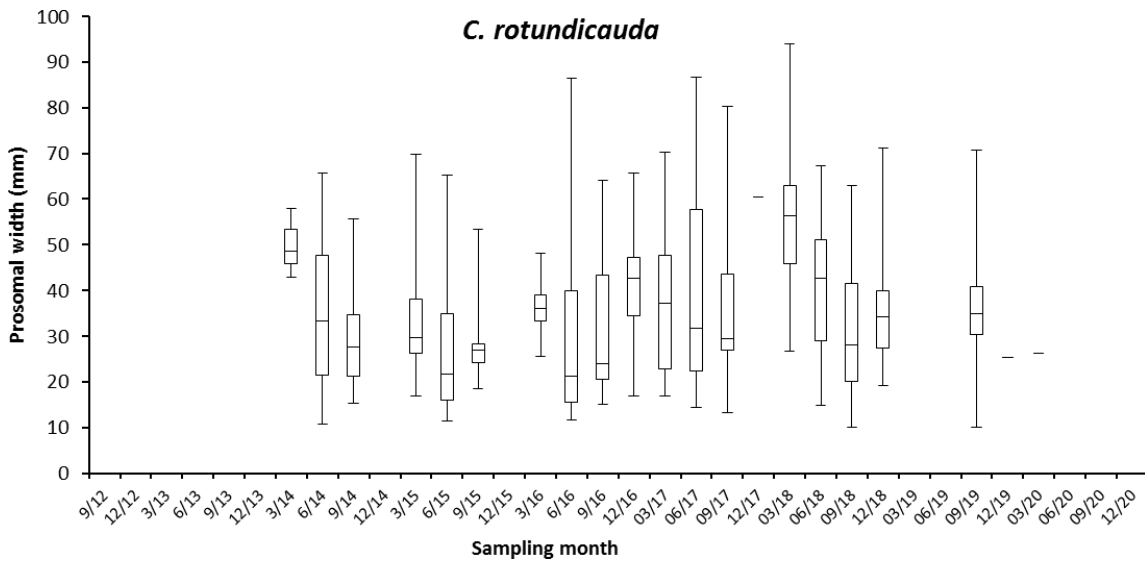
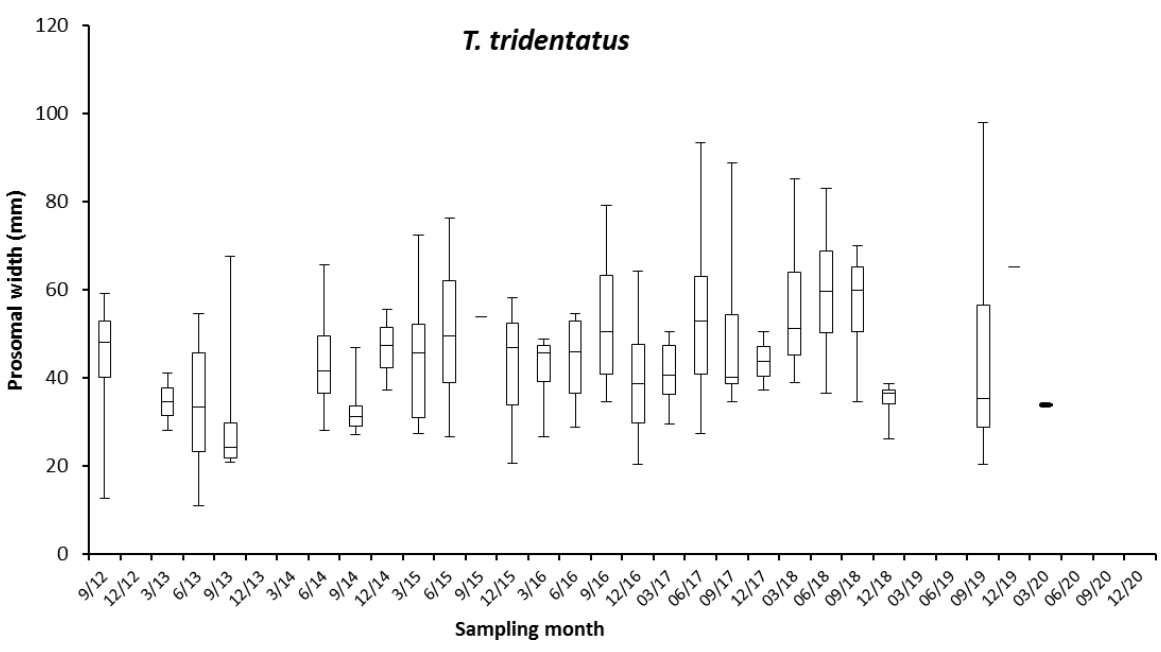
Figure 3.7 Box plot of prosomal width of horseshoe crab in the sampling zone TC3 along the sampling months. (The box represents 50% of the sample (upper to lower quartile) with a middle line showing the median value. The upper whisker and lower whisker showed the 25% of sample above upper quartile and below the lower quartile respectively)

- 3.6.34 **Figure 3.7 of Appendix O** shows the changes of prosomal width of *Carcinoscorpius rotundicauda* and *Tachypleus tridentatus* in TC3. As mentioned above, *Carcinoscorpius rotundicauda* was rarely found between September 2012 and December 2013 hence the data were lacking. In March 2014, the major size (50% of individual records between upper (top box) and lower quartile (bottom box)) ranged 40 – 60 mm while only few individuals were found. From March 2014 to September 2018, the median prosomal width (middle line of whole box) and major size (whole box) decreased after March of every year. It was due to more small individuals found in June indicating new rounds of spawning. Also, there were slight increasing trends of body size from June to March of next year since 2015. It indicated a stable growth of individuals. Focused on larger juveniles (upper whisker), the size range was quite variable (prosomal width 60 – 90 mm) along the sampling months. Juveniles reaching this size might gradually migrate to sub-tidal habitats.

- 3.6.35 For *Tachypleus tridentatus*, the major size ranged 20-50 mm while the number of individuals fluctuated from September 2012 to June 2014. Then a slight but consistent growing trend was observed from September 2014 to June 2015. The prosomal width increased from 25 – 35 mm to 35 – 65 mm. As mentioned, the large individuals might have reached a suitable size for migrating from the nursery soft shore to subtidal habitat. It accounted for the declined population in TC3. From March to September 2016, slight increasing trend of major size was noticed again. From December 2016 to June 2017, similar increasing trend of major size was noted with much higher number of individuals. It reflected new round of spawning. In September 2017, the major size decreased while the trend was different from previous two years. Such decline might be the cause of serial cyclone hit between June and September 2017 (to be discussed in the 'Seagrass survey' section). From December 2017 to September 2018, increasing trend was noted again. It indicated a stable growth of individuals. From September 2018 to that of next year, the average prosomal widths were decreased from 60mm to 36mm. It indicated new rounds of spawning occurred during September to November 2018. In December 2019, an individual with larger body size (prosomal width 65mm) was found in TC3 which reflected the stable growth of individuals. In March 2020, the average prosomal width (middle line of the whole box) of *Tachypleus tridentatus* in TC3 was 33.97 mm which is smaller than that in December 2019. It was in normal fluctuation. From June 2020 to December 2020 (present survey), no horseshoe crab was recorded in TC3. Across the whole monitoring period, the larger juveniles (upper whisker) usually reached 60 – 80 mm in prosomal width, even 90 mm occasionally. The juveniles reaching this size might gradually migrate to sub-tidal habitats.

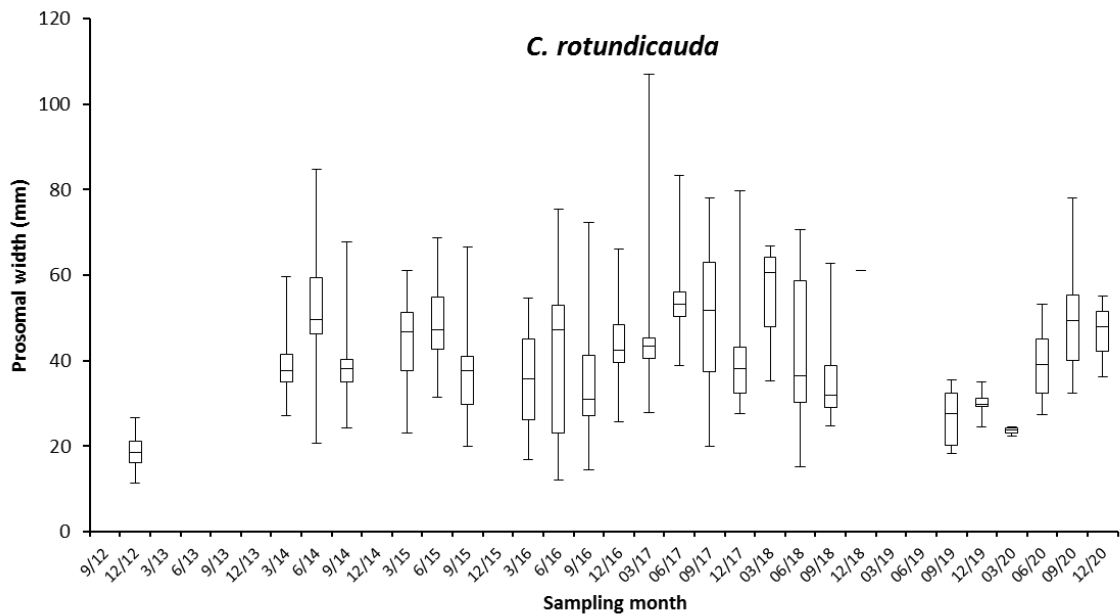
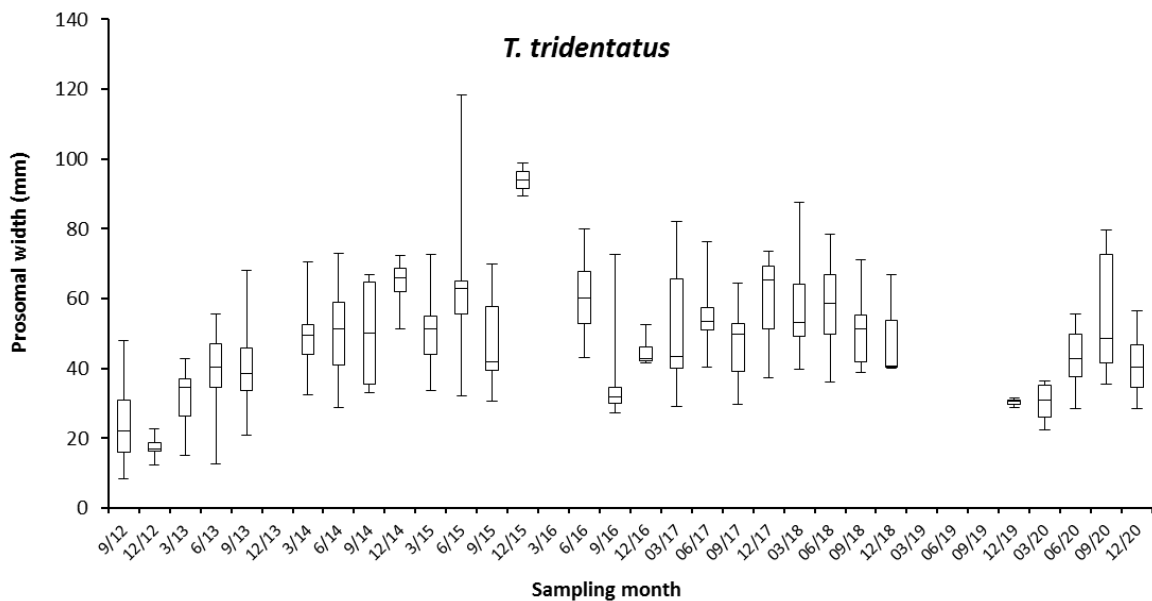
Figure 3.8 Box plot of prosomal width of horseshoe crab in the sampling zone ST along the sampling months. (The box represents 50% of the sample (upper to lower quartile) with a middle line showing the median value. The upper whisker and lower whisker showed the 25% of sample above upper quartile and below the lower quartile respectively.)

- 3.6.36 **Figure 3.8 of Appendix O** shows the changes of prosomal width of *Carcinoscorpius rotundicauda* and *Tachypleus tridentatus* in ST. As mentioned above, *Carcinoscorpius rotundicauda* was rarely found between September 2012 and December 2013 hence the data were lacking. From March 2014 to September 2018, the size of major population decreased and more small individuals (i.e. lower whisker) were recorded after June of every year. It indicated new round of spawning. Also, there were similar increasing trends of body size from September to June of next year between 2014 and 2017. It indicated a stable growth of individuals. The larger juveniles (i.e. upper whisker usually ranged 60 – 80 mm in prosomal width except one individual (prosomal width 107.04 mm) found in March 2017. It reflected juveniles reaching this size would gradually migrate to sub-tidal habitats.

- 3.6.37 For *Tachypleus tridentatus*, a consistent growing trend was observed for the major population from December 2012 to December 2014 regardless of change of search record. The prosomal

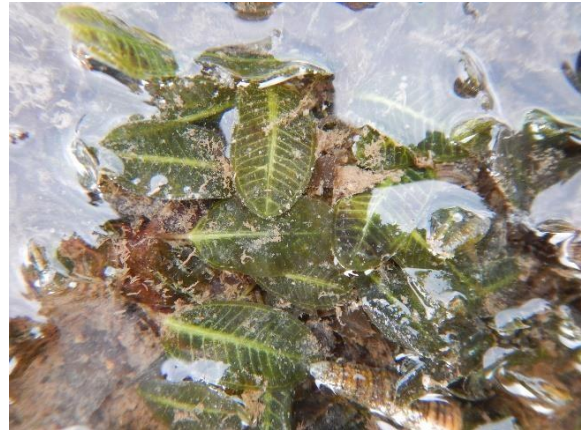
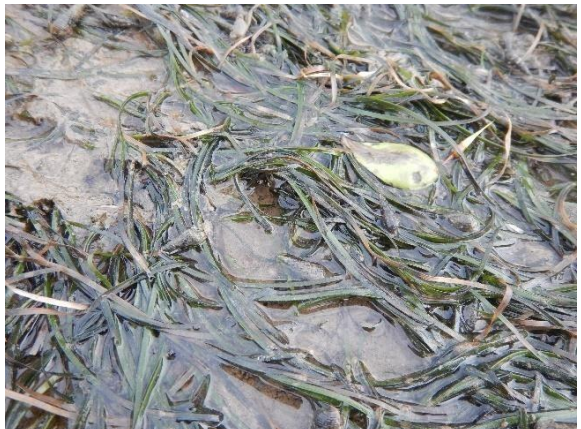
Extensive patch of *Halophila ovalis*

Medium, horizontal patch of *Zostera japonica*

Figure 3.10 Examples of photographic records of seagrass beds (record in June 2017)

- 3.6.42 Since the commencement of the EM&A monitoring programme, two species of seagrass *Halophila ovalis* and *Zostera japonica* were recorded in TC3 and ST (**Figure 3.10 of Appendix O**). In general *Halophila ovalis* was occasionally found in TC3 in few, small to medium patches. But it was commonly found in ST in medium to large seagrass bed. Moreover it had sometimes grown extensively and had covered significant mudflat area at 0.5 – 2.0 m above C.D. between TC3 and ST. Another seagrass species *Zostera japonica* was found in ST only. It was relatively lower in vegetation area and co-existed with *Halophila ovalis* nearby the mangrove strand at 2.0 m above C.D.
- 3.6.43 According to the previous results, majority of seagrass bed was confined in ST, the temporal change of both seagrass species were investigated in details:

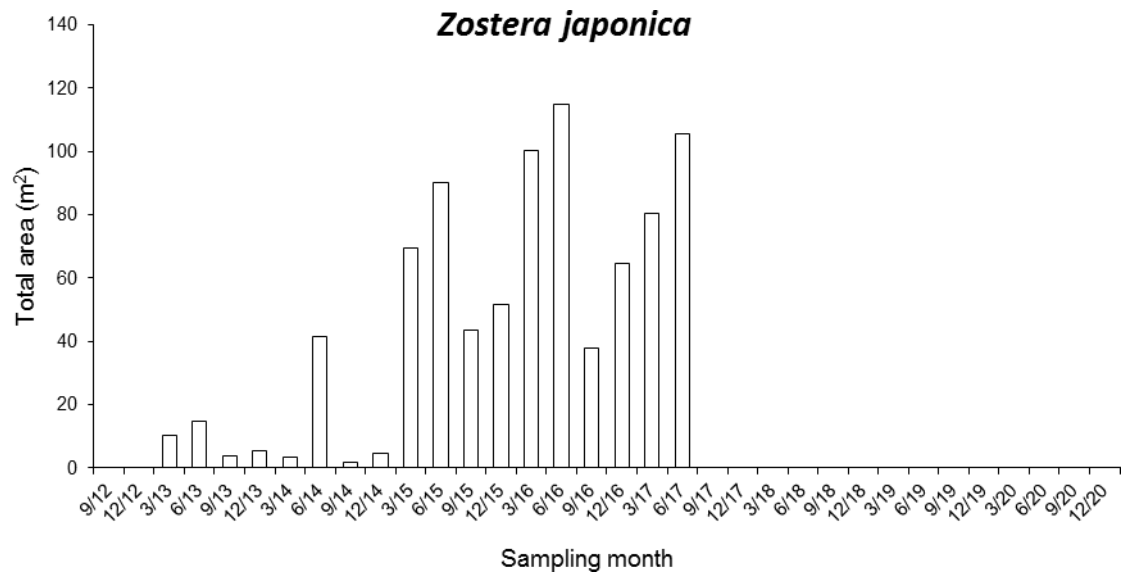
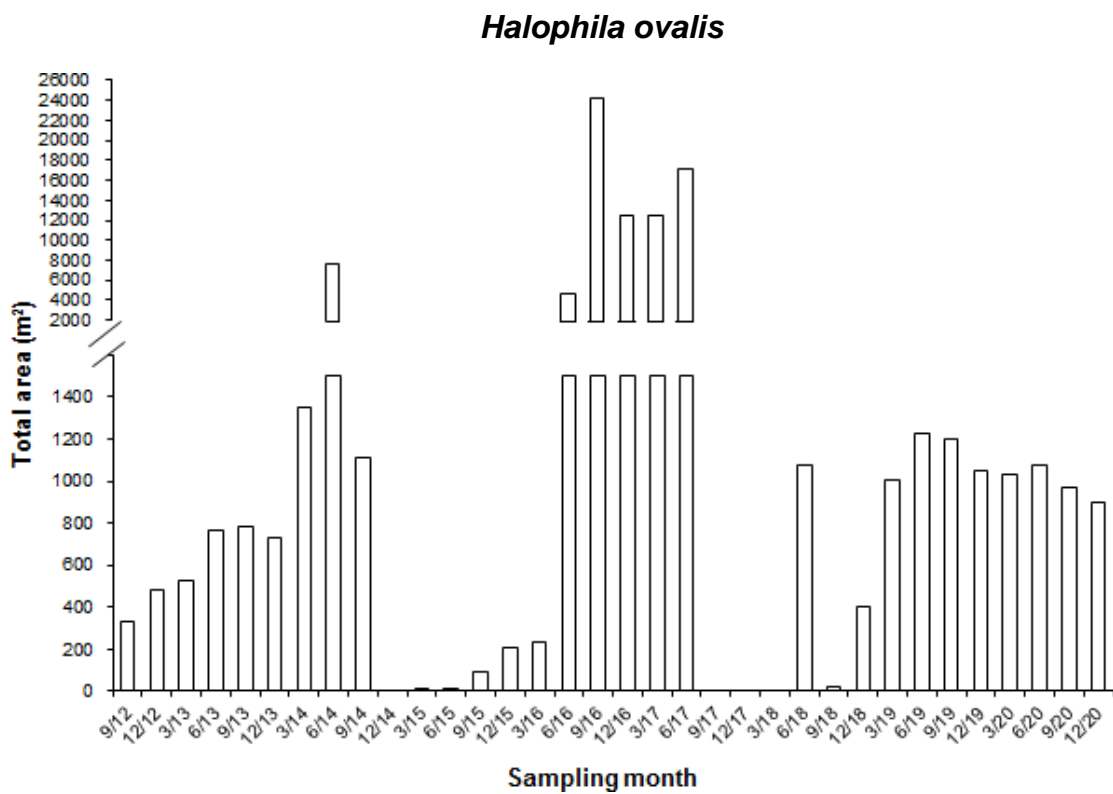
Figure 3.11 Temporal changes of estimated total area of seagrass beds in ST

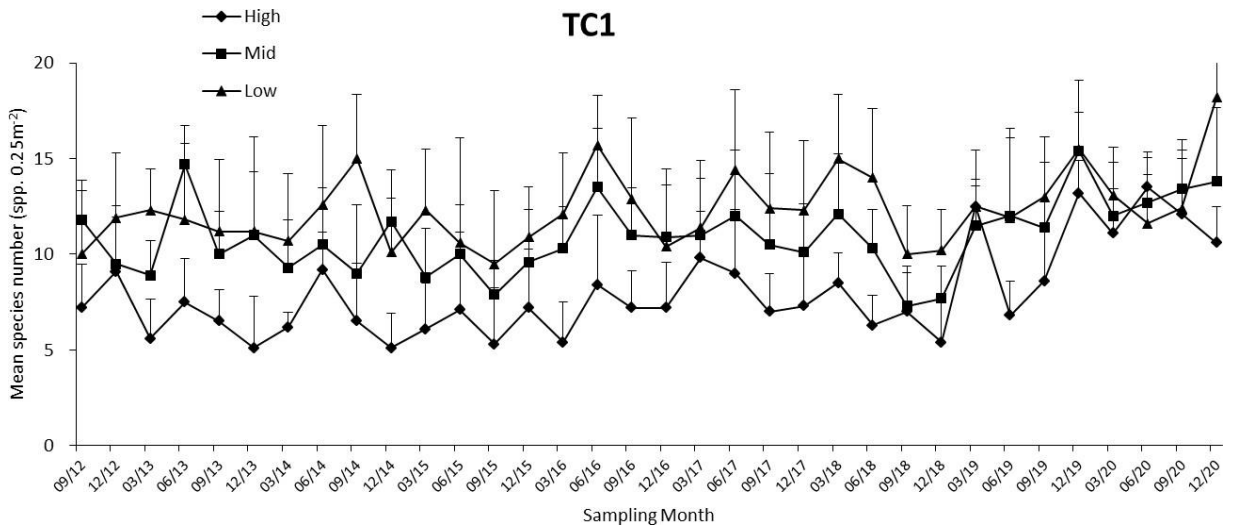
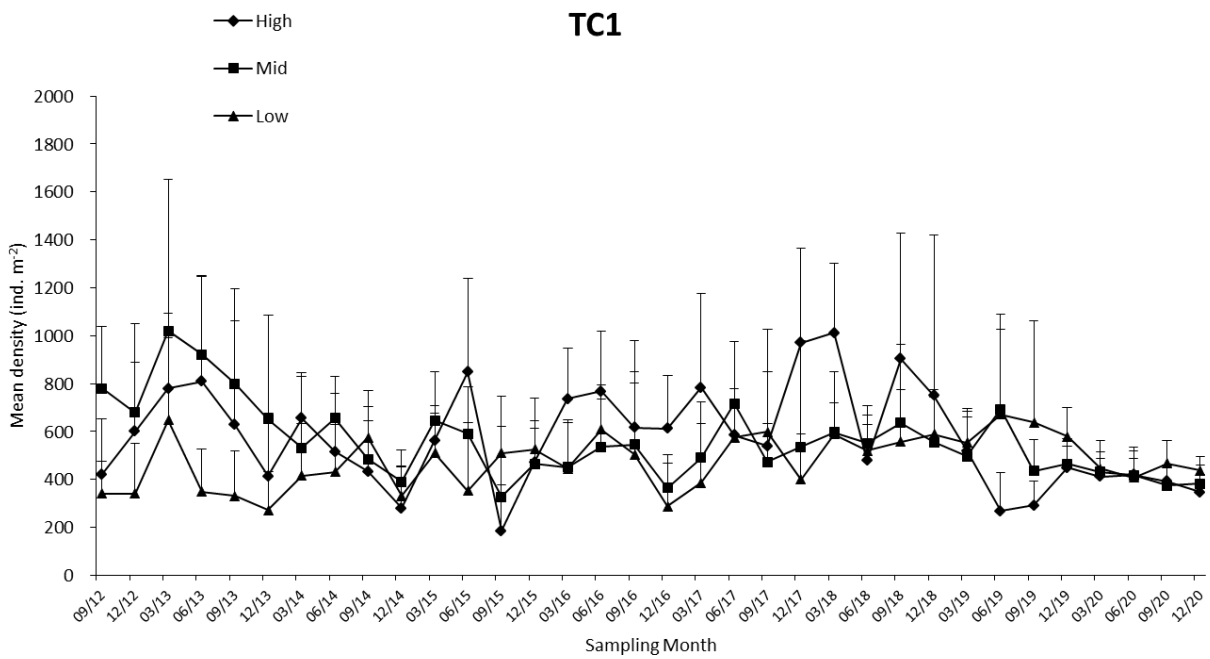
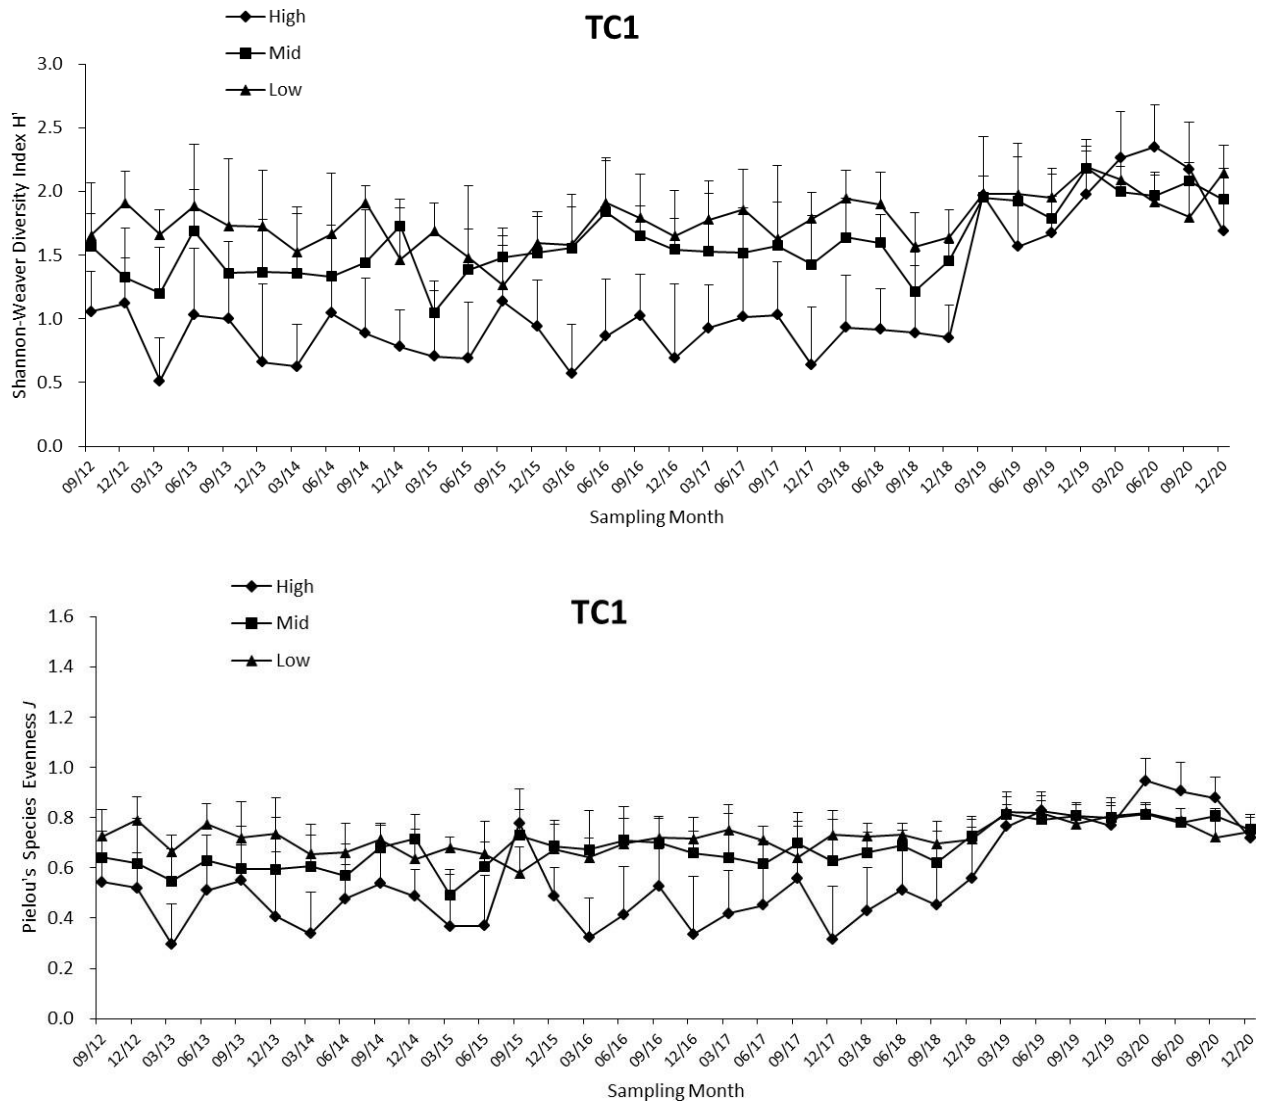
Figure 3.14 Temporal changes of mean number of species, mean density, Shannon-Weaver Diversity Index (H') and Pielou's Species Evenness (J) (mean + SD) at every tidal level in sampling zone TC1

Figure 3.14(Cont'd) Temporal changes of mean number of species, mean density, Shannon-Weaver Diversity Index (H') and Pielou's Species Evenness (J) (mean + SD) at every tidal level in sampling zone TC1

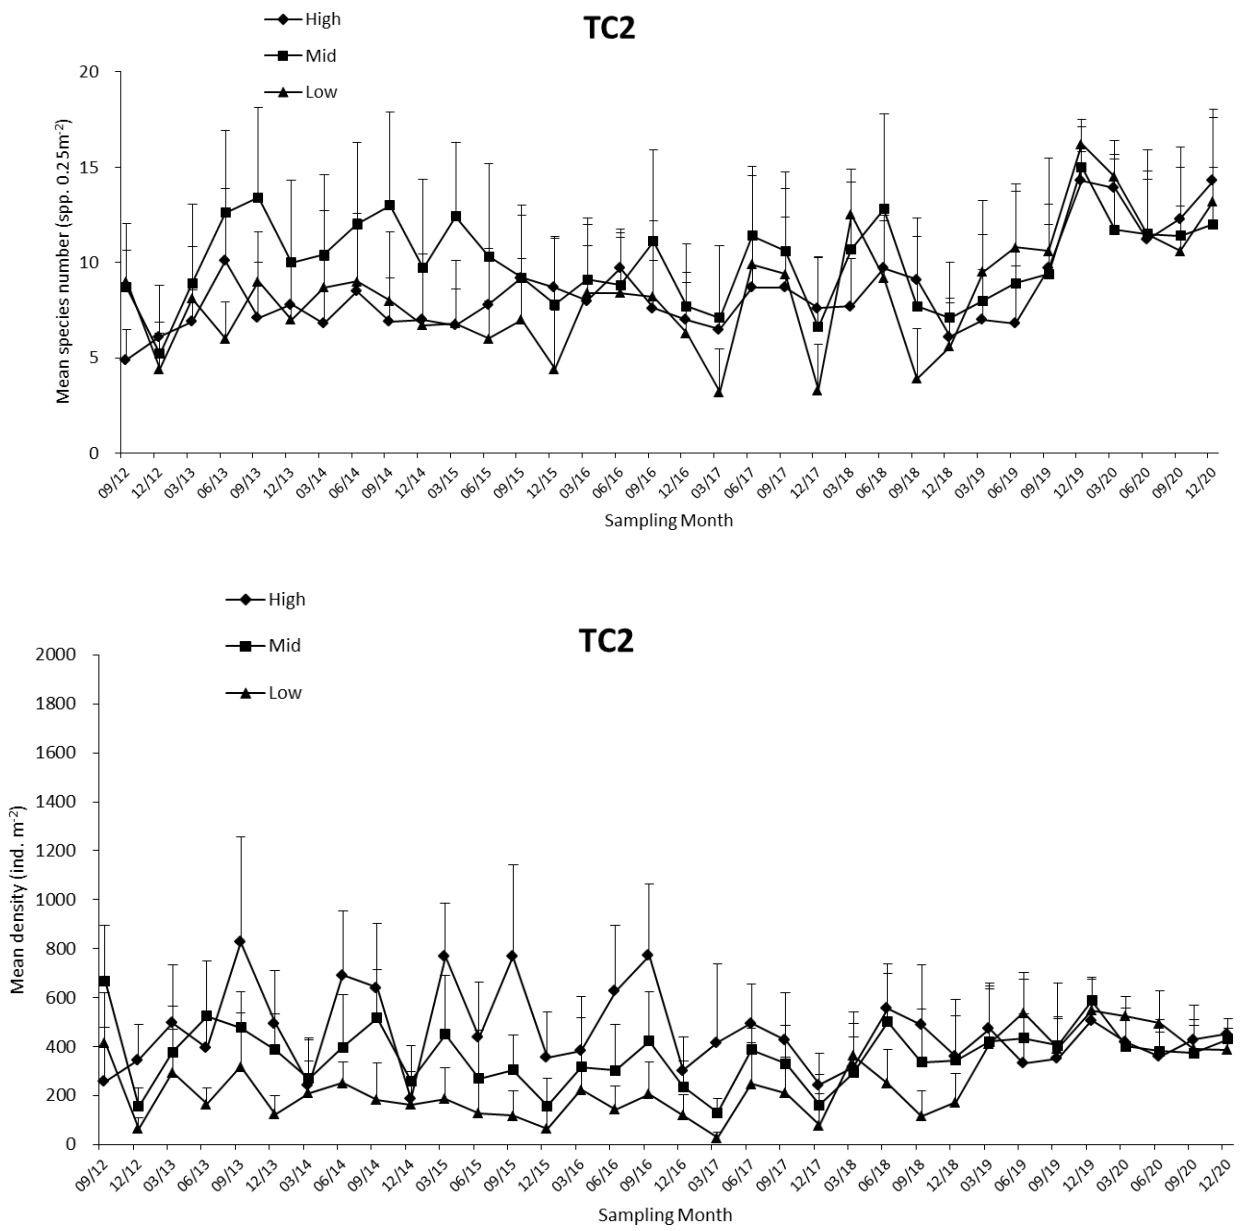
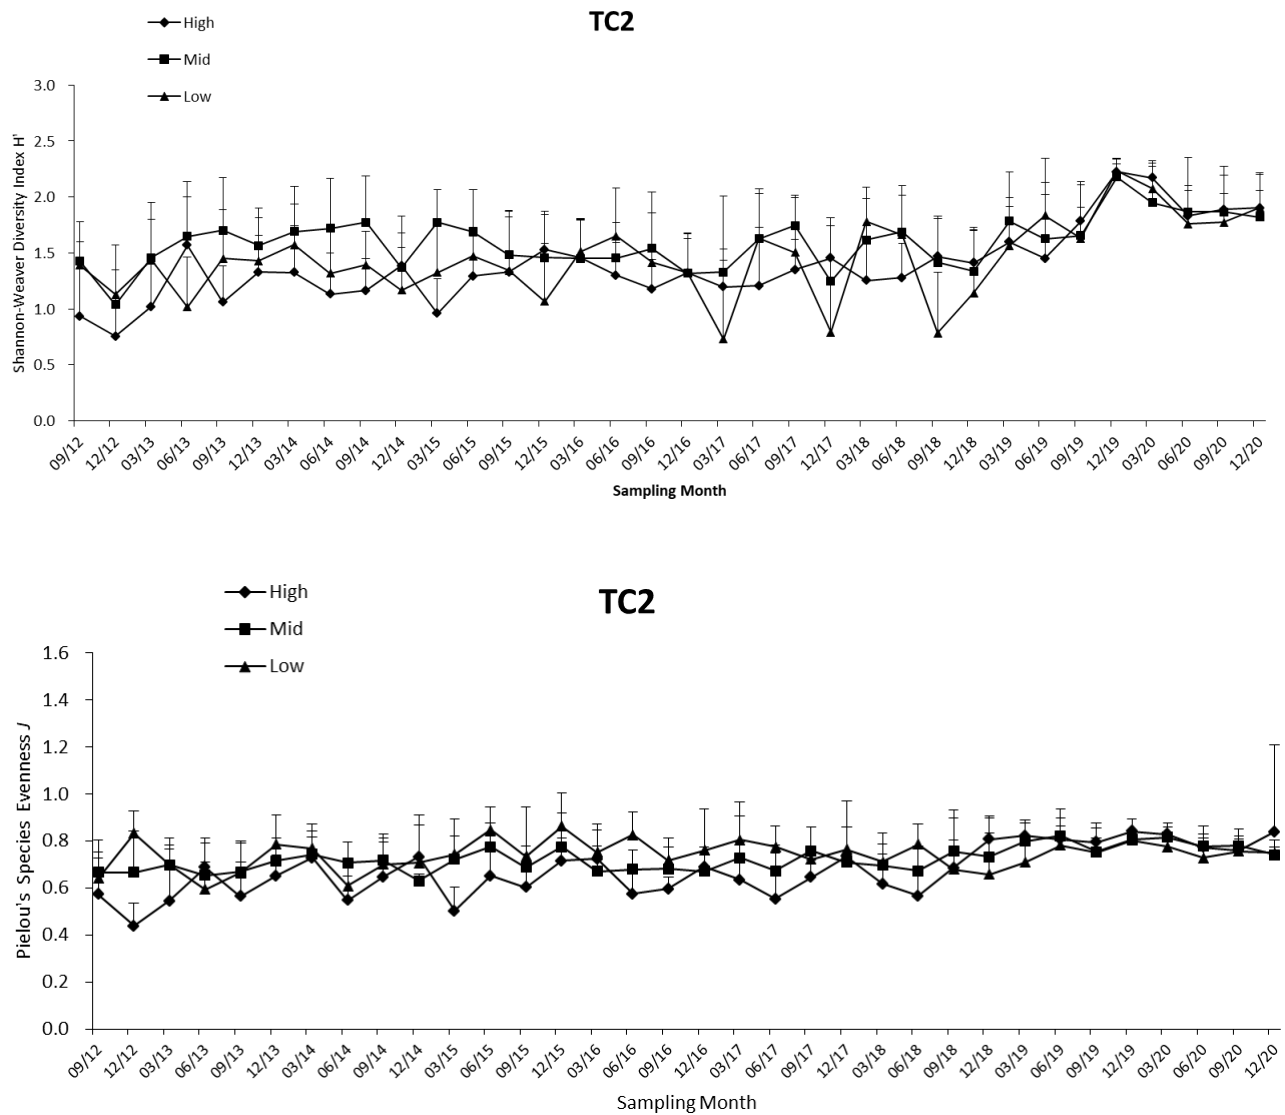
Figure 3.15 Temporal changes of mean number of species, mean density, Shannon-Weaver Diversity Index (H') and Pielou's Species Evenness (J) (mean + SD) at every tidal level in sampling zone TC2

Figure3.15(Cont'd) Temporal changes of mean number of species, mean density, Shannon-Weaver Diversity Index (H') and Pielou's Species Evenness (J) (mean + SD) at every tidal level in sampling zone TC2
