Contract No. HY/2011/03

**Hong Kong-Zhuhai-Macao Bridge Hong Kong Link Road
Section between Scenic Hill and Hong Kong Boundary Crossing
Facilities**

Quarterly EM&A Report No. 34 (December 2020 to February 2021)

25 March 2021

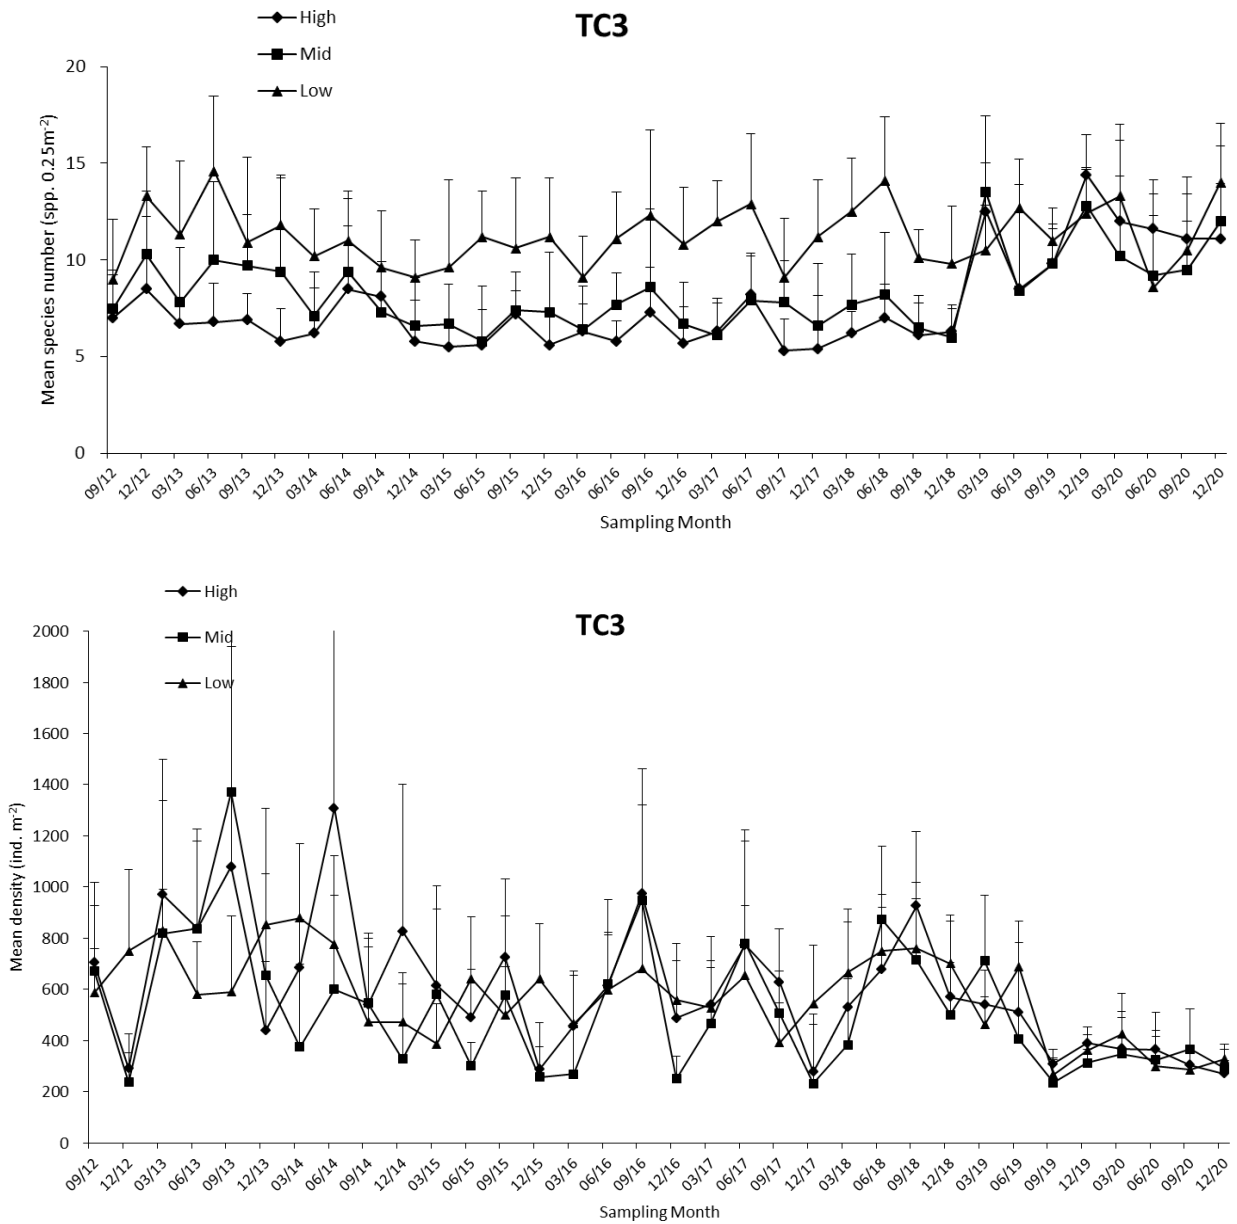
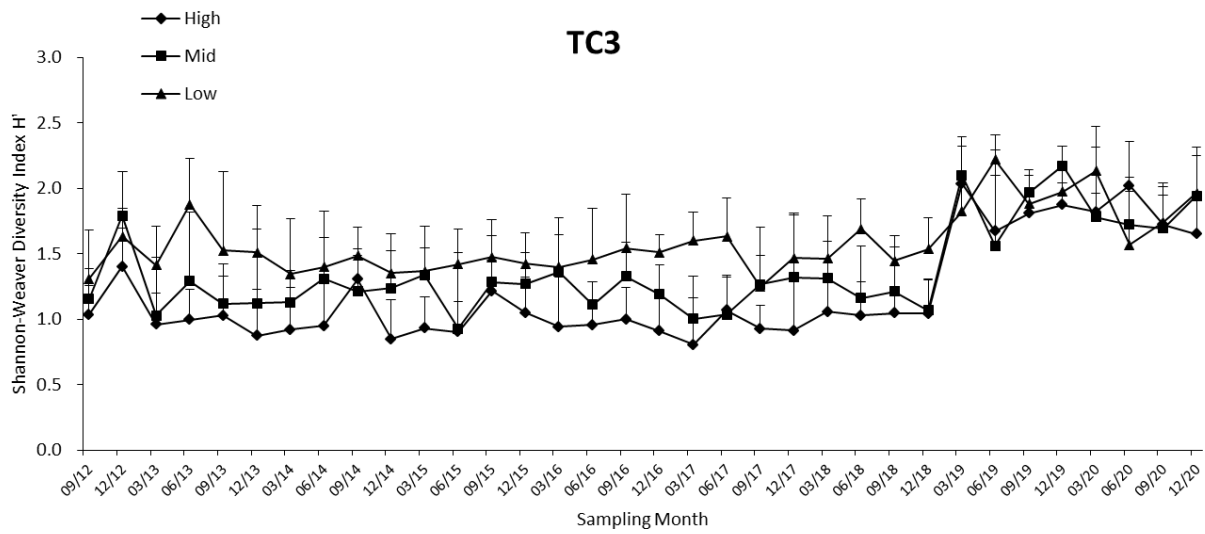
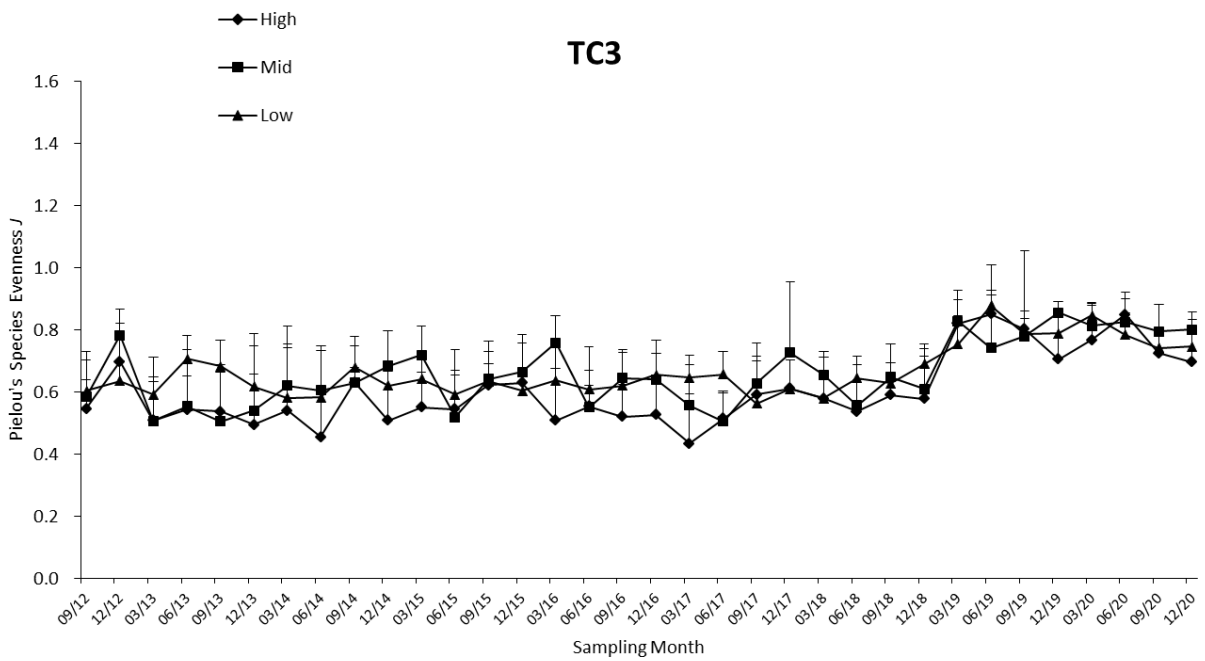
Figure 3.16 Temporal changes of mean number of species, mean density, Shannon-Weaver Diversity Index (H') and Pielou's Species Evenness (J) (mean + SD) at every tidal level in sampling zone TC3

Figure 3.16(Cont'd) Temporal changes of mean number of species, mean density, Shannon-Weaver Diversity Index (H') and Pielou's Species Evenness (J) (mean + SD) at every tidal level in sampling zone TC3

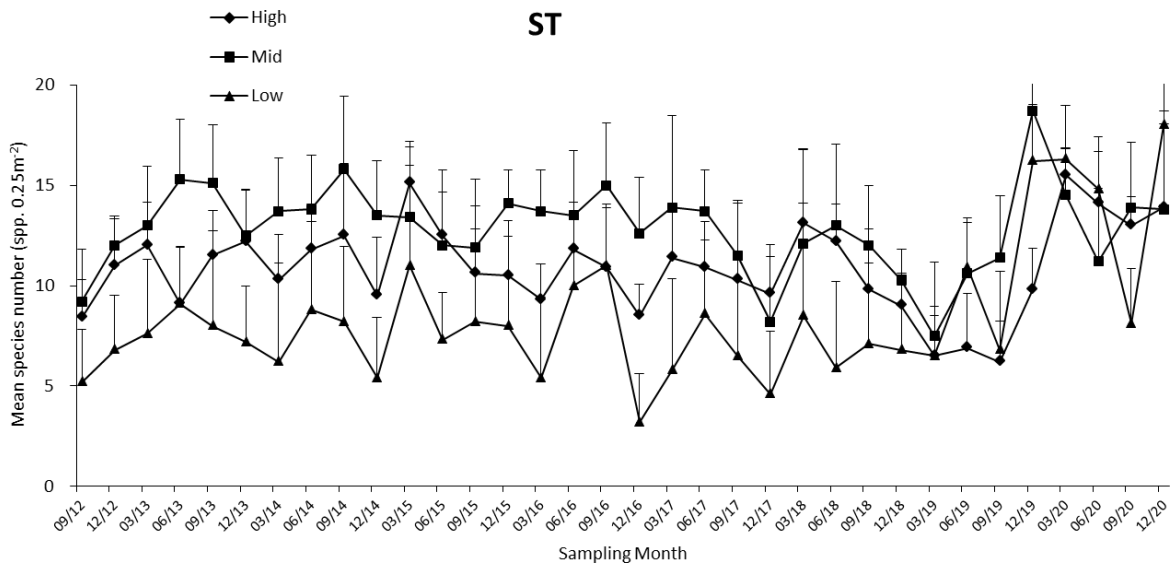
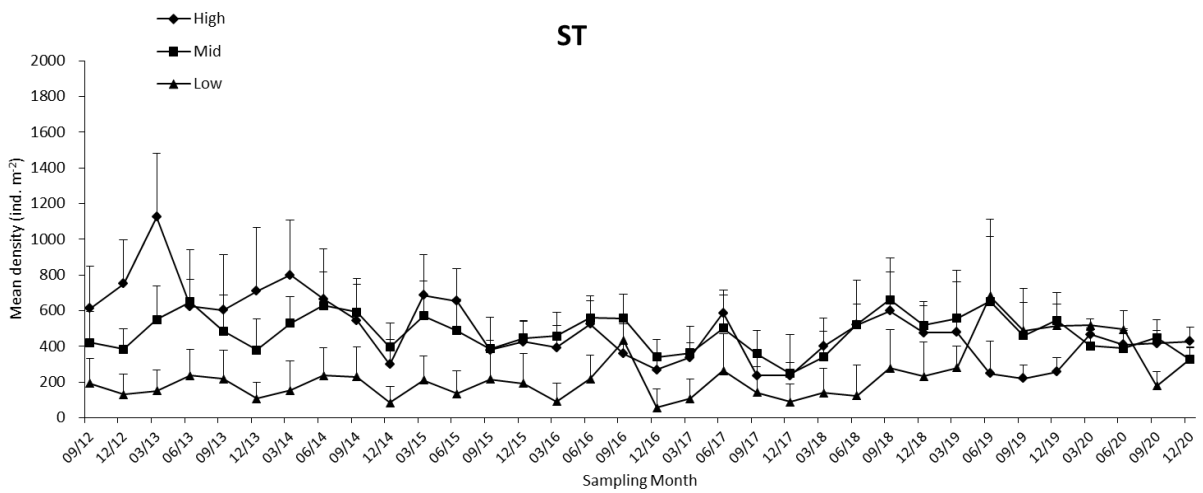
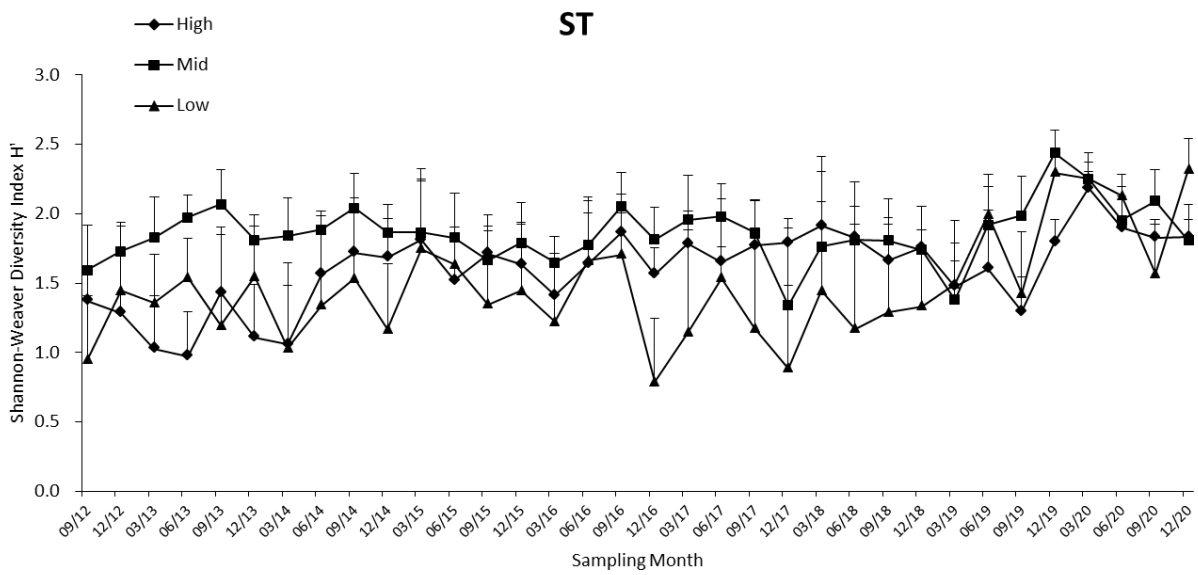
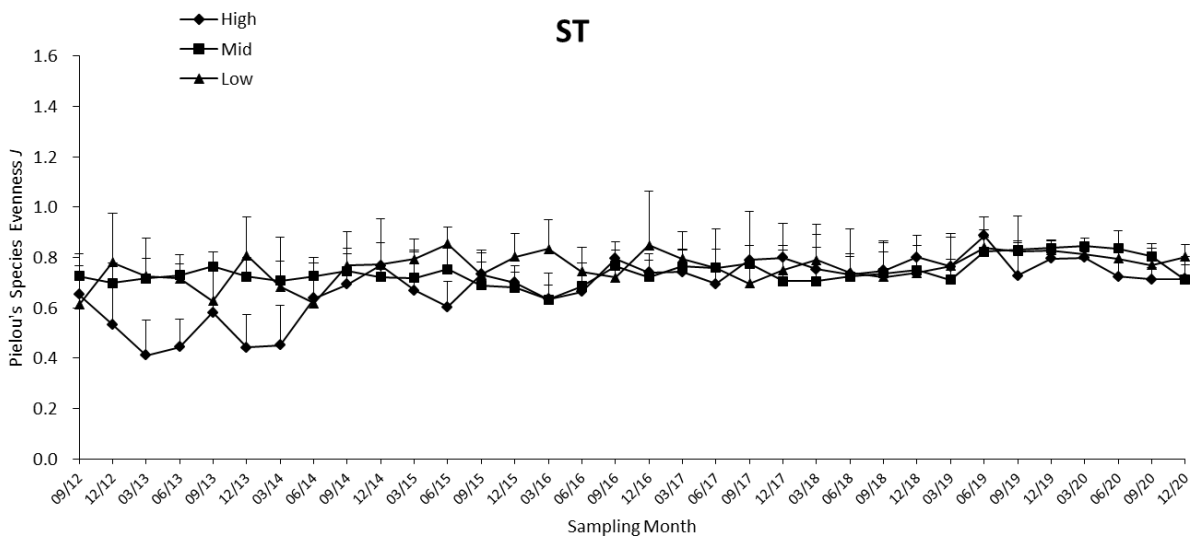
Figure 3.17 Temporal changes of mean number of species, mean density, Shannon-Weaver Diversity Index (H') and Pielou's Species Evenness (J) (mean + SD) at every tidal level in sampling zone S

Figure 3.17(Cont'd) Temporal changes of mean number of species, mean density, Shannon-Weaver Diversity Index (H') and Pielou's Species Evenness (J) (mean + SD) at every tidal level in sampling zone ST
