Contract No. HY/2011/03

**Hong Kong-Zhuhai-Macao Bridge Hong Kong Link Road
Section between Scenic Hill and Hong Kong Boundary Crossing
Facilities**

Quarterly EM&A Report No. 35 (March 2021 to May 2021)

6 July 2021

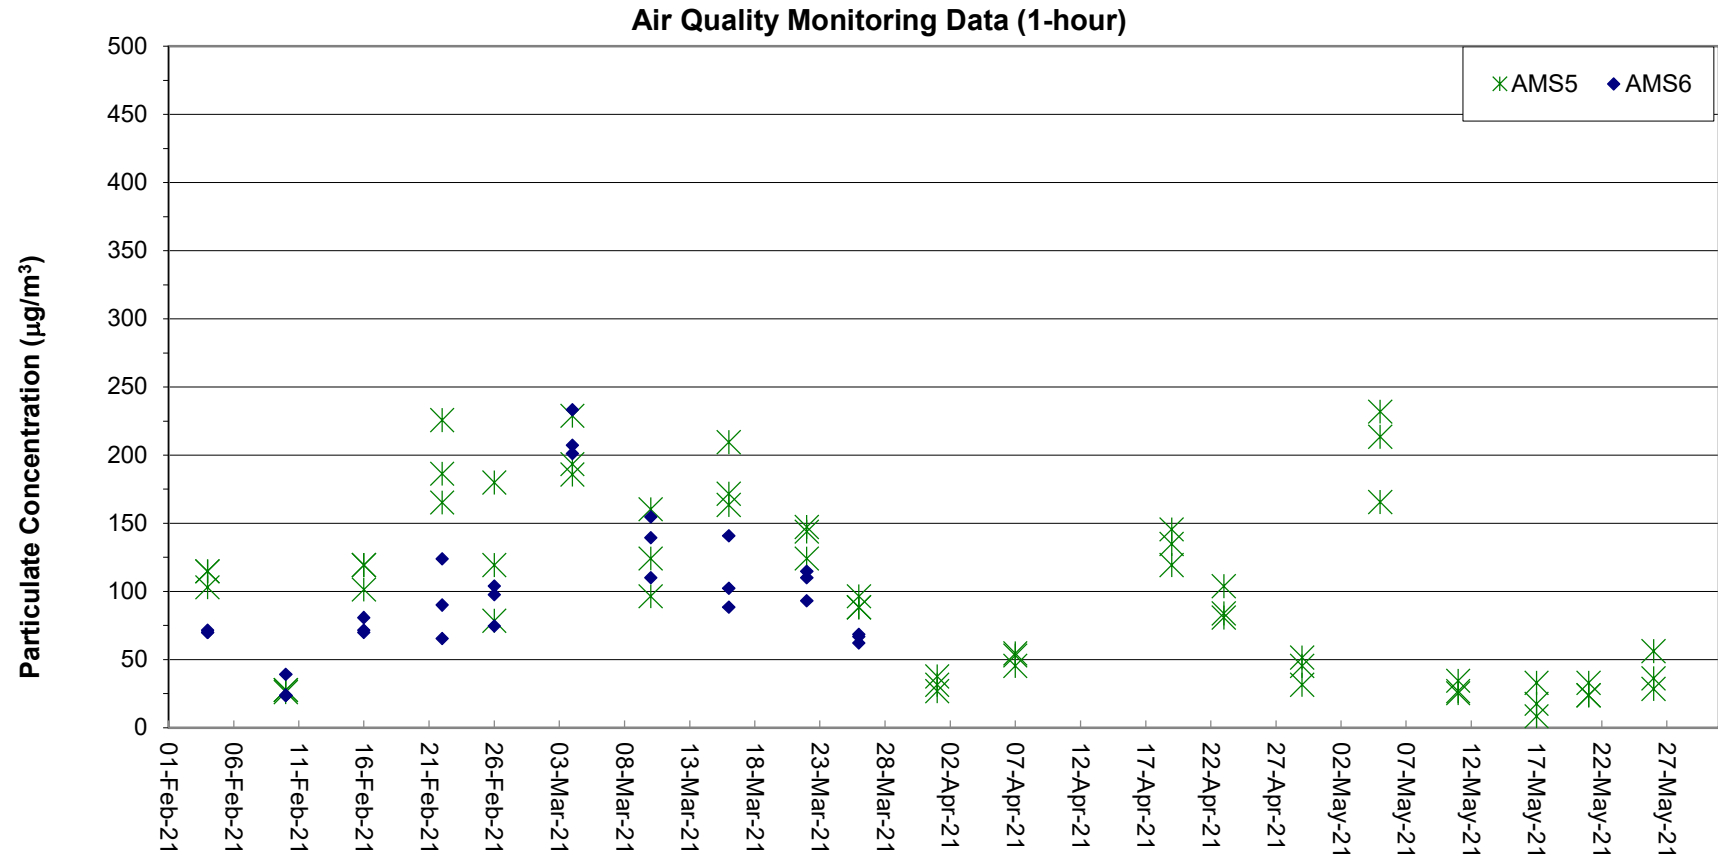
Graphical Plot of 1-hour TSP at AMS5 and AMS6

1) The existing air quality monitoring location AMS6 - Dragonair / CNAC (Group) Building (HKIA) was handed over to Airport Authority Hong Kong on 31 March 2021. 1-hr TSP monitoring at AMS6 was temporarily suspended starting from 1 April 2021.

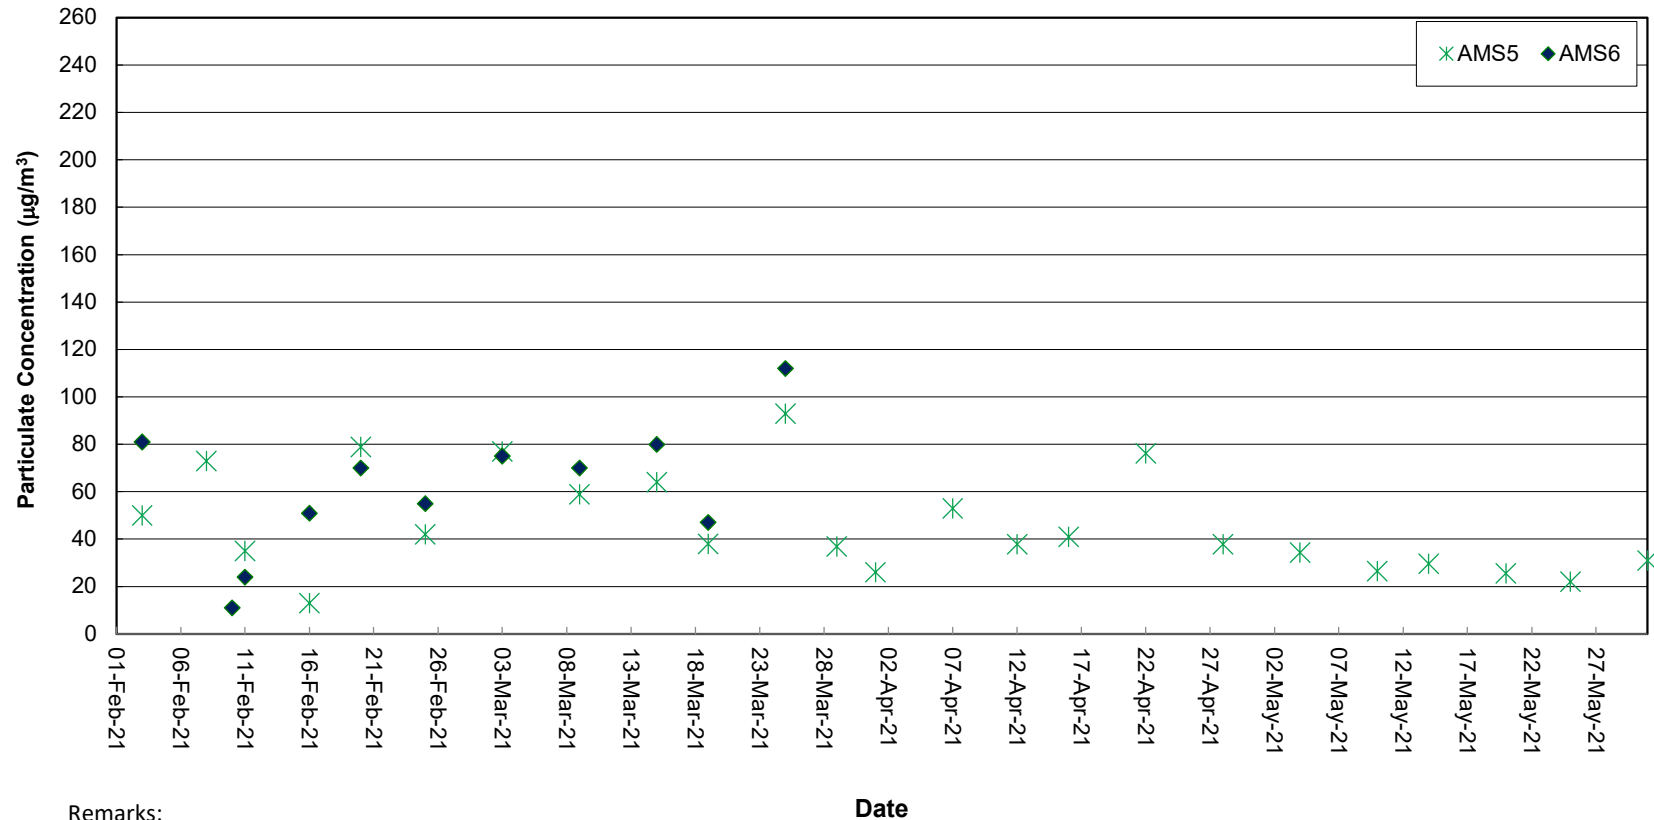
Graphical Plot of 24-hour TSP at AMS5 and AMS6

- 1) Due to timer problem at monitoring station AMS6 - Dragonair / CNAC (Group) Building (HKIA), 24-hr TSP monitoring at AMS6 was rescheduled from 8 February 2021 to 10 February 2021.
- 2) Due to motor failure of HVS at monitoring station AMS6 - Dragonair / CNAC (Group) Building (HKIA), 24-hr TSP monitoring at AMS6 on 29 March 2021 was cancelled.
- 3) The existing air quality monitoring location AMS6 - Dragonair / CNAC (Group) Building (HKIA) was handed over to Airport Authority Hong Kong on 31 March 2021. 24-hr TSP monitoring at AMS6 was temporarily suspended starting from 1 April 2021.

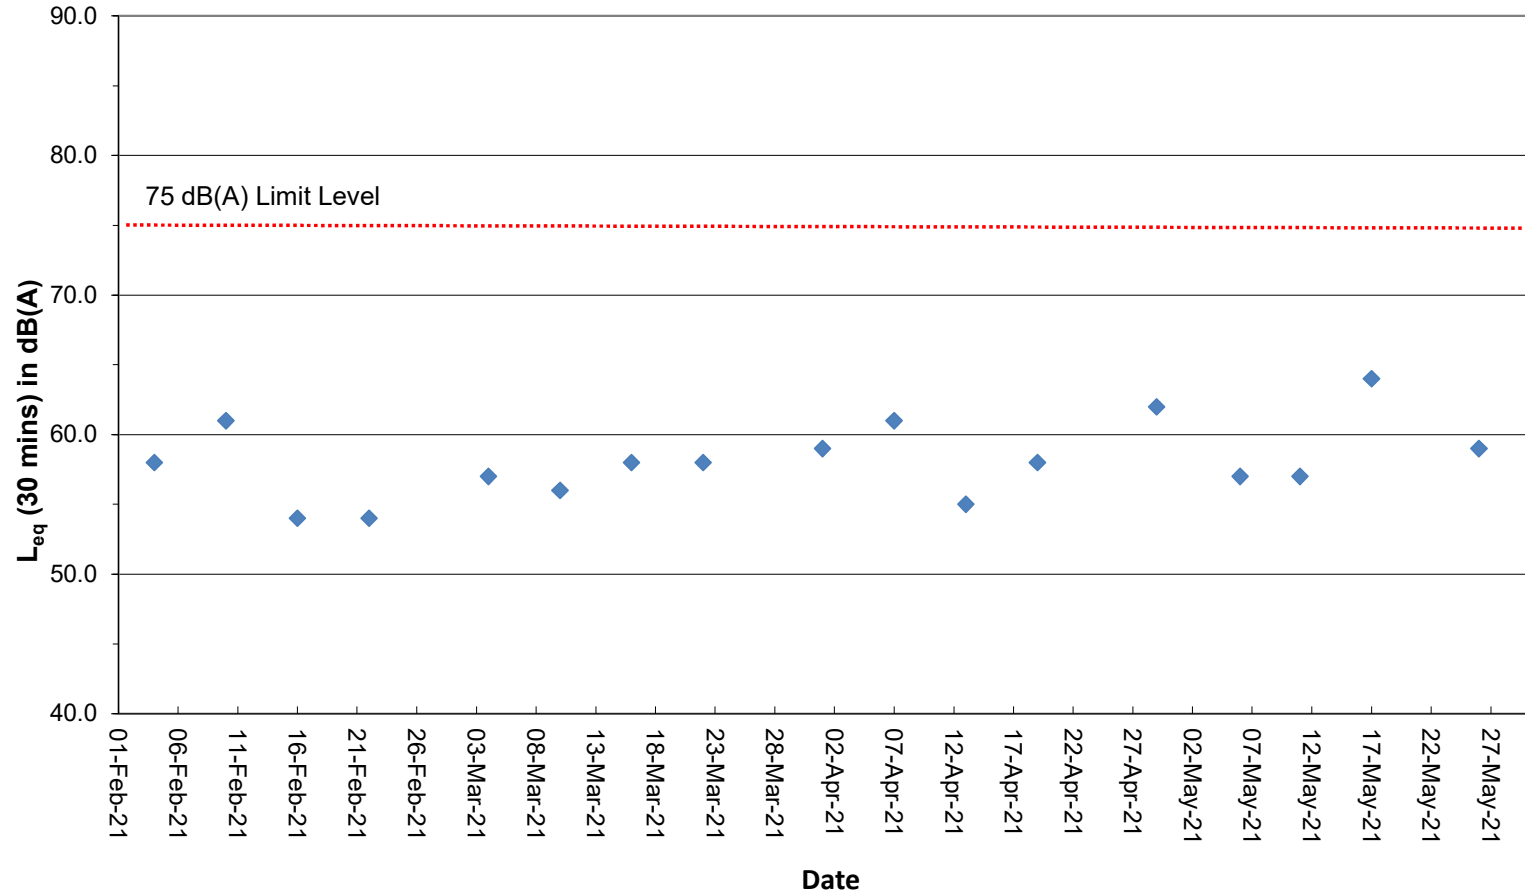
Graphical Plot of Noise Levels at NMS5

(1) A facade correction of +3 dB(A) was applied to the measured noise level.

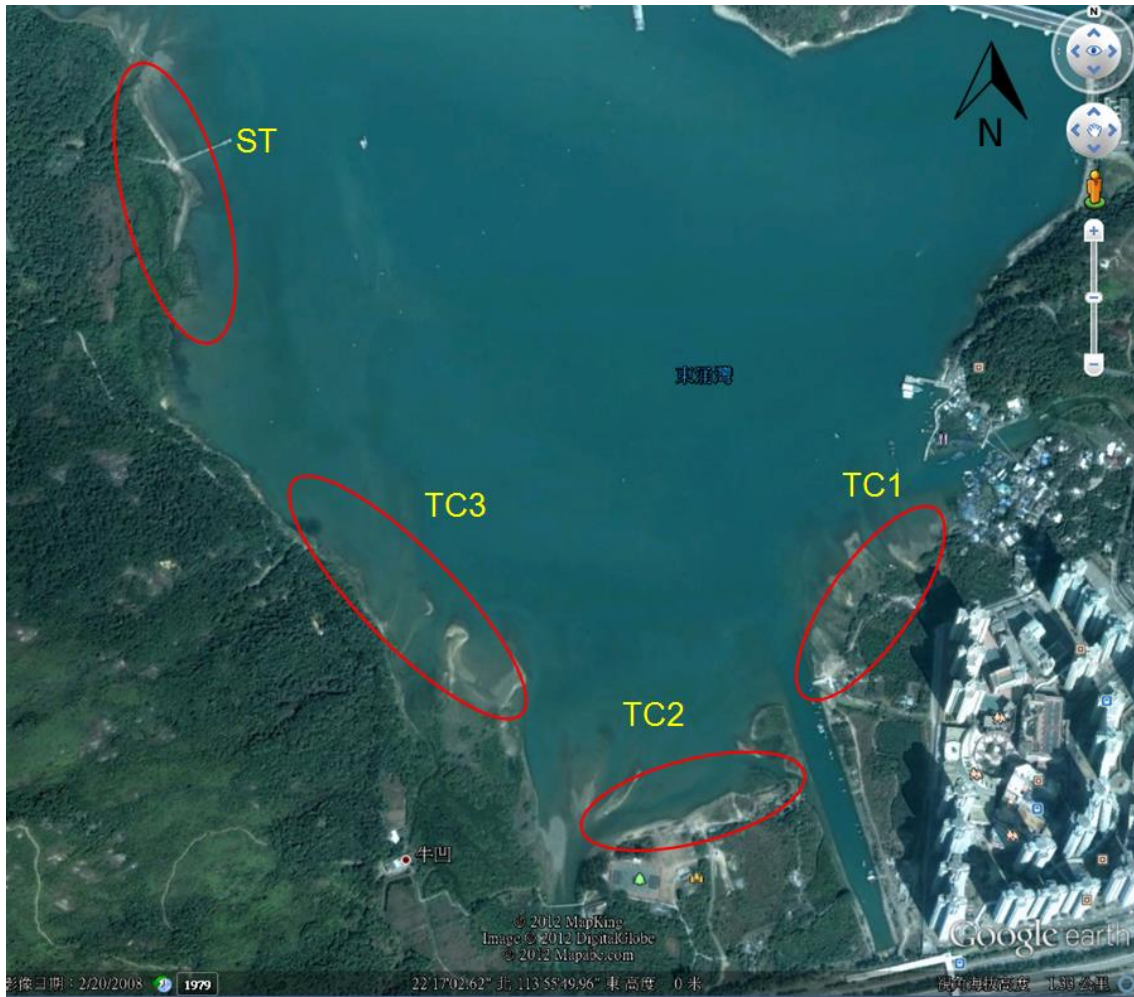
Figure 2.1 Locations of sampling zones. The study site was divided into three sampling zones (TC1, TC2, TC3) in Tung Chung Bay and one zone in San Tau (ST) (map generated from Google Map).

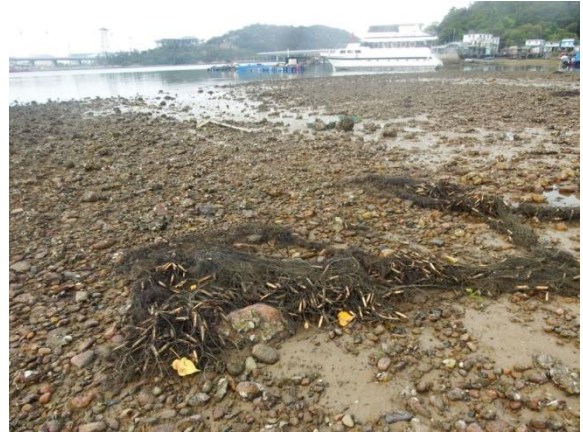
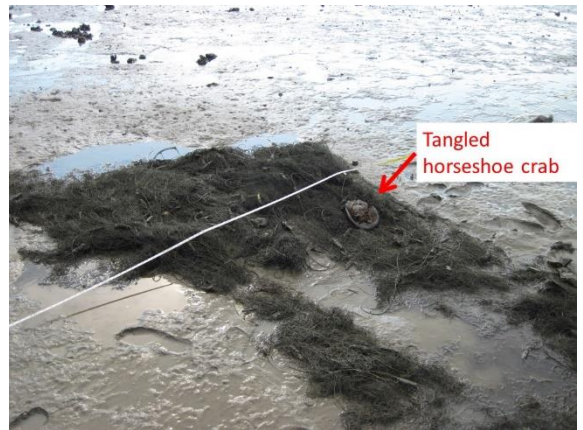
Figure 2.3 *Examples of photographic record of the big trashes found on the mudflat.*

- 3.6.7 Since the field survey of June 2016, increasing number of trashes and even big trashes (**Figure 2.3 of Appendix O**) were found in every sampling zone. It raised a concern about the solid waste dumping and current-driven waste issues in Tung Chung Wan. Respective measures (e.g. manual clean-up) should be implemented by responsible governmental agency units.

Plastic waste

Trash gill net

Trash gill net and hand trolley

A tangled horseshoe crab on a trash net
(record in June 2017)

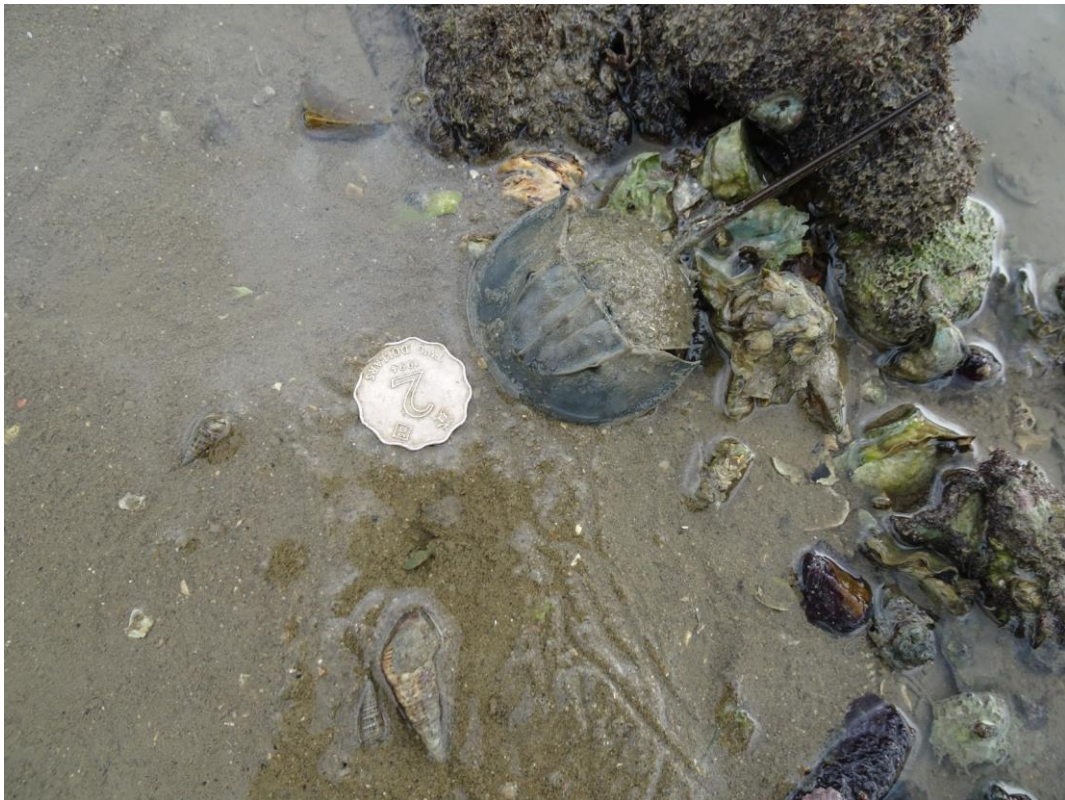
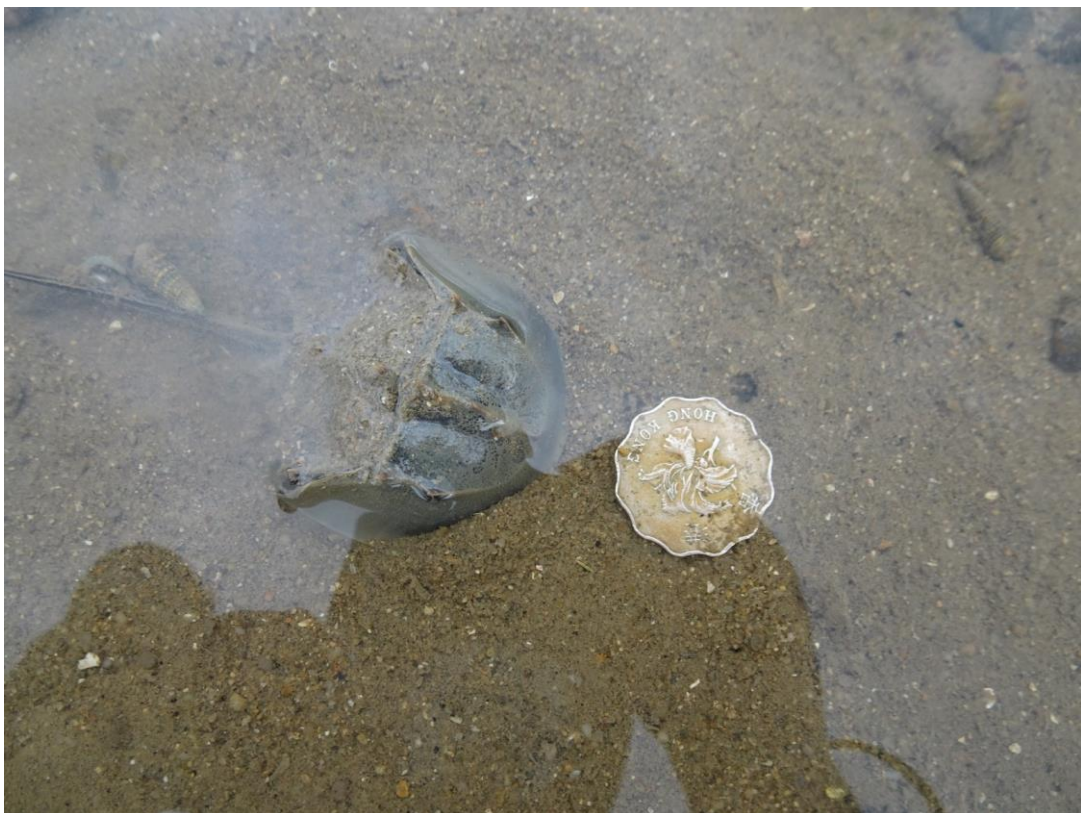
Figure 3.1 Examples of photographic records of horseshoe crab (March 2021)

- 3.6.16 In total of 22 and 18 individuals of *Carcinoscorpius rotundicauda* and *Tachypleus tridentatus* were found in present survey. The recorded individuals were mainly distributed along the shoreline in ST and TC3. All of them were observed on similar substratum (fine sand or soft mud, slightly submerged). Photo records of the observed horseshoe crab are shown in **Figure 3.1 of Appendix O** and the present survey result regarding horseshoe crab are presented in **Table 3.1 of Appendix O**. The complete survey records are presented in **Annex II of Appendix O**.

ST *Carcinoscorpius rotundicauda*

ST *Tachypleus tridentatus*

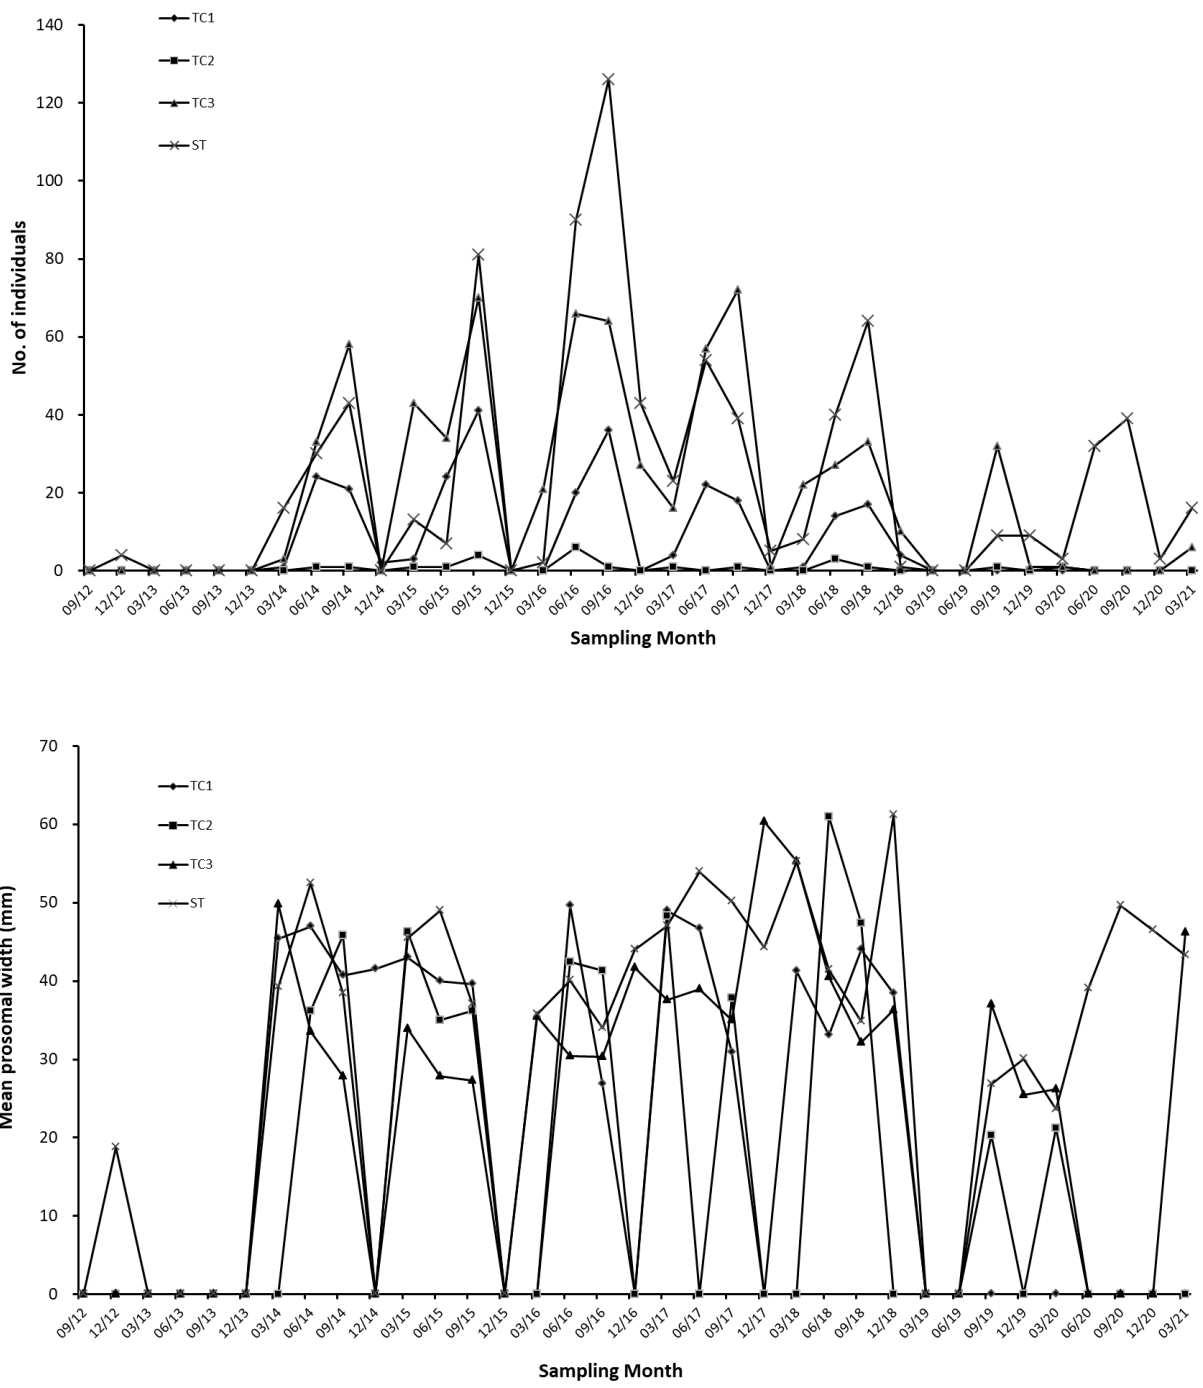
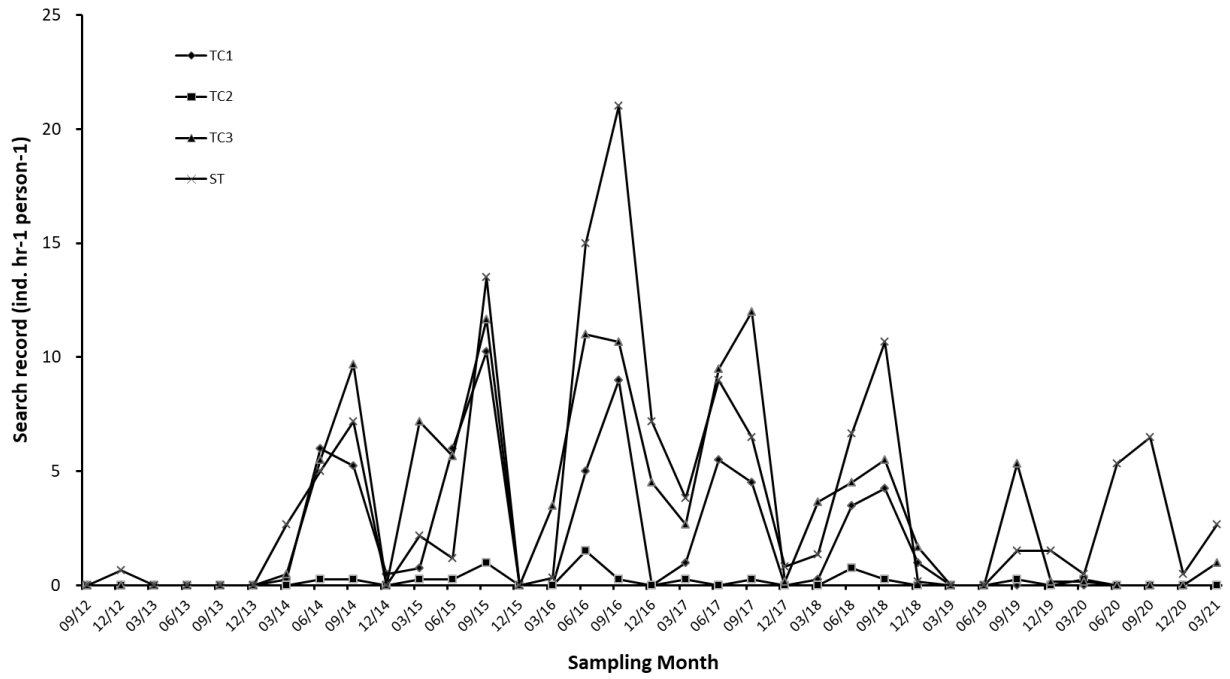
Figure 3.5 Changes of number of individuals mean prosomal width and search record of horseshoe crab *Carcinoscorpius rotundicauda* in every sampling zone along the sampling months

- 3.6.29 Throughout the monitoring period, the search records of horseshoe crabs were fluctuated and at moderate – very low level in June (**Figures 3.5 and 3.6 of Appendix O**). Low – Very low search record was found in June 2013, totally 82 individuals of *Tachypleus tridentatus* and 0 ind. of *Carcinoscorpius rotundicauda* were found in TC1, TC3 and ST. Compare with the search record of June 2013, the numbers of *Tachypleus tridentatus* were gradually decreased in June 2014 and 2015 (55 ind. in 2014 and 18 ind. in 2015); the number of *Carcinoscorpius rotundicauda* raise to 88 and 66 individuals. in June 2014 and 2015 respectively. In June 2016, the search record increased about 3 times compare with June 2015. In total, 182 individuals of *Carcinoscorpius rotundicauda* and 47 individuals. of *Tachypleus tridentatus* were noted, respectively. Then, the search record was similar to June 2016. The number of recorded *Carcinoscorpius rotundicauda* (133 ind.) slightly dropped in June 2017. However, that of *Tachypleus tridentatus* rapidly increased (125 ind.). In June 2018, the search record was low to moderate while the numbers of *Tachypleus tridentatus* dropped sharply (39 ind.). In June 2019, 10 individuals of *Tachypleus tridentatus* were observed in TC3 and ST. All of them, however, were large individuals (prosomal width >100mm), their records are excluded from the data analysis to avoid mixing up with the juvenile population living on intertidal habitat. Until September 2020, the number of *Carcinoscorpius rotundicauda* and *Tachypleus tridentatus* gradually increased to 39 ind. and 28 ind., respectively. In December 2020, the number of *Carcinoscorpius rotundicauda* and *Tachypleus tridentatus* greatly decreased to 3 ind. and 7 ind.,

- 3.6.30 The search record of horseshoe crab declined obviously in all sampling zones during dry season especially December (**Figures 3.5 and 3.6 of Appendix O**) throughout the monitoring period. Very low – low search record was found in December from 2012 to 2015 (0-4 ind. of *Carcinoscorpius rotundicauda* and 0-12 ind. of *Tachypleus tridentatus*). The horseshoe crabs were inactive and burrowed in the sediments during cold weather (<15 °C). Similar results of low search record in dry season were reported in a previous territory-wide survey of horseshoe crab. For example, the search records in Tung Chung Wan were 0.17 ind. hr⁻¹person⁻¹ and 0.00 ind. hr⁻¹ person⁻¹ in wet season and dry season respectively (details see Li, 2008). Compare with the search record of December from 2012 to 2015, which of December 2016 were much higher relatively. There were totally 70 individuals of *Carcinoscorpius rotundicauda* and 24 individuals of *Tachypleus tridentatus* in TC3 and ST. Since the survey was carried in earlier December with warm and sunny weather (~22 °C during dawn according to Hong Kong Observatory database, Chek Lap Kok station on 5 December 2016), the horseshoe crab was more active (i.e. move onto intertidal shore during high tide for foraging and breeding) and easier to be found. In contrast, there was no search record in TC1 and TC2 because the survey was conducted in mid-December with colder and cloudy weather (~20 °C during dawn on 19 December). The horseshoe crab activity would decrease gradually with the colder climate. In December of 2017, 2018 and 2019, very low search records were found again as mentioned above.

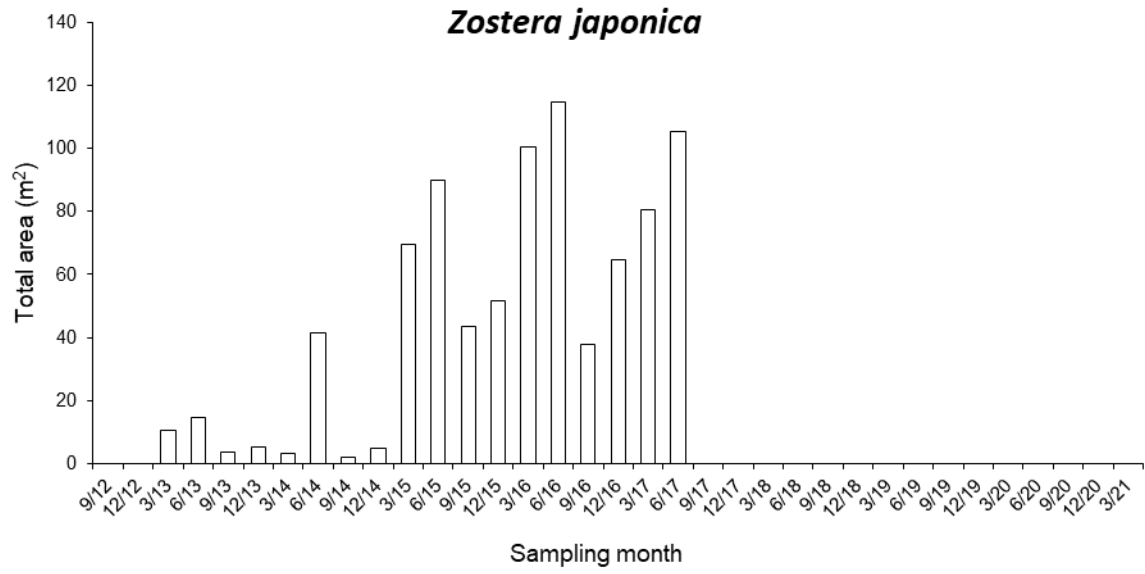
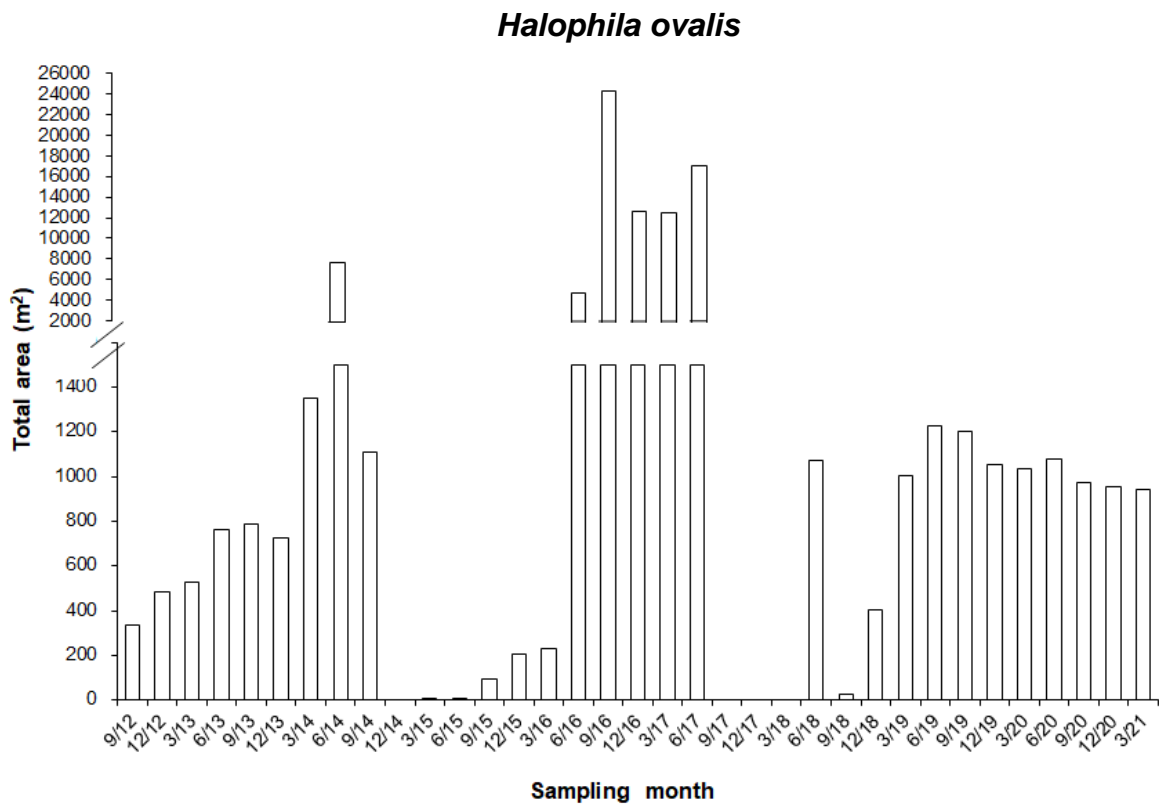
Figure 3.11 Temporal changes of estimated total area of seagrass beds in ST

Sampling zone	TC3 <i>Halophila ovalis</i>	ST <i>Halophila ovalis</i>
Number of patches	10	8
Total area (m²)	238.25	942.05
Average area (m²)	21.66	117.76
