Contract No. HY/2011/03

**Hong Kong-Zhuhai-Macao Bridge Hong Kong Link Road
Section between Scenic Hill and Hong Kong Boundary Crossing
Facilities**

Quarterly EM&A Report No. 36 (June 2021 to August 2021)

29 September 2021

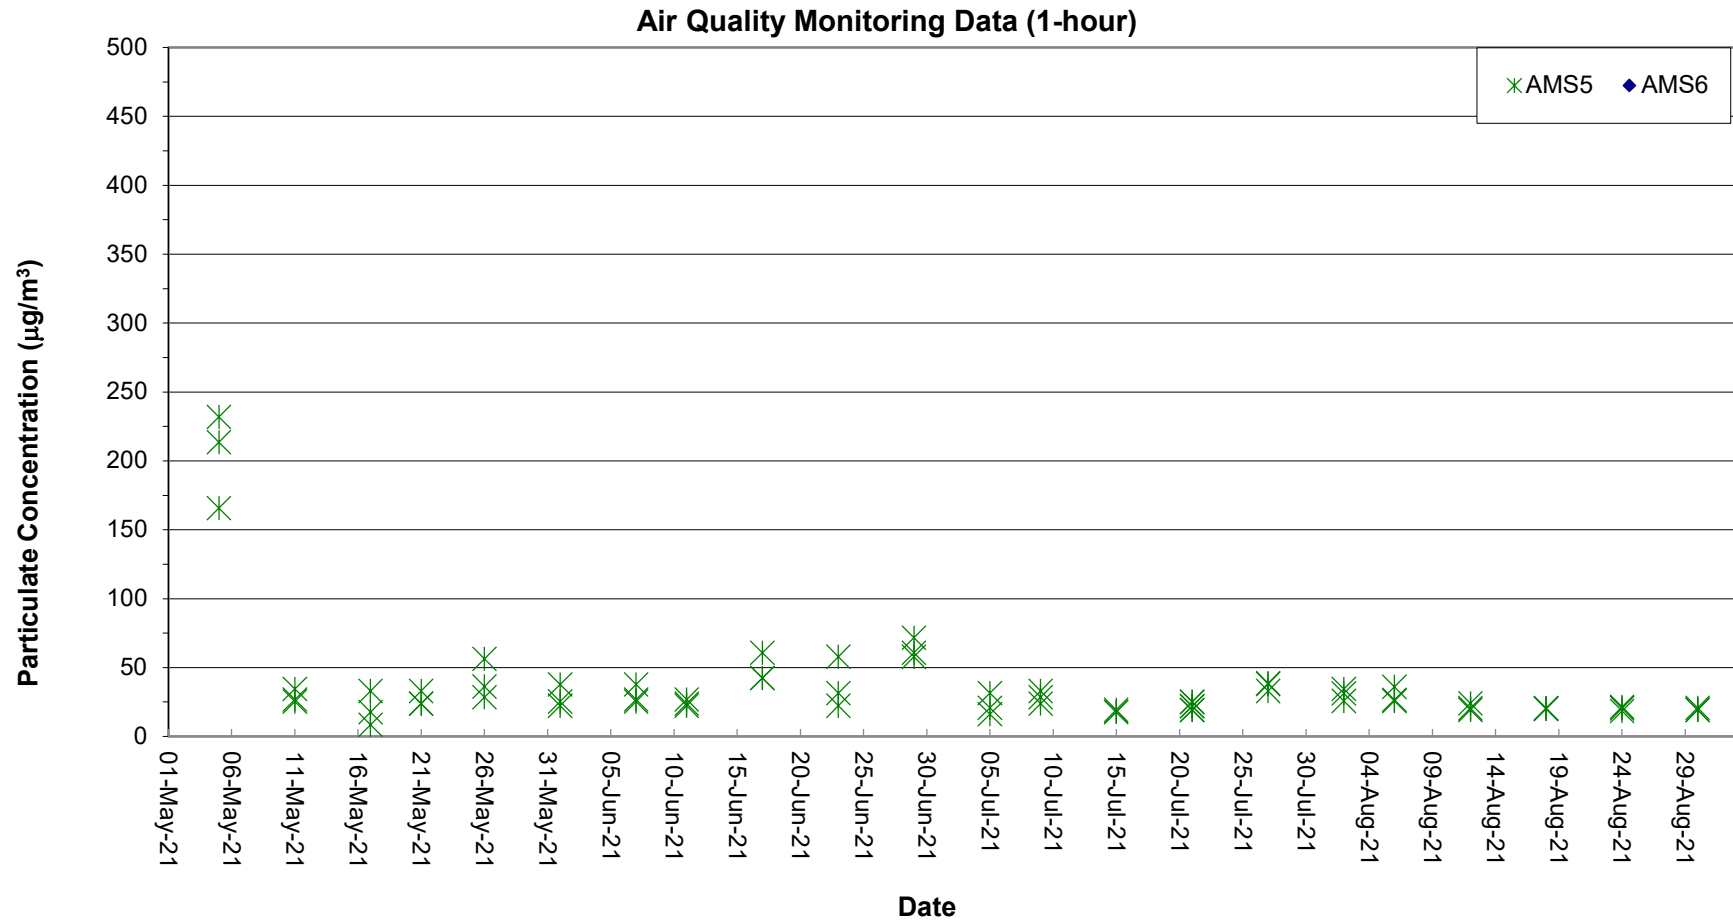
Graphical Plot of 1-hour TSP at AMS5 and AMS6

1) The existing air quality monitoring location AMS6 - Dragonair / CNAC (Group) Building (HKIA) was handed over to Airport Authority Hong Kong on 31 March 2021. 1-hr TSP monitoring at AMS6 was temporarily suspended starting from 1 April 2021.

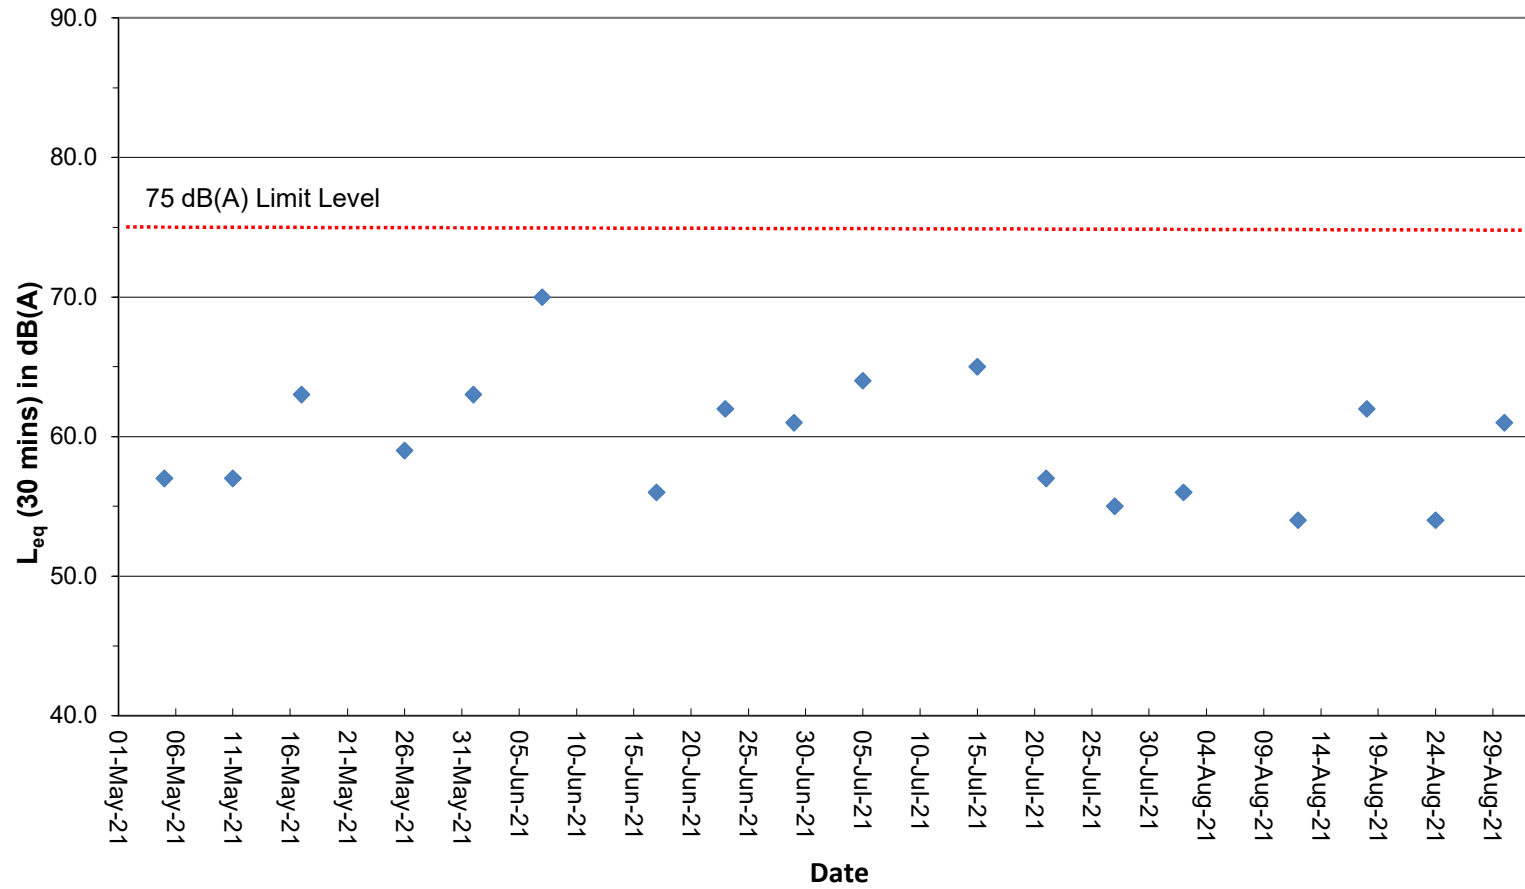
Graphical Plot of Noise Levels at NMS5

(1) A facade correction of +3 dB(A) was applied to the measured noise level.

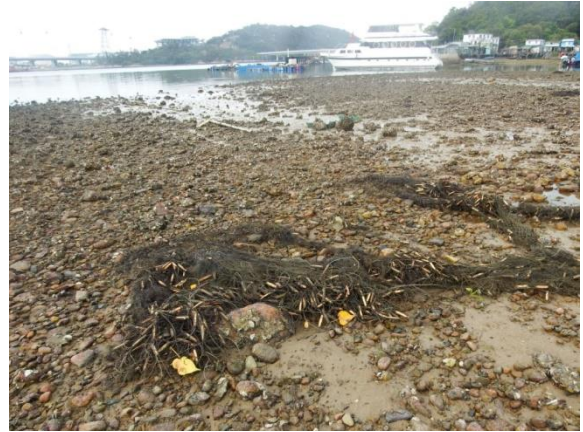
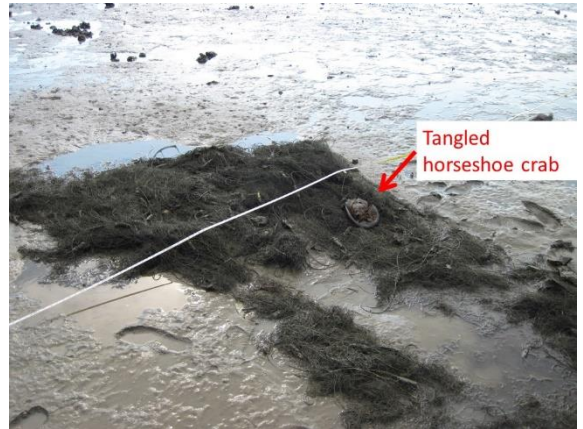
Figure 2.3 *Examples of photographic record of the big trashes found on the mudflat.*

- 3.6.7 Since the field survey of June 2016, increasing number of trashes and even big trashes (**Figure 2.3 of Appendix O**) were found in every sampling zone. It raised a concern about the solid waste dumping and current-driven waste issues in Tung Chung Wan. Respective measures (e.g. manual clean-up) should be implemented by responsible governmental agency units.

Plastic waste

Trash gill net

Trash gill net and hand trolley

A tangled horseshoe crab on a trash net
(record in June 2017)

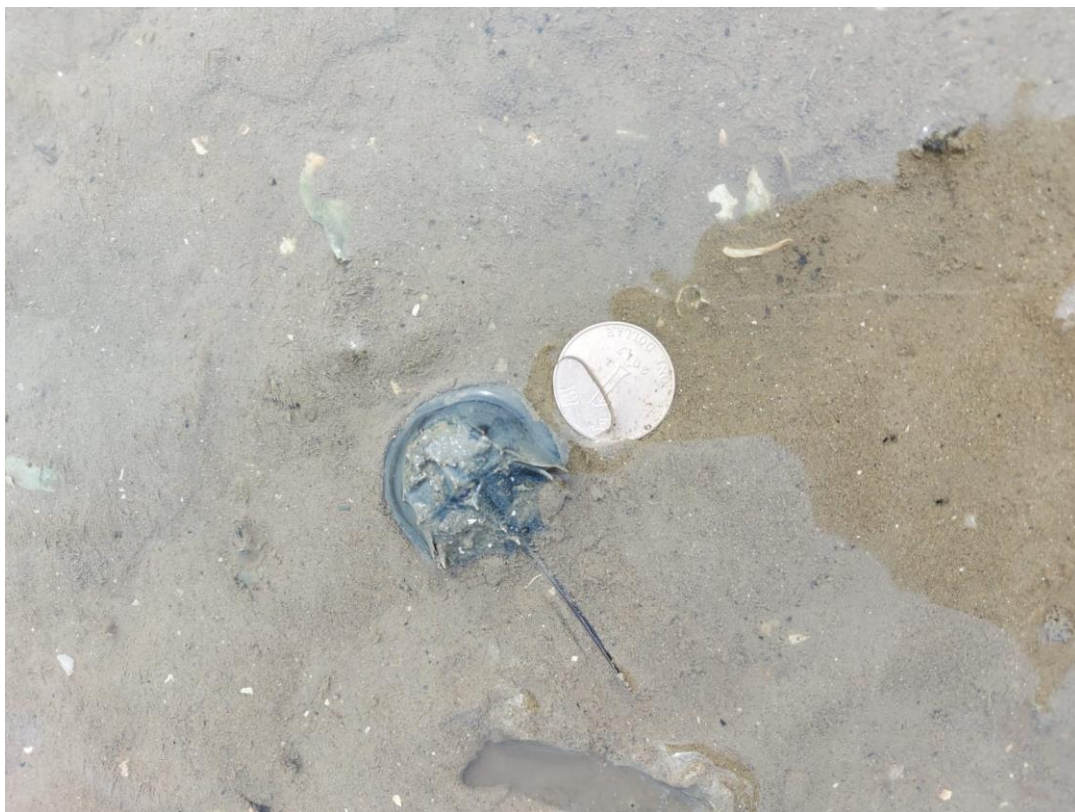
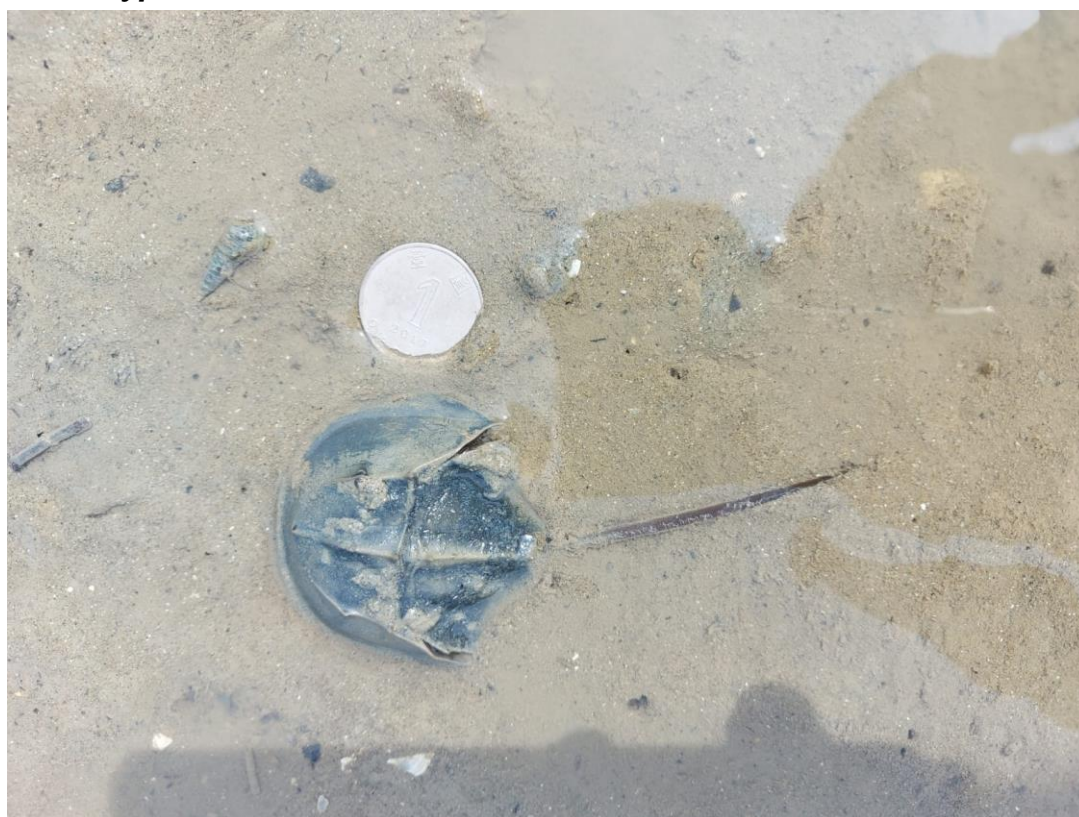
Figure 3.1 Examples of photographic records of horseshoe crab (June 2021)

- 3.6.16 In total of 32 and 33 individuals of *Carcinoscorpius rotundicauda* and *Tachypleus tridentatus* were found in present survey. The recorded individuals were mainly distributed along the shoreline in ST and TC3. All of them were observed on similar substratum (fine sand or soft mud, slightly submerged). Photo records of the observed horseshoe crab are shown in **Figure 3.1 of Appendix O** and the present survey result regarding horseshoe crab are presented in **Table 3.1 of Appendix O**. The complete survey records are presented in **Annex II of Appendix O**.

ST *Carcinoscorpius rotundicauda*

ST *Tachypleus tridentatus*

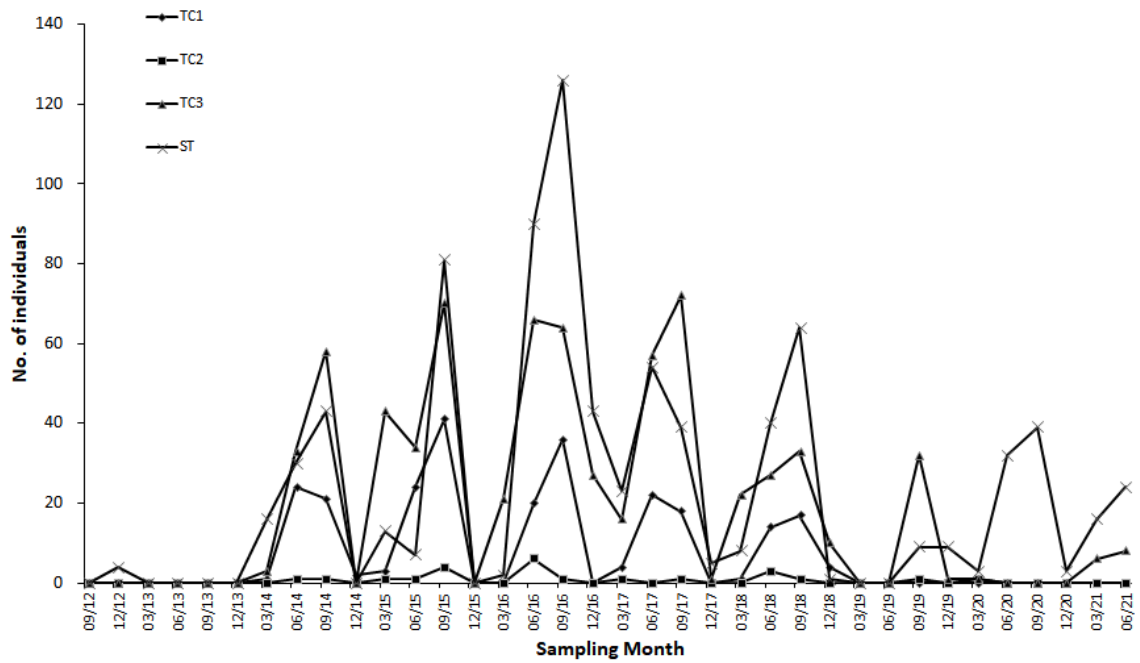
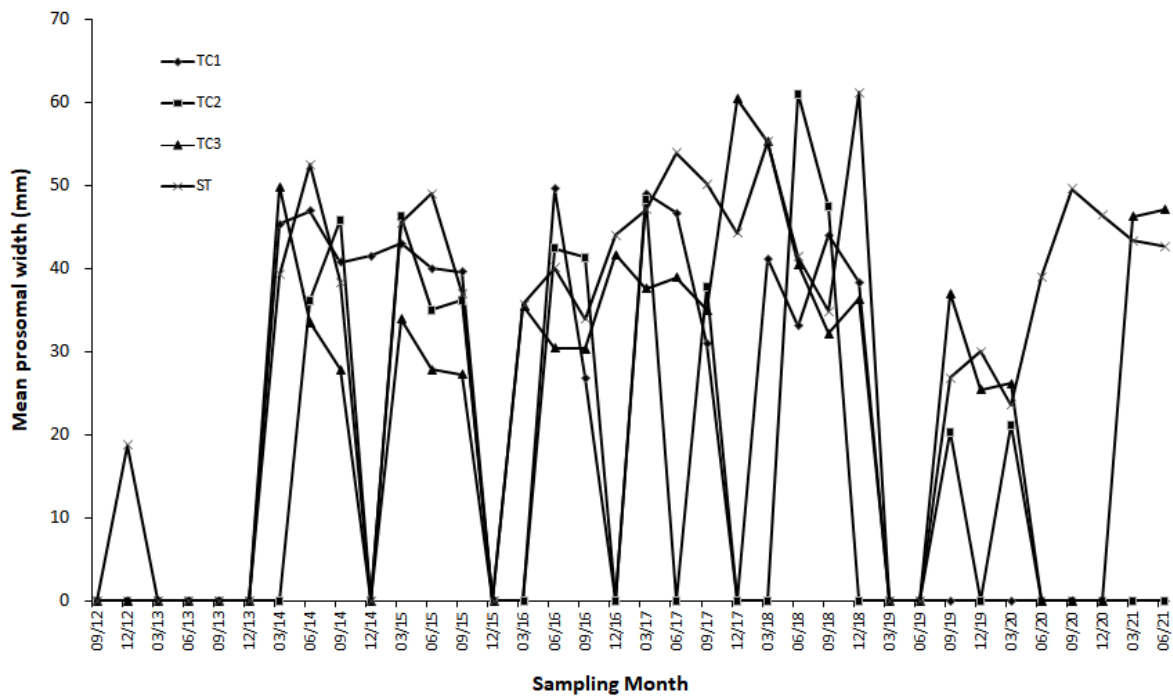
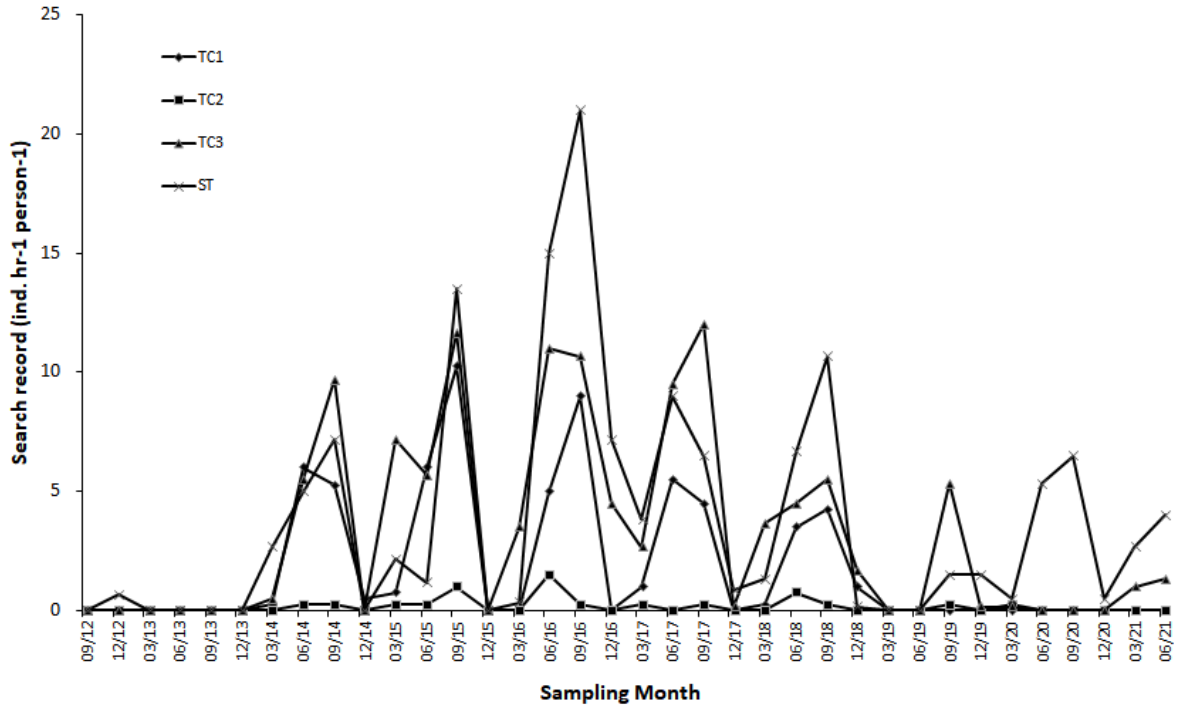
Figure 3.5 Changes of number of individuals mean prosomal width and search record of horseshoe crab *Carcinoscorpis rotundicauda* in every sampling zone along the sampling months

- 3.6.29 Throughout the monitoring period, the search records of horseshoe crabs were fluctuated and at moderate – very low level in June (**Figures 3.5 and 3.6 of Appendix O**). Low – Very low search record was found in June 2013, totally 82 individuals of *Tachypleus tridentatus* and 0 ind. of *Carcinoscorpius rotundicauda* were found in TC1, TC3 and ST. Compare with the search record of June 2013, the numbers of *Tachypleus tridentatus* were gradually decreased in June 2014 and 2015 (55 ind. in 2014 and 18 ind. in 2015); the number of *Carcinoscorpius rotundicauda* raise to 88 and 66 individuals. in June 2014 and 2015 respectively. In June 2016, the search record increased about 3 times compare with June 2015. In total, 182 individuals of *Carcinoscorpius rotundicauda* and 47 individuals. of *Tachypleus tridentatus* were noted, respectively. Then, the search record was similar to June 2016. The number of recorded *Carcinoscorpius rotundicauda* (133 ind.) slightly dropped in June 2017. However, that of *Tachypleus tridentatus* rapidly increased (125 ind.). In June 2018, the search record was low to moderate while the numbers of *Tachypleus tridentatus* dropped sharply (39 ind.). In June 2019, 10 individuals of *Tachypleus tridentatus* were observed in TC3 and ST. All of them, however, were large individuals (prosomal width >100mm), their records are excluded from the data analysis to avoid mixing up with the juvenile population living on intertidal habitat. Until September 2020, the number of *Carcinoscorpius rotundicauda* and *Tachypleus tridentatus* gradually increased to 39 ind. and 28 ind., respectively. In December 2020, the number of

- 3.6.30 The search record of horseshoe crab declined obviously in all sampling zones during dry season especially December (**Figures 3.5 and 3.6 of Appendix O**) throughout the monitoring period. Very low – low search record was found in December from 2012 to 2015 (0-4 ind. of *Carcinoscorpius rotundicauda* and 0-12 ind. of *Tachypleus tridentatus*). The horseshoe crabs were inactive and burrowed in the sediments during cold weather (<15 °C). Similar results of low search record in dry season were reported in a previous territory-wide survey of horseshoe crab. For example, the search records in Tung Chung Wan were 0.17 ind. hr⁻¹ person⁻¹ and 0.00 ind. hr⁻¹ person⁻¹ in wet season and dry season respectively (details see Li, 2008). Compare with the search record of December from 2012 to 2015, which of December 2016 were much higher relatively. There were totally 70 individuals of *Carcinoscorpius rotundicauda* and 24 individuals of *Tachypleus tridentatus* in TC3 and ST. Since the survey was carried in earlier December with warm and sunny weather (~22 °C during dawn according to Hong Kong Observatory database, Chek Lap Kok station on 5 December 2016), the horseshoe crab was more active (i.e. move onto intertidal shore during high tide for foraging and breeding) and easier to be found. In contrast, there was no search record in TC1 and TC2 because the survey was conducted in mid-December with colder and cloudy weather (~20 °C during dawn on 19 December). The horseshoe crab activity would decrease gradually with the colder climate. In December of 2017, 2018 and 2019, very low search records were found again as mentioned above.

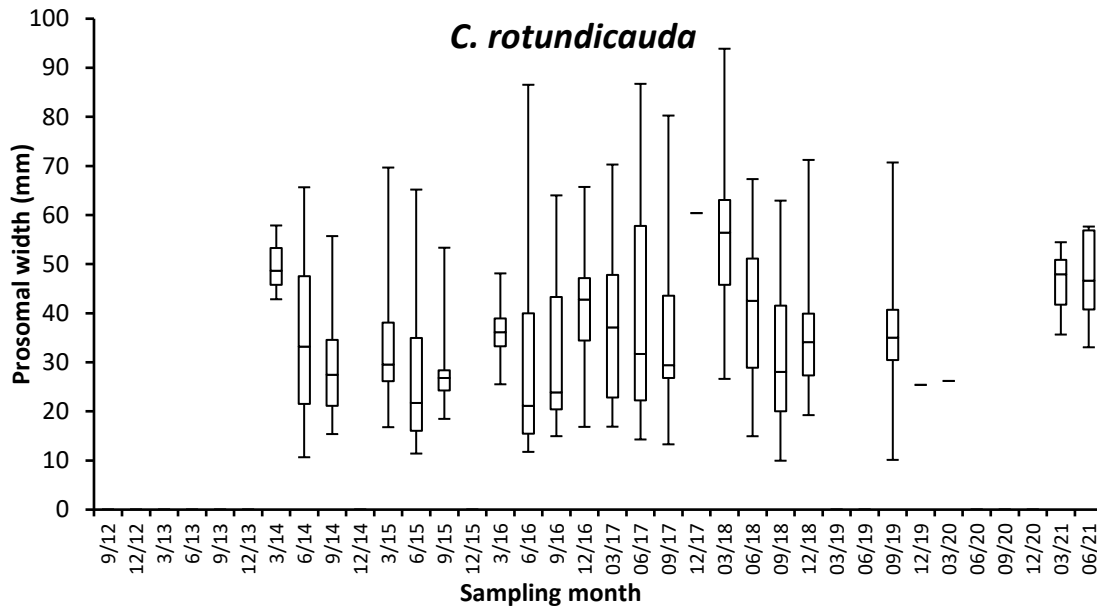
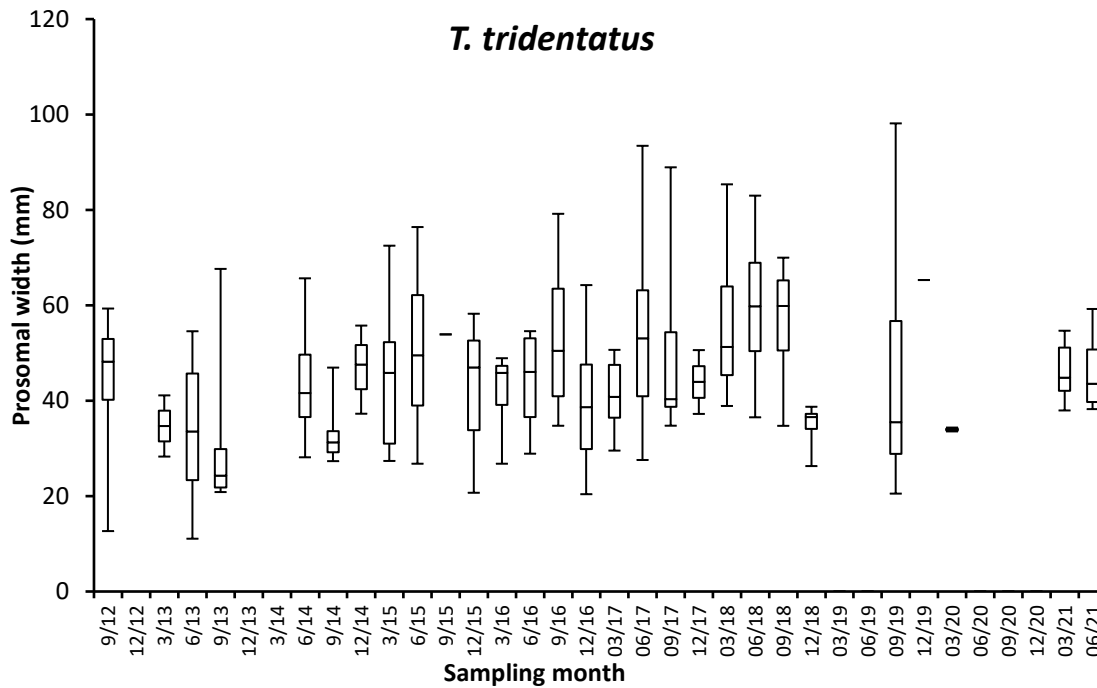
- 3.6.34 **Figure 3.7 of Appendix O** shows the changes of prosomal width of *Carcinoscorpius rotundicauda* and *Tachypleus tridentatus* in TC3. As mentioned above, *Carcinoscorpius rotundicauda* was rarely found between September 2012 and December 2013 hence the data were lacking. In March 2014, the major size (50% of individual records between upper (top box) and lower quartile (bottom box)) ranged 40 – 60 mm while only few individuals were found. From March 2014 to September 2018, the median prosomal width (middle line of whole box) and major size (whole box) decreased after March of every year. It was due to more small individuals found in June indicating new rounds of spawning. Also, there were slight increasing trends of body size from June to March of next year since 2015. It indicated a stable growth of individuals. Focused on larger juveniles (upper whisker), the size range was quite variable (prosomal width 60 – 90 mm) along the sampling months. Juveniles reaching this size might gradually migrate to sub-tidal habitats.

- 3.6.35 For *Tachypleus tridentatus*, the major size ranged 20-50 mm while the number of individuals fluctuated from September 2012 to June 2014. Then a slight but consistent growing trend was observed from September 2014 to June 2015. The prosomal width increased from 25 – 35 mm to 35 – 65 mm. As mentioned, the large individuals might have reached a suitable size for migrating from the nursery soft shore to subtidal habitat. It accounted for the declined population in TC3. From March to September 2016, slight increasing trend of major size was noticed again. From December 2016 to June 2017, similar increasing trend of major size was noted with much higher number of individuals. It reflected new round of spawning. In September 2017, the major size decreased while the trend was different from previous two years. Such decline might be the cause of serial cyclone hit between June and September 2017 (to be discussed in the 'Seagrass survey' section). From December 2017 to September 2018, increasing trend was noted again. It indicated a stable growth of individuals. From September 2018 to that of next year, the average prosomal widths were decreased from 60mm to 36mm. It indicated new rounds of spawning occurred during September to November 2018. In December 2019, an individual with larger body size (prosomal width 65mm) was found in TC3 which reflected the stable growth of individuals. In March 2020, the average prosomal width (middle line of the whole box) of *Tachypleus tridentatus* in TC3 was 33.97 mm which is smaller than that in December 2019. It was in normal fluctuation. From June 2020 to December 2020, no horseshoe crab was recorded in TC3. In June 2021 (present survey), 9 individuals of *Tachypleus tridentatus* with body size (prosomal width 45.51mm) was found in TC3 which reflected the stable growth of individuals. Across the whole monitoring period, the larger juveniles (upper whisker) usually reached 60 – 80 mm in prosomal width, even 90 mm occasionally. The juveniles reaching this size might gradually migrate to sub-tidal habitats.

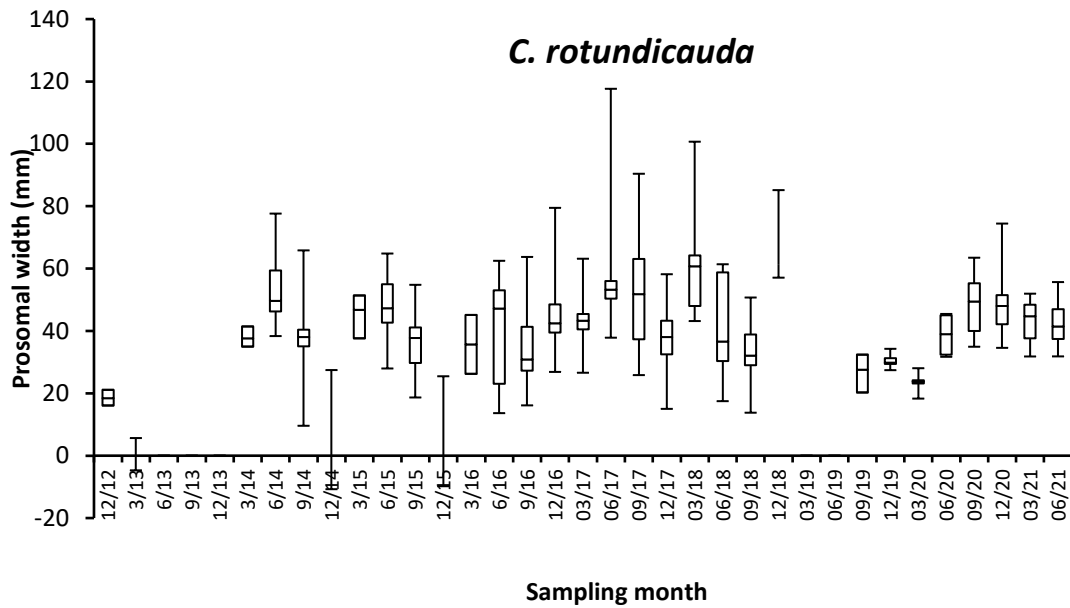
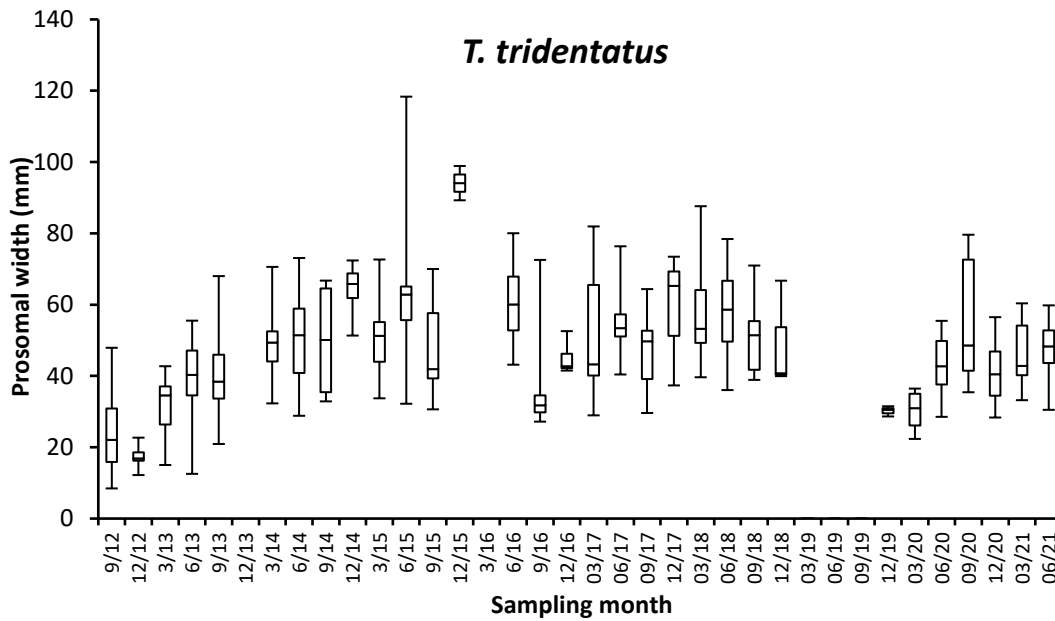
- 3.6.36 **Figure 3.8 of Appendix O** shows the changes of prosomal width of *Carcinoscorpius rotundicauda* and *Tachypleus tridentatus* in ST. As mentioned above, *Carcinoscorpius rotundicauda* was rarely found between September 2012 and December 2013 hence the data were lacking. From March 2014 to September 2018, the size of major population decreased and more small individuals (i.e. lower whisker) were recorded after June of every year. It indicated new round of spawning. Also, there were similar increasing trends of body size from

September to June of next year between 2014 and 2017. It indicated a stable growth of individuals. The larger juveniles (i.e. upper whisker usually ranged 60 – 80 mm in prosomal width except one individual (prosomal width 107.04 mm) found in March 2017. It reflected juveniles reaching this size would gradually migrate to sub-tidal habitats.

- 3.6.37 For *Tachypleus tridentatus*, a consistent growing trend was observed for the major population from December 2012 to December 2014 regardless of change of search record. The prosomal width increased from 15-30 mm to 60 – 70 mm. As mentioned, the large juveniles might have reached a suitable size for migrating from the nursery soft shore to subtidal habitat. From March to September 2015, the size of major population decreased slightly to a prosomal width 40 – 60 mm. At the same time, the number of individuals decreased gradually. It further indicated some of large juveniles might have migrated to sub-tidal habitat, leaving the smaller individuals on shore. There was an overall growth trend. In December 2015, two big individuals (prosomal width 89.27 mm and 98.89 mm) were recorded only while it could not represent the major population. In March 2016, the number of individual was very few in ST that no box plot could be produced. In June 2016, the prosomal width of major population ranged 50 – 70 mm. But it dropped clearly to 30 – 40 mm in September 2016 followed by an increase to 40 – 50 mm in December 2016, 40 – 70 mm in March 2017 and 50 – 60mm in June 2017. Based on overall higher number of small individuals from June 2016 to September 2017, it indicated another round of spawning. From September 2017 to June 2018, the major size range increased slightly from 40 – 50 mm to 45 – 60 mm indicating a continuous growth. In September 2018, decrease of major size was noted again that might reflect new round of spawning. Throughout the monitoring period, the larger juveniles ranged 60 – 80 mm in prosomal width. Juveniles reaching this size would gradually migrate to sub-tidal habitats.

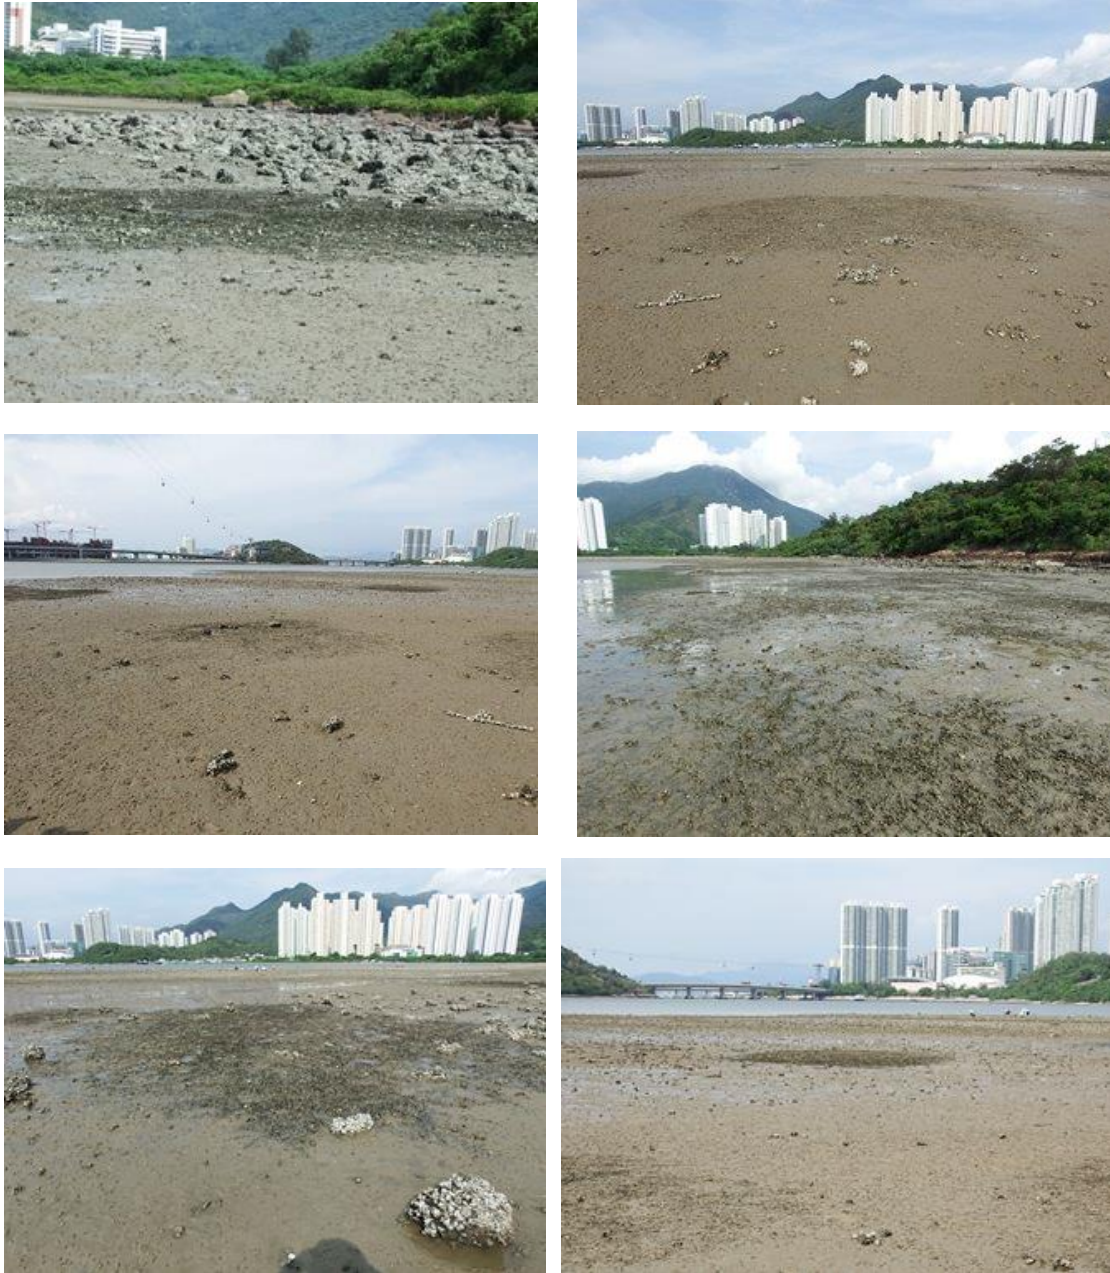
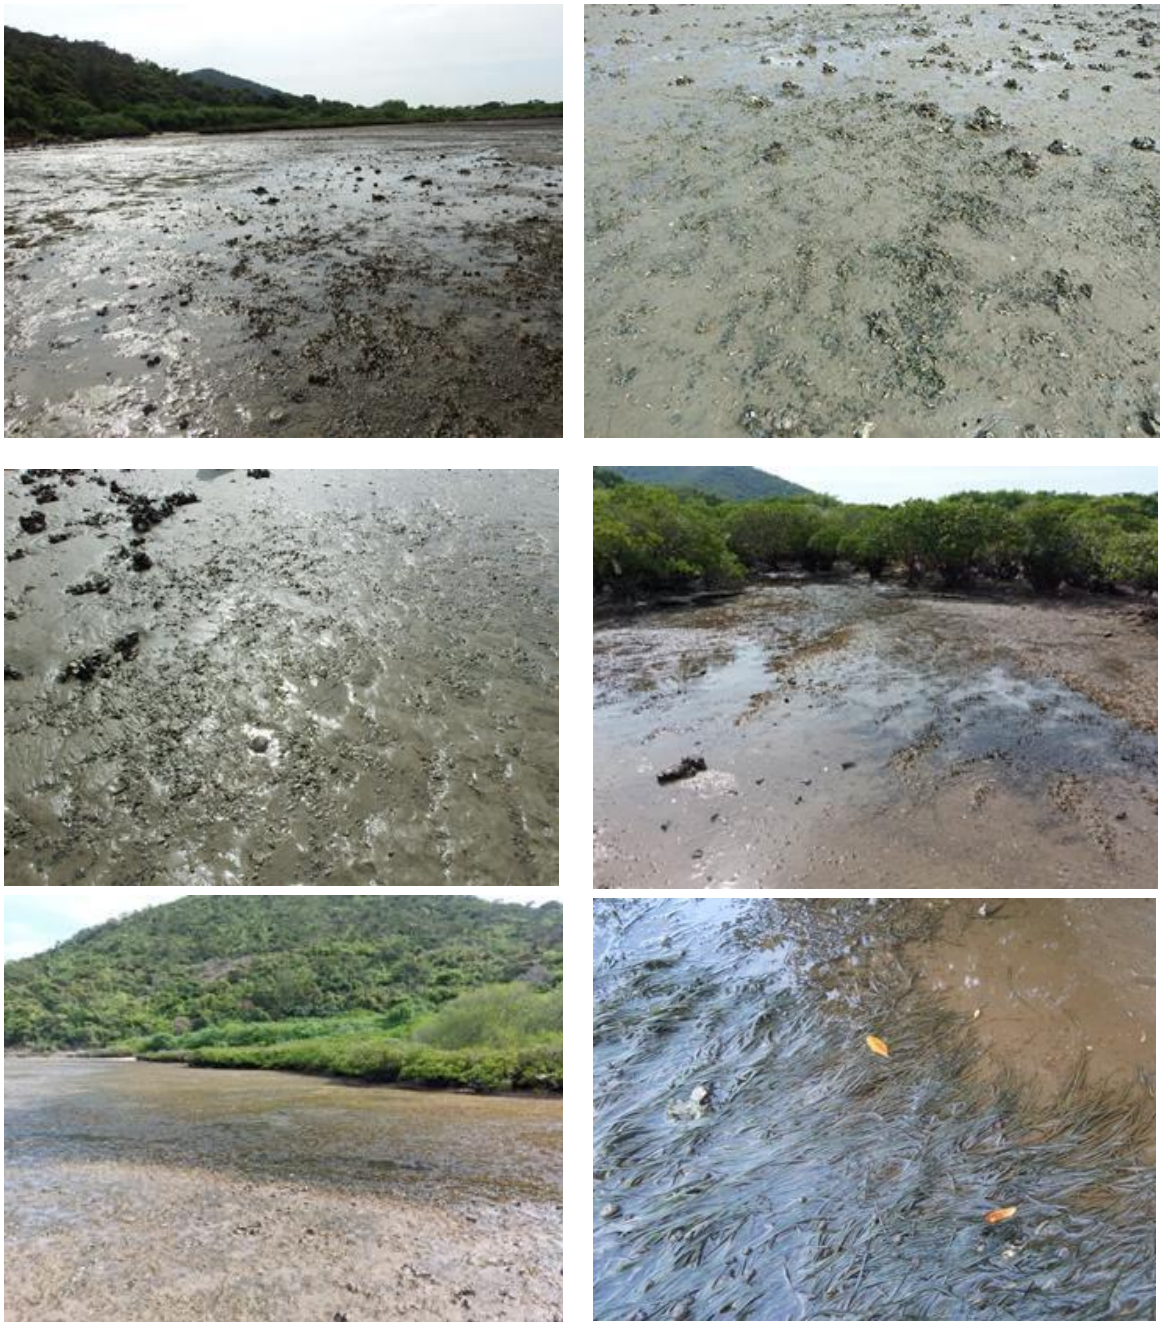
Figure 3.9 *Photographic record of seagrass beds in present survey.*

- 3.6.41 Two seagrass species *Halophila ovalis* and *Zostera japonica* were found in present survey. *Halophila ovalis* was found in TC3 and ST and *Zostera japonica* was found in ST. In ST, there

were eight small sized and two large sized of *Halophila ovalis* found at tidal zone 1.5m above C.D nearby mangroves plantation. The larger strand had area ~950m² in high vegetation coverage (80 – 90%) and ~400m² in high vegetation coverage (70 – 80%). At close vicinity, seven small sized (~0.8m² -80m²) of *Halophila ovalis* beds were observed at tidal zone 1.5m above C.D. Five out of seven small sized of *Halophila ovalis* beds were in moderate vegetation coverage (50-60%) while the ~20m² and ~950m² of *Halophila ovalis* beds were in high vegetation coverage (80 – 100%) respectively. In TC3, ten small patches of *Halophila ovalis* were found attidal zone 1.5 – 2.0m above C.D. One seagrass patch had area 1.8m² was in low to moderate vegetation coverage (40 – 50%) and some of them were in moderate to high vegetation coverage (60 – 100%). Another seagrass species *Zostera japonica* was found at tidal zone 1.5m above C.D nearby mangroves plantation with ~45m² in moderate to high vegetation coverage (70 - 80%). **Table 3.2 of Appendix O** summarizes the results of present seagrass beds survey and the photograph records of the seagrass are shown on **Figure 3.9 of Appendix O**. The complete record throughout the monitoring period is presented in **Annex III of Appendix O**.

***Halophila ovalis* in TC3**

***Halophila ovalis* and *Zostera japonica* in ST**
