Central Police Station Conservation
and Revitalisation Project:
4th Annual EM&A Review Report
(1 November 2014 to 31 October
2015)

Issue Date: June 2016

Environmental Resources Management

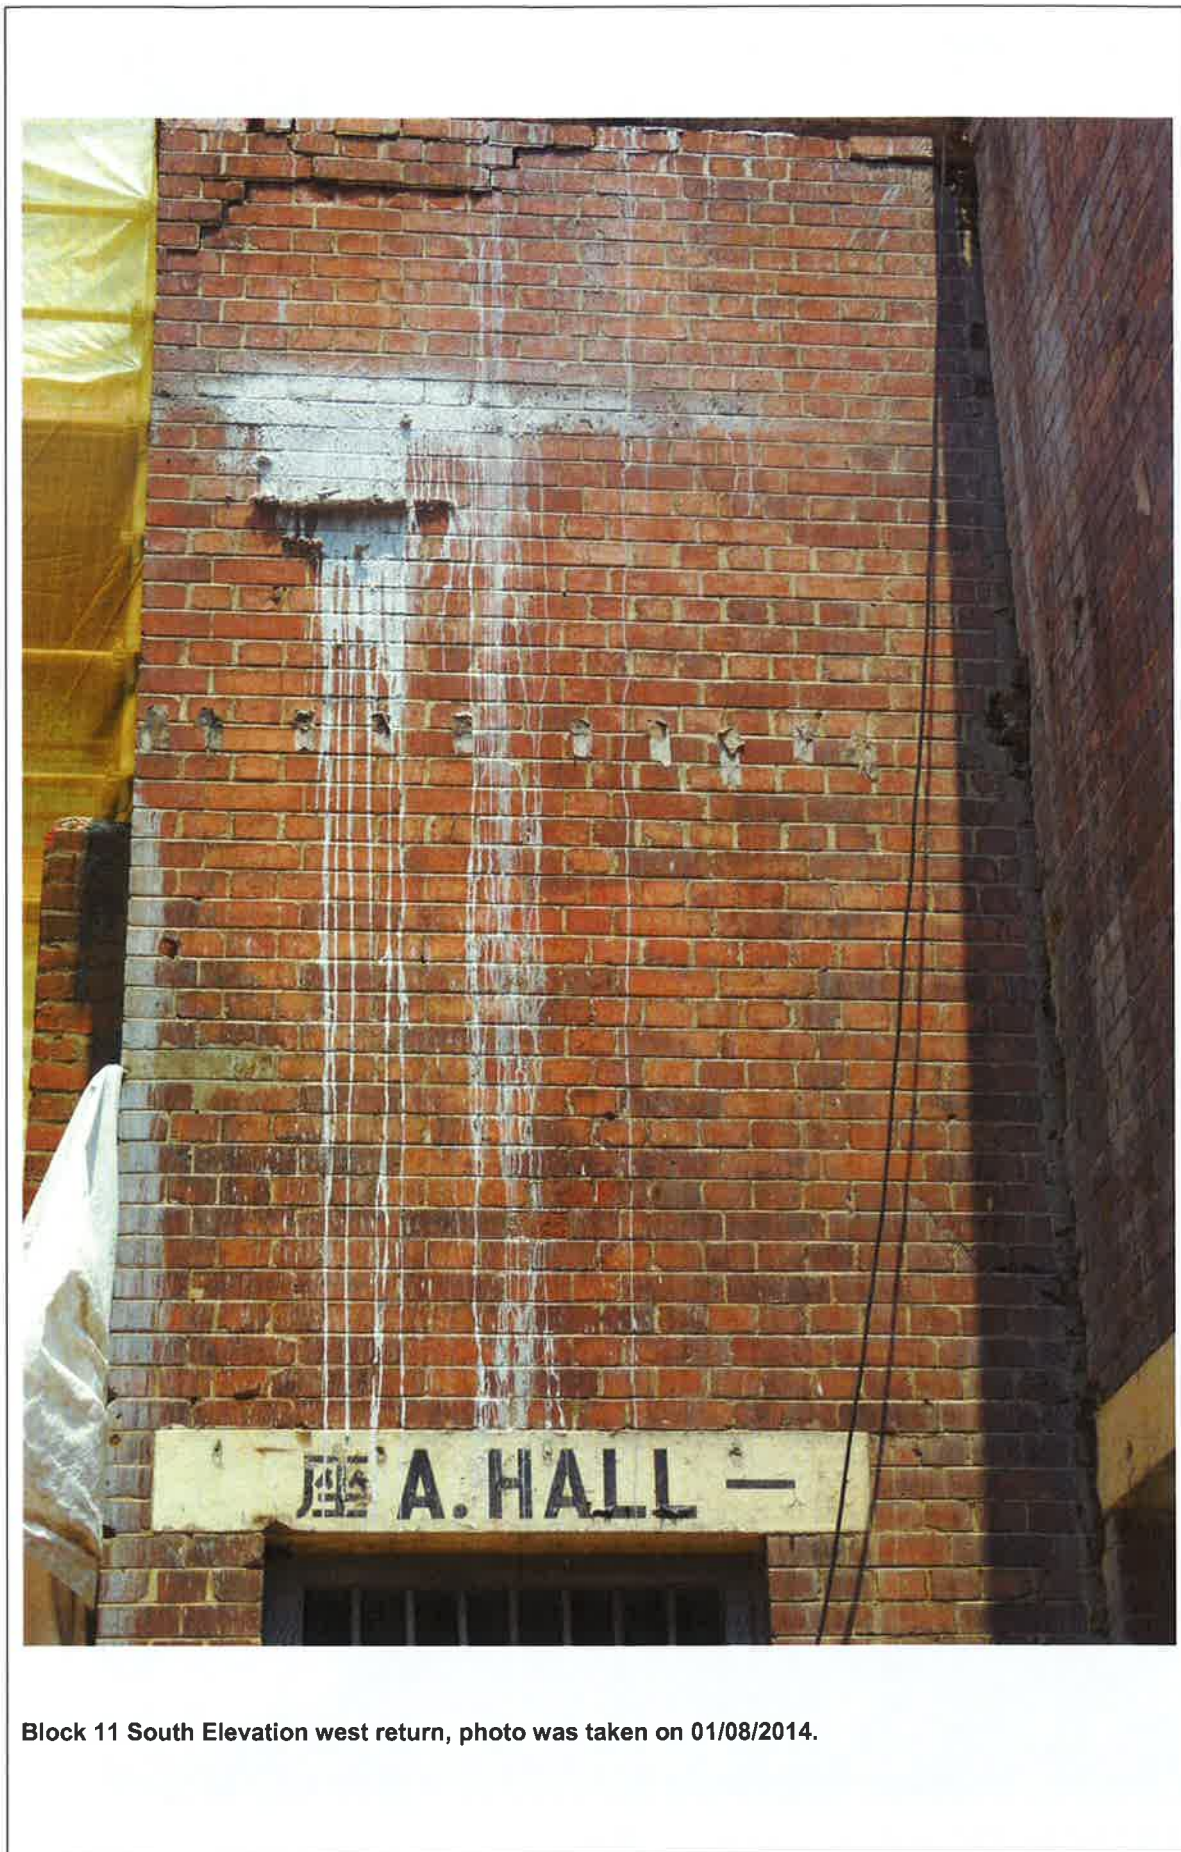
Block 11 South Elevation west return, photo was taken on 01/08/2014.

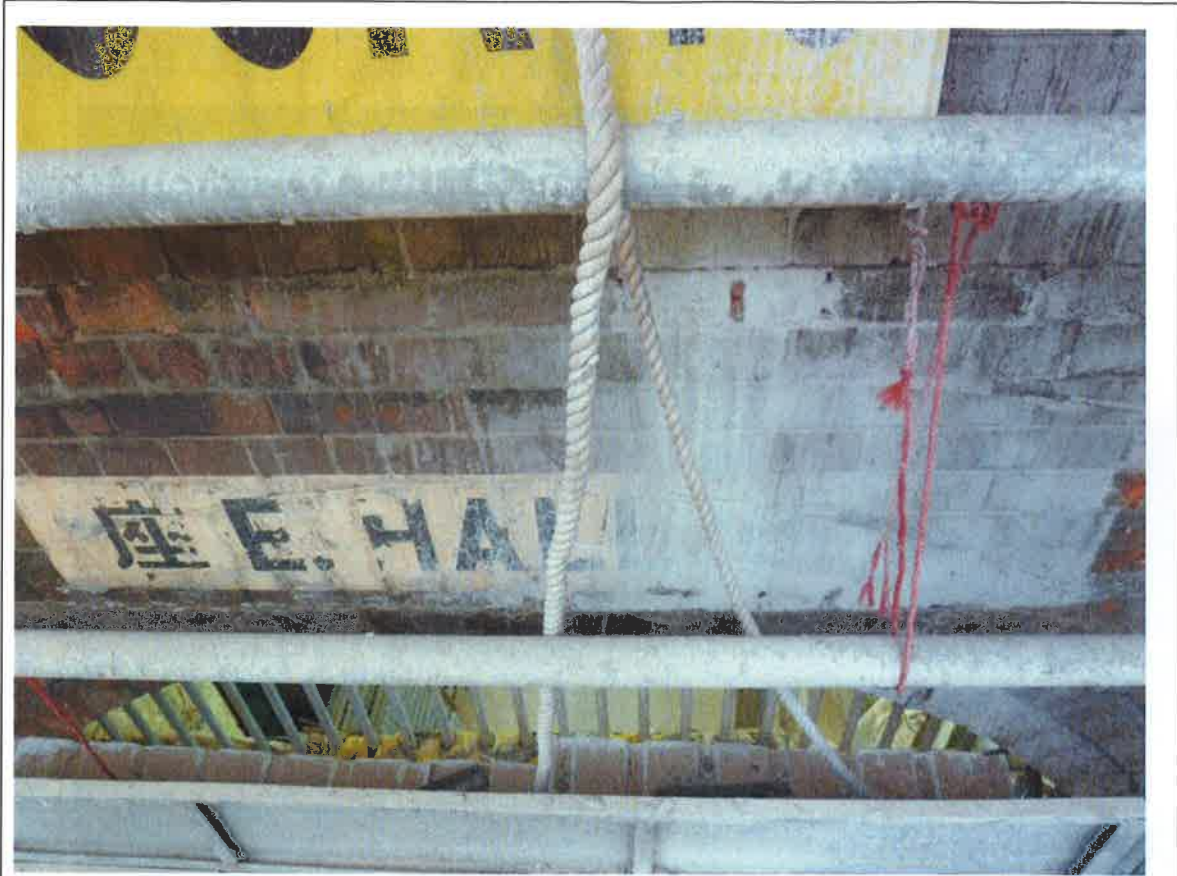
- b) During our inspection of Building 15 facades with GCL on 28th October 2014, it was observed that no protection had been provided to the existing painted sign 'E Hall' on the west elevation. It was observed that a works package contractor had spilt concrete down the face of the west façade whilst transporting concrete through the window to re-cast the floors. This has caused damage to the brickwork and painted sign and is likely to ultimately cause the loss of the historic painted sign.

Block 15 West Elevation, photo was taken on 03/11/2014.

Proposed Mitigation Measures: YES (please specify):
Instruct Contractor to comply with Contract Documents. Assess extent of damages and propose proposals for rectification.

1. Review and revise the work practices of the works package contractors.
2. Supervise the work operations to ensure compliance with the Contract Documents.
3. Advise how monitoring procedures are being carried out by the Management Contractor.
4. Assess the extent of any damage and submit proposals to rectify the damage at no cost to the contract.

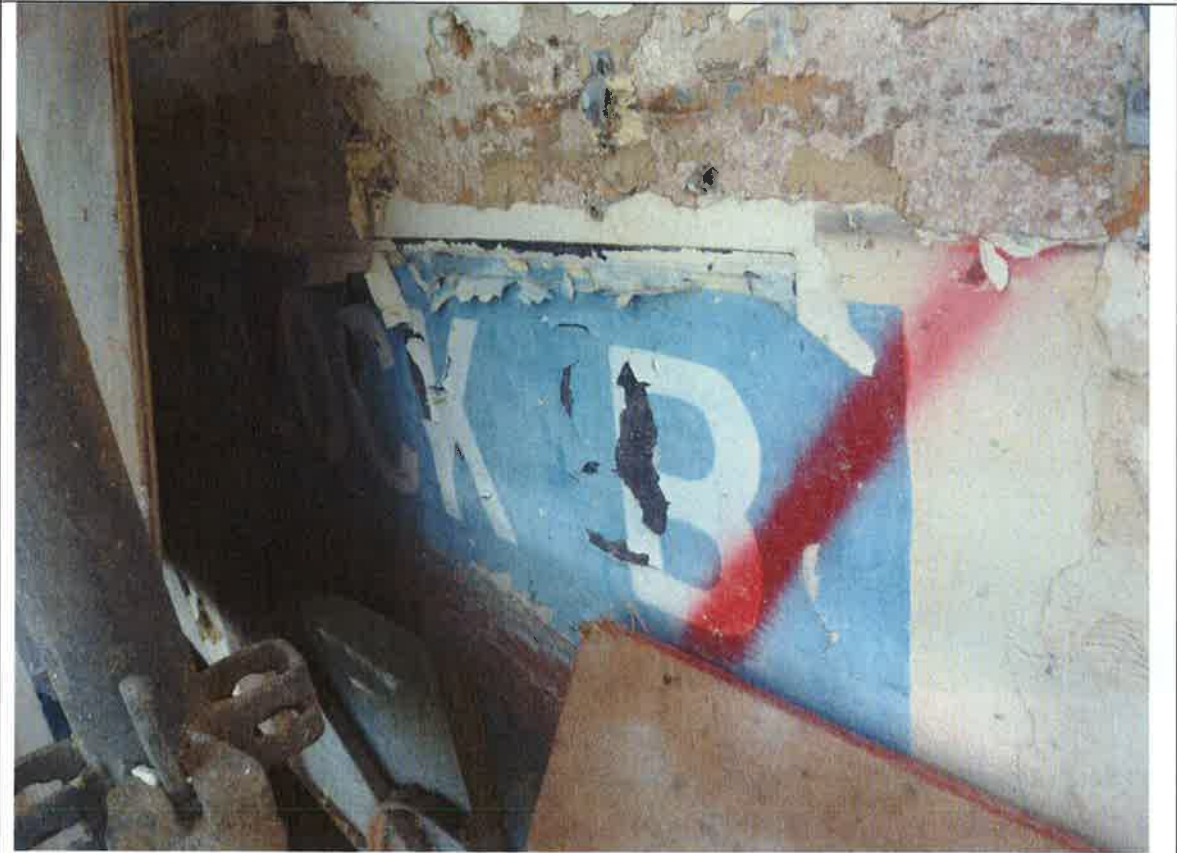
- c) During our joint survey inspection to Building 04 south elevation on 11th November 2014, it was observed that the CDE- painted sign has no protection. Moreover, the works package contractor has damaged the painted sign with their red paint. Loss of the painted sign is likely in order to clean off the red paint.

Block 04 South Elevation, photo was taken on 11/11/2014.

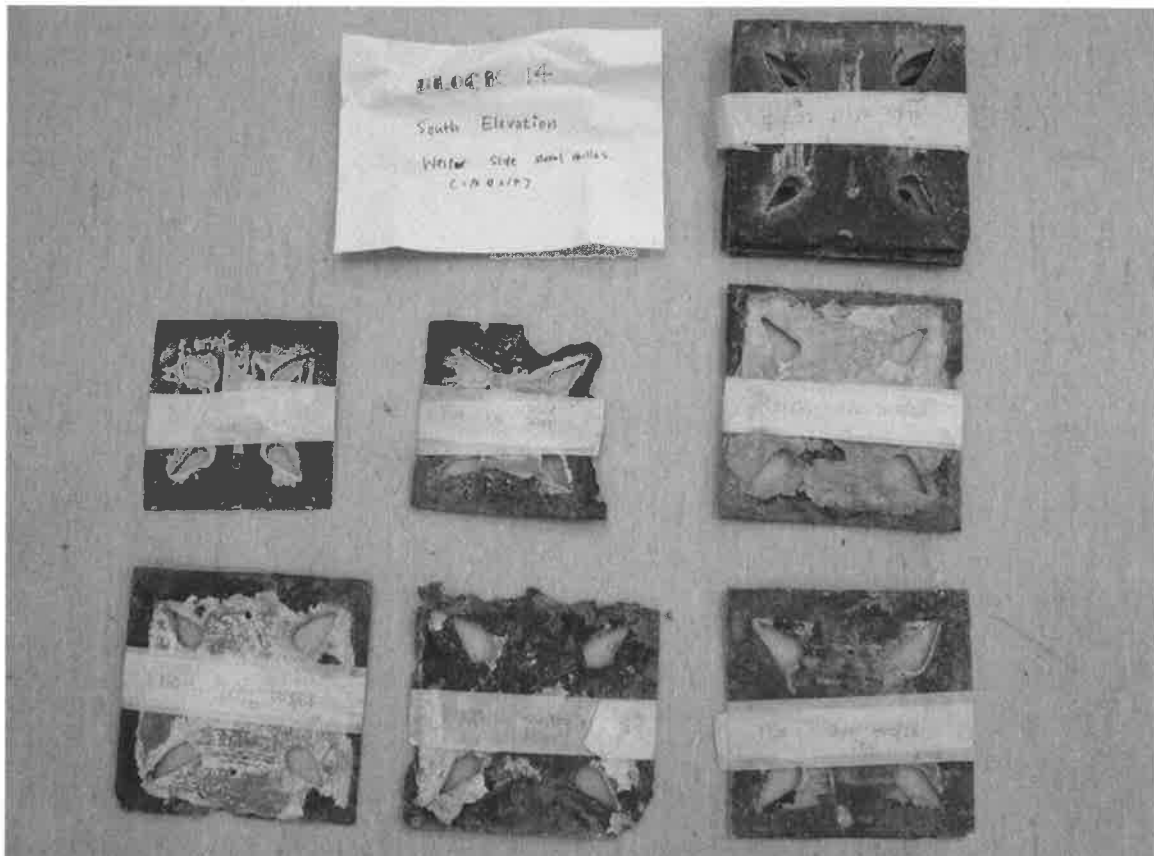
- 11 Existing Metal grilles from Block 14 South Elevation west part (handed over by GCL on 21st November 2014)

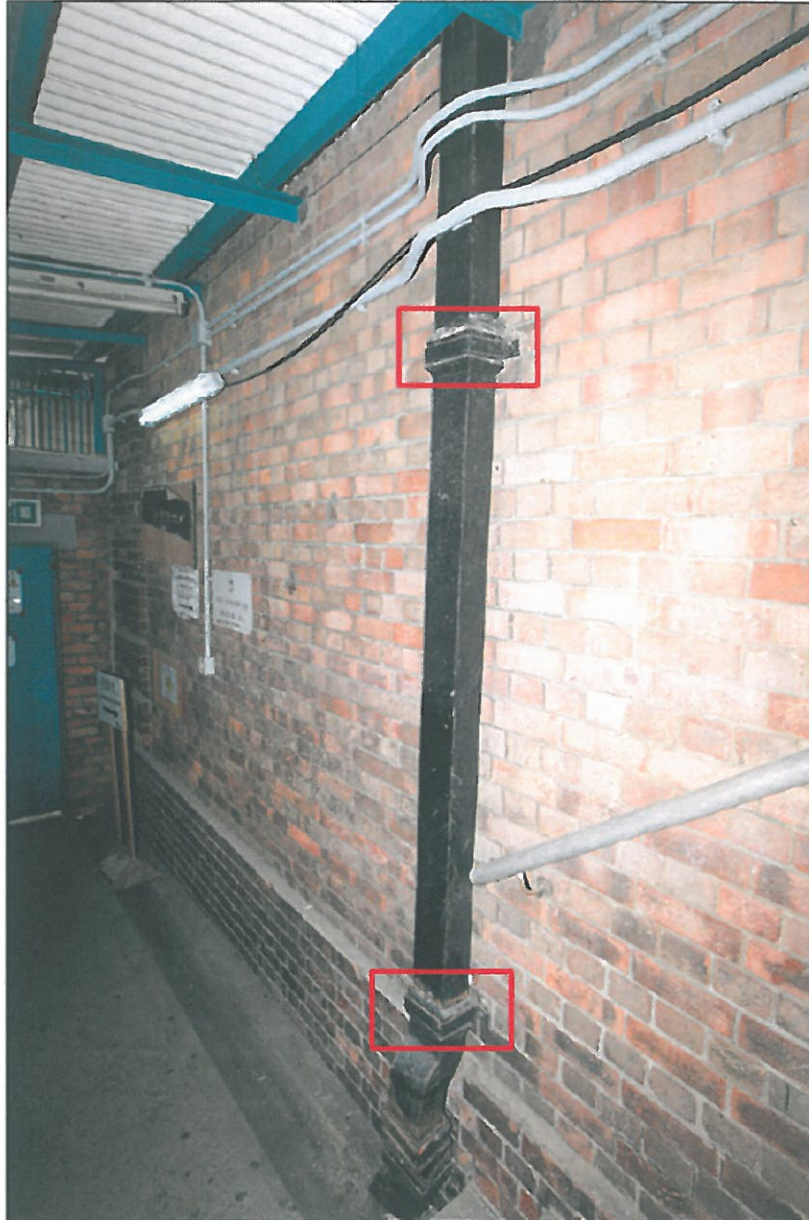
Photo 09-Ext-229 General view of the brick wall at the staircase to Block 09 (21-11-2011)

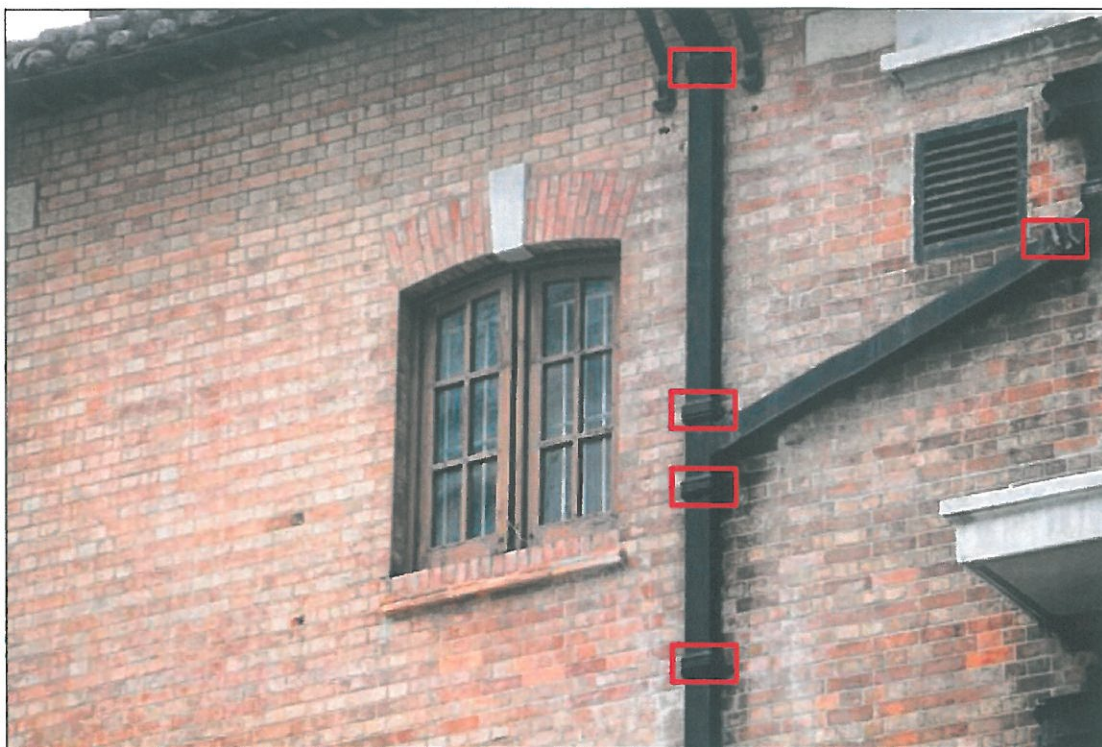
Photo 09-Ext-182 General view of the metal downpipes (17-8-2011)

Above, photograph taken from Management Contractor photo record survey report dated 17 August 2011 showing the fixing holderbats of RWP on Block 9 South Elevation.

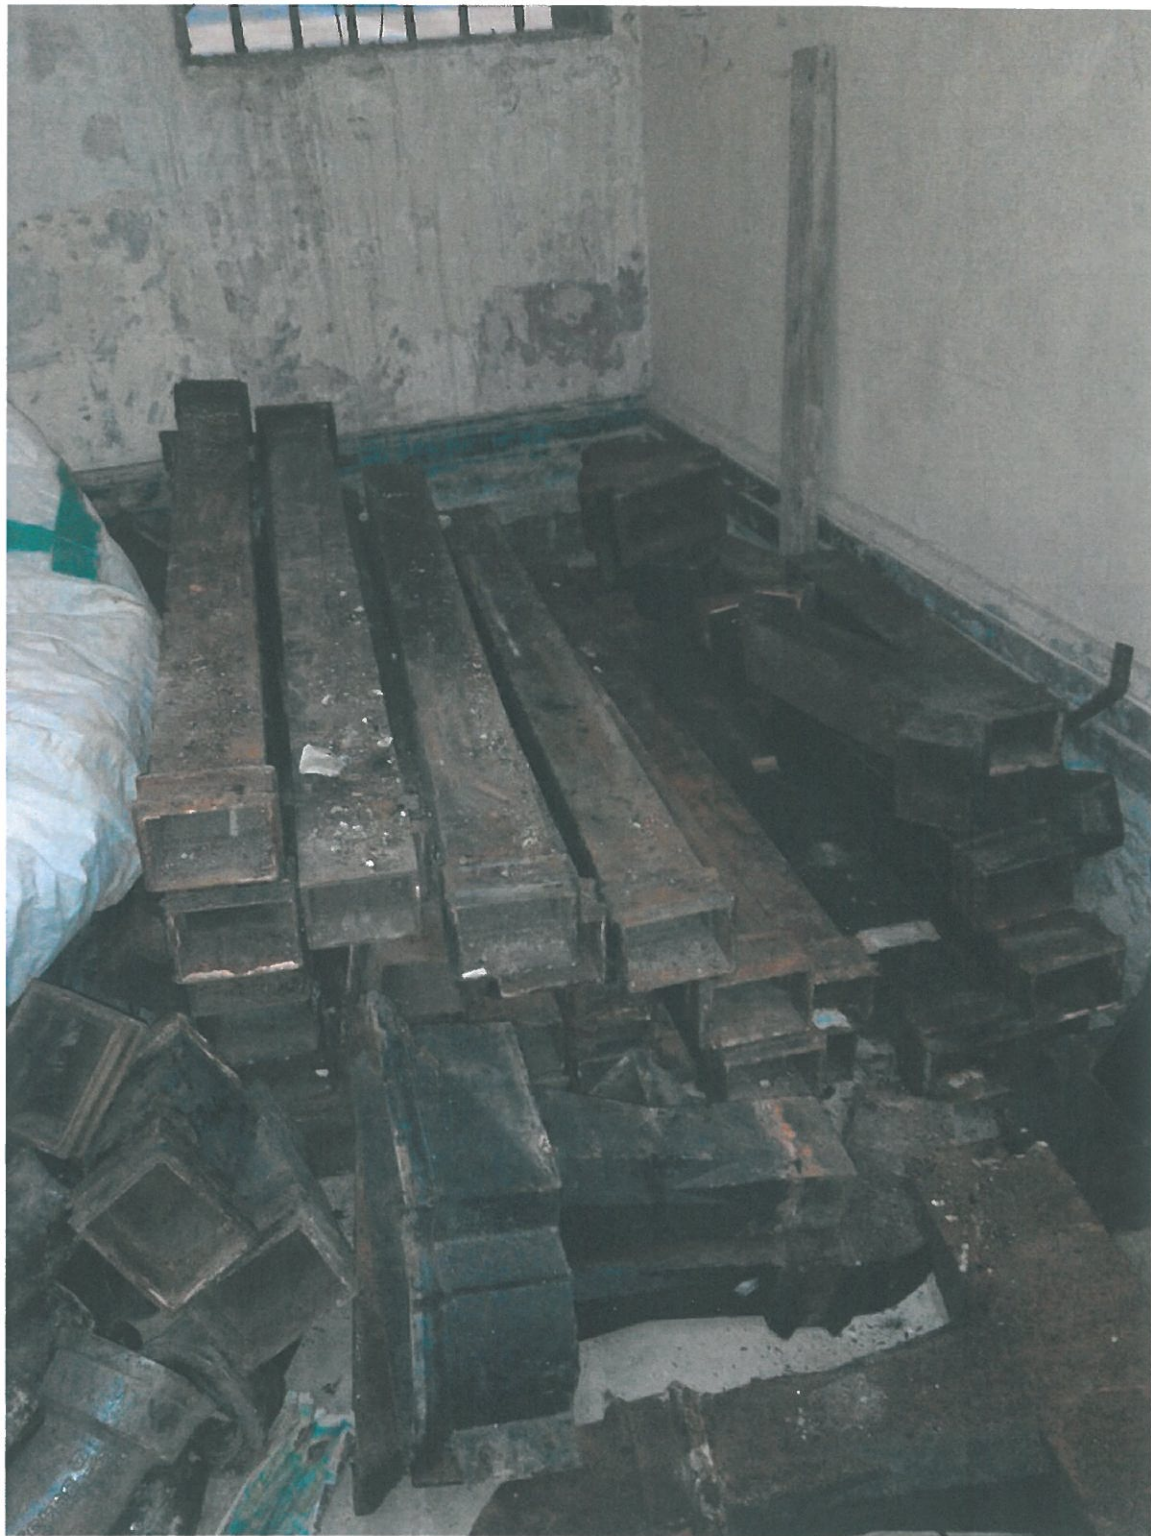
Above, photograph taken 30 September 2014 showing existing rain water goods from Block 9, only two holderbats were handed over, others assumed lost.

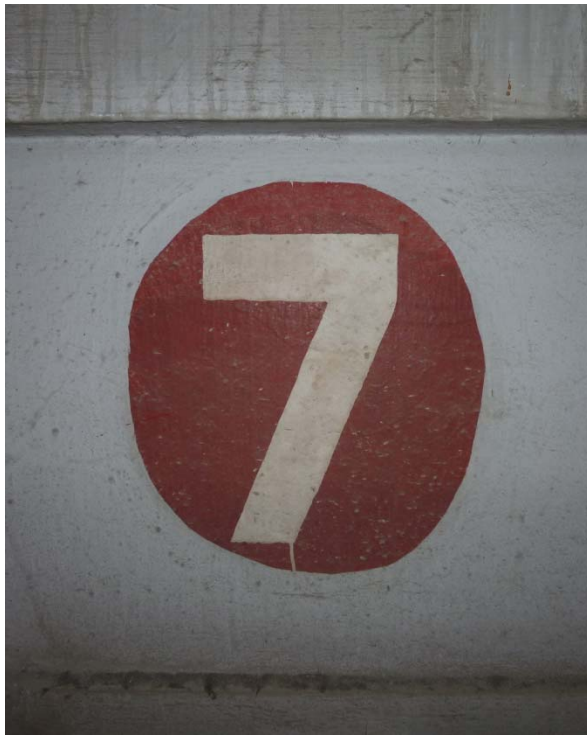
Is protection of existing building adequate and effective?	7/10	4 th February 2015, it was observed that the painted sign in Block 4 was not protected. GCL was informed and protection was installed. 27 th February 2015, it was observed that the painted sign 'D Hall' to Block 14 has now been lost. This is despite numerous reminders, including during the Site Audit Inspections. Heritage fabric has been lost.
--	------	--

Before: photo was taken on 20th Jan 2011

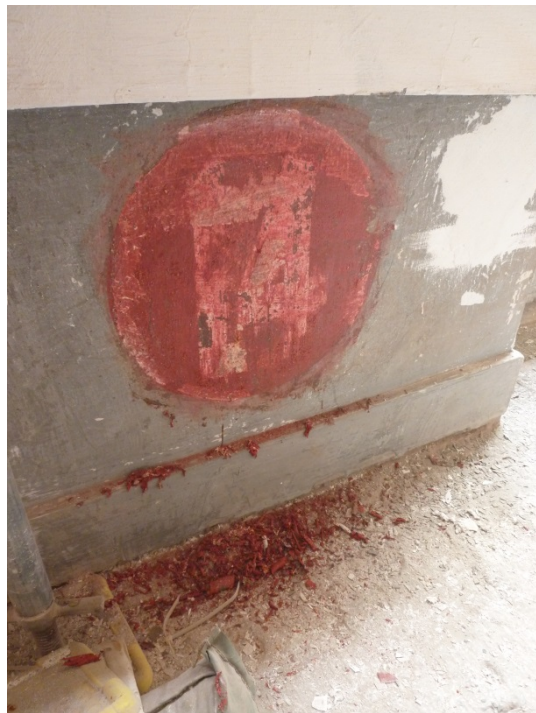
After: Photo was taken on 21st Jan 2015

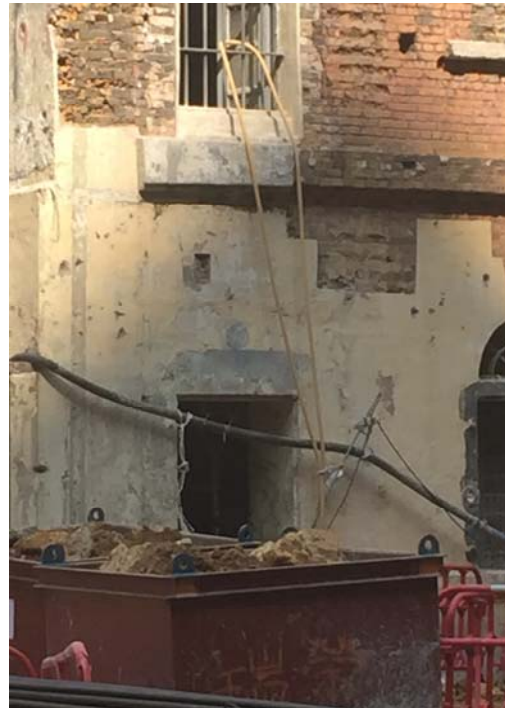
After: Photo was taken on 27th February 2015.

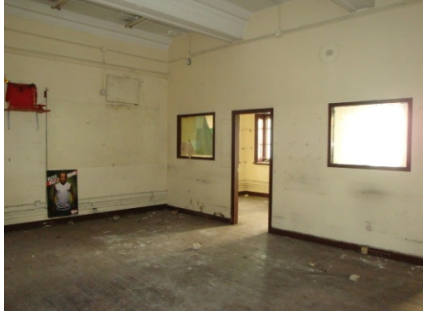
Element no.	Description	Photo ref	Significance	Proposal	Mitigation	Impact
01.011	Concrete floor

Low	Replace where new kitchens and plant rooms to be installed	Carefully remove and retain existing floorboards for re-use. Ensure controlled demolition of concrete structure and removal of debris from building to avoid damage to adjacent surfaces. Protect or carefully remove and set aside adjacent elements such as skirting boards	Low

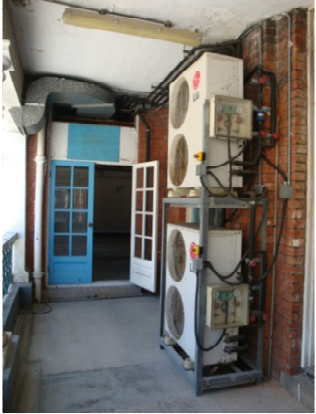
Element no.	Description	Photo ref	Significance	Proposal	Mitigation	Impact
01.020	External airconditioning units and other external services

Adverse	Remove and make good brickwork	Not applicable	High
01.021	Stair balustrades

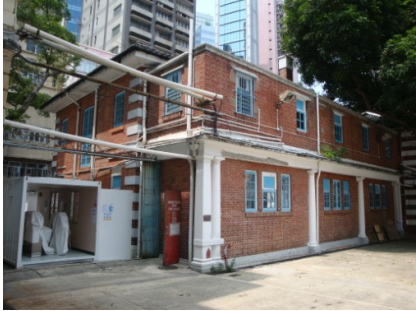
Element no.	Description	Photo ref.	Significance	Proposal	Mitigation	Impact
02.007	Rainwater goods

Adverse	Replace with cast iron in pattern to match original and in correct locations	No applicable	High

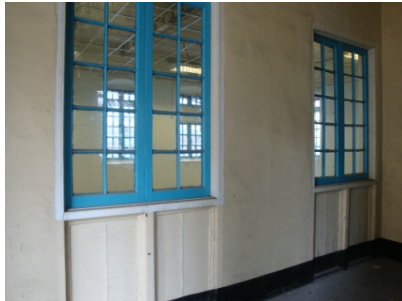
Element no.	Description	Photo ref.	Significance	Proposal	Mitigation	Impact
03.005	Timber spandrel panels below windows

Low	Conceal in exceptional cases eg. where adjacent new lift shaft	Retain frame and spandrel panel where possible. Remove only where necessary in connection with re-planning of interiors. Record on measured survey drawings.	Low
03.006	Timber floors

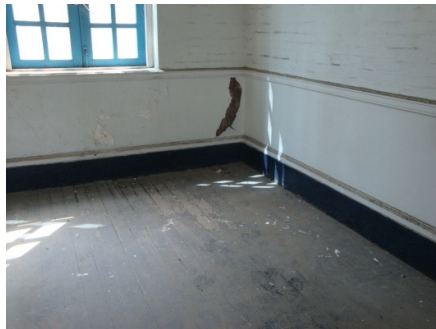
High	Replace where new kitchens and plant rooms to be installed	Limit extent of removal as much as possible. Carefully remove and retain existing floorboards for re-use. Ensure controlled dismantling of timber structure and set aside for possible re-use. Protect or carefully remove and set aside adjacent elements such as skirting boards	Medium

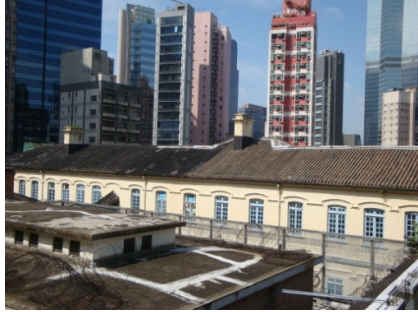
Element no.	Description	Photo ref.	Significance	Proposal	Mitigation	Impact
03.016	Pitched roofs

High	New penetrations through roofs for ventilation ducts and other services	Arrange new penetrations so that they conform with the geometry of the existing roof. Model the size and shape of the new ducts so that the impact on the roofscape is minimised. Finish the new ducts in a non-reflective material that is neutral in colour and mid-tone.	High
03.017	Lean-to structure adjacent North wall

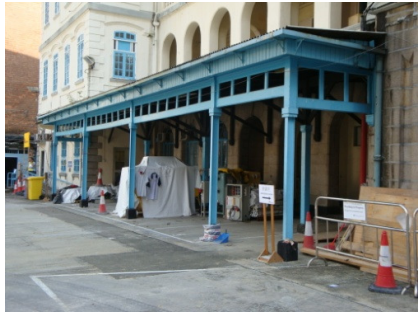
Moderate	Remove	Record on measured survey drawings. Make good walls where roof structure abuts	Moderate

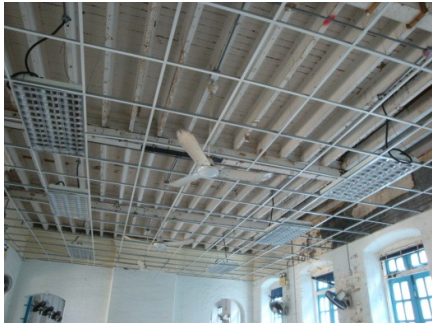
Moderate	Sub-divide two rooms on each floor to provide service core, comprising: lifts, toilets, plant rooms, stores	Form new sub-visions using lightweight partitions to achieve reversibility. Form straight joints at abutments with existing retained walls. Notch new partitions around existing brick corbels at high level as a reminder of current condition.	Moderate
03.021	Exposed soffits of timber floors

Moderate	Underline existing floors to achieve specified fire resistance stated in Code	Avoid unnecessary damage to existing structure. New lining will reduce extent of intervention into existing structure. Keep level of new linings well clear of window heads.	Moderate

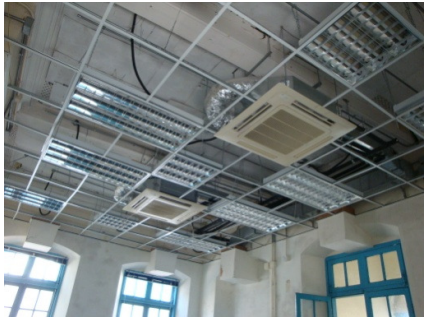
Element no.	Description	Photo ref.	Significance	Proposal	Mitigation	Impact
04.001	Lay-in grid suspended ceiling

Adverse	Remove	Not applicable	High
04.002	Timber thresholds at external doors and internal doors between main corridor and individual rooms

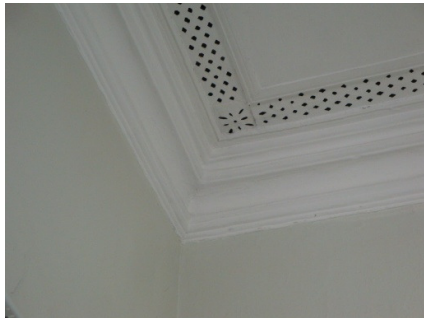
Element no.	Description	Photo ref.	Significance	Proposal	Mitigation	Impact
04.003	Plaster box cornice

Moderate	Remove in exceptional cases where eg. where adjacent new lift shafts	Cut back neatly to a square edge and ensure remaining section is secure.	Moderate

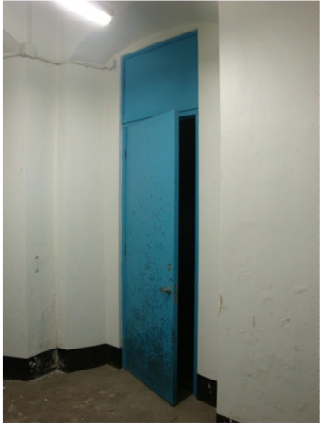
Element no.	Description	Photo ref.	Significance	Proposal	Mitigation	Impact
04.006	Block existing door openings

Moderate	Block opening as part of re-planning of interior	Retain existing door frame and architraves. Use framing and non-combustible sheet linings to block opening.	Moderate

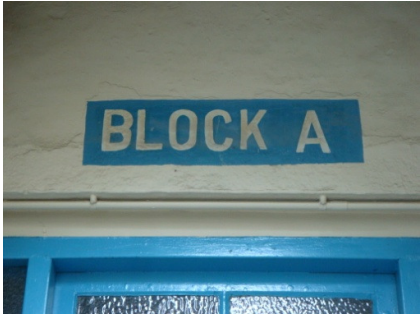
Element no.	Description	Photo ref.	Significance	Proposal	Mitigation	Impact
04.014	Painted signs

High	Protect in situ	Not applicable	N/A
04.015	Fixed signs

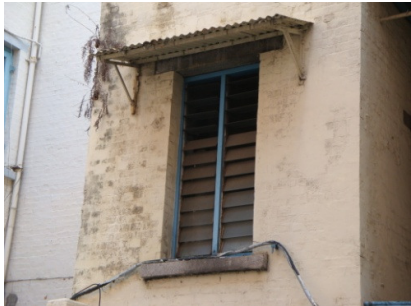
Element no.	Description	Photo ref.	Significance	Proposal	Mitigation	Impact
06.005	Altered doors and windows

Adverse	Adverse	Repair or renew as necessary existing frames to match original patterns	Not applicable
06.006	External airconditioning units and other external services

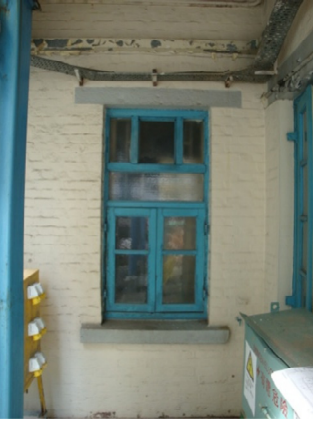
Adverse	Strip off and redecorate	Sample and analyse existing paint media; select new media to suit substrate and significance	High
07.004	Altered doors and windows

Adverse	Repair or renew as necessary existing frames to match original patterns	Not applicable	High

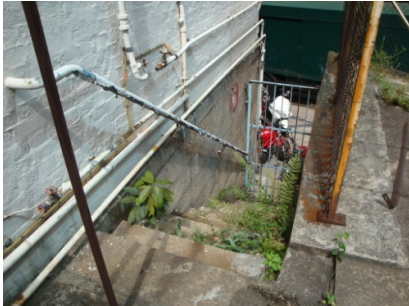
Element no.	Description	Photo ref.	Significance	Proposal	Mitigation	Impact
07.005	External airconditioning units and other external services

Adverse	Remove and make good brickwork	Not applicable	High
07.006	Clothes drying racks

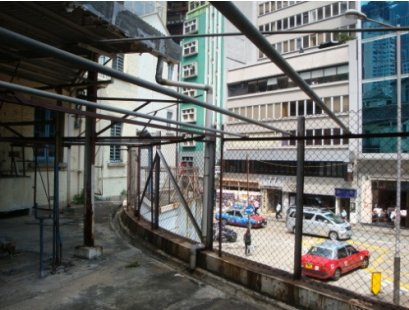
Adverse	Remove	Not applicable	Low

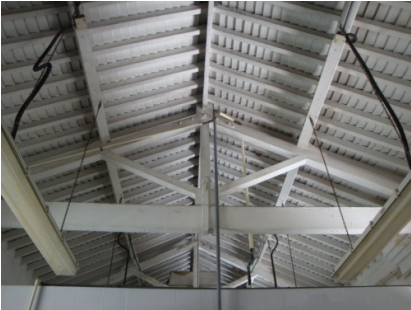
Element no.	Description	Photo ref.	Significance	Proposal	Mitigation	Impact
08.005	Timber roof structure

High	Retain	Not applicable	Neutral
08.006	External stair at west end

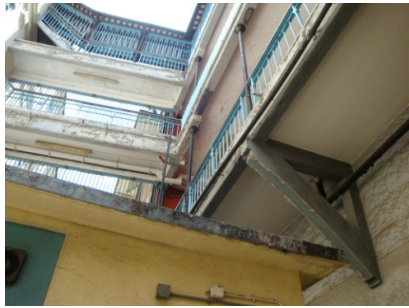
Element no.	Description	Photo ref.	Significance	Proposal	Mitigation	Impact
					clashes.	
08.011	Cantilever balconies on north side

Moderate	Repair and retain insitu	Not applicable

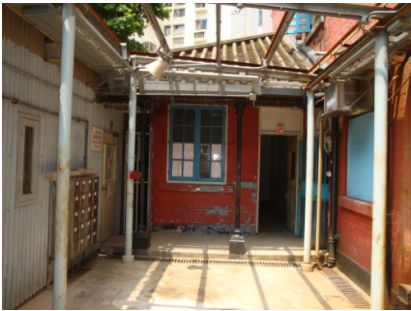
Element no.	Description	Photo ref.	Significance	Proposal	Mitigation	Impact
08.014	Single-storey outbuilding with pitched roof over

Low	Demolish to make way for new loading bay.	Record on measured survey drawings. Infill existing internal opening leaving reveals exposed. Tooth-in new brickwork at abutments after existing walls removed. Salvage cast iron columns for possible re-use.	Low
08.015	Corrugated steel sheet on balcony balustrades

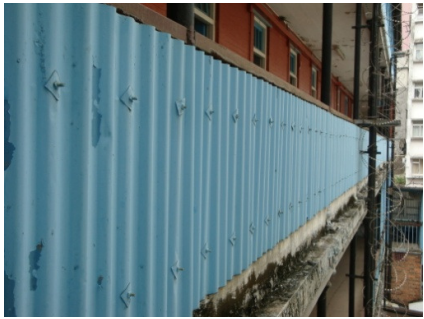
Adverse	Remove	Not applicable	Low

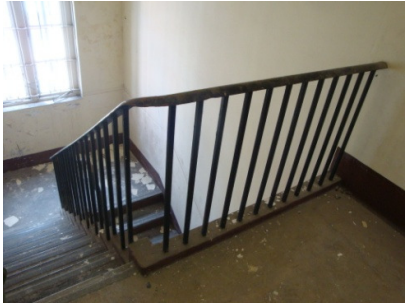
Element no.	Description	Photo ref.	Significance	Proposal	Mitigation	Impact
09.008	Stair balustrades

High	Balustrades to be supplemented with additional handrails and supports to mitigate non-compliance with code	New fittings to be of their time and made reversible. Physical intervention to existing stairs and balustrades to be kept to the minimum.	Moderate
09.009	Fixed signs

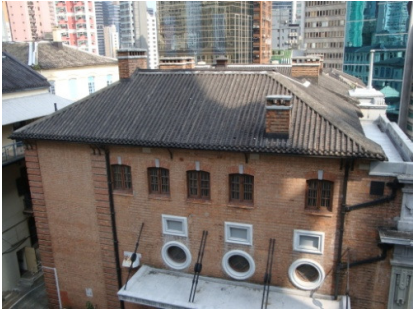
Adverse	Remove and make good brickwork	Not applicable	High
09.011	Pitched roofs

High	New penetrations through roofs for ventilation ducts and other services	Arrange new penetrations so that they conform with the geometry of the existing roof. Model the size and shape of the new ducts so that the impact on the roofscape is minimised. Finish the new ducts in a non-reflective material that is neutral in colour and mid-tone.	High

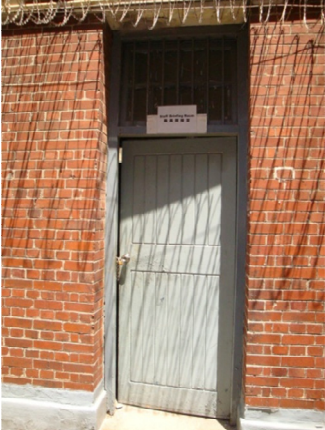
Element no.	Description	Photo ref.	Significance	Proposal	Mitigation	Impact
11.010	Timber doors

Low	Repair and retain	Not applicable	Neutral

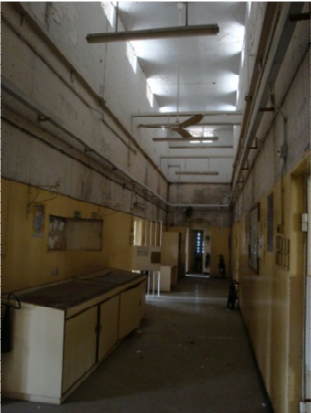
Element no.	Description	Photo ref.	Significance	Proposal	Mitigation	Impact
14.022	Top-lit central hall

High	Retain insitu	Not applicable	Neutral

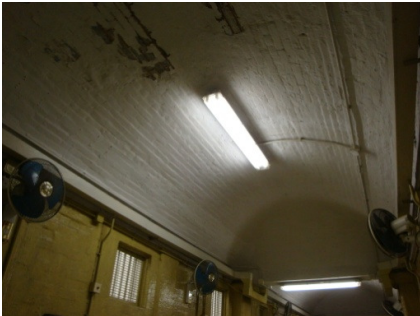
Element no.	Description	Photo ref.	Significance	Proposal	Mitigation	Impact
14.031	Brick vault over central hall at Ground Floor

High	Retain insitu	Not applicable	Neutral
14.032	Terrazzo floor in central hall at Ground floor

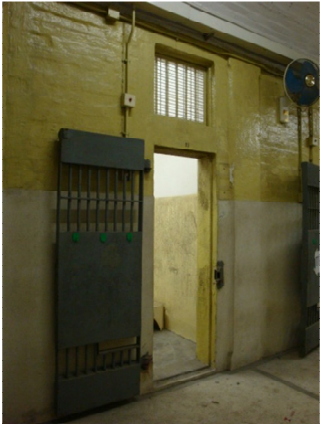
Element no.	Description	Photo ref.	Significance	Proposal	Mitigation	Impact
14.036	Cell walls flanking central hall

High	Remove to accommodate new cafe	Record on measured survey drawings. Retain selected cells for interpretation purposes.	Moderate

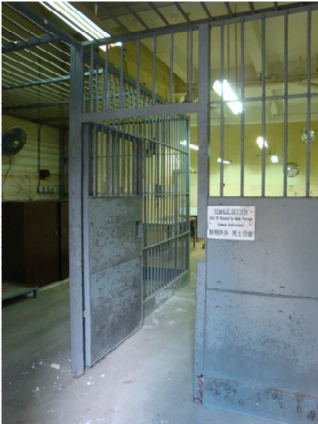
Element no.	Description	Photo ref.	Significance	Proposal	Mitigation	Impact
17.017	Security screen at Ground Floor main entrance

Low	Remove to accommodate gallery space	Record on measured drawings	Low

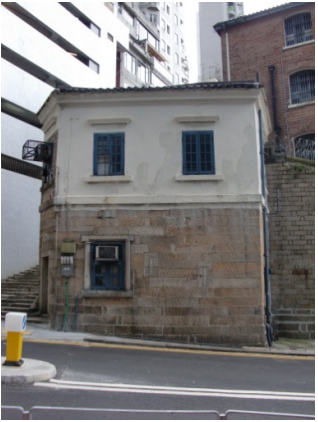
Element no.	Description	Photo ref.	Significance	Proposal	Mitigation	Impact
19.004	External stone wall facing

High	Carry out close inspection of painted areas to determine extent of original granite facing and remove paint media where applicable.	Not applicable	Moderate
