The Jockey Club CPS Limited

Central Police Station Conservation  
and Revitalisation Project:  
*85<sup>th</sup> Monthly EM&A Report*  
*(1 November to 30 November 2020)*

Issue Date: December 2020

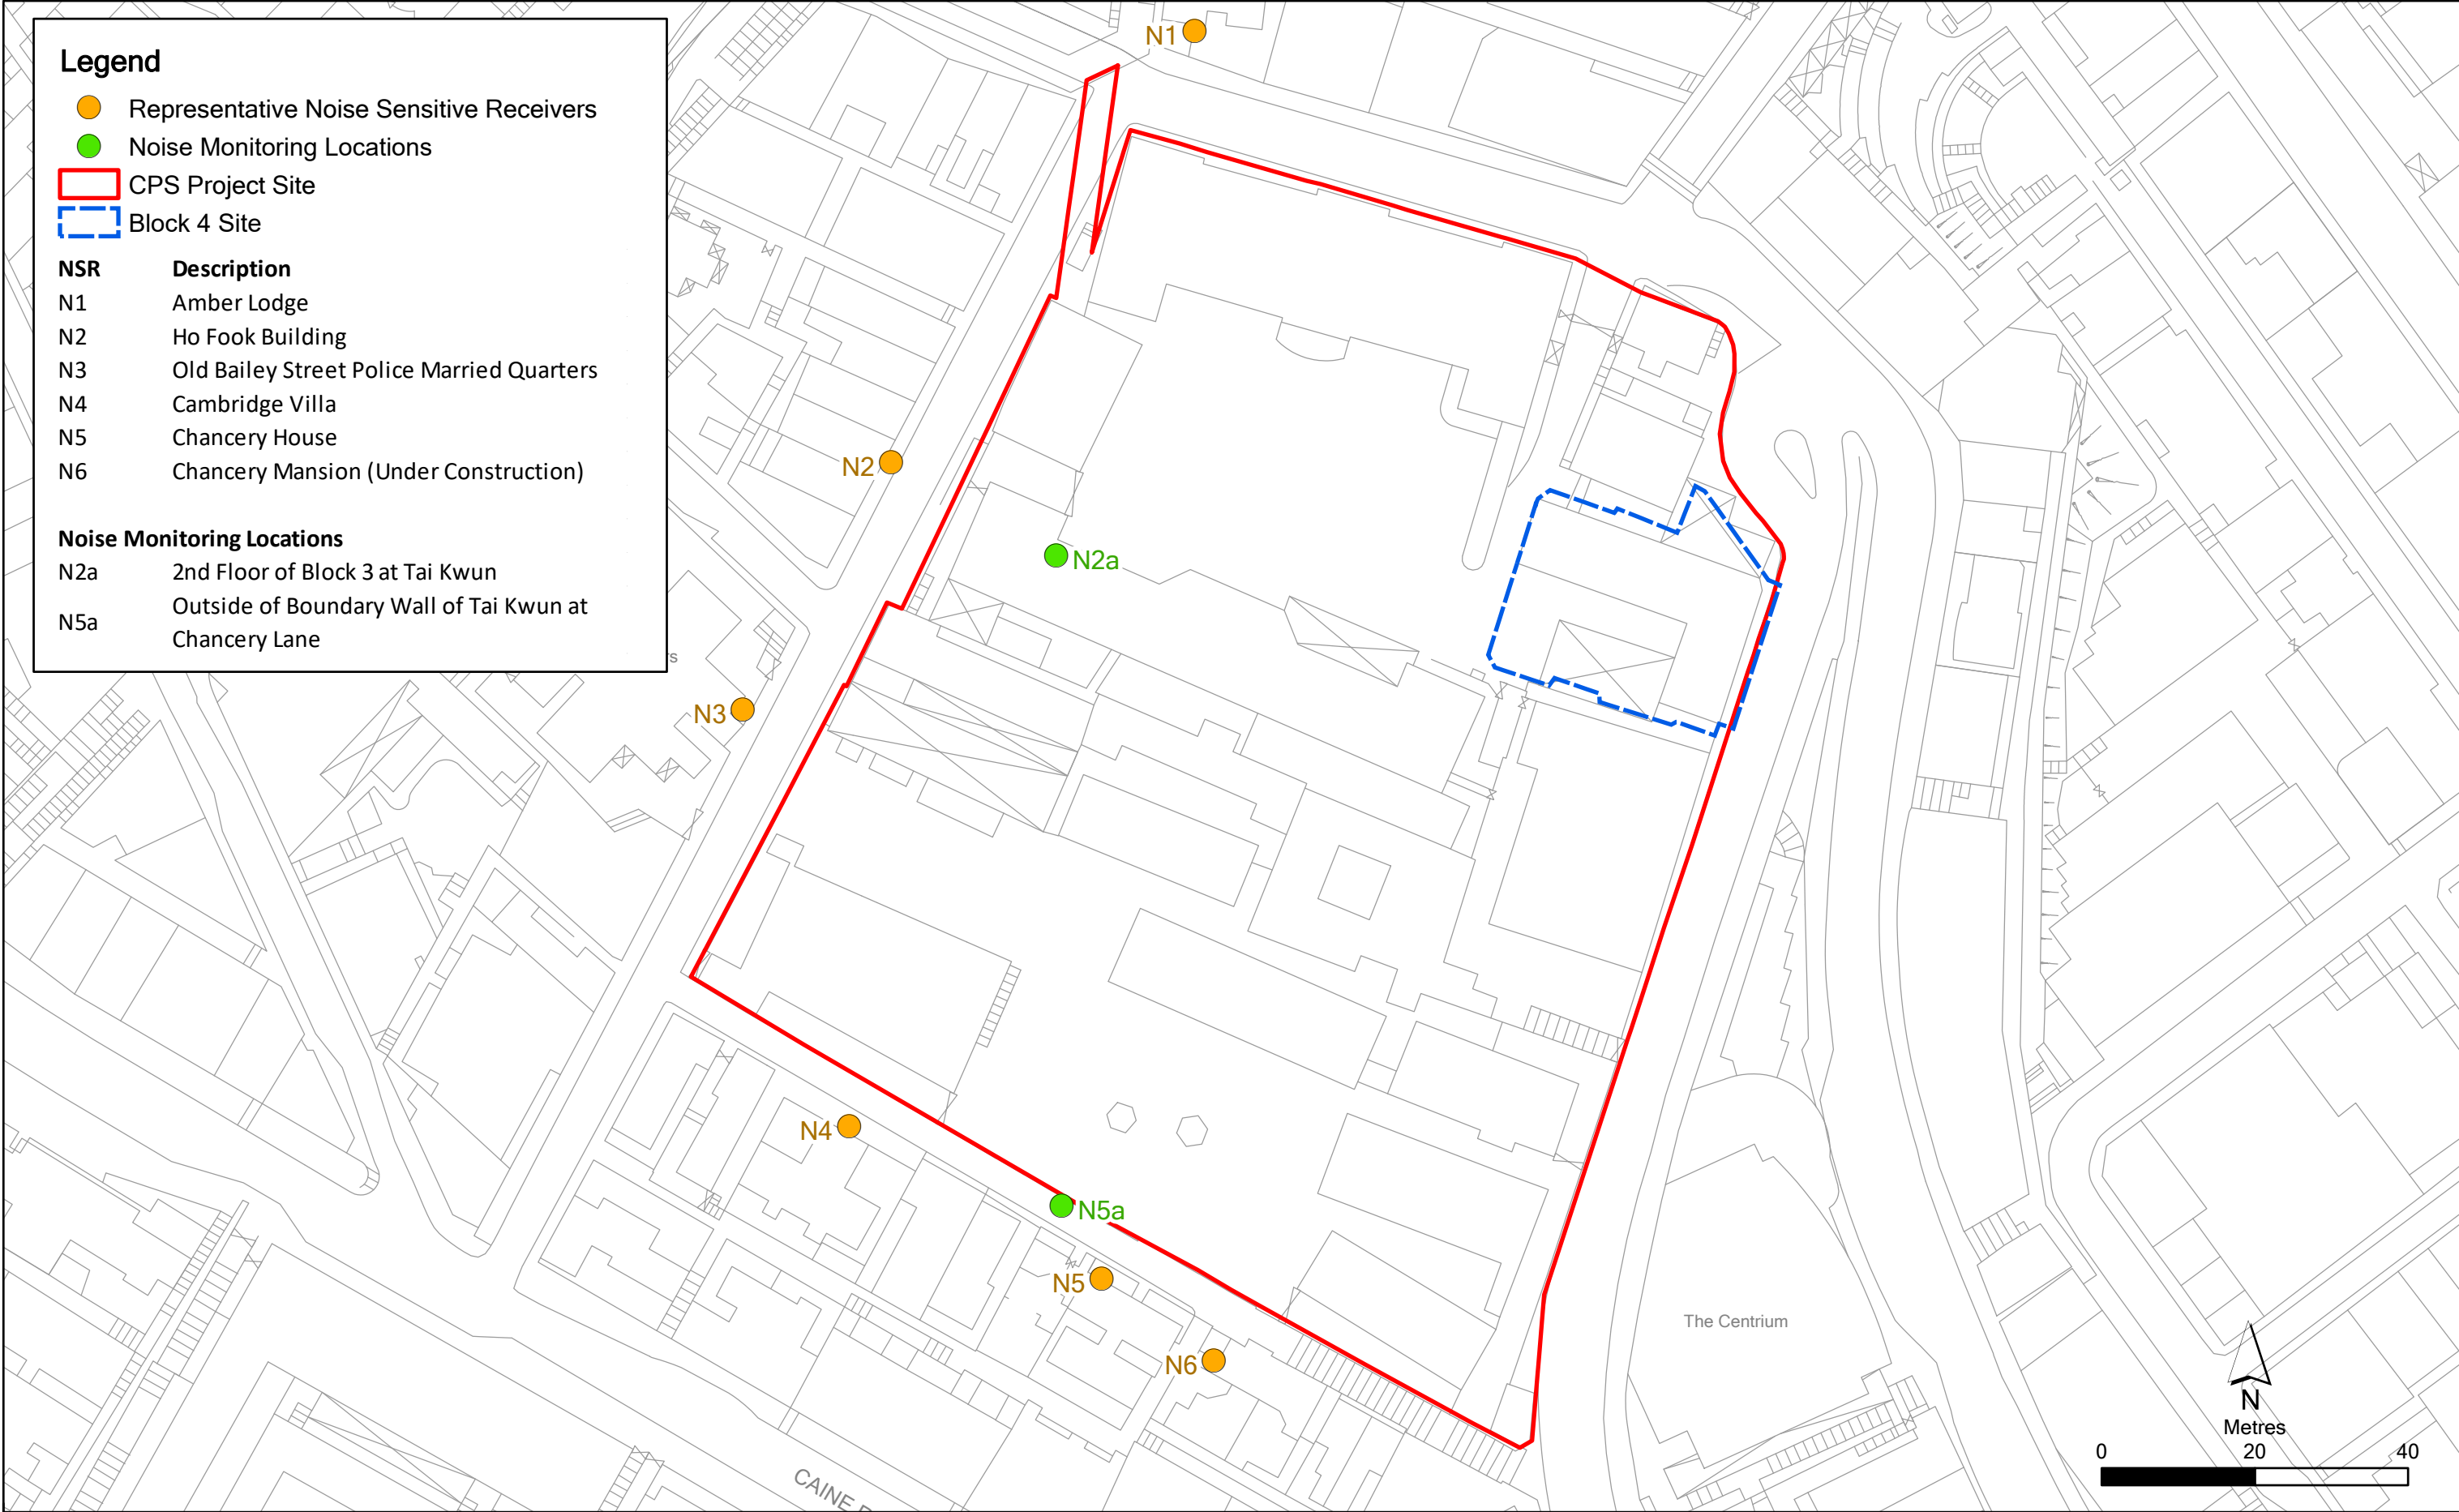
Location of Representative Noise Sensitive Receivers and Noise Monitoring Locations

NSR	Description
N1	Amber Lodge
N2	Ho Fook Building
N3	Old Bailey Street Police Married Quarters
N4	Cambridge Villa
N5	Chancery House
N6	Chancery Mansion (Under Construction)

Noise Monitoring Locations	
N2a	2nd Floor of Block 3 at Tai Kwun
N5a	Outside of Boundary Wall of Tai Kwun at Chancery Lane

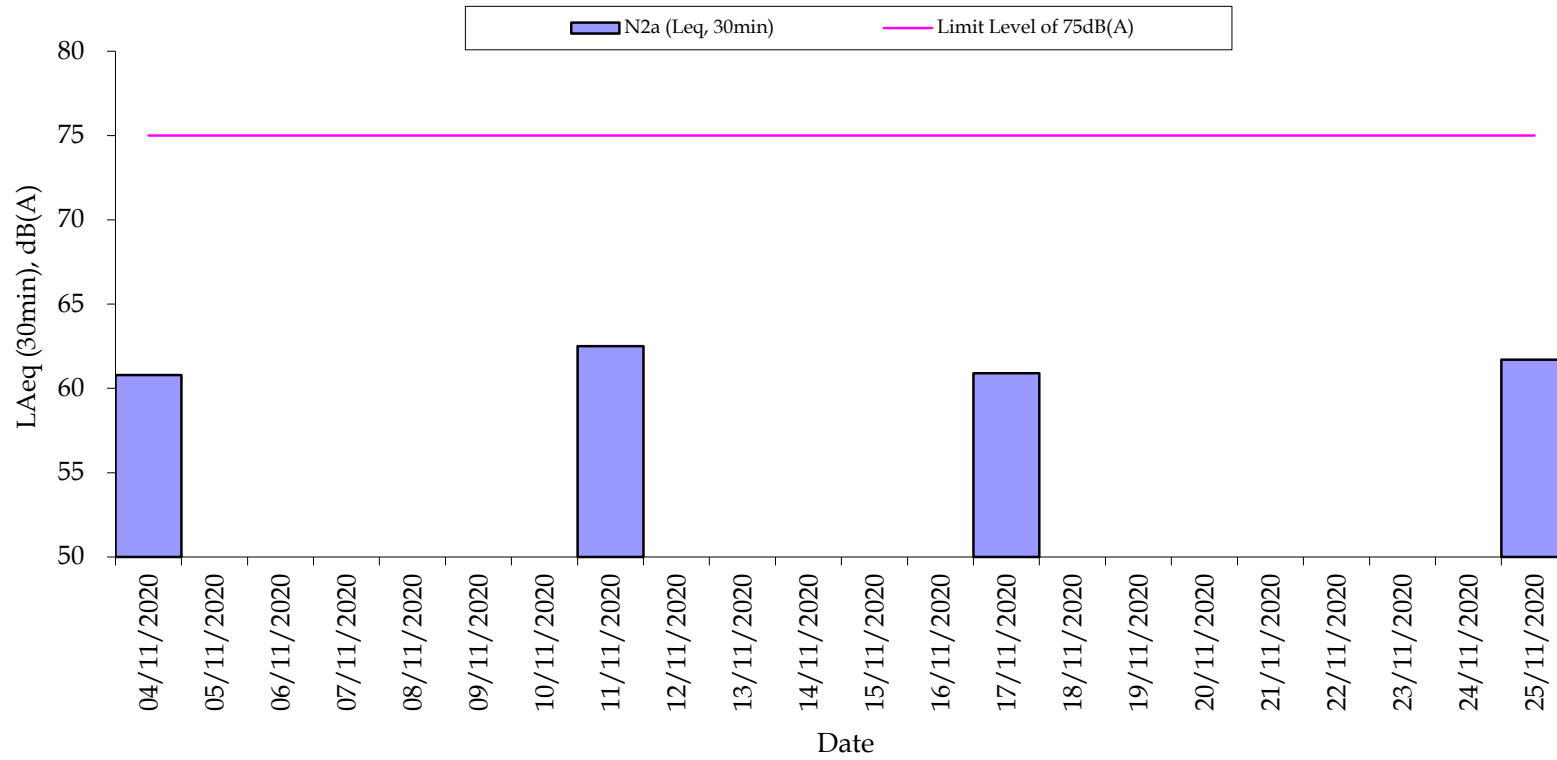
Normal Weekdays Noise Monitoring Results at 2nd Floor of Block 3 at Tai Kwun (N2a) (Leq, 30min)

- 75dB(A) was adopted as the Limit Level during normal weekdays in the reporting period

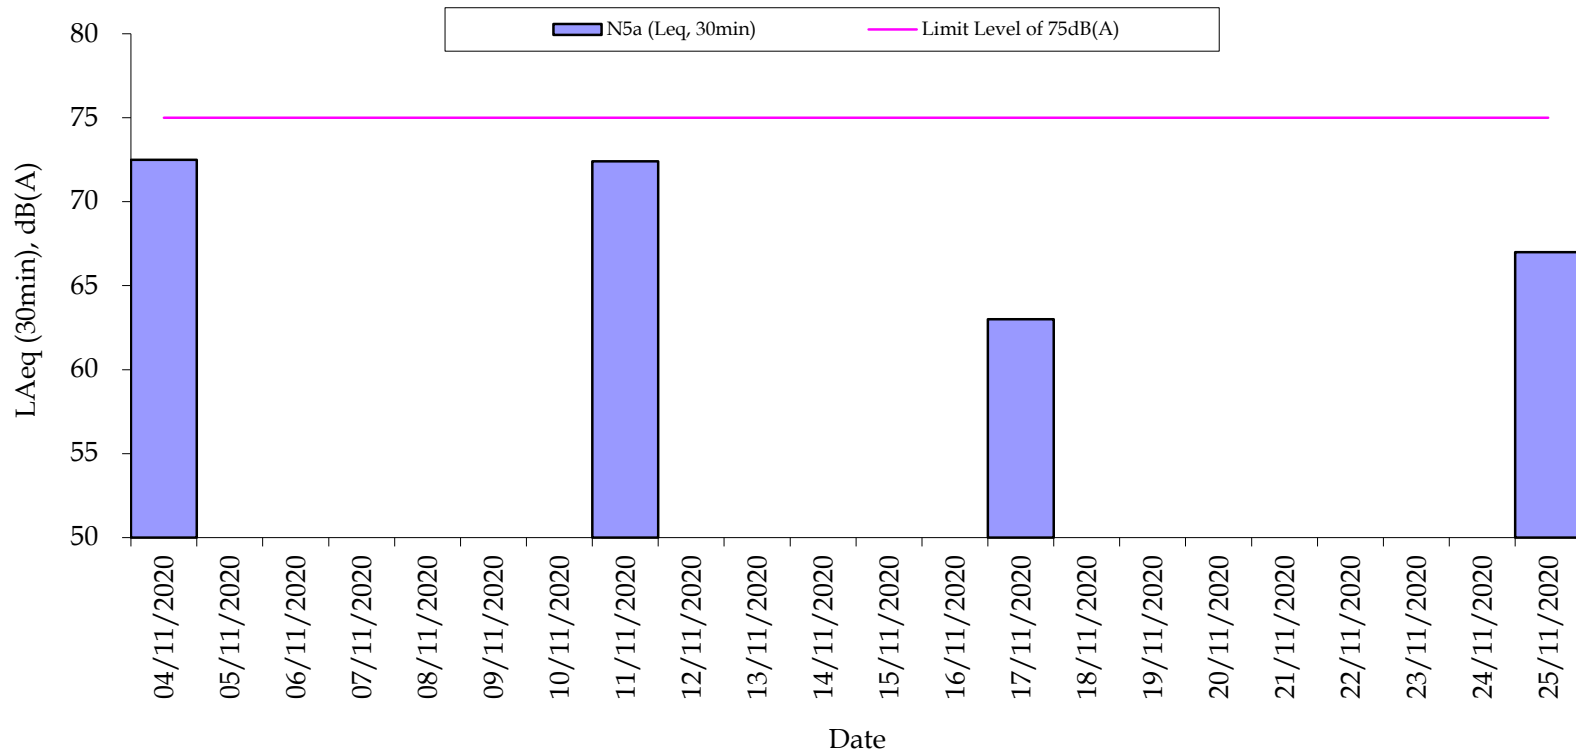
Normal Weekdays Noise Monitoring Results Outside of Boundary Wall of Tai Kwun at Chancery Lane (N5a)  
(Leq, 30min)

- 75dB(A) was adopted as the Limit Level during normal weekdays in the reporting period.
- Correction of +3dB(A) was added to the monitoring data for free-field measurement.
