Central Police Station Conservation
and Revitalisation Project:
92nd Monthly EM&A Report
(1 October to 31 October 2023)

Issue Date: November 2023

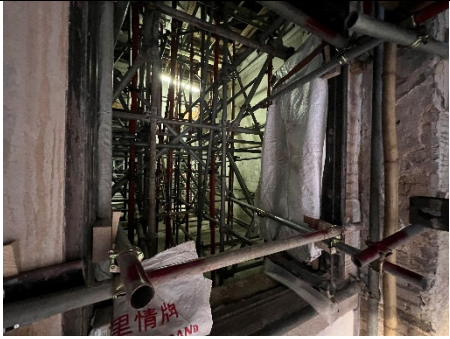
<p>3.5</p>	<p>Is protection of the existing building adequate and effective?</p>	<p>4/10</p>

<p>Protections to existing timber windows.</p>

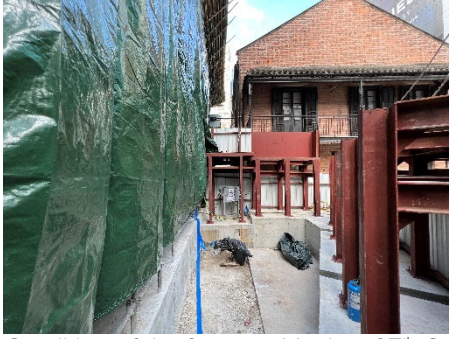
<p>Condition of the Sergeant Yard on 27th Oct.</p>	<p>[Inspections dated 4th, 13th, 17th and 27th Oct 2023] Protections to existing timber windows and doors insitu were generally found sufficient during all visits. However, general deterioration of protection due to loss of adhesiveness of adhesive tape was noticed.</p> <p>[Inspection dated 17th and 27th Oct 2023] Previously reported issue of deteriorated protection to window casements and shutters was addressed. New protection has been installed with new labels added.</p> <p>[Inspection dated 13th, 17th and 27th Oct 2023] The hoarding construction in Sergeant Yard was completed in early Oct. The area was found to be kept tidy during site inspection on 13th, 17th and 27th Oct.</p>

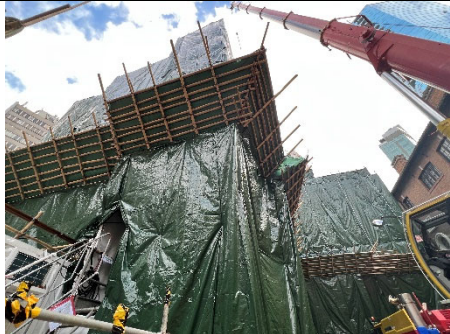
<p>Condition of the scaffolding on 17th Oct.</p>   <p>Installation of bamboo working platform in progress.</p>   <p>Damaged fretwork found on 2/F dated 27th Oct.</p>	<p>[Inspection dated 13th, 17th and 27th Oct 2023] The scaffolding modification works including installation of tarpaulin and bamboo catch fans were completed.</p> <p>[Inspection dated 27th Oct 2023]. The installation of bamboo working platform on 2/F high level is in progress. The working platform is to facilitate the upcoming roof removal works.</p> <p>[Inspection dated 27th Oct 2023]. Damage pieces of timber fretwork were found on 2/F, which is possibly caused by the installation of the bamboo working platform at high level. Contractor was notified and requested to provide sufficient protections to the existing fretwork and cornice.</p>
--	--	---	--

- Damage pieces of timber fretwork were found on 2/F. Contractor was notified and requested to provide sufficient protections to the existing fretwork and cornice.

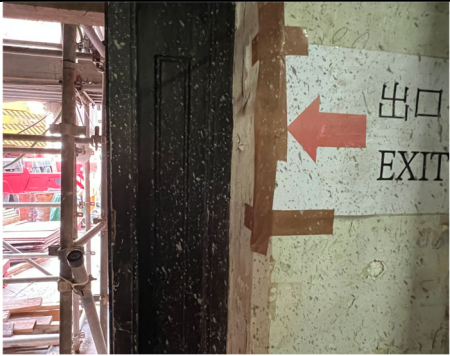
<p>Generally, recommendations to improve or rectify protection to heritage fabric have been met with a positive response by the contractor and were carried out in a timely manner.</p> <p>However, the splashes of concrete mortar caused by missing protection to existing walls and door frames have not yet been cleaned and removed.</p> <p>The recurring incident related to the lack of sufficient protection to historic fabrics shall be improved (2nd reminder).</p>
Sub-Total		50/70		
4 SITE SUPERVISION

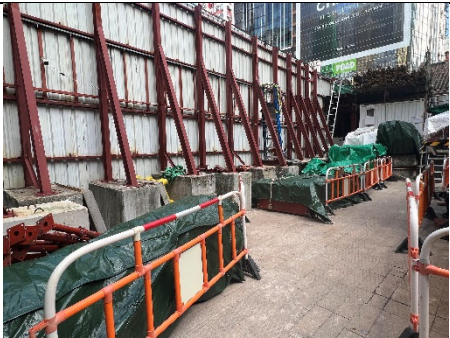
<p>The site is generally being kept tidy.</p>	<p>[Inspections dated 4th, 13th, 17th and 27th Oct 2023] During all our visits, the site was observed as being well maintained and is generally in a tidy condition.</p> <p>No incident, water ponding or leakage was reported.</p>

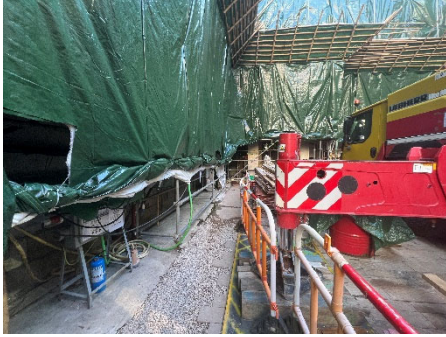
<p>The site is generally being kept tidy.</p>	
4.3	Is sequencing of operations managed efficiently?	9/10

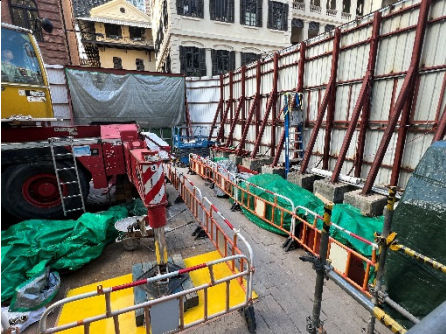
<p>Working area has been fenced off.</p>

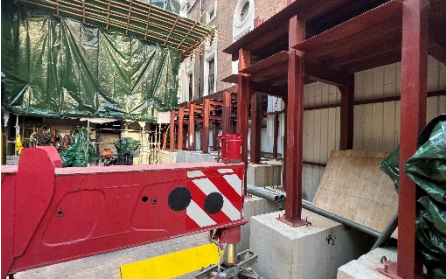
<p>Remaining hoarding construction near Blk 9 is completed.</p>	No adverse comments.

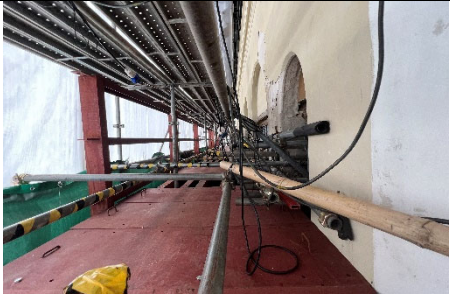
<p>Catch fan construction on East elevation dated 17th Oct.</p>

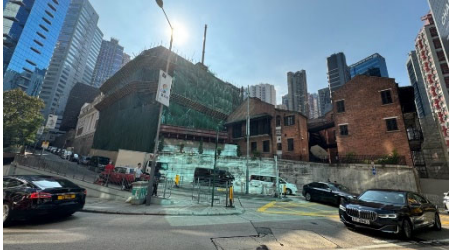
<p>Scaffolding and hoarding arrangement are maintained along Arbutnot Road</p>	
	Sub-Total	52/60
