Central Police Station Conservation  
and Revitalisation Project:  
*93<sup>rd</sup> Monthly EM&A Report*  
*(1 November to 30 November 2023)*

Issue Date: December 2023

**Block 4 Investigation, Removal and the Associated Alteration Works –  
Heritage Checker Monthly Site Audit Checklist for Cultural Heritage**

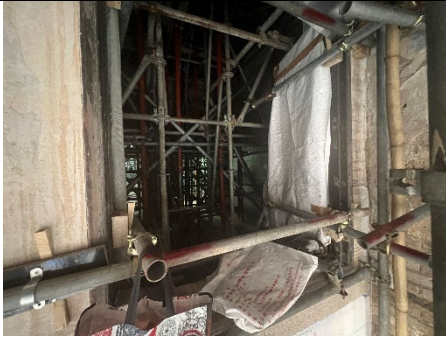
<p>3.5</p>	<p>Is protection of the existing building adequate and effective?</p>	<p>6/10</p>

<p>Protections to existing timber windows.</p>

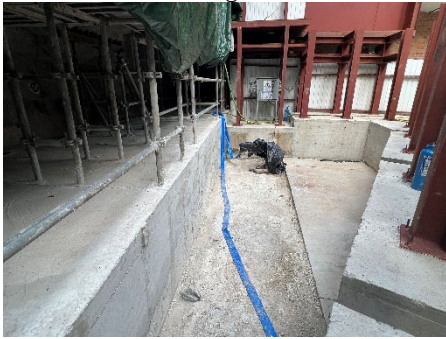
<p>Condition of the Sergeant Yard on 15<sup>th</sup> Nov.</p>

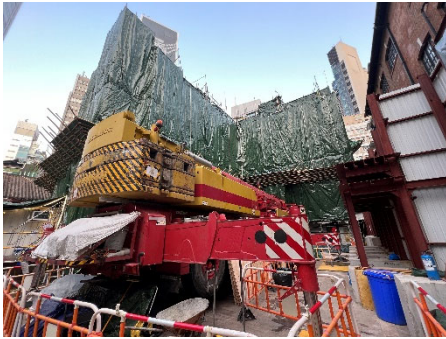
<p>Condition of the scaffolding on 27<sup>th</sup> Nov.</p>	<p>[Inspections dated 1<sup>st</sup>, 10<sup>th</sup>, 15<sup>th</sup>, 24<sup>th</sup> and 27<sup>th</sup> Nov] Protections to existing timber windows and doors insitu were generally found sufficient during all visits. The previously reported loose protection has been made good by the Contractor.</p> <p>[Inspection dated 1<sup>st</sup>, 10<sup>th</sup>, 15<sup>th</sup>, 24<sup>th</sup> and 27<sup>th</sup> Nov] The hoarding construction in Sergeants Yard, which was originally completed in early October, was found to be clean and tidy during all site visits.</p> <p>[Inspection dated 1<sup>st</sup>, 10<sup>th</sup>, 15<sup>th</sup>, 24<sup>th</sup> and 27<sup>th</sup> Nov] The scaffolding was found well maintained during all site visits.</p>

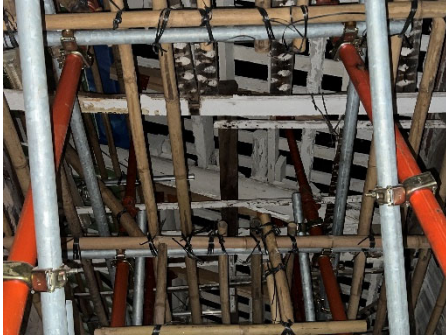
<p>Completed bamboo working platform.</p>

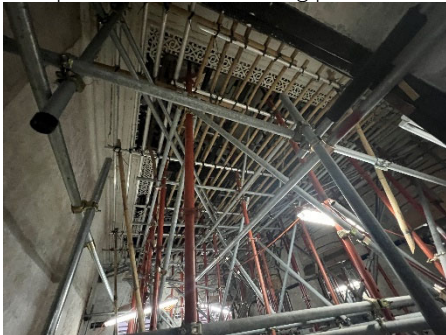
<p>Condition of the ceiling in Room 04/S/11 dated 10<sup>th</sup> Nov.</p>	<p>[Inspection dated 15<sup>th</sup> Nov 2023]. The installation of bamboo working platform to facilitate the roof removal works was observed as being completed during site visit on 15<sup>th</sup> Nov.</p> <p>[Inspection dated 1<sup>st</sup>, 10<sup>th</sup>, 15<sup>th</sup>, 24<sup>th</sup> and 27<sup>th</sup> Nov]. Following the reporting of the damaged fretwork in the previous report No. 13, no further damages was observed during this reporting period.</p> <p>Despite being requested in the previous report, the contractor to date has not added any further protective measures to the fretwork and cornice which shall be removed and salvaged soon.</p>

- Splashes of concrete mortar caused by missing protection to existing walls and door frames have been cleaned off. Protection to the heritage fabric was supplemented.
- The damaged fretwork was observed not to have additional damage during this reporting period. No further protective measures were added to the fretwork and cornice which shall be removed and salvaged soon.

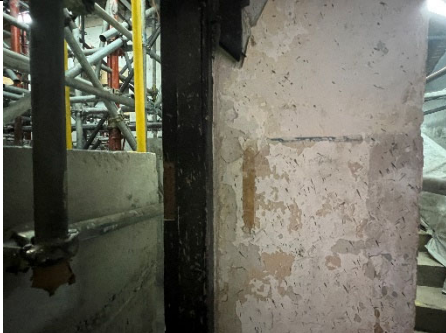
3.6	Are errors rectified promptly and effectively?	6/10

<p>Generally, recommendations to improve or rectify protection to heritage fabric have been met with a positive response by the contractor and were carried out in a timely manner.</p> <p>Note: Previously reported splashes of concrete mortar on the existing walls and door frames have been cleaned off during this reporting period.</p>
	<b>Sub-Total</b>	<b>54/70</b>

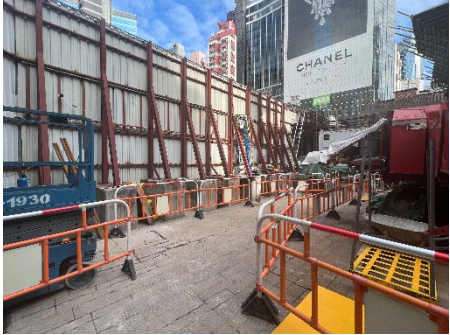
<p>The site is generally being kept tidy.</p>

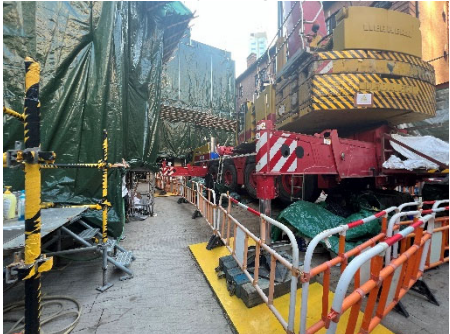
<p>The site is generally being kept tidy.</p>	[Inspections dated 1 <sup>st</sup> , 10 <sup>th</sup> , 15 <sup>th</sup> , 24 <sup>th</sup> and 27 <sup>th</sup> Nov] During all our visits, the site was observed as being well maintained and is generally in a tidy condition.  No incident, water ponding or leakage was reported.

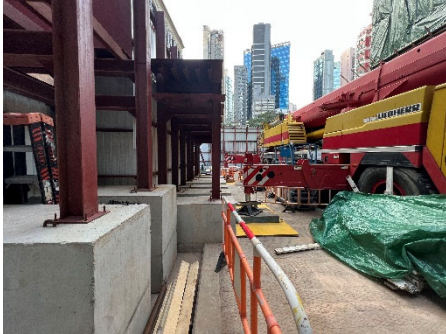
<p>Mobile crane on site with working area fenced off.</p>

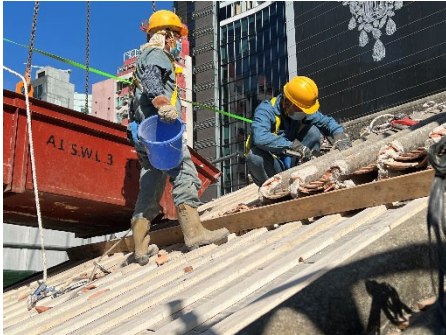
<p>Removal of roof tiles dated 24<sup>th</sup> Nov.</p>	<p>[Inspections dated 1<sup>st</sup>, 10<sup>th</sup>, 15<sup>th</sup>, 24<sup>th</sup> and 27<sup>th</sup> Nov] The mobile crane was observed during all 5 site inspections with the area fenced off.</p> <p>[Inspections dated 24<sup>th</sup> and 27<sup>th</sup> Nov] Safe lines and harness were provided for working on the roof. However, the Contractor was reminded to review the number of safe lines should the number of workers working on the roof removal increase.</p>

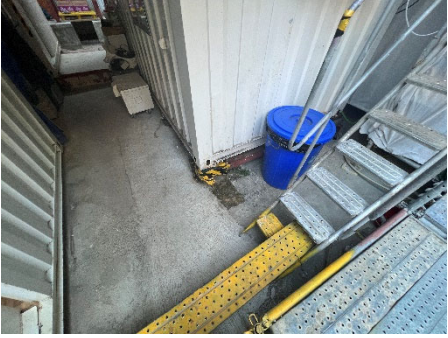
<p>Site hut area found to be tidy and well maintained.</p>	<p>[Inspections dated 1<sup>st</sup>, 10<sup>th</sup>, 15<sup>th</sup>, 24<sup>th</sup> and 27<sup>th</sup> Nov] The contractors site hut is being kept reasonably clean, tidy, and organised.</p>
4.6	Is the site managed in a safe manner?	8/10

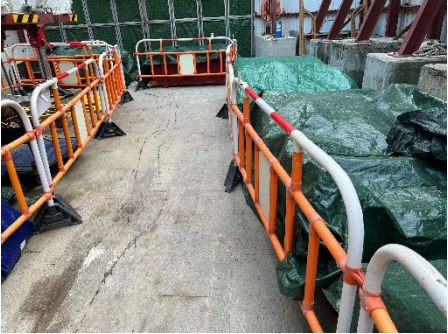
<p>Working area has been fenced off.</p>

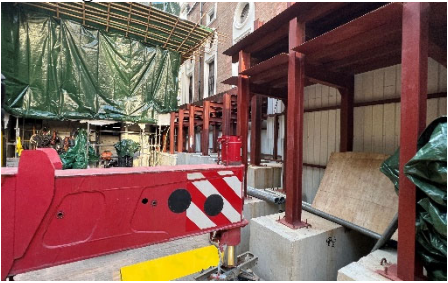
<p>Hoarding condition near Blk 9</p>	<p>No adverse comments.</p>

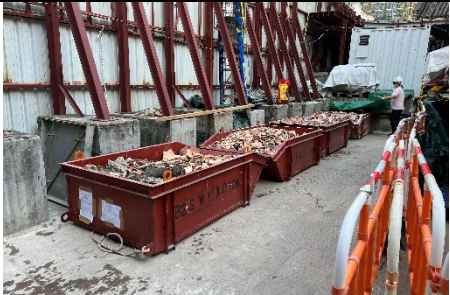
<p>Disposal of site waste follows the waste management plan.</p>

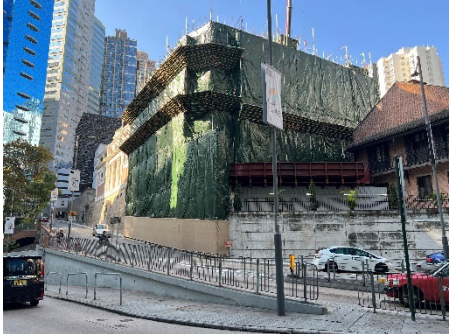
<p>Scaffolding and hoarding arrangement are maintained along Arbutnot Road</p>	
	<b>Sub-Total</b>	<b>51/60</b>
