Central Police Station Conservation  
and Revitalisation Project:  
96<sup>th</sup> Monthly EM&A Report  
(1 February to 29 February 2024)

**Block 4 Investigation, Removal and the Associated Alteration Works –  
Heritage Checker Monthly Site Audit Checklist for Cultural Heritage**

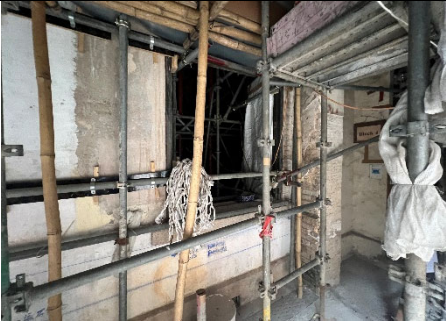
<p>Protections to existing timber windows.</p>

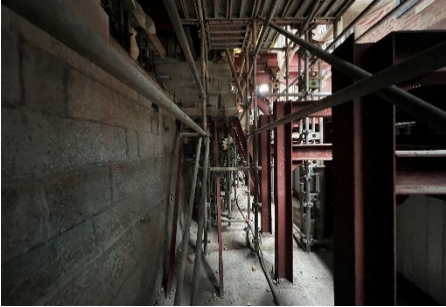
<p>Temporary supports to West Corbel in Sergeants Yard on 27<sup>th</sup> Feb.</p>

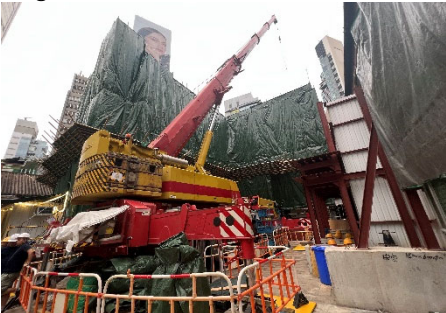
<p>Condition of the scaffolding on 23<sup>rd</sup> Feb.</p>	<p>[Inspections dated 6<sup>th</sup>, 20<sup>th</sup>, 23<sup>rd</sup> and 27<sup>th</sup> Feb 2024] Protections to existing timber windows and doors insitu were generally found sufficient during all visits.</p> <p>[Inspections dated 6<sup>th</sup>, 20<sup>th</sup>, 23<sup>rd</sup> and 27<sup>th</sup> Feb 2024] The hoarding construction in Sergeants Yard, which was originally completed in early October, was found to be clean and tidy during all site visits.</p> <p>[Inspections dated 6<sup>th</sup>, 20<sup>th</sup>, 23<sup>rd</sup> and 27<sup>th</sup> Feb 2024] The scaffolding was found well maintained during all site visits.</p>

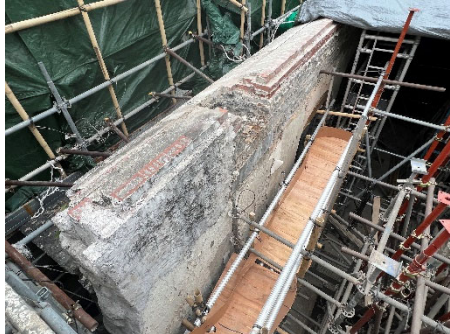
<p>Photo showing the wall near West Corbel before demolition.</p>

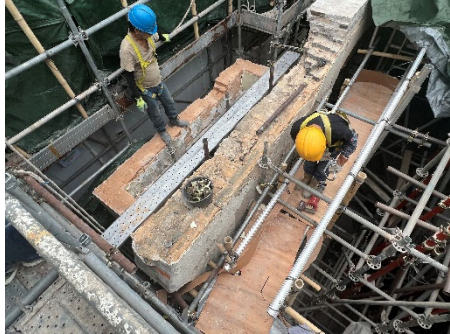
<p>Temporary works near West Corbel on 2/F in progress.</p>	<p>[Inspections dated 23<sup>rd</sup> and 27<sup>th</sup> Feb 2024] The Stage 2 and 3 removal works have commenced on 21<sup>st</sup> Feb after the approval from Commissioner for Heritage's Office was received.</p> <p>The work sequence and methodology followed the approved method statement.</p> <p>[Inspections dated 27<sup>th</sup> Feb 2024] As requested by HKJC and Arup, installation of additional temporary supports was carried out by the contractor to further enhance the site safety provisions during demolition works near the West Corbel on 2/F.</p>
--	--	---	--

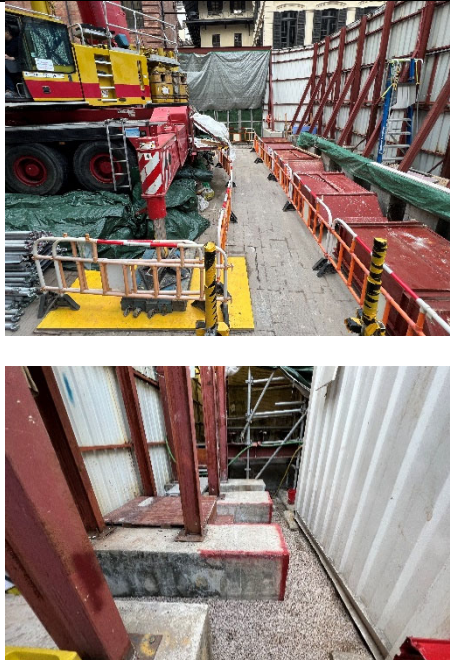
<p>The site is generally being kept tidy.</p>	<p>[Inspections dated 6<sup>th</sup>, 20<sup>th</sup>, 23<sup>rd</sup> and 27<sup>th</sup> Feb 2024] During all our visits, the site was observed as being well maintained and is generally in a tidy condition.</p> <p>No further water ponding or leakage was observed during this reporting period.</p>

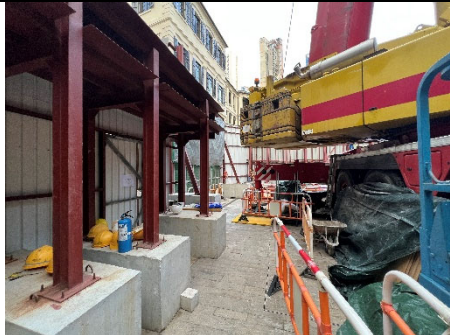
<p>Mobile crane on site with working area fenced off.</p>

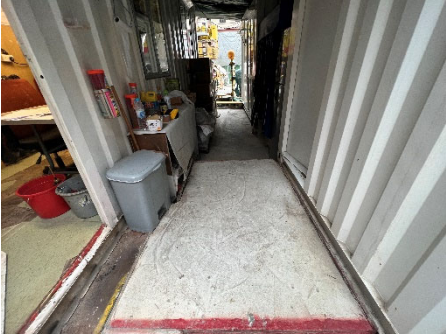
<p>Site hut area found to be tidy and well maintained.</p>	<p>[Inspections dated 6<sup>th</sup>, 20<sup>th</sup>, 23<sup>rd</sup> and 27<sup>th</sup> Feb 2024] The contractors site hut is being kept reasonably clean, tidy, and organised.</p>
4.6	Is the site managed in a safe manner?	8/10

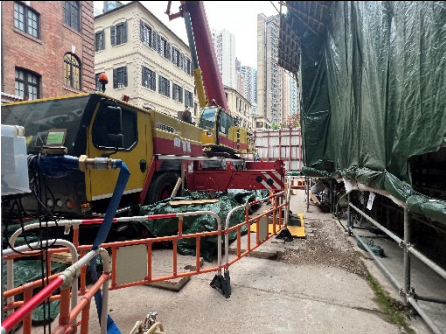
<p>Working area has been fenced off.</p>	No adverse comments.

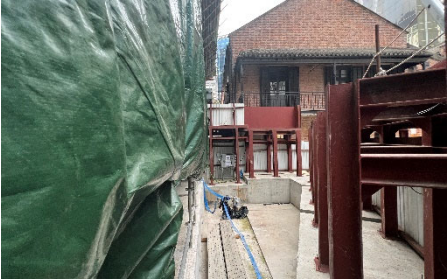
<p>Hoarding condition near Blk 6&amp;7</p>

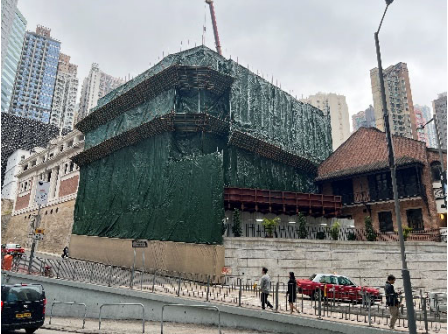
<p>Scaffolding and hoarding arrangement are maintained along Arbuthnot Road</p>	
	<b>Sub-Total</b>	<b>57/60</b>
