The Jockey Club CPS Limited

Central Police Station Conservation
and Revitalisation Project:
97th Monthly EM&A Report
(1 March to 31 March 2024)

Issue Date: April 2024

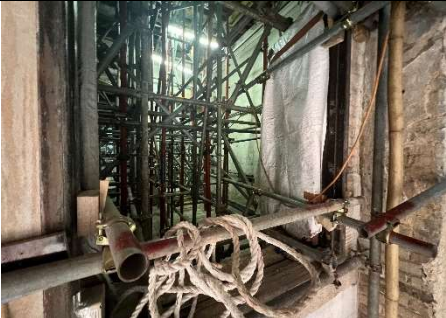
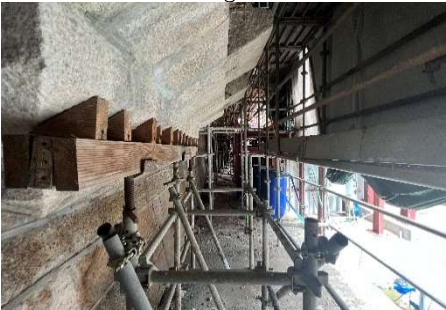
| <p>3.5</p> | <p>Is protection of the existing building adequate and effective?</p> | <p>6/10</p> | <p>Protections to existing timber windows.</p> <p>Temporary supports to East Corbel in Sergeants Yard on 27th March.</p> <p>Condition of the scaffolding on 12th March.</p> | <p>[Inspections dated 5th, 8th, 12th, 19th, and 27th Mar 2024] Protections to existing timber windows and doors on G/F were generally found sufficient during all visits but with signs of deterioration. Contractor was reminded to maintain sufficient protection to the portion that are to be retained.</p> <p>[Inspections dated 5th, 8th, 12th, 19th, and 27th Mar 2024] The hoarding construction in Sergeants Yard, which was originally completed in early October, was found to be generally clean and tidy during all site visits.</p> <p>[Inspections dated 5th, 8th, 12th, 19th, and 27th Mar 2024] The scaffolding was found well maintained during all site visits.</p> |

- Protection to existing timber windows and doors on G/F had signs of deterioration during all site visits. The Contractor was reminded to maintain sufficient protection to the portion that are to be retained.

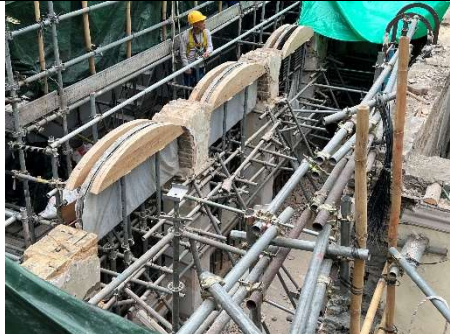
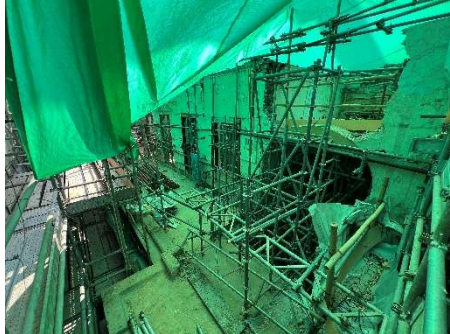
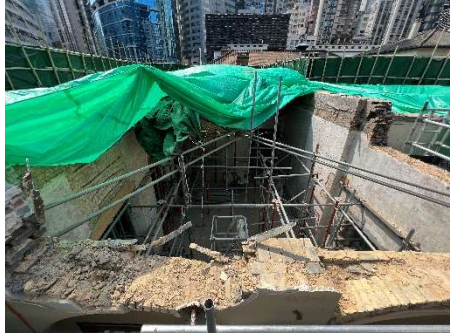
| | | <p>Removal in Wall Zone 1 dated 5th March.</p> <p>Photo showing the completed works in Wall Zone 1 dated 8th March.</p> <p>Removal in Wall Zone 2 dated 8th March.</p> | <p>[Inspections dated 5th, 8th, 12th, 19th, and 27th Mar 2024] The Stage 2 and 3 removal works have continued on site since late February.</p> <p>Based on the observation on site, the work sequence and methodology followed the approved method statement. Selected CDEs have been salvaged and relocation to temporary storage space on ground level.</p> |

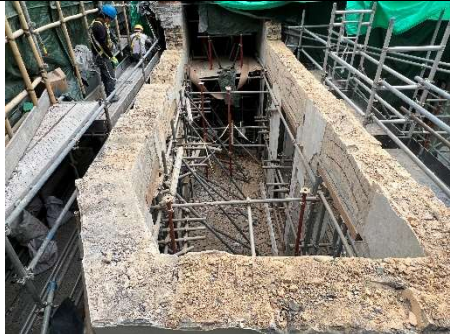
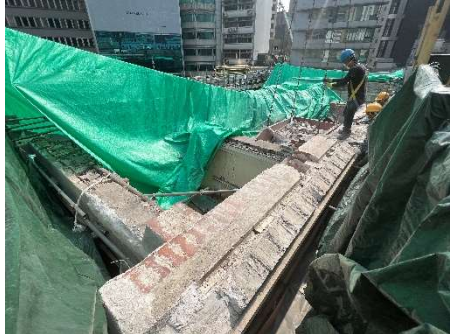
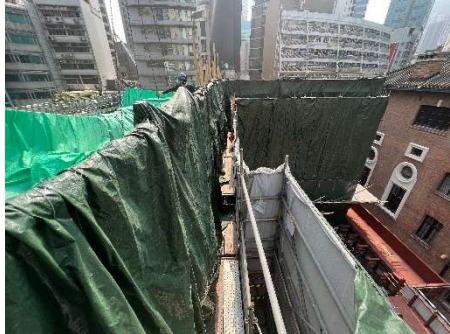
| | | <p>Removal in Wall Zone 3 dated 14th March.</p> <p>Removal in Wall Zone 5 dated 27th March.</p> <p>Modification of bamboo scaffolding dated 27th March.</p> | <p>[Inspections dated 27th Mar 2024] Modification of the existing bamboo scaffolding was in progress.</p> |

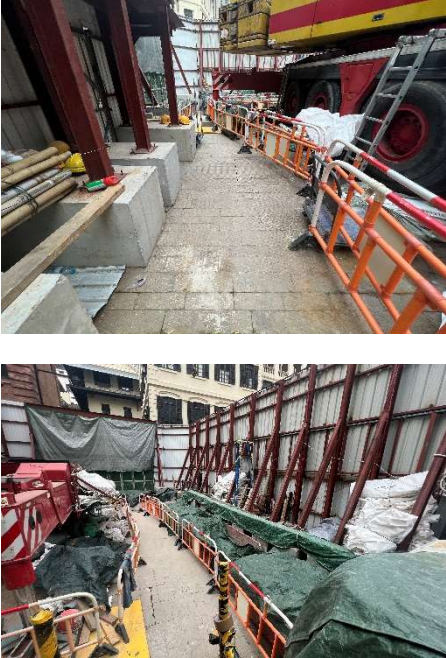
| 4.2 | Is the site kept reasonably tidy? | 6/10 | <p>The site is generally being kept tidy.</p> | [Inspections dated 5 th , 8 th , 12 th and 19 th Mar 2024] During all our visits, the site was observed as being well maintained and is generally in a tidy condition. |

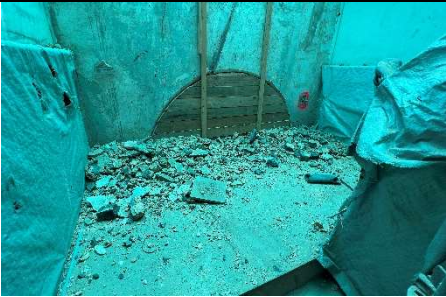
| | | | <p>Debris found at the landing between 1/F and 2/F in ST02 on 27th March.</p> | <p>[Inspections dated 27th Mar 2024] Large number of debris were found on the ST02 landing between 1/F and 2/F. The contractor was reminded to remove the debris in a timely manner and maintain sufficient protection before the completion of 3D scanning and salvaging of the relevant staircase portion.</p> |

- Large amount of debris was found at the landing between 1/F and 2/F. The Contractor was reminded to remove the debris in a timely manner and maintain sufficient protection.

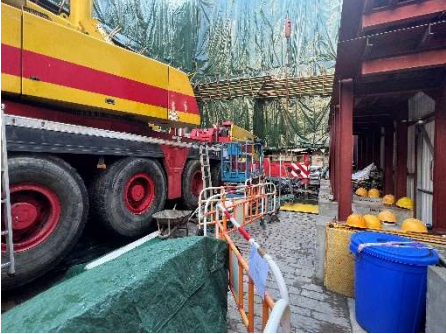
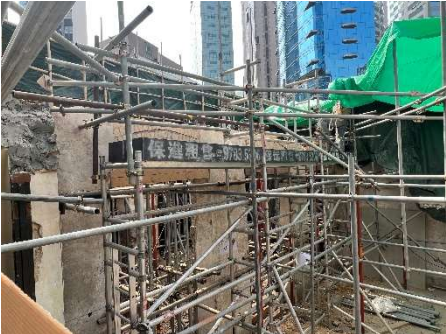
| 4.3 | Is sequencing of operations managed efficiently? | 8/10 | <p>Mobile crane on site with working area fenced off.</p> <p>Working platform erected for demolishing of internal wall.</p> | <p>[Inspections dated 5th, 8th, 12th, 19th, and 27th Mar 2024] The mobile crane was observed during all 5 site inspections with the area fenced off.</p> <p>During this reporting period, AMO has been notified on the previously reported termite infestation issue. At the time of publishing this report, the treatment of the affected timber members remain under discussion.</p> <p>[Inspections dated 12th Mar 2024] Working platform was erected to provide safe access for demolishing the internal walls.</p> |

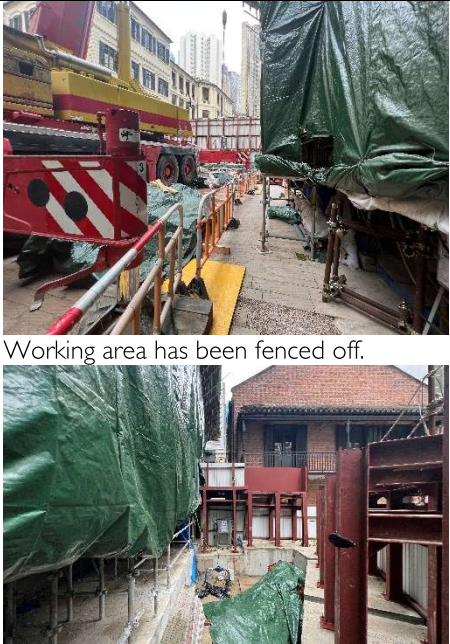
| 4.6 | Is the site managed in a safe manner? | 8/10 | <p>Working area has been fenced off.</p> <p>Hoarding condition near Blk 6&7</p> | <p>No adverse comments.</p> |

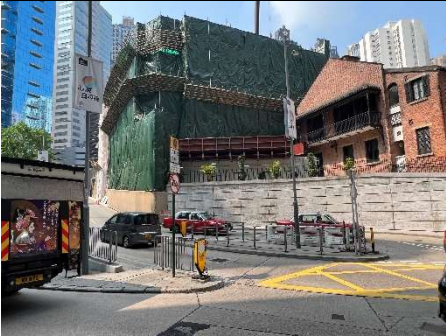
| | | | <p>Scaffolding and hoarding arrangement are maintained along Arbutnot Road</p> | |
