Central Police Station Conservation
and Revitalisation Project:
26th Quarterly EM&A Report
(1 February 2018 to 30 April 2018)

<i>Annex M</i>	<i>Summary of Condition of Character Defining Elements, Historic Buildings and Structures</i>

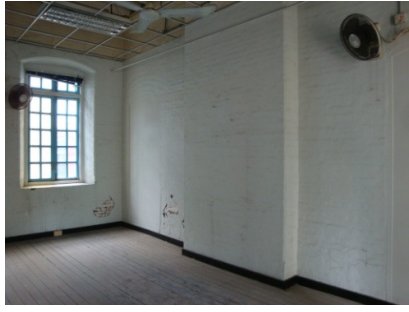
Low	Repair and retain in current location	Not applicable	Neutral
03.026	Window in south wall; original dormitory space

Moderate	Remove window and take down brickwork spandrel; subdivide space to form new fire-protected escape route.	Record existing condition on measured survey drawings. New partition wall to be reversible.	Low

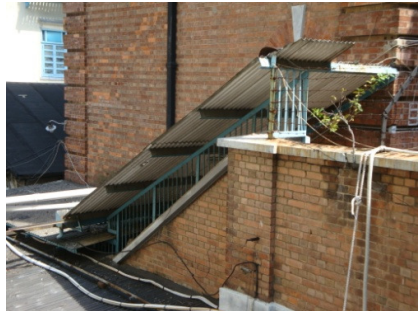
Adverse	Repair or renew as necessary existing frames to match original patterns	Not applicable	High
09.015	Sloping canopy over external stair on west side

Adverse	Remove canopy and supporting structure	Not applicable	Moderate
