Central Police Station Conservation  
and Revitalisation Project:  
*28<sup>th</sup> Quarterly EM&A Report*  
*(1 September 2020 to 30 November*  
*2020)*

Issue Date: February 2021

A Summary of Condition of  
Character Defining Elements,  
Historic Buildings and  
Structures

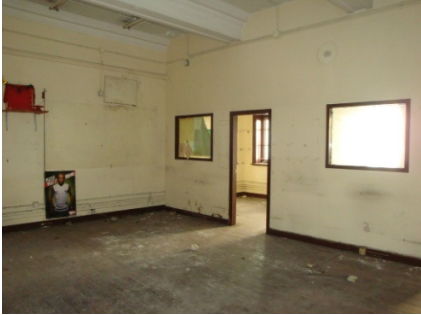
Element no.	Description	Photo ref	Significance	Proposal	Mitigation	Impact
01.011	Concrete floor

Low	Replace where new kitchens and plant rooms to be installed	Carefully remove and retain existing floorboards for re-use. Ensure controlled demolition of concrete structure and removal of debris from building to avoid damage to adjacent surfaces. Protect or carefully remove and set aside adjacent elements such as skirting boards	Low

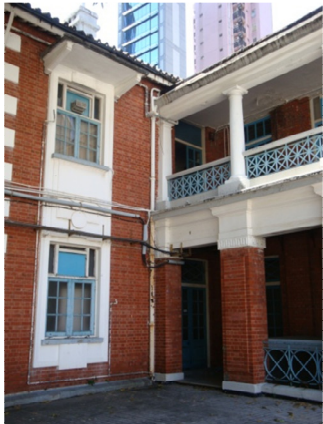
Element no.	Description	Photo ref	Significance	Proposal	Mitigation	Impact
01.012	Rainwater goods

Adverse	Replace with cast iron in pattern to match original and in correct locations	Not applicable	High

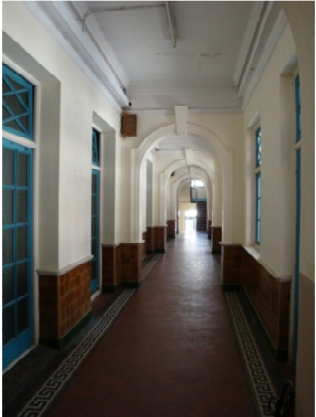
Element no.	Description	Photo ref	Significance	Proposal	Mitigation	Impact
01.022	Main corridors

High	Install new lighting, fire sprinklers, fire doors to comply with Fire Services Code	New fittings to be mounted in a manner that is of its time and reversible. Avoid physical intervention with existing plaster box cornices, architraves, dado rails	High
01.023	Painted signs

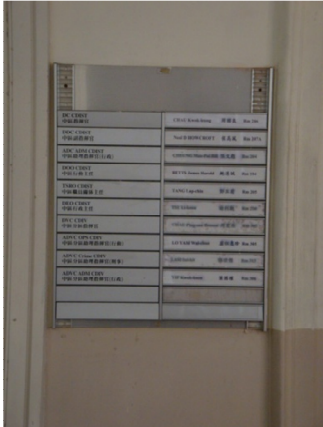
Element no.	Description	Photo ref	Significance	Proposal	Mitigation	Impact
01.024	Fixed signs

Low-High	Remove and refix/display in visitors' centre/discard	Record each sign and assess significance individually and treat accordingly	N/A

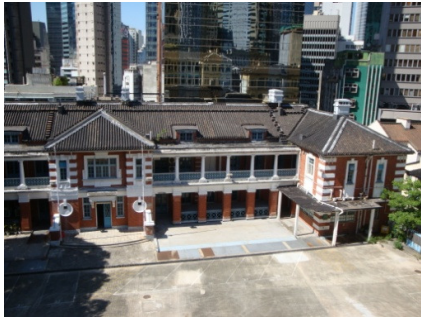
Element no.	Description	Photo ref	Significance	Proposal	Mitigation	Impact
01.025	Pitched roofs

High	New penetrations through roofs for ventilation ducts and other services	<p>Arrange new penetrations so that they conform with the geometry of the existing roof.</p> <p>Model the size and shape of the new ducts so that the impact on the roofscape is minimised.</p> <p>Finish the new ducts in a non-reflective material in a neutral mid-tone.</p>	High

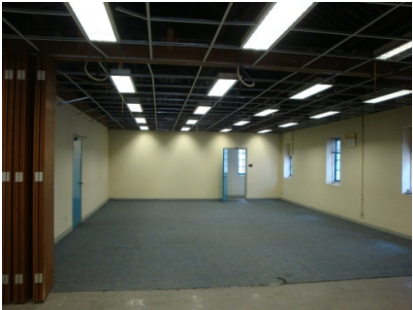
Element no.	Description	Photo ref.	Significance	Proposal	Mitigation	Impact
02.001	Lay-in grid suspended ceiling

Adverse	Remove	Not applicable	High
02.002	Modern internal doors

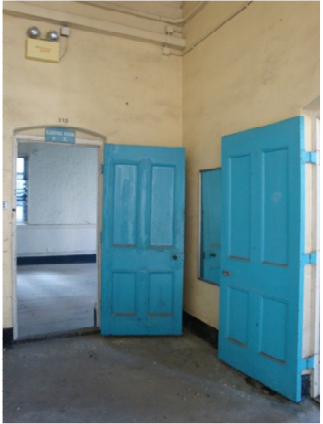
Element no.	Description	Photo ref.	Significance	Proposal	Mitigation	Impact
3.002	Panelled doors

Moderate	Replace where necessary to achieve fire resistance to comply with Code	Re-use where possible. Record design on survey drawings where item cannot be re-used.	Moderate

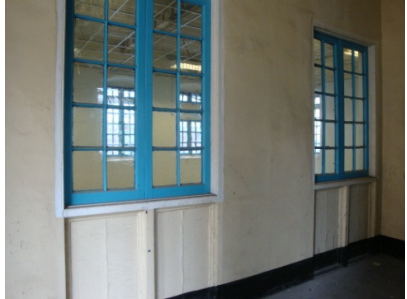
Element no.	Description	Photo ref.	Significance	Proposal	Mitigation	Impact
03.005	Timber spandrel panels below windows

Low	Conceal in exceptional cases eg. where adjacent new lift shaft	Retain frame and spandrel panel where possible. Remove only where necessary in connection with re-planning of interiors. Record on measured survey drawings.	Low
03.006	Timber floors

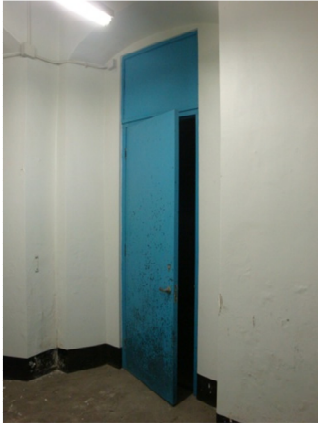
Element no.	Description	Photo ref.	Significance	Proposal	Mitigation	Impact
04.006	Block existing door openings

Moderate	Block opening as part of re-planning of interior	Retain existing door frame and architraves. Use framing and non-combustible sheet linings to block opening.	Moderate

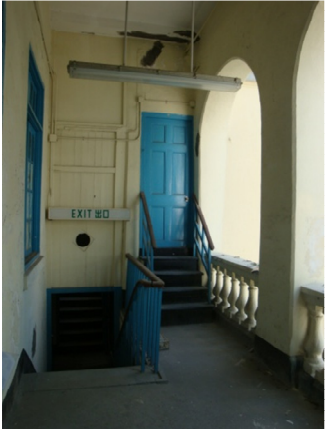
Element no.	Description	Photo ref.	Significance	Proposal	Mitigation	Impact
04.021	Steps up to doorway on FF verandah

Moderate	Remove steps and doorway to form new fore escape route	Record steps and doorway on measured drawings	Moderate

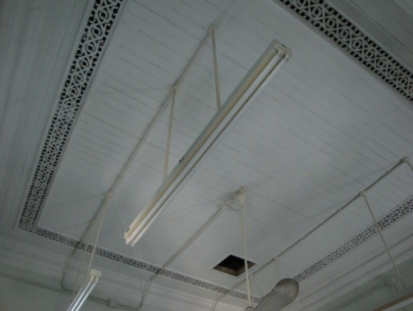
Element no.	Description	Photo ref.	Significance	Proposal	Mitigation	Impact
04.024	Clay tile floor		Low	Retain and repair as necessary	Not applicable	Neutral
04.025	Matched-boarded ceiling with perforated border

Moderate	Repair and retain insitu	Not applicable	Neutral

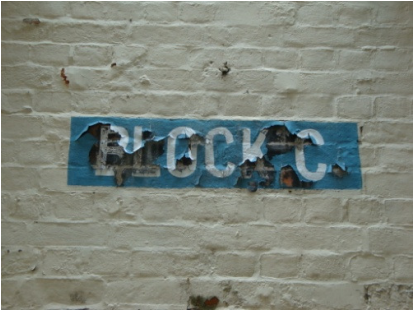
Element no.	Description	Photo ref.	Significance	Proposal	Mitigation	Impact
06.007	Painted signs

High	Protect in situ	Not applicable	N/A
06.008	Fixed signs

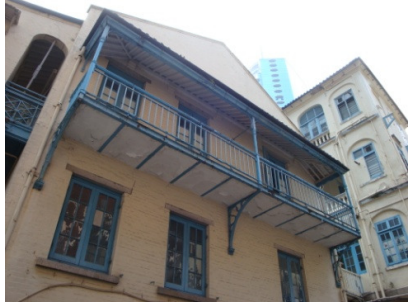
Element no.	Description	Photo ref.	Significance	Proposal	Mitigation	Impact
06.009	Cantilever balconies

High	Retain and repair as necessary.	Avoid highly visible intervention to enhance structural integrity and/or compliance with building codes. Restrict access if necessary to achieve this objective.	Low
06.010	Iron balustrades

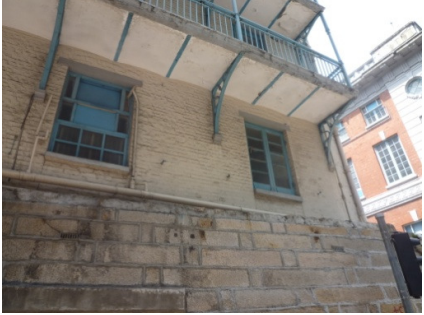
Element no.	Description	Photo ref.	Significance	Proposal	Mitigation	Impact
07.003	Exterior decorations

Adverse	Strip off and redecorate	Sample and analyse existing paint media; select new media to suit substrate and significance	High
07.004	Altered doors and windows

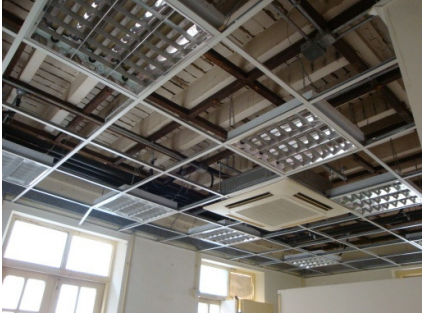
Element no.	Description	Photo ref.	Significance	Proposal	Mitigation	Impact
07.008	Lay-in grid suspended ceiling

Adverse	Remove	Not applicable	High
07.009	Corbelled brickwork at perimeter of room

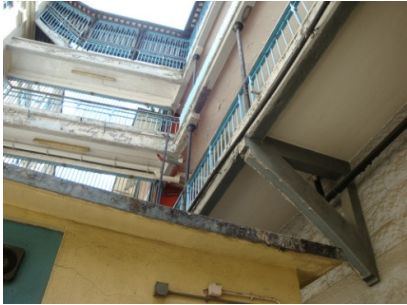
Element no.	Description	Photo ref.	Significance	Proposal	Mitigation	Impact
					clashes.	
08.011	Cantilever balconies on north side

Moderate	Repair and retain insitu	Not applicable

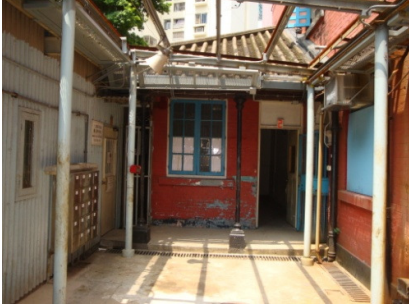
Element no.	Description	Photo ref.	Significance	Proposal	Mitigation	Impact
08.014	Single-storey outbuilding with pitched roof over

Low	Demolish to make way for new loading bay.	<p>Record on measured survey drawings.</p> <p>Infill existing internal opening leaving reveals exposed.</p> <p>Tooth-in new brickwork at abutments after existing walls removed.</p> <p>Salvage cast iron columns for possible re-use.</p>	Low
08.015	Corrugated steel sheet on balcony balustrades

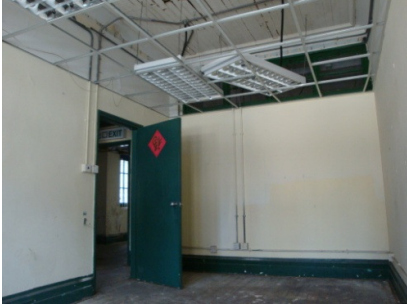
Element no.	Description	Photo ref.	Significance	Proposal	Mitigation	Impact
09.003	Internal walls

Moderate	Remove selected internal walls where strictly necessary as part of re-planning of interiors	Walls or early or original date to be retained in part eg. By leaving a “nib” where the wall is bonded to another wall. At the point where the wall is cut away, form the cut-line on the line of a vertical joint in alternate courses. Bricks in the remaining courses to be left “as cut”, and not re-bonded, as evidence of the current condition.	Moderate
09.004	Plaster box cornice

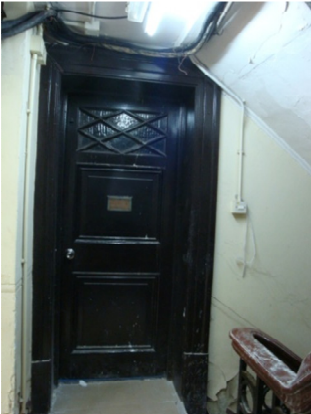
Element no.	Description	Photo ref.	Significance	Proposal	Mitigation	Impact
09.006	Block existing door openings

Moderate	Block opening as part of re-planning of interior	Retain existing door frame and architraves. Use framing and non-combustible sheet linings to block opening.	Moderate
09.007	Form new door openings		Moderate	Form new opening as part of re-planning of interiors	New doors and frames to be of their time to avoid confusion about provenance	Moderate

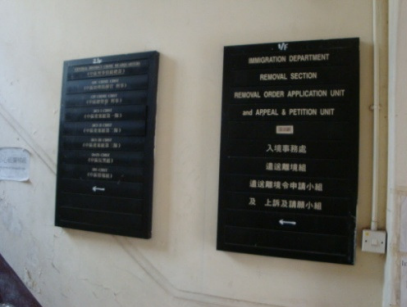
Element no.	Description	Photo ref.	Significance	Proposal	Mitigation	Impact
09.008	Stair balustrades	 	High	Balustrades to be supplemented with additional handrails and supports to mitigate non-compliance with code	New fittings to be of their time and made reversible. Physical intervention to existing stairs and balustrades to be kept to the minimum.	Moderate
09.009	Fixed signs

Low-High	Remove and refix/display in visitors' centre/discard	Record each sign and assess significance individually and treat accordingly	N/A

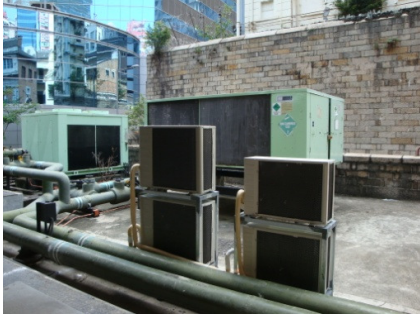
Element no.	Description	Photo ref.	Significance	Proposal	Mitigation	Impact
09.010	External airconditioning units and other external services

Adverse	Remove and make good brickwork	Not applicable	High
09.011	Pitched roofs

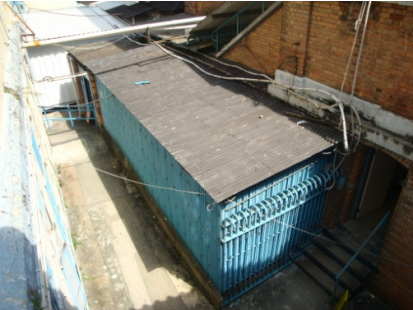
Element no.	Description	Photo ref.	Significance	Proposal	Mitigation	Impact
09.016	Single storey secure shelter at North West corner

Low	Demolish	Make good brickwork at abutments.	Low
09.017	Iron railing adjacent south side of item 09.016 above

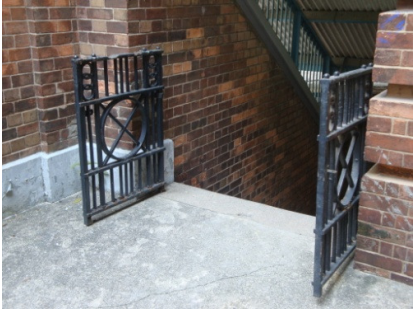
Element no.	Description	Photo ref.	Significance	Proposal	Mitigation	Impact
09.026	Iron gates at top of external stair

Moderate	Retain	No applicable	Neutral
09.027	Iron balustrade adjacent terrace at First Floor east side

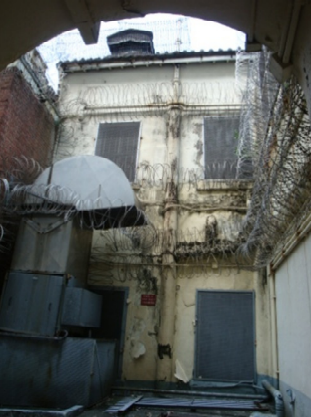
Adverse	Repair or renew as necessary existing frames to match original patterns	Not applicable	High
10.009	External airconditioning units and other external services

Adverse	Remove and make good brickwork	Not applicable	High

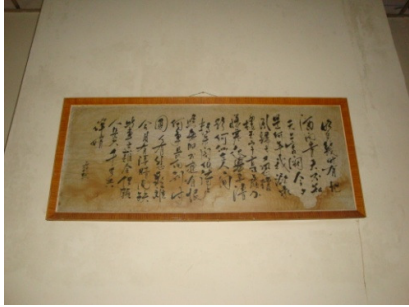
Element no.	Description	Photo ref.	Significance	Proposal	Mitigation	Impact
10.011	Fixed signs

Low-High	Remove and refix/display in visitors' centre/discard	Record each sign and assess significance individually and treat accordingly	N/A
10.012	Pitched roofs

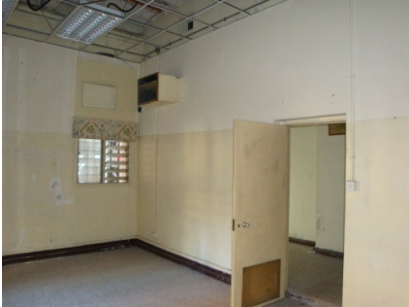
Element no.	Description	Photo ref.	Significance	Proposal	Mitigation	Impact
10.013	Internal walls

Moderate	Remove selected internal walls where strictly necessary as part of re-planning of interiors	Walls or early or original date to be retained in part eg. By leaving a “nib” where the wall is bonded to another wall. At the point where the wall is cut away, form the cut-line on the line of a vertical joint in alternate courses. Bricks in the remaining courses to be left “as cut”, and not re-bonded, as evidence of the current condition.	Moderate

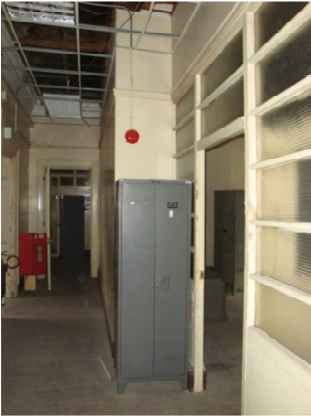
Element no.	Description	Photo ref.	Significance	Proposal	Mitigation	Impact
10.014	Partitions on SF

Moderate	Remove partitions	Record partitions on measured drawings	Moderate
10.015	Blocked windows on south elevation of south-east wing

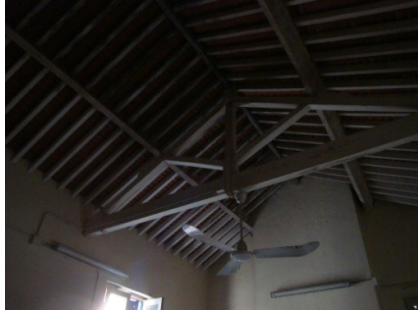
Element no.	Description	Photo ref.	Significance	Proposal	Mitigation	Impact
10.018	Timber roof structure above south-east wing

Moderate	Repair as necessary and retain	Avoid intrusive alteration. Retain open appearance/	Low
10.019	Timber stair

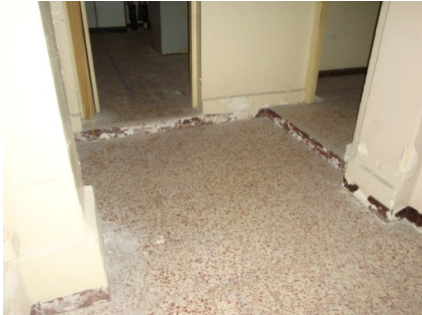
Element no.	Description	Photo ref.	Significance	Proposal	Mitigation	Impact
10.020	Clay/terrazzo tile floor on Ground Floor and steps

Adverse	Adjust levels to enable level access and replace floor finish	Not applicable	Low
10.024	Granite wall on North elevation

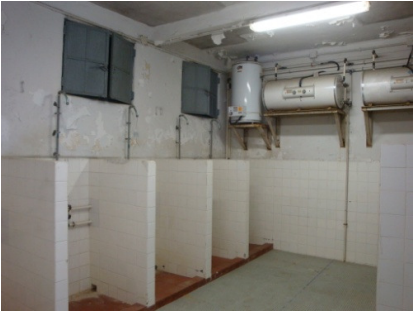
Element no.	Description	Photo ref.	Significance	Proposal	Mitigation	Impact
11.001	Form new door openings

Low	Form new opening as part of re-planning of interiors	New doors and frames to be of their time to avoid confusion about provenance	Low

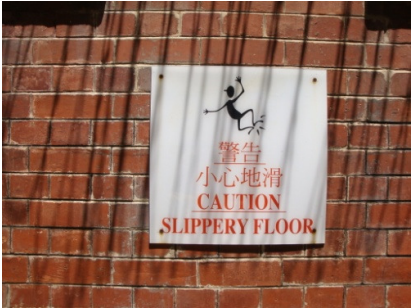
Element no.	Description	Photo ref.	Significance	Proposal	Mitigation	Impact
11.004	Fixed signs

Low-High	Remove and refix/display in visitors' centre/discard	Record each sign and assess significance individually and treat accordingly	N/A
11.005	Concrete stairs

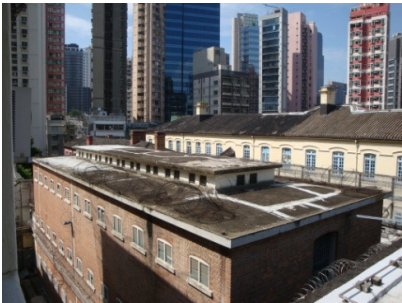
Element no.	Description	Photo ref.	Significance	Proposal	Mitigation	Impact
12.001	Flat roof

Moderate	Repair and retain	Avoid roof penetrations as far as possible	Low
12.002	Cells at GF level

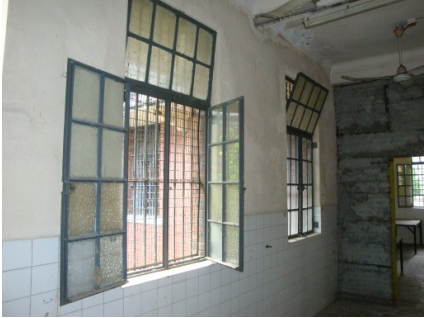
Element no.	Description	Photo ref.	Significance	Proposal	Mitigation	Impact
13.009	Metal window frames

Moderate	Repair and retain	Not applicable	Neutral
13.010	Internal security screens

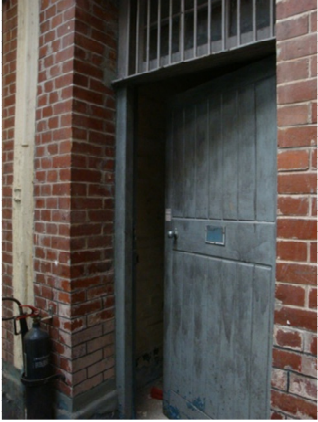
Element no.	Description	Photo ref.	Significance	Proposal	Mitigation	Impact
13.015	Timber boarded doors with fanlight over

Low	Repair as necessary and retain	Not applicable	Neutral
13.015	Vinyl tile floor

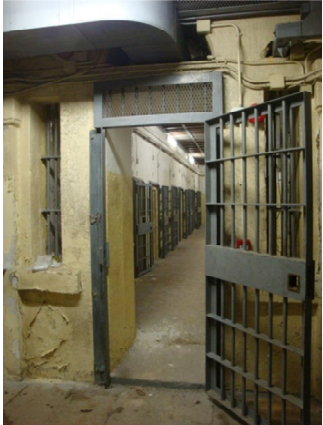
Element no.	Description	Photo ref.	Significance	Proposal	Mitigation	Impact
14.001	West entrance at Lower Ground Floor

Moderate	Retain as public entrance at this level.	<p>Retain security gate and granite threshold.</p> <p>Adjust adjacent ground level as necessary to achieve barrier-free access.</p> <p>Pin gate back against adjacent wall in the open position if necessary.</p>	Low

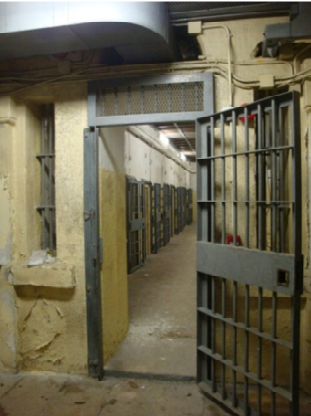
Element no.	Description	Photo ref.	Significance	Proposal	Mitigation	Impact
14.002	Half-round headed doorway and side lights

Moderate	Retain	Remove air duct and make good masonry above arch.	Low

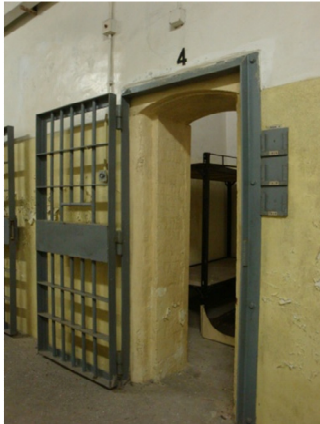
Element no.	Description	Photo ref.	Significance	Proposal	Mitigation	Impact
14.004	Brick reveals with bull-nosed arrisses and segmental arch over (generally north side, alternating with granite surrounds – see previous item)

High	Retain door surround and gate wherever possible	Pin back gate against wall	Low

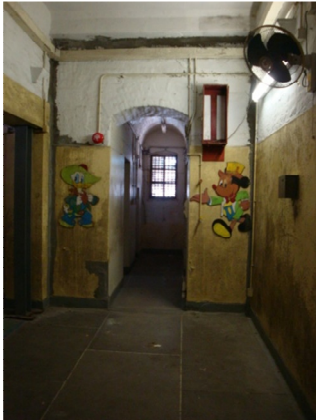
Element no.	Description	Photo ref.	Significance	Proposal	Mitigation	Impact
14.005	Arched opening at East end First Floor

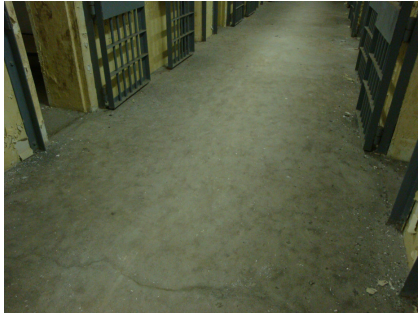
Low	Retain as existing	Not applicable	Low
14.006	Concrete floor generally at Lower Ground Floor

Low	Excavate entire floor to install piled underpinning	Record levels on measured survey drawings.  Install new floor at the same level.	Low

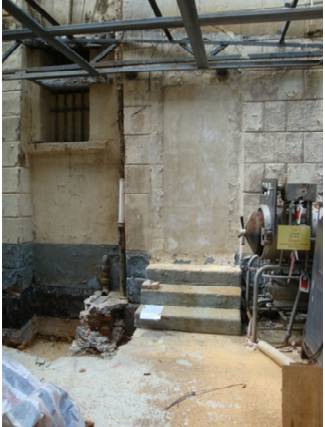
Element no.	Description	Photo ref.	Significance	Proposal	Mitigation	Impact
14.010	Blocked doorway at south-east corner

Low	Preserve blocked opening intact.	Not applicable	Neutral

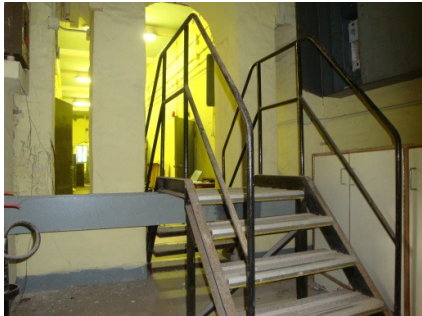
Moderate	Retain insitu	Not applicable	Neutral
14.013	Structural steelwork bracing and temporary access stair

Adverse	Remove upon completion of underpinning	Not applicable	Moderate

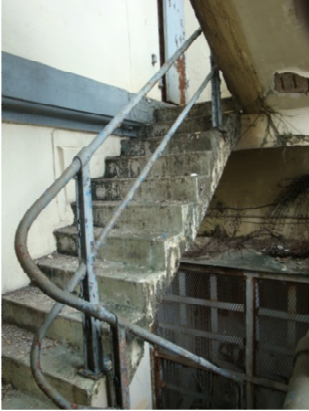
Element no.	Description	Photo ref.	Significance	Proposal	Mitigation	Impact
14.014	RC staircase at north-east corner

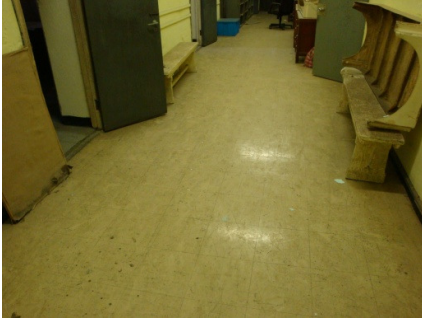
Low	Remove	Record on measured drawings	Low
14.015	Vinyl tile floor on suspended timber floor

Adverse	Remove vinyl tiles and restore boards if possible; alternatively, replace boards with new timber to match other boarded floors elsewhere on the site.	Not applicable	Low

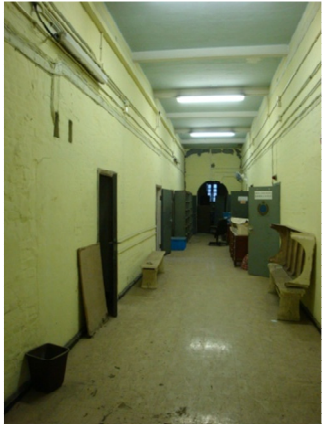
Element no.	Description	Photo ref.	Significance	Proposal	Mitigation	Impact
14.016	Cell walls at Ground Floor

Moderate	Retain insitu	<p>Use existing door openings wherever possible.</p> <p>Avoid further alteration to existing altered openings where feasible.</p>	Low

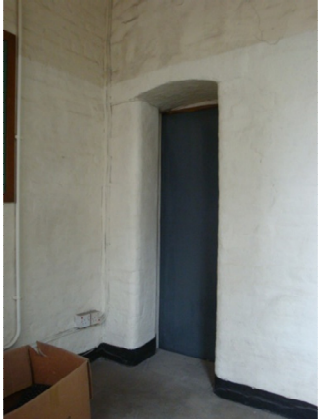
High	Preserve insitu	Avoid any service penetrations from adjacent spaces	Neutral
14.018	Brickwork surrounds to doorways with segmental arches over

Moderate	Increase width in selected locations to allow wheelchairs to pass	Record on measured survey drawings.  Limit interventions as far as possible.	Low

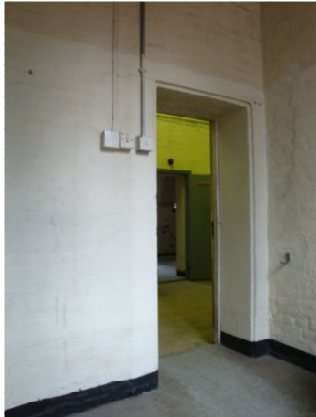
Element no.	Description	Photo ref.	Significance	Proposal	Mitigation	Impact
14.019	Granite surrounds to doorways with lintels over

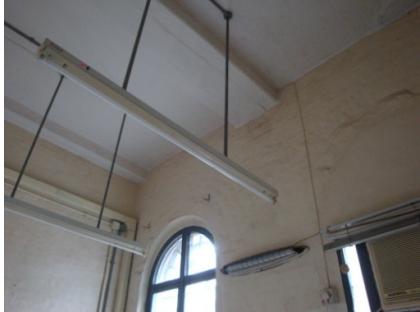
Moderate	Increase width in selected locations to allow wheelchairs to pass	Record on measured survey drawings.  Limit interventions as far as possible.	Low
14.020	Flat ceilings at Ground Floor

Low	Form penetrations for services installations where necessary	Avoid disruption of beams.	Low

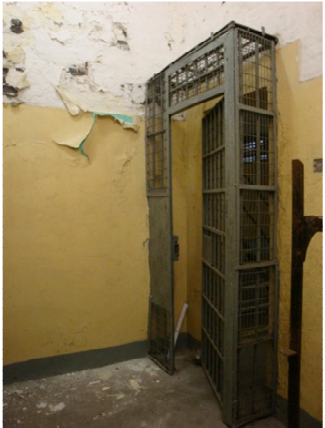
Element no.	Description	Photo ref.	Significance	Proposal	Mitigation	Impact
14.024	Inset security gate and screen in First Floor cells

Low	Remove to suit new use	Remove where necessary.  Record on measured drawings.	Low

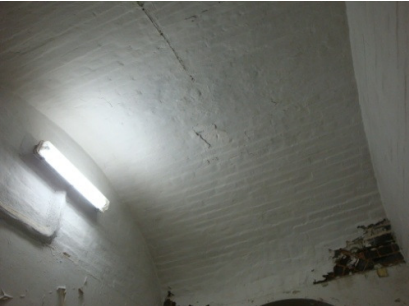
High	Retain insitu	Avoid penetrations for services	Neutral
14.034	Cell walls (later additions)

Moderate	Remove where necessary to accommodate new cafe	Record on measured drawings	Low

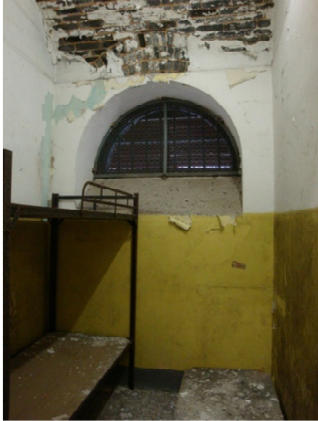
Element no.	Description	Photo ref.	Significance	Proposal	Mitigation	Impact
14.035	Brickwork spandrels below cell windows on south side at Ground Floor

Moderate	Remove to accommodate new cafe	Record on measured survey drawings	Low

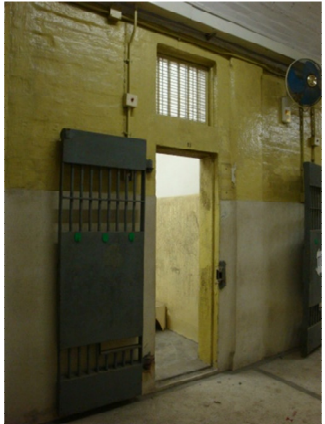
Element no.	Description	Photo ref.	Significance	Proposal	Mitigation	Impact
14.036	Cell walls flanking central hall

High	Remove to accommodate new cafe	Record on measured survey drawings.  Retain selected cells for interpretation purposes.	Moderate

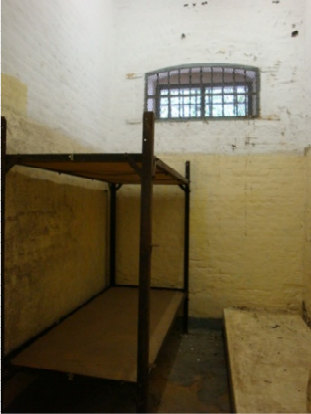
High	Retain insitu	Not applicable	Neutral
14.044	Brickwork spandrels below cell windows at Second Floor

Moderate	Remove to enable new use	Record on measured drawings.  Confine changes to one elevation, north or south.	Low

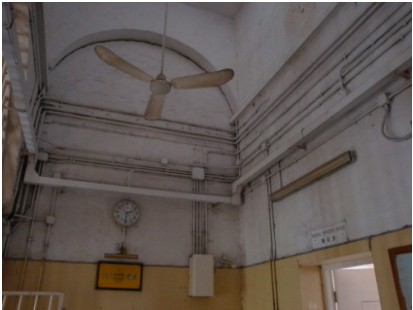
Element no.	Description	Photo ref.	Significance	Proposal	Mitigation	Impact
14.047	View ports adjacent entrance doors	 	Moderate	Retain insitu	Not applicable	Neutral
14.048	Services installations

Adverse	Remove	Not applicable	Moderate

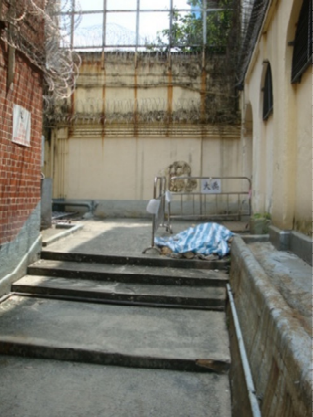
Low	Retain insitu	Not applicable	Neutral
14.052	Fence wall, east end of D Hall Yard

Low	Remove to reinstate access to granite stair to Lower Ground Floor level	Record on measured drawings	Low

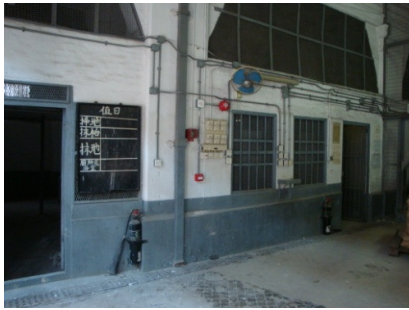
Element no.	Description	Photo ref.	Significance	Proposal	Mitigation	Impact
15.001	Dividing walls at Lower Ground Floor

Moderate	Remove to enable multi-purpose use	Record on measured survey drawings	Low
15.002	Dividing walls at Lower Ground Floor

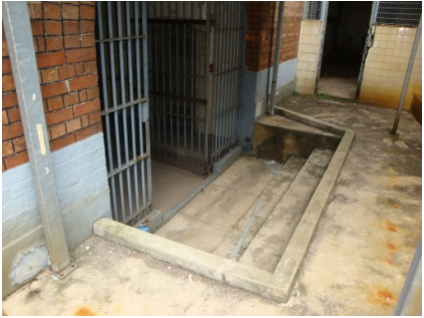
Element no.	Description	Photo ref.	Significance	Proposal	Mitigation	Impact
15.006	Raised ground level adjacent entrance

Low	Remove to enable level access	Record on measured survey drawings	Low
15.007	Access balconies and apertures

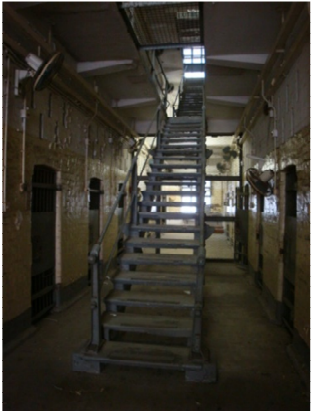
Element no.	Description	Photo ref.	Significance	Proposal	Mitigation	Impact
15.008	Central staircase

High	Retain	Provide secondary staircase within cell blocks to achieve code compliance	Low

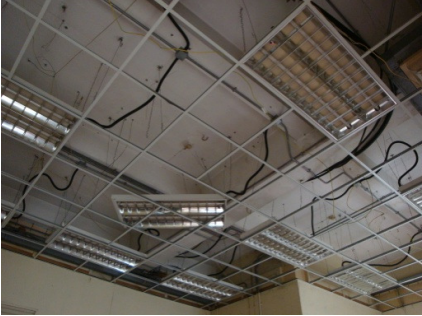
Element no.	Description	Photo ref.	Significance	Proposal	Mitigation	Impact
17.001	Lay-in grid suspended ceiling

Adverse	Remove	Not applicable	High

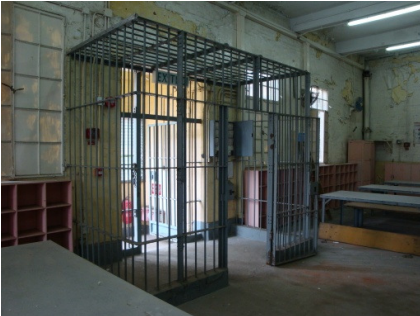
Element no.	Description	Photo ref.	Significance	Proposal	Mitigation	Impact
17.006	Security screen at First Floor entrance

Low	Remove	Record on measured drawings	Low
17.007	Metal windows

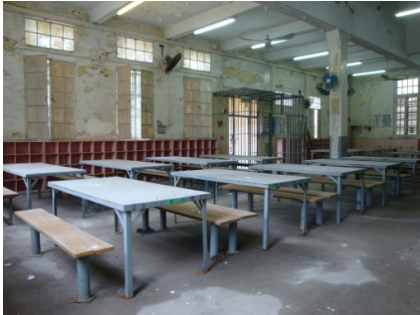
Element no.	Description	Photo ref.	Significance	Proposal	Mitigation	Impact
17.008	Fixed furniture

Moderate	Remove to accommodate gallery space	None	Low
17.009	Security screens

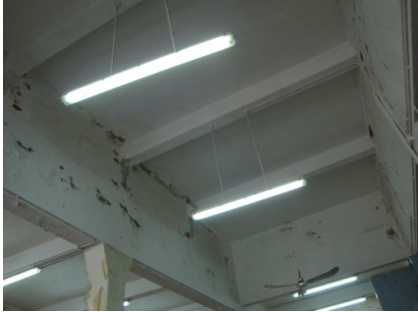
Element no.	Description	Photo ref.	Significance	Proposal	Mitigation	Impact
17.012	Blocked up lantern light

Low	Unblock lantern and fit glazing	Record on measured drawings	Low
17.013	Security gates at Ground openings

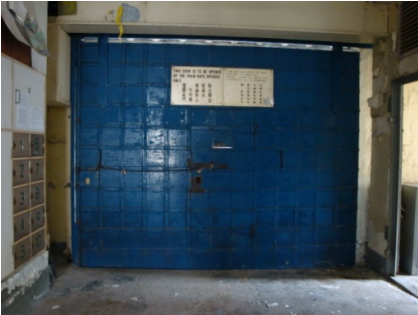
Element no.	Description	Photo ref.	Significance	Proposal	Mitigation	Impact
17.018	Blue Entrance Gate (facing Old Bailey Street)

High	Retain in situ	Maintain in working order	Neutral
17.019	Blue Entrance Gate (inner) and enclosed yard

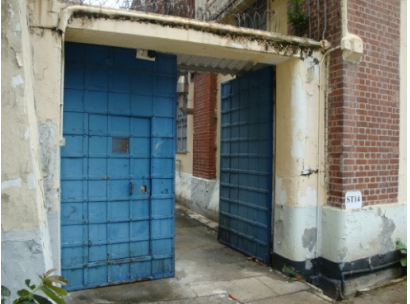
Element no.	Description	Photo ref.	Significance	Proposal	Mitigation	Impact
17.020	Blue Entrance Gate (inner) facing Prison Yard

Moderate	Retain gate and enclosing frame	Repair and maintain in working order	Low

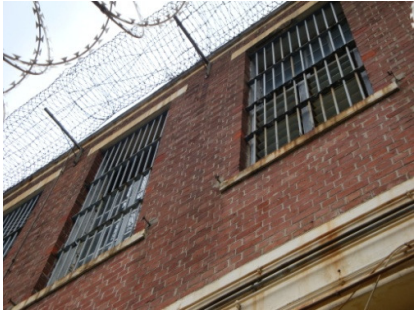
Element no.	Description	Photo ref.	Significance	Proposal	Mitigation	Impact
17.022	Metal security bars at windows

Moderate	Remove as part of blocking up window openings to accommodate gallery space at First Floor	Record on measured drawings	Low
17.023	External toilets at Ground Floor adjacent East elevation

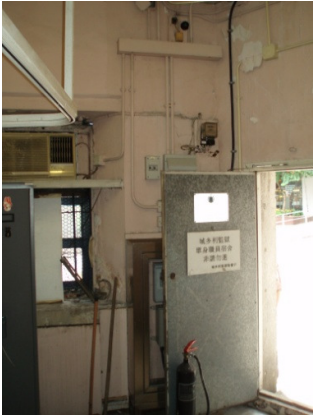
Element no.	Description	Photo ref.	Significance	Proposal	Mitigation	Impact
19.009	Electrical services

Adverse	Remove	Not applicable	Moderate
19.010	Lay-in grid suspended ceiling
